Millstone Farm

Site Walk Photos

April 17, 2019

The purpose of this visit was to look at the
condition of the existing trails and Millstone's
new trail

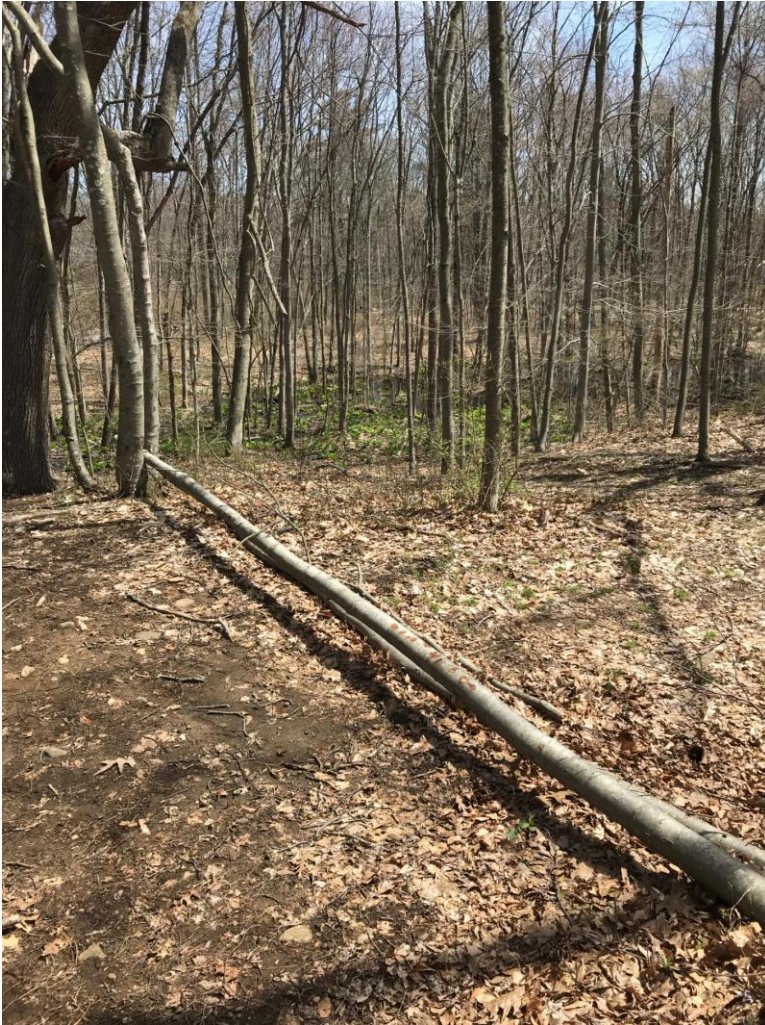
- A. First section of the existing trail (as shown on the Updated Schedule B Map) that has been blocked with these logs. These logs were cut & placed here clearly to direct people to Millstone's new trail.

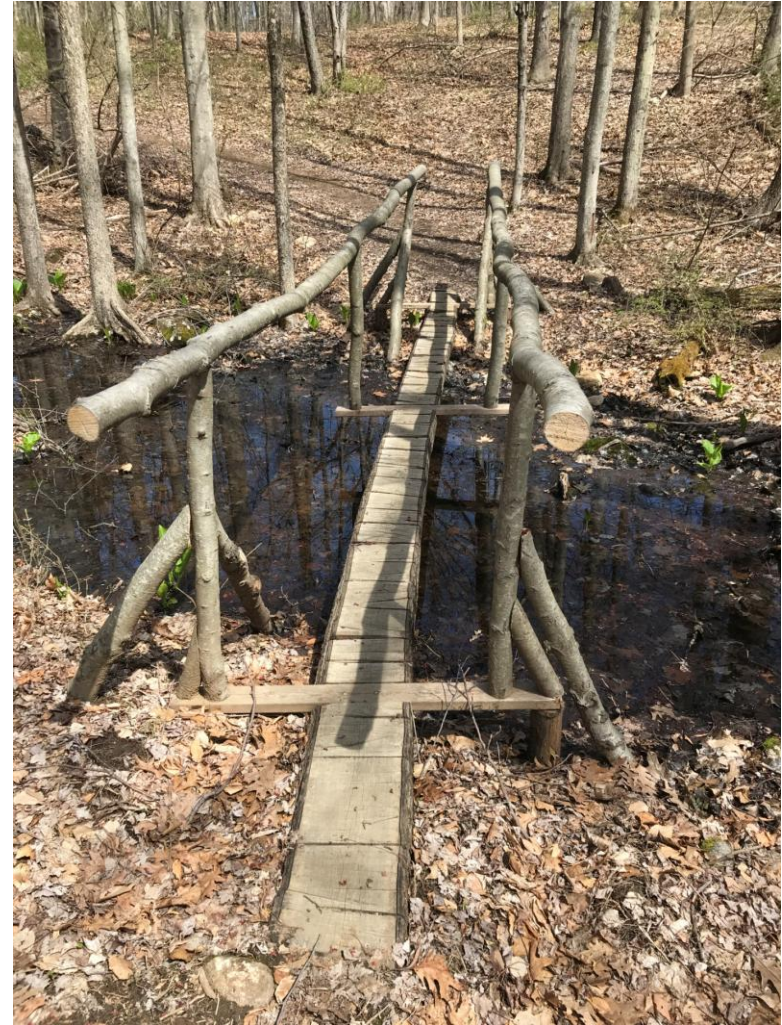
- B. One of two (2) bridges along Millstone's new trail. This water crossing is simply half of a log with some supporting hand rails. This type of crossing will likely rot quicker than if it was pressure treated wood.

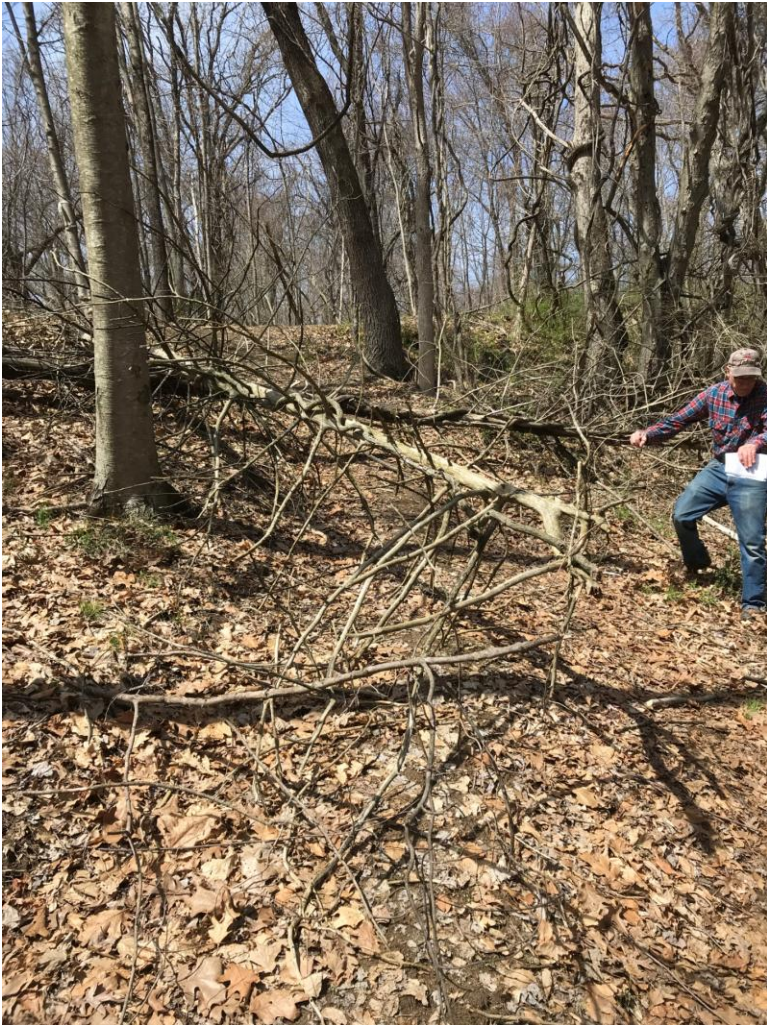
C. Millstone's new trail already blocked by a fallen dead tree.

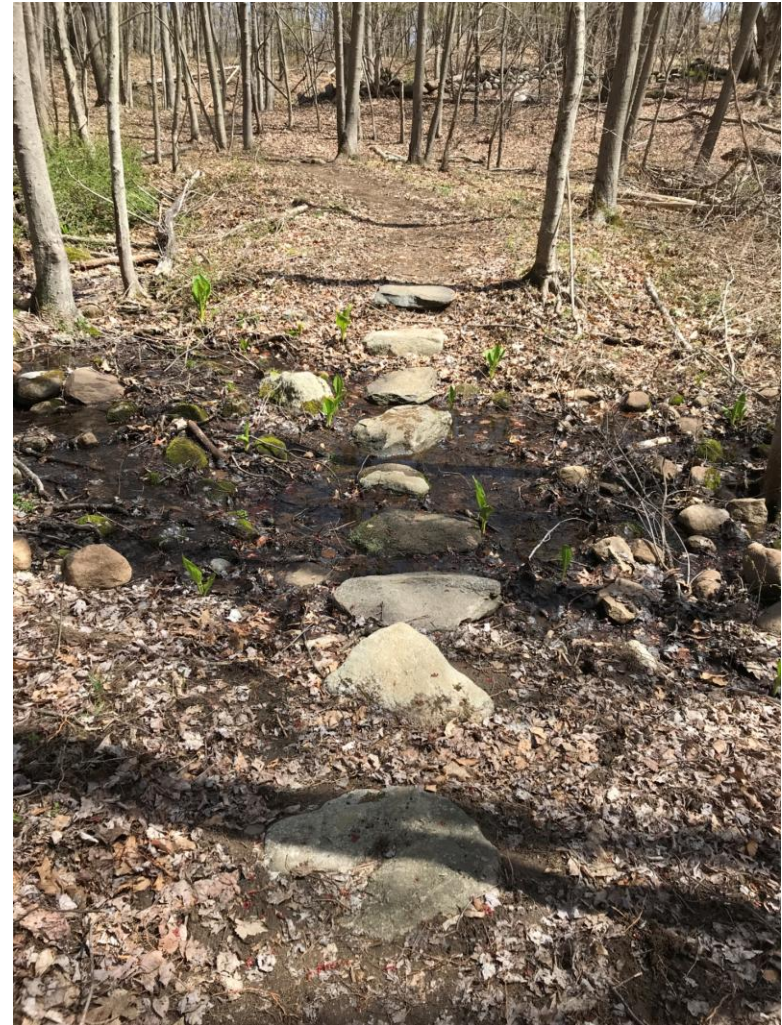
D. The placement of stepping stones seems to be done without regard to the physical abilities of an average hiker/walker.

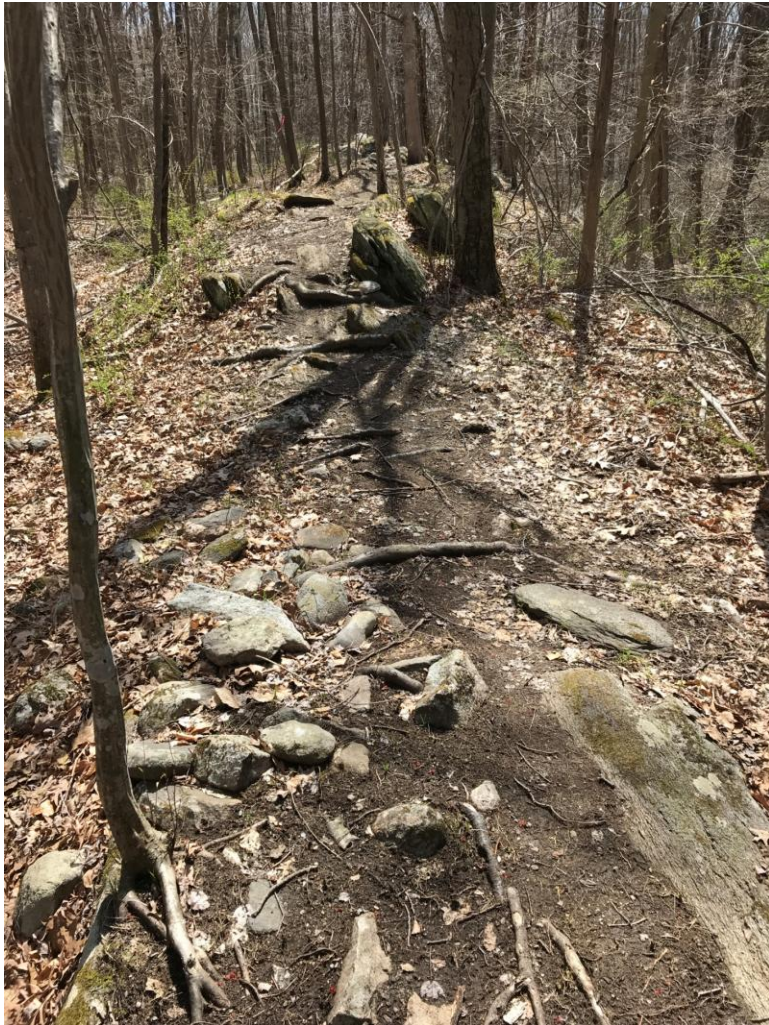
E. This trail section was designed to be difficult to walk with the roots, rocks etc.

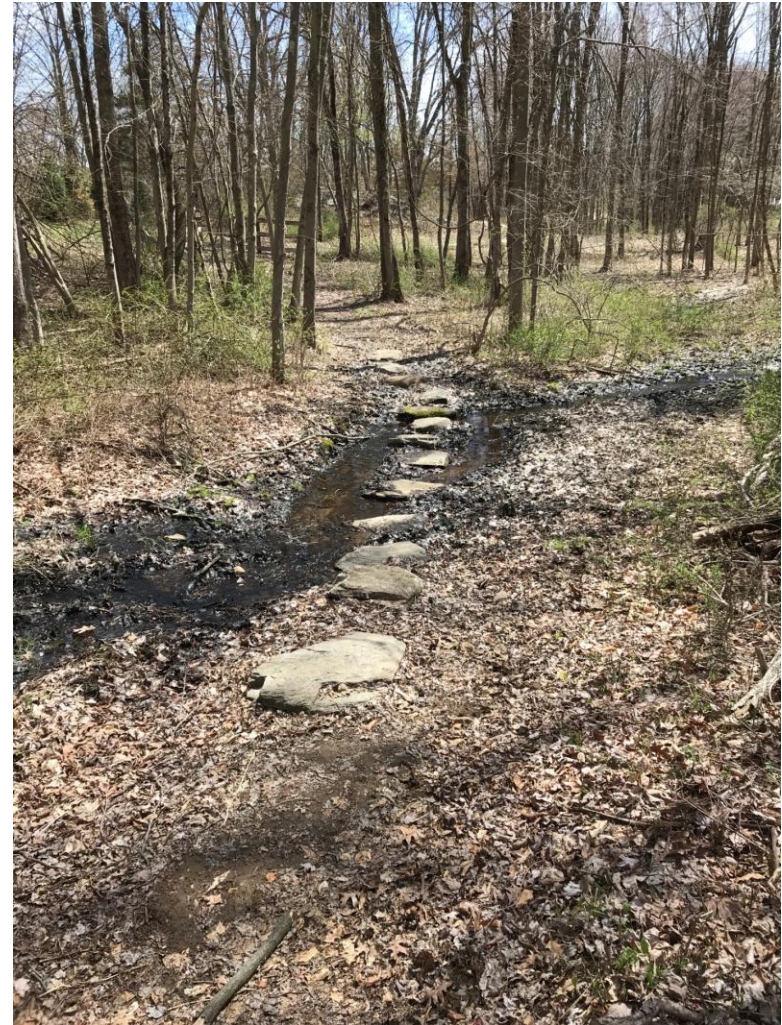
F. The placement of stepping stones seems to be done without regard to the physical abilities of an average hiker/walker.

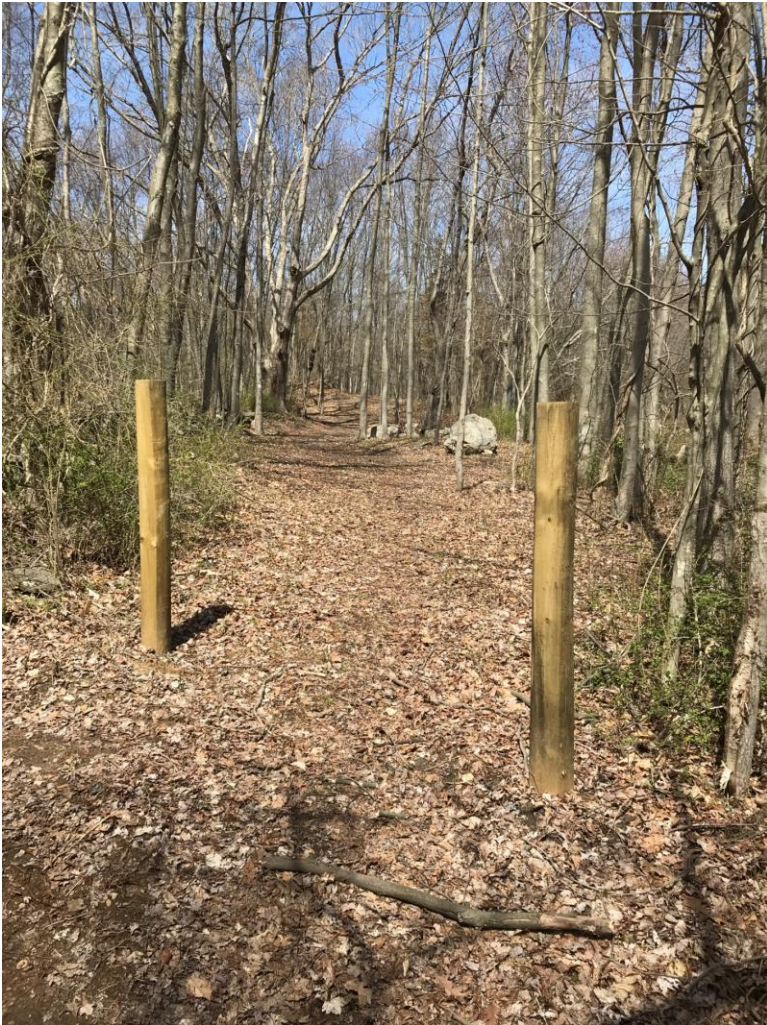
G. This section of the existing trail (as shown on the Updated Schedule B Map) looks like it is planned to be blocked with fencing given the installation of these fence posts.

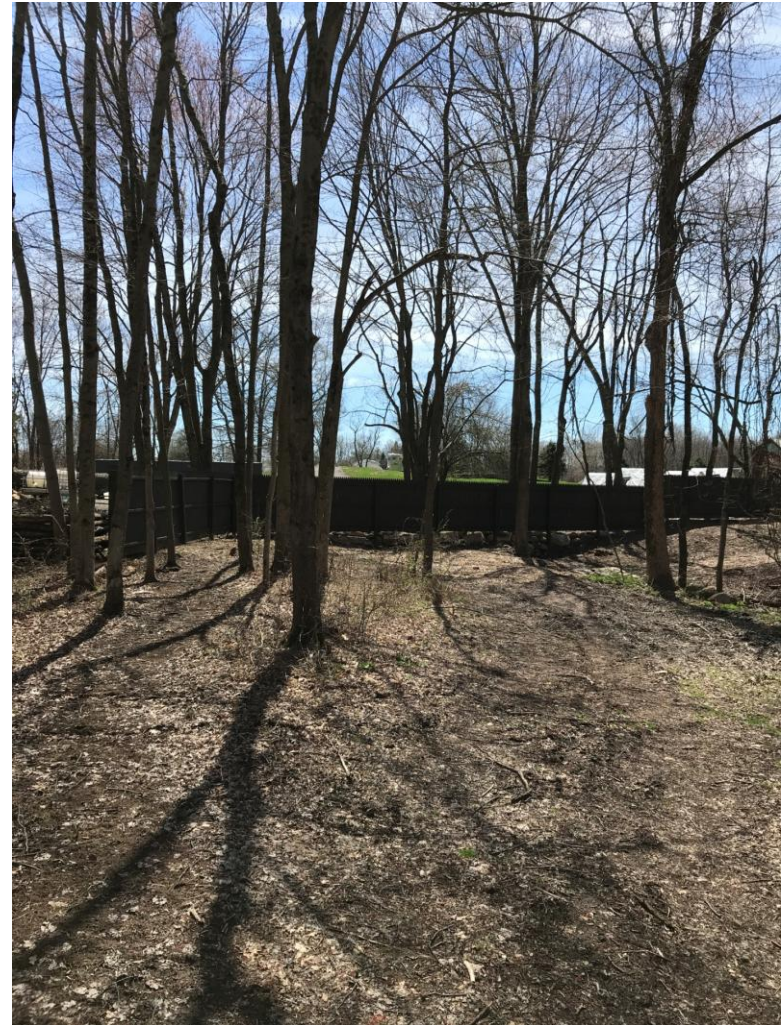
H. This section of the existing trail (as shown on the Updated Schedule B Map) that has been blocked with a large stockade fence.

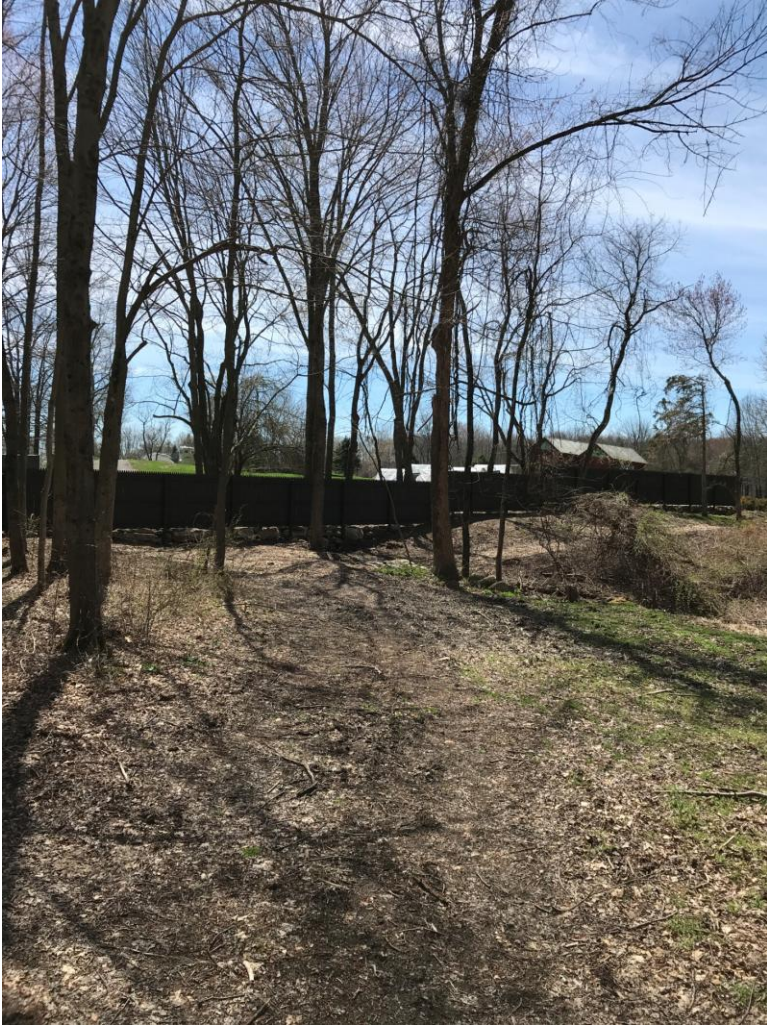
I. This section of the existing trail (as shown on the Updated Schedule B Map) that has been blocked with a large stockade fence.

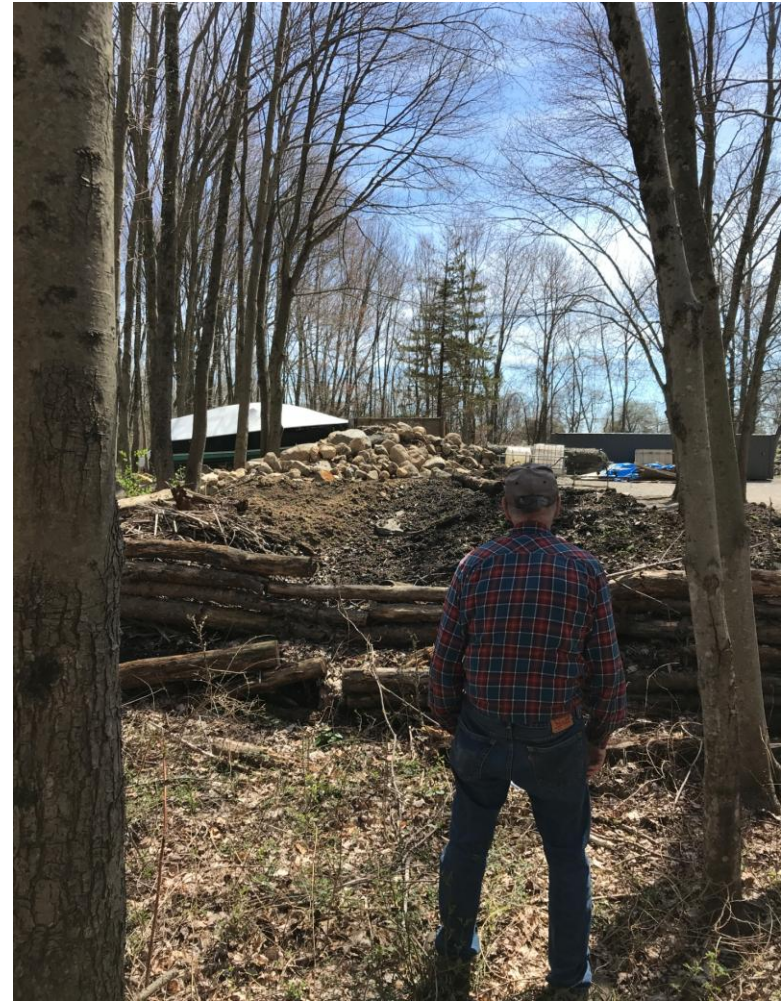
J. Unsightly materials storage area and a recreational boat stored in the protected property.

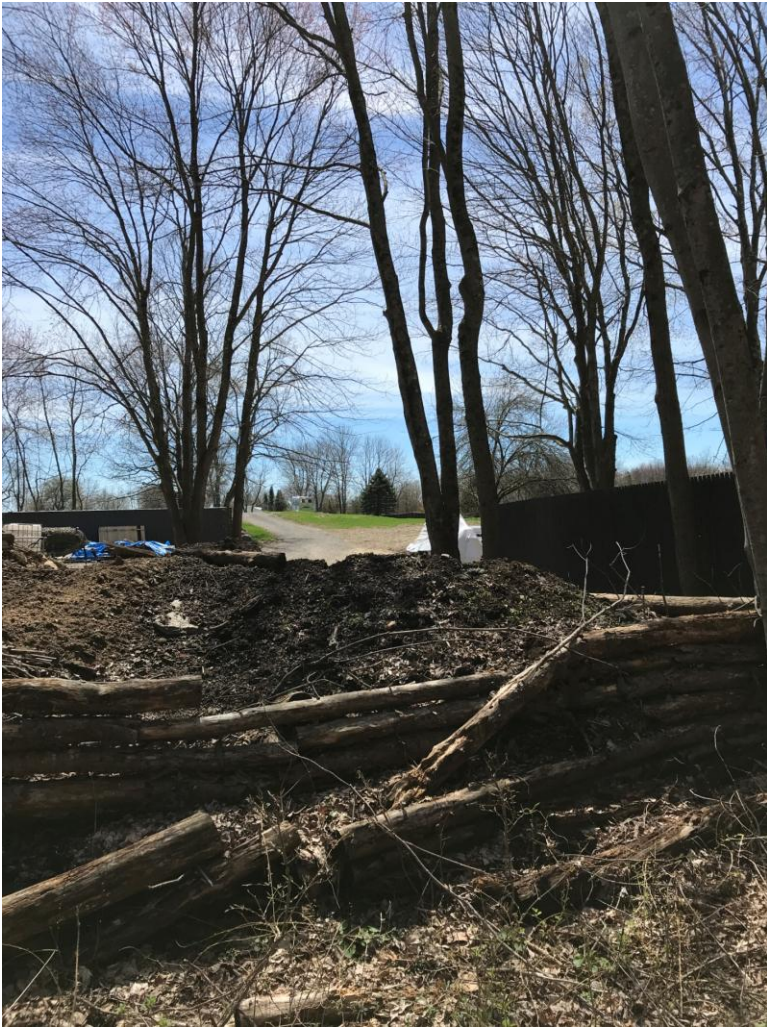
K. Export containers are stored on the protected property.

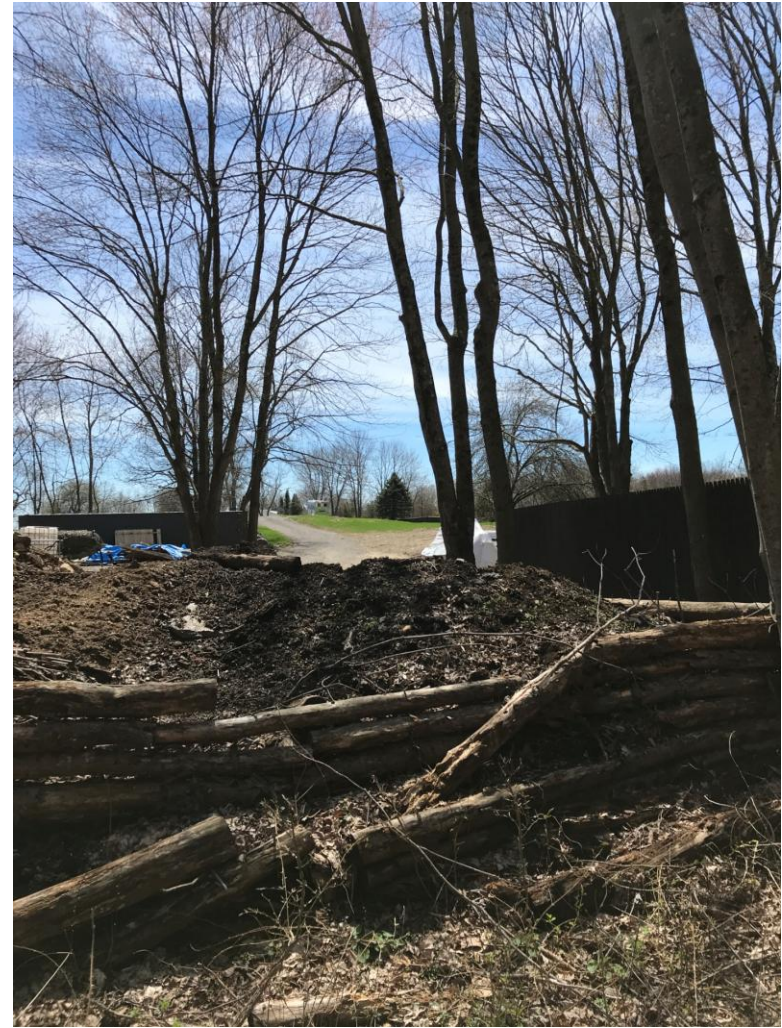
L. Export containers are stored on the protected property.

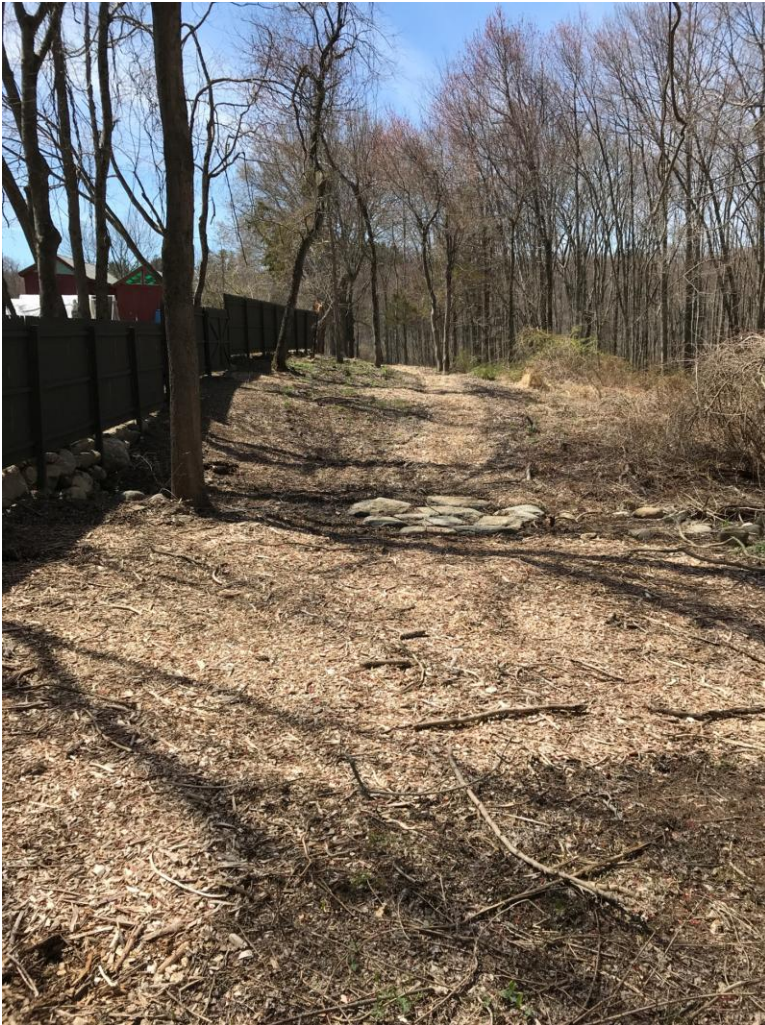
M. View showing long stockade fencing which limits views of the fields from Millstone's new trail.

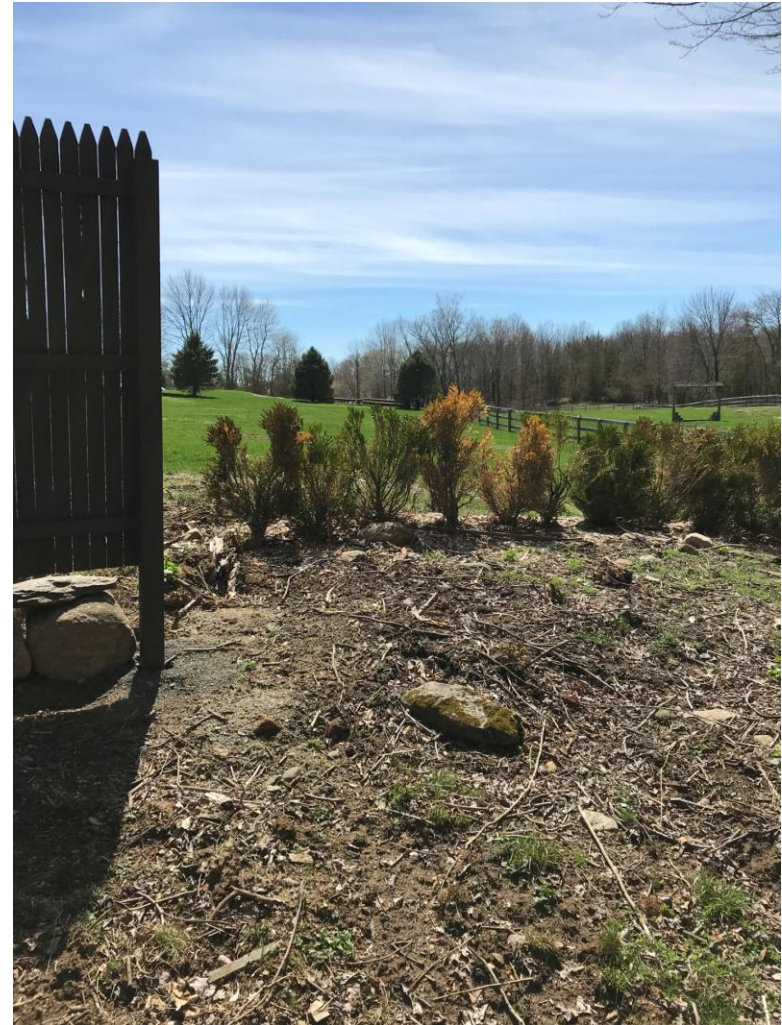
N. View showing a new hedge row where land was cleared for views. This will limit views of the fields from Millstone's new trail.

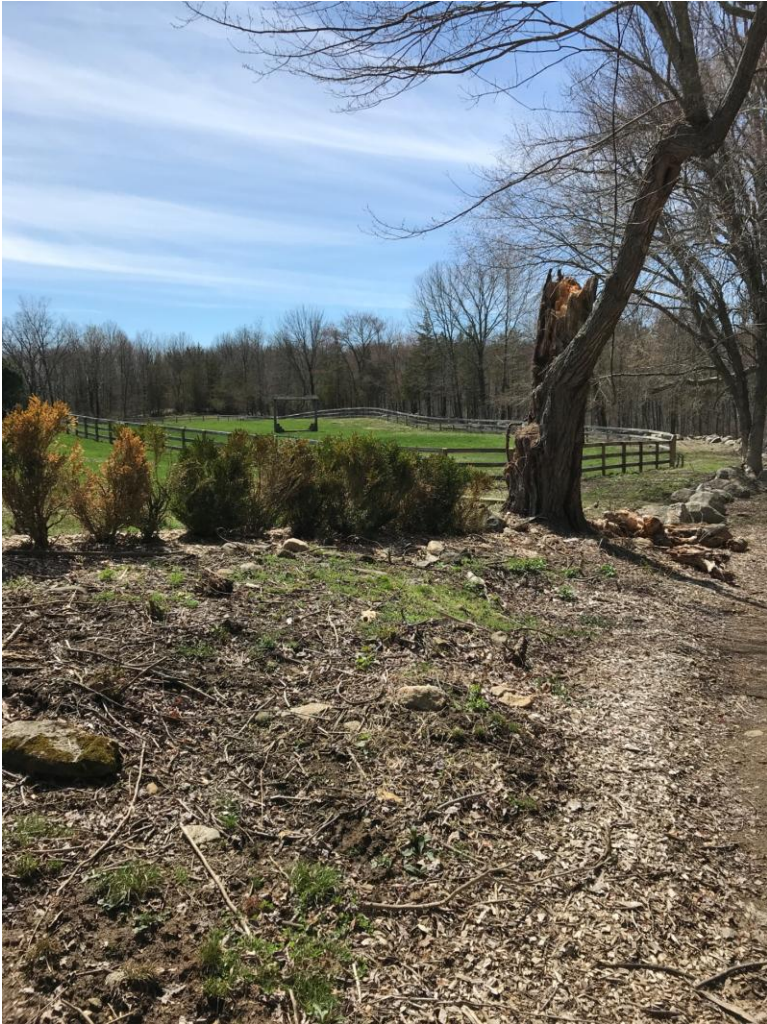
O. View showing a new hedge row where land was cleared for views. This will limit views of the fields from Millstone's new trail.

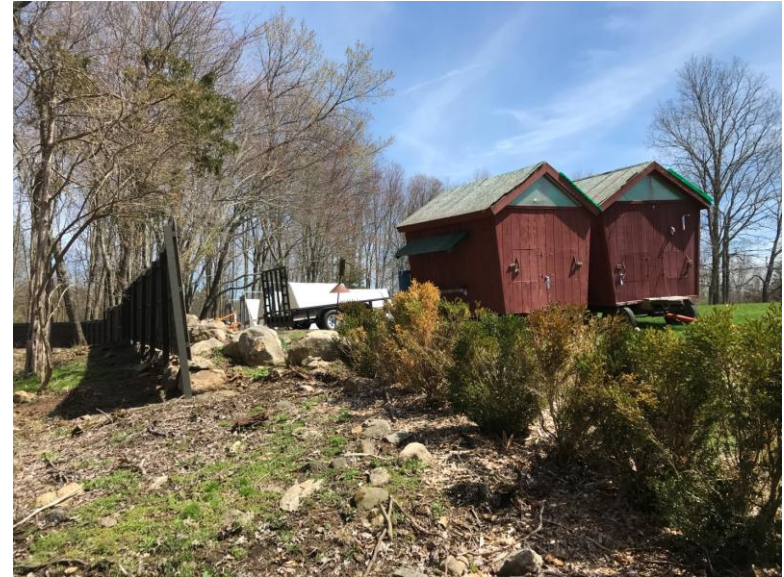
P. View showing a new hedge row where land was cleared for views. This will limit views of the fields from Millstone's new trail.

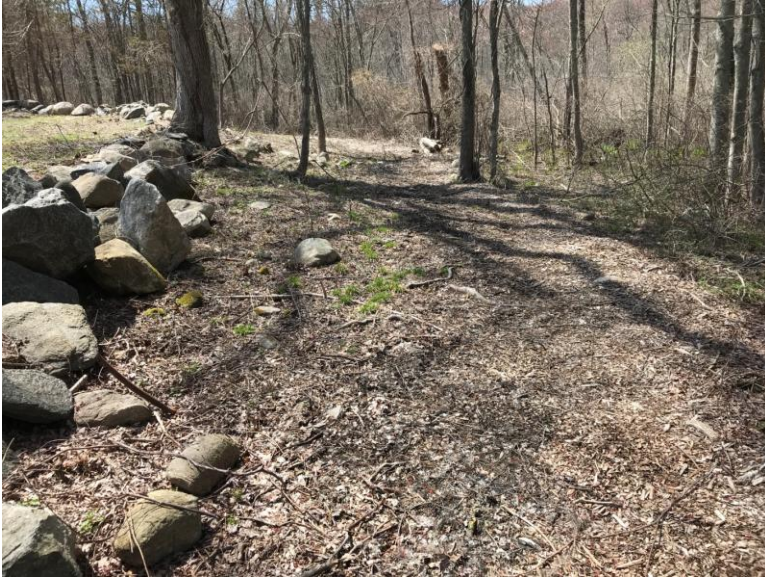
Q. This section of Millstone's new trail was very wet and muddy because it was constructed in a wetland. This area is essentially impassable unless a hiker wears high waterproof boots.

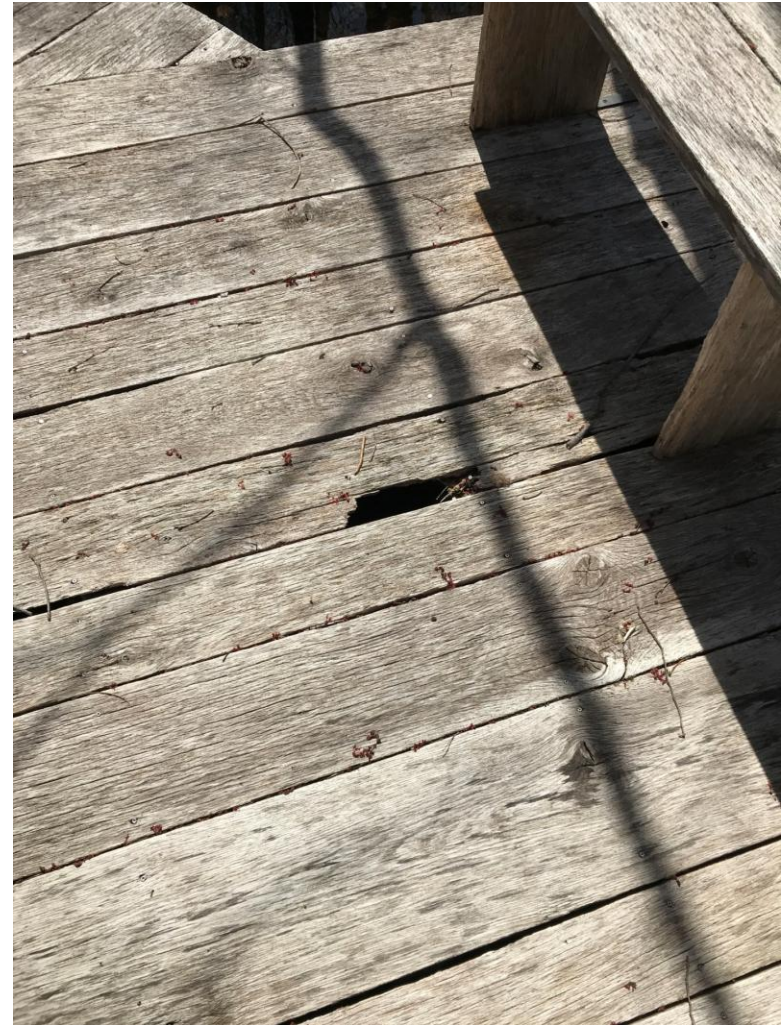
R. Pieces of the existing boardwalk are rotten to the point where holes are forming.

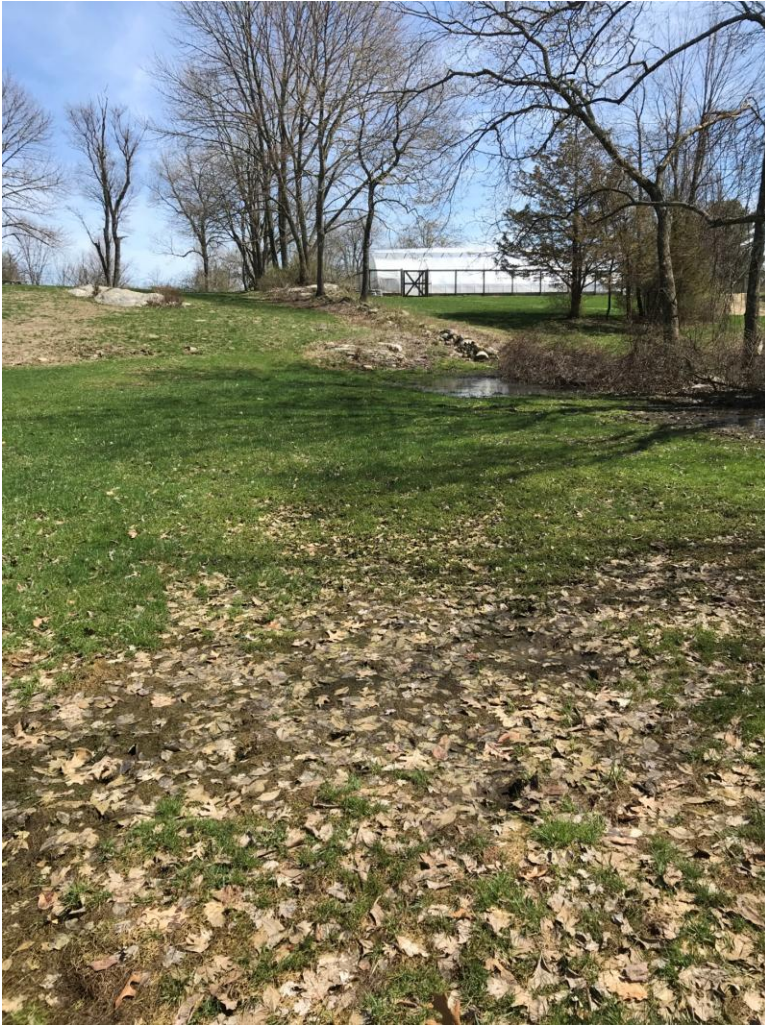
S. The existing trail (as shown on the Updated Schedule B Map) has not been cleared and marked. This shows an area where the trail should be defined and marked as per the Conservation Restriction Amendment.

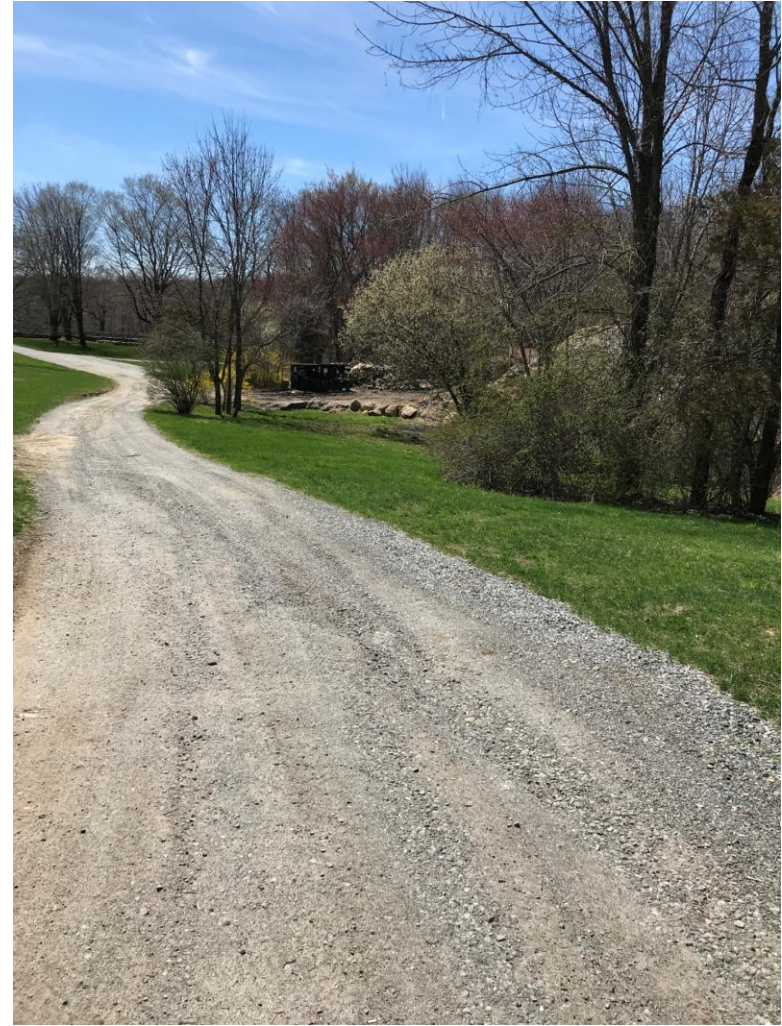
T. The existing trail (as shown on the Updated Schedule B Map) has not been cleared and marked. This shows an area where the trail should be defined and marked as per the Conservation Restriction Amendment.

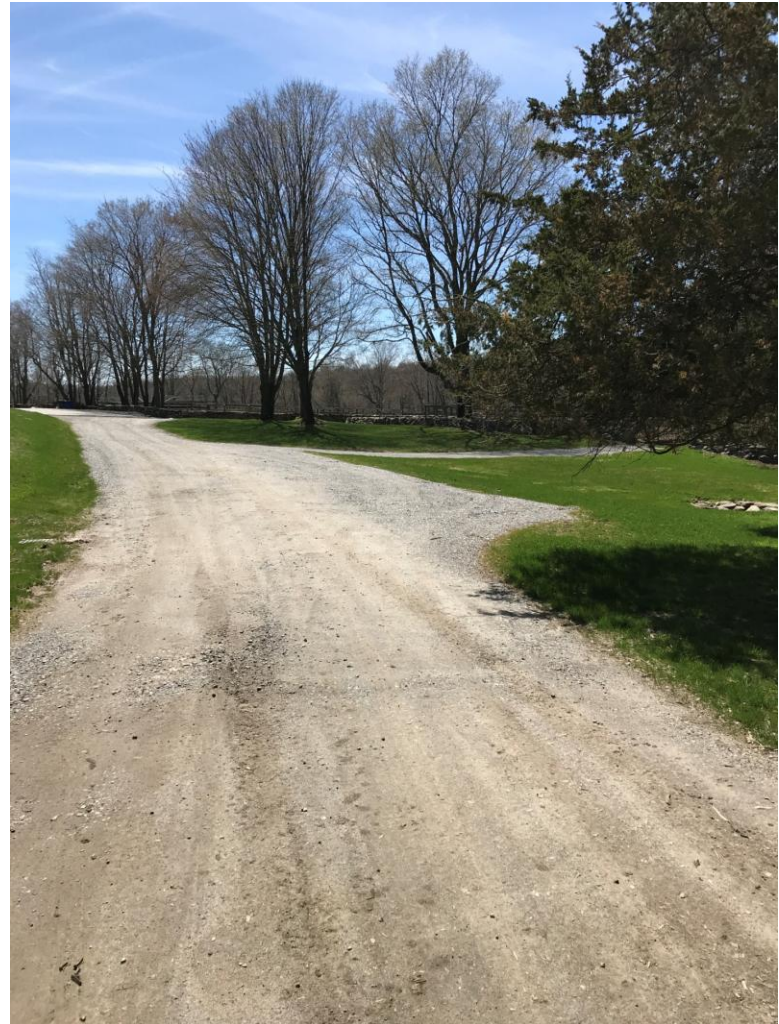
V. The existing trail (as shown on the Updated Schedule B Map) has not been cleared and marked. This shows an area where the trail should be defined and marked as per the Conservation Restriction Amendment.

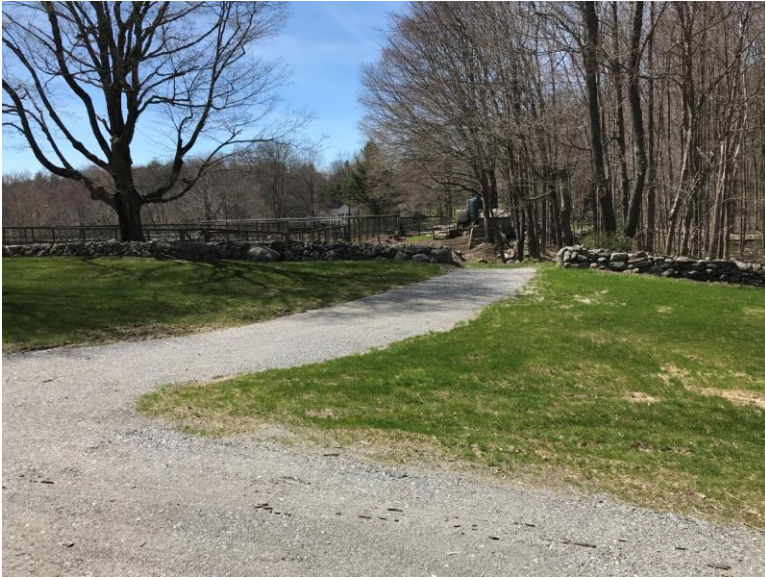
W. The existing trail (as shown on the Updated Schedule B Map) has not been cleared and marked. This shows an area where the trail should be defined and marked as per the Conservation Restriction Amendment.

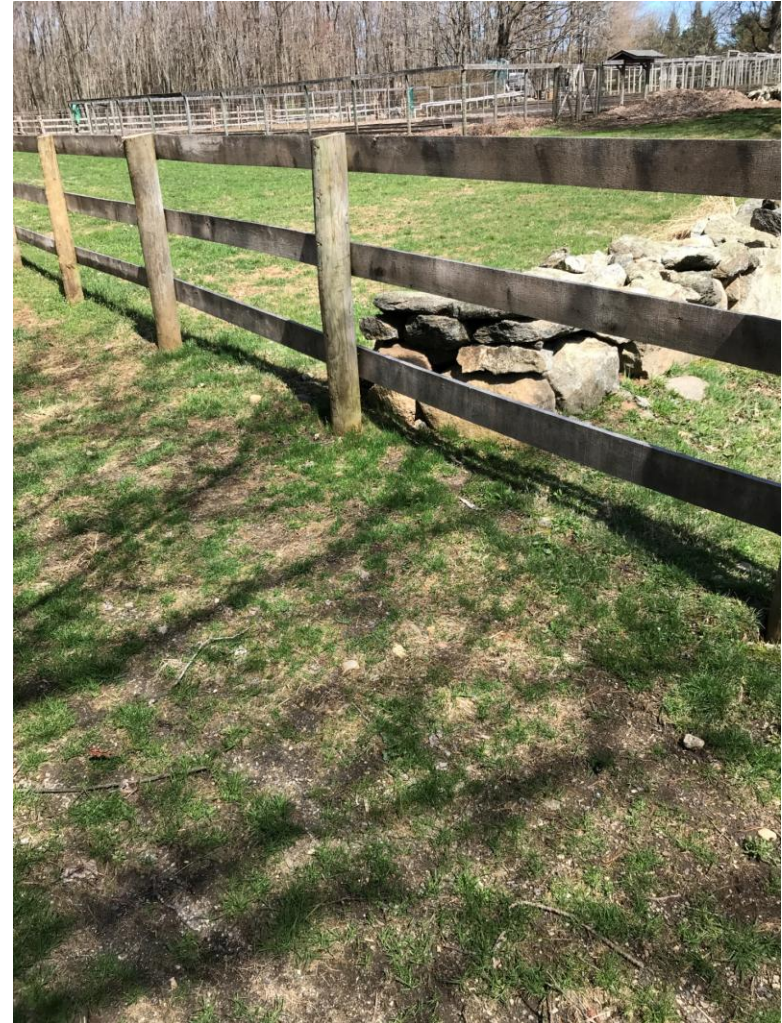
X. This section of the original stonewall has been removed.

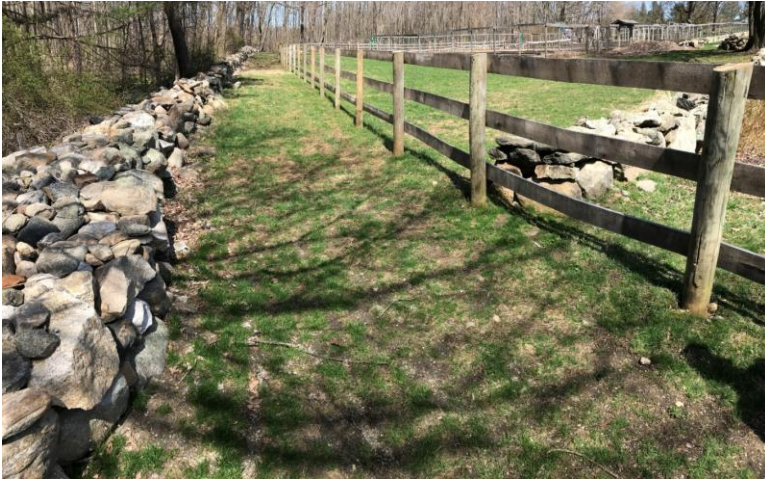
Y. The existing trail (as shown on the Updated Schedule B Map) has not been cleared and marked. This shows an area where the trail should be defined and marked as per the Conservation Restriction Amendment.

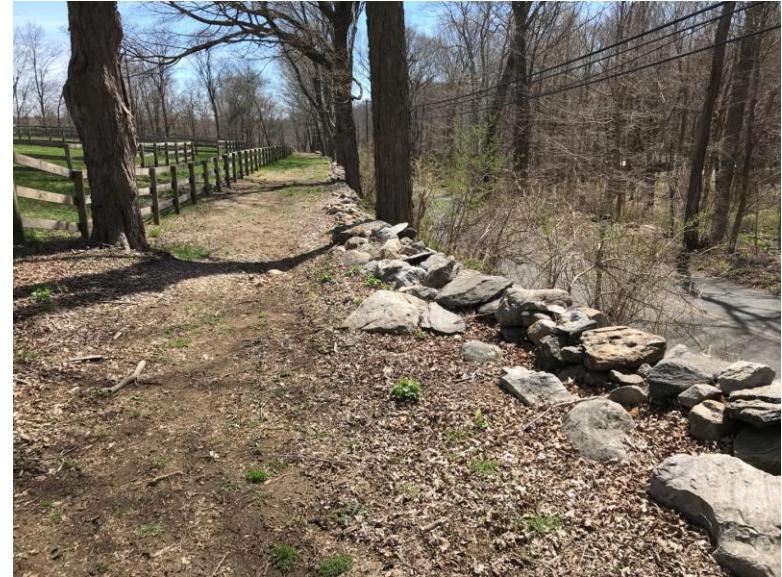
Z. The existing trail (as shown on the Updated Schedule B Map) has not been cleared and marked. This shows an area where the trail should be defined and marked as per the Conservation Restriction Amendment.

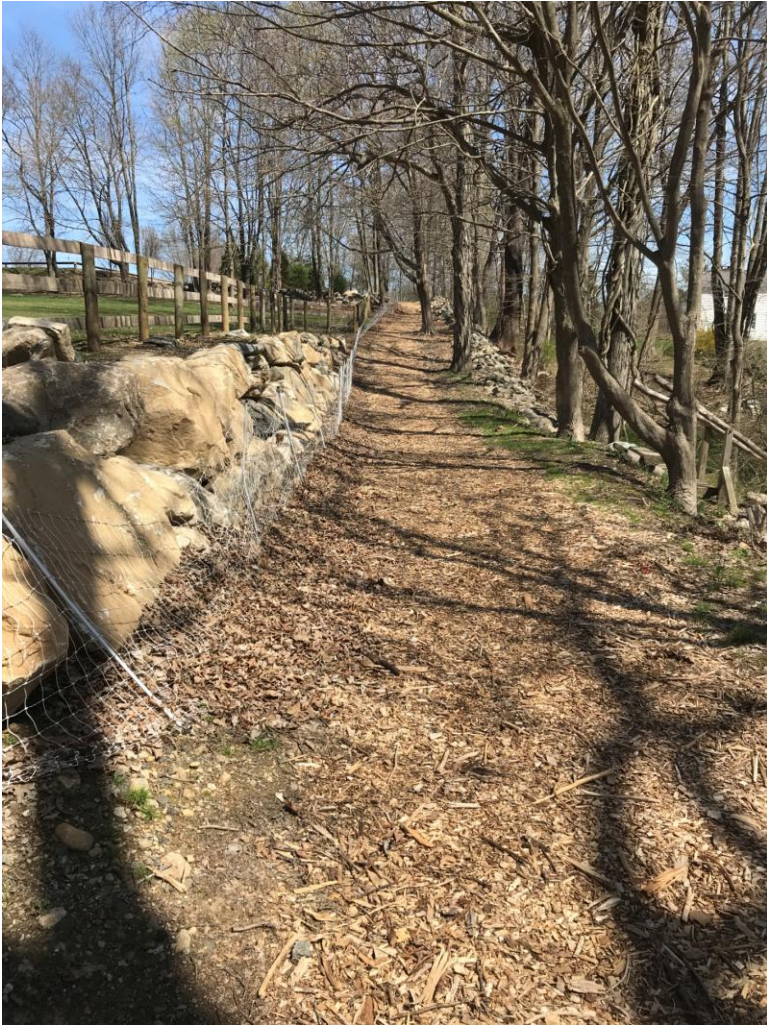
AA. The topography in this area was altered. Fill material was added across this field and a retaining was constructed. This raised the grades several feet and is prohibited in the Conservation Restriction. See Section 2.1(b) Prohibition of Earth Altering Activities.

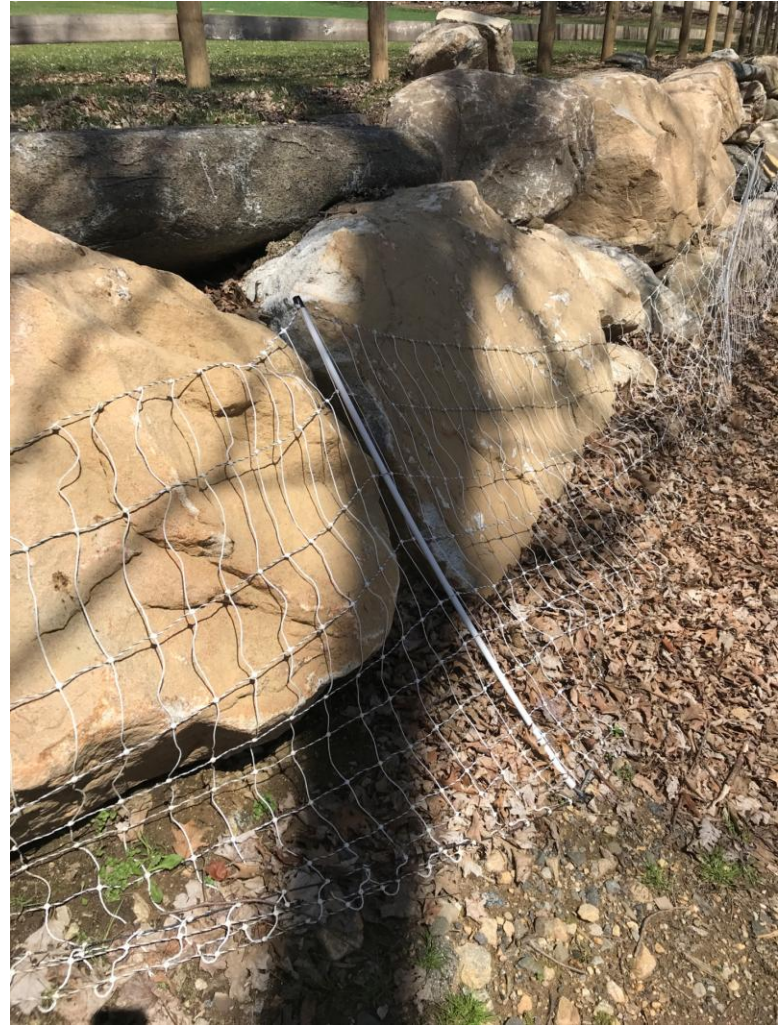
BB. This electric fence was placed along Millstone's new trail and the existing trail (as shown on the Updated Schedule B Map) has not been marked. An electric fence should not be located along a trail designed for public recreation.

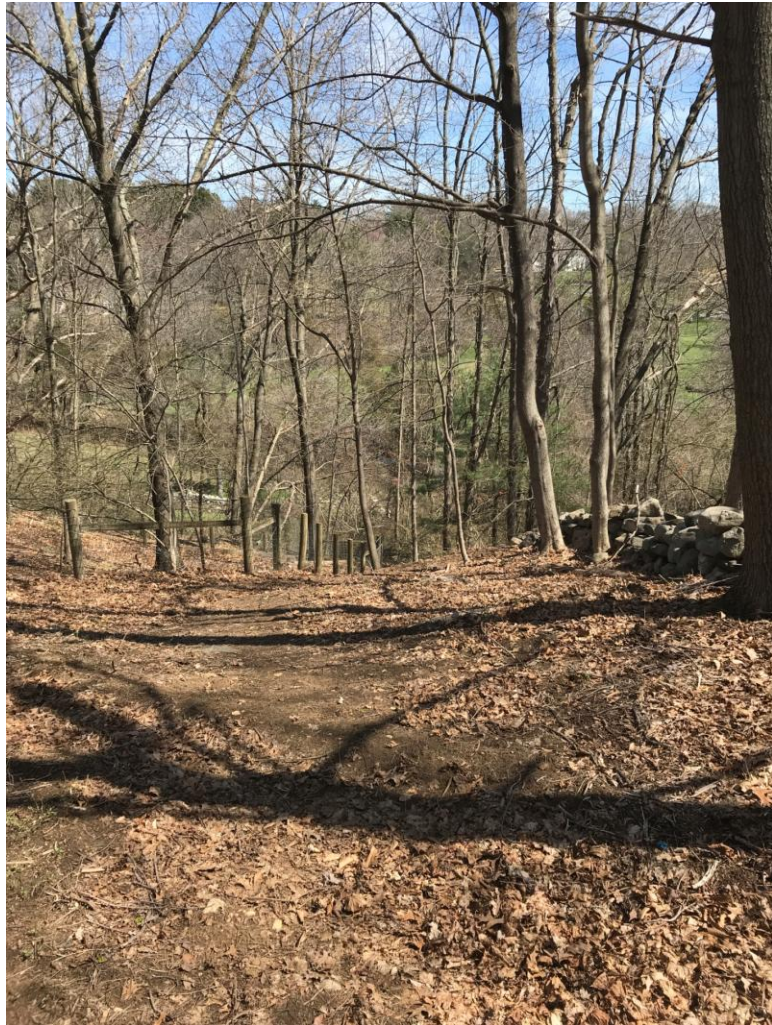
CC. The grades of Millstone's new trail in this area are extremely steep. This will result in future erosion and the trail is barely able to be walked especially when covered with leaves.

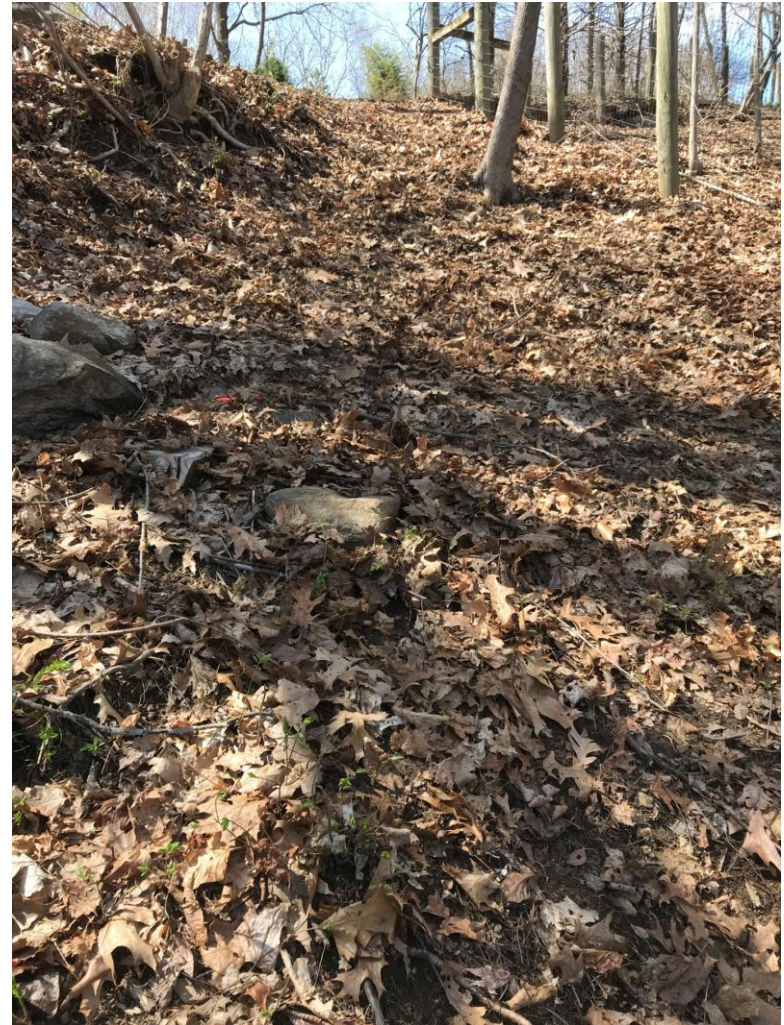
DD. The grades of Millstone's new trail in this area are extremely steep. This will result in future erosion and the trail is barely able to be walked especially when covered with leaves.

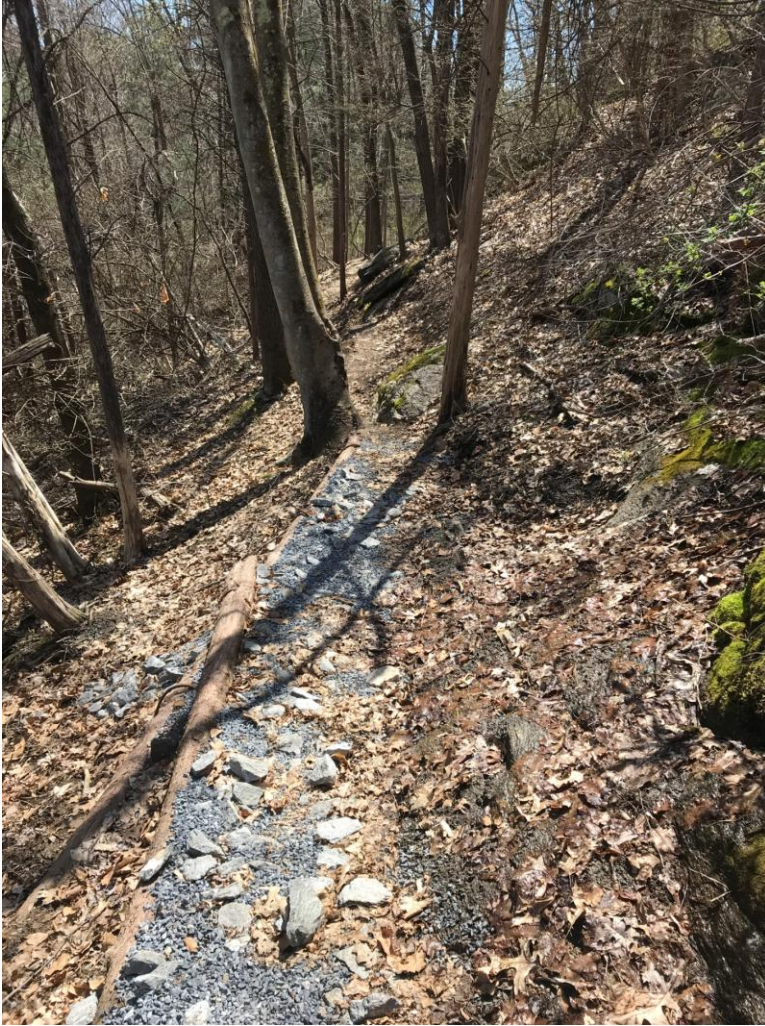
EE. Trails in general are too narrow and not even susceptible to two persons walking side by side.
