Millstone Farm

Site Walk Photos

April 17, 2019

The purpose of this visit was to look at the
condition of the existing trails and Millstone's
new trail

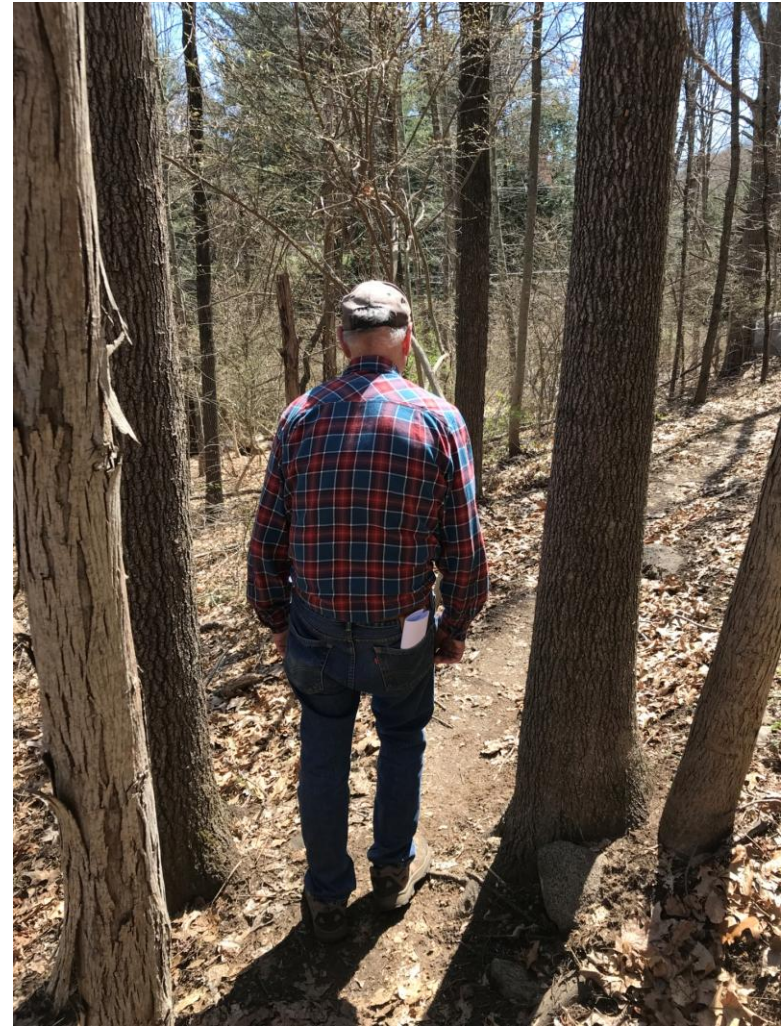
FF. Trails in general are too narrow and not even susceptible to two persons walking side by side.

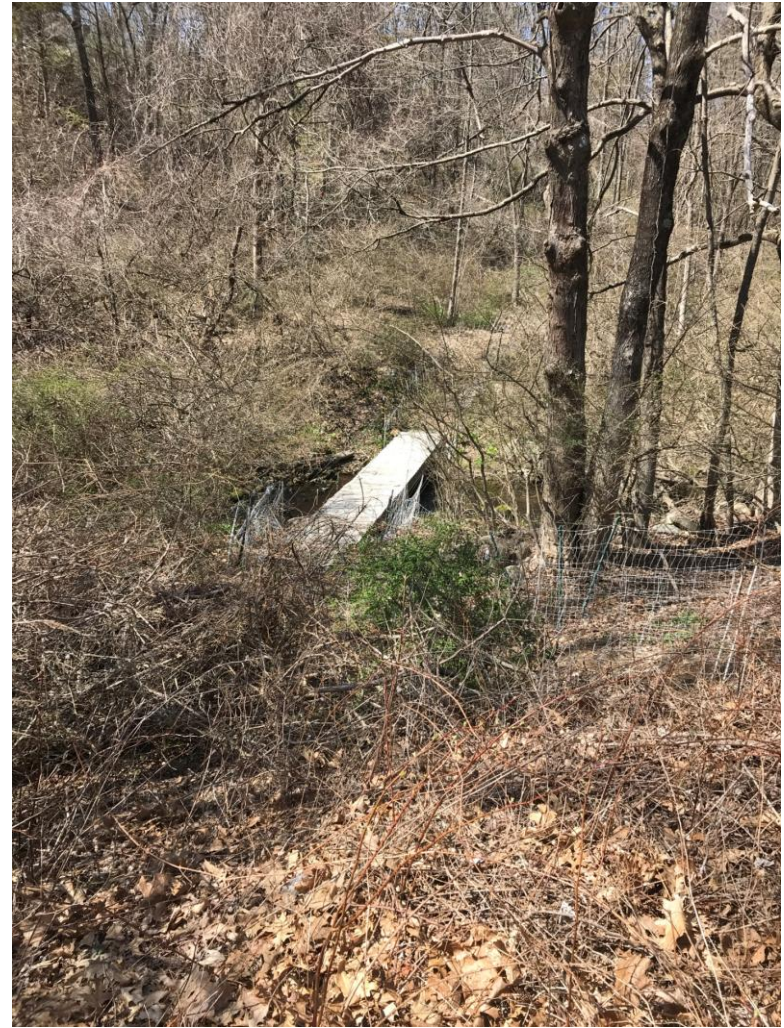
HH. Older bridge where the existing trail (as shown on the Updated Schedule B Map) is supposed to be cleared and marked.

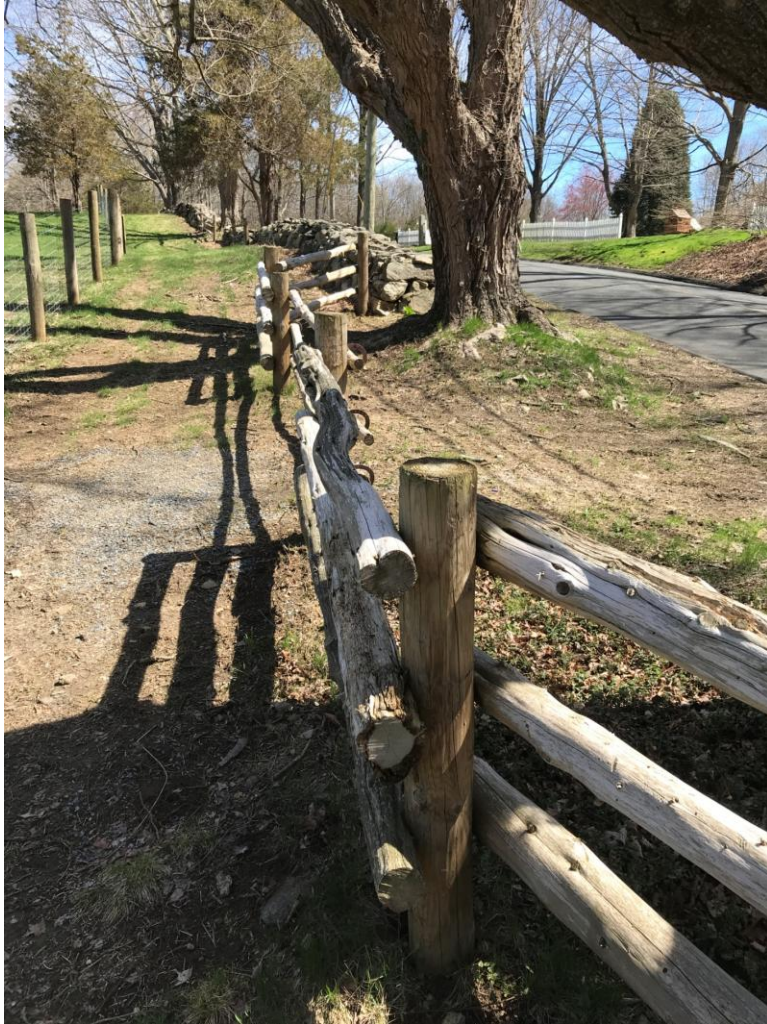
II. Access to the public trail from Millstone Road is blocked by this farm fence.

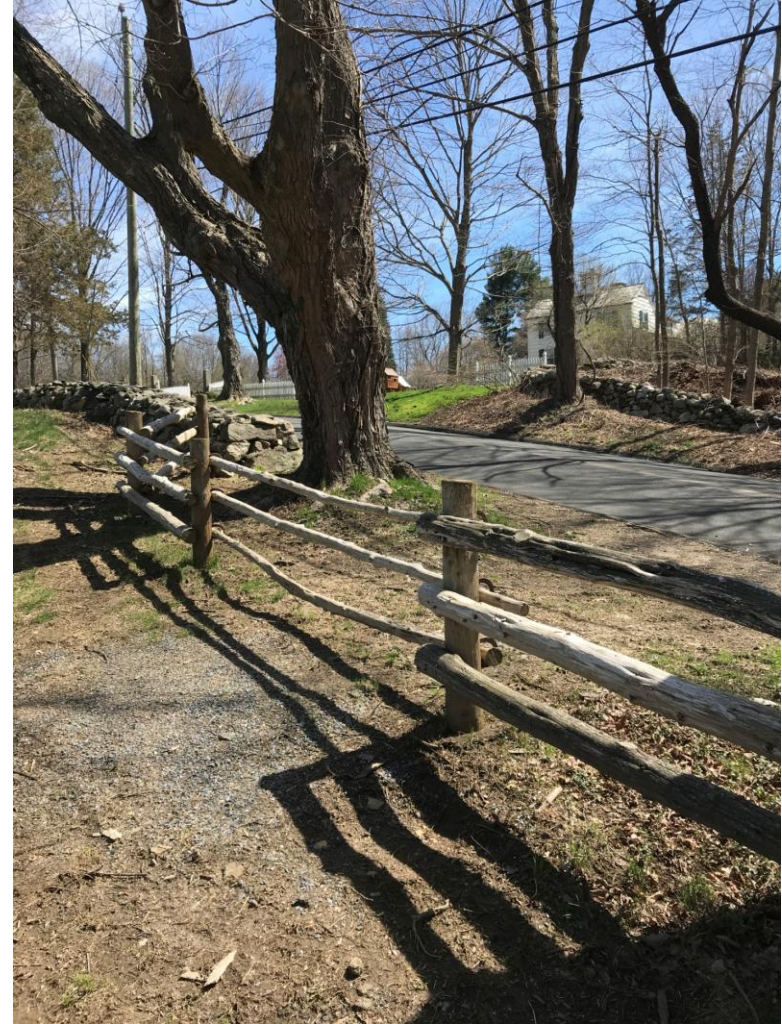
JJ. Access to the public trail from Millstone Road is blocked by this farm fence.

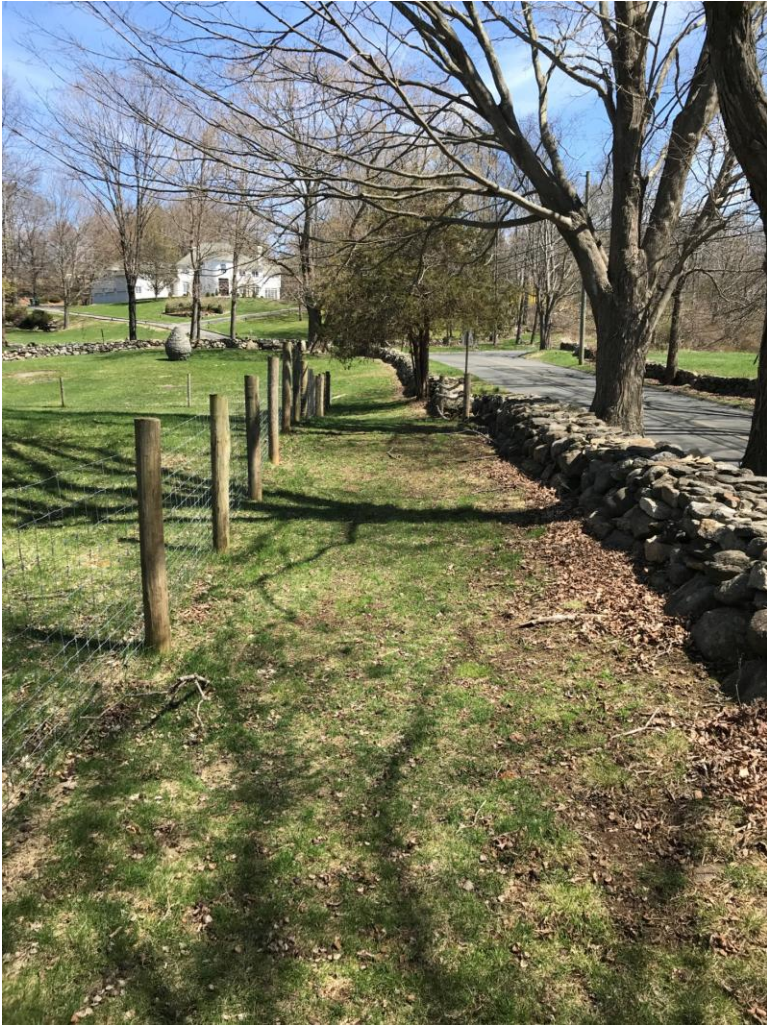
KK. The existing trail (as shown on the Updated Schedule B Map) has not been cleared and marked.
