**47 Mollbrook Drive**

Photos from Site Inspection on 1/22/2021

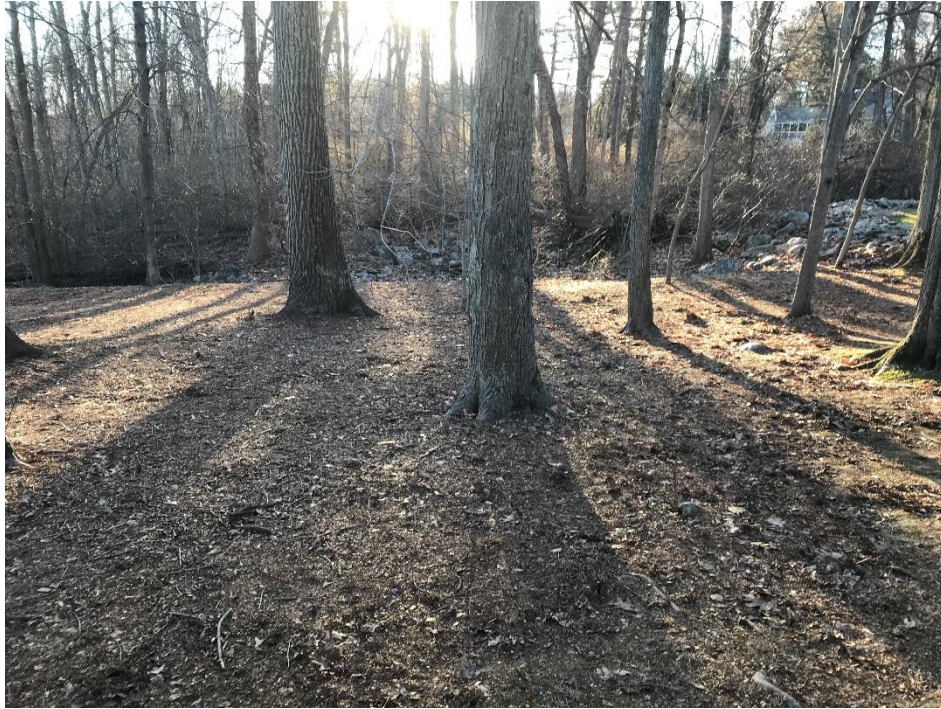
A. Photos of cleared area facing Southeast with watercourse in the distance.

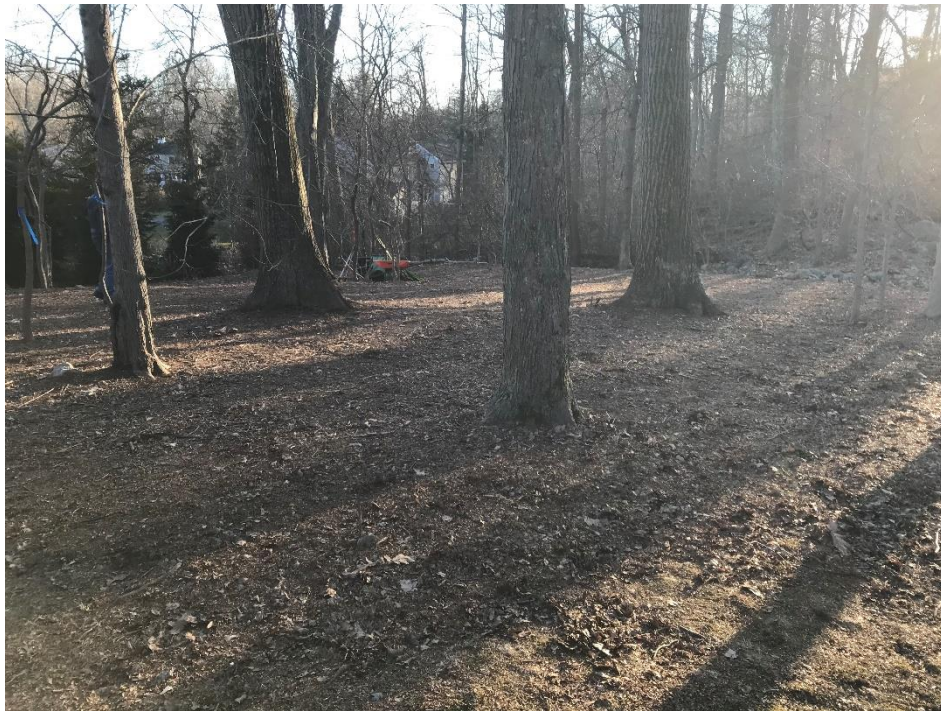
B. Photos of cleared area facing South with watercourse in the distance.

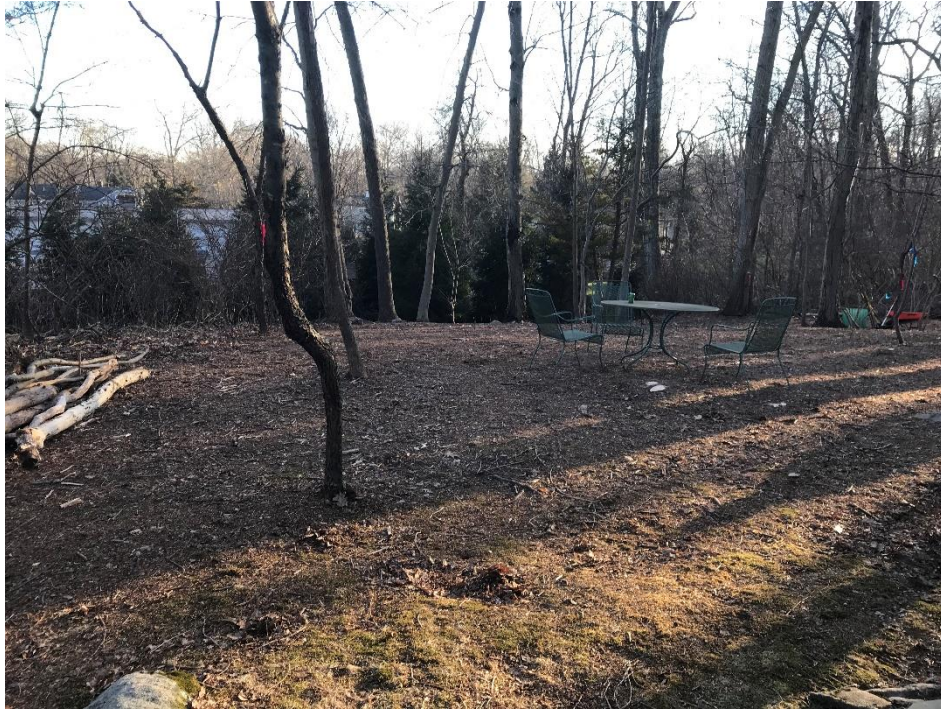
C. Photo of cleared area facing Southwest.

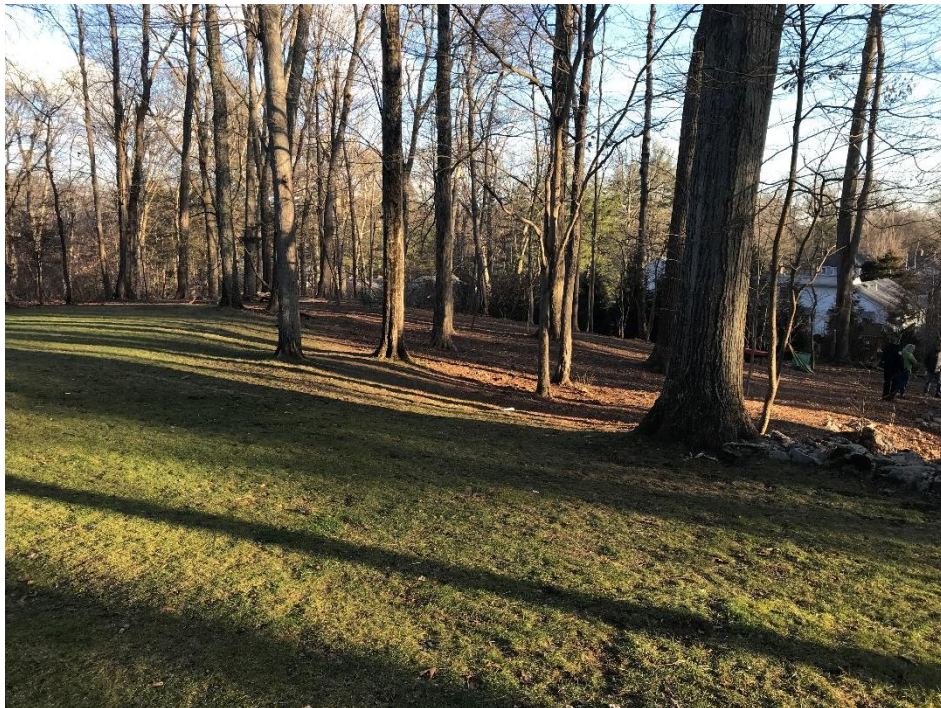
D. Photo of cleared area facing Southwest, watercourse is to the East.

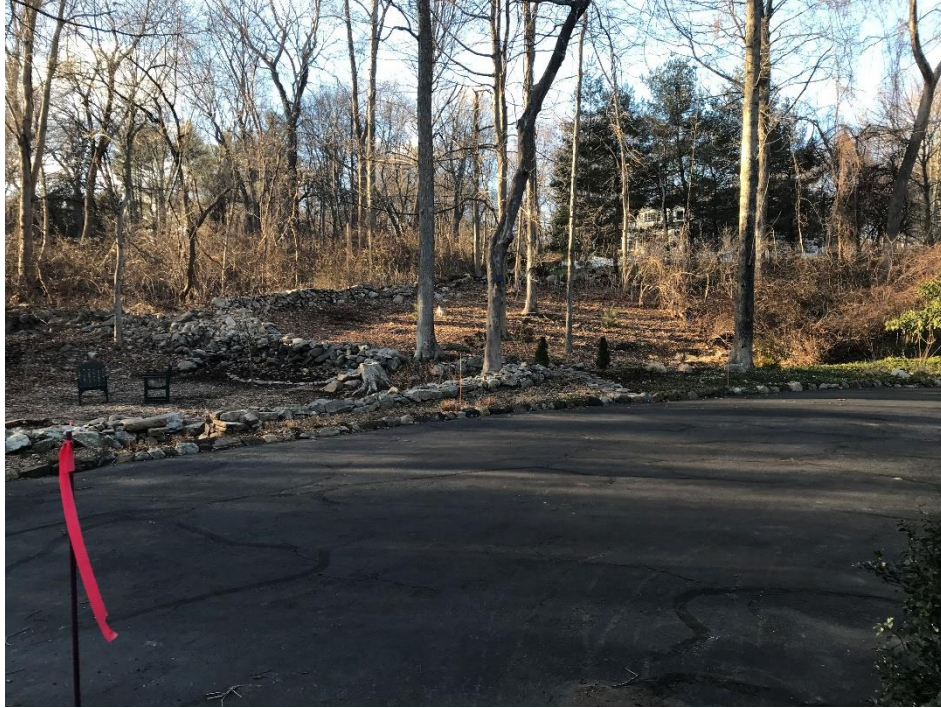
E. Photo of second cleared area facing North, watercourse is to the West.
