IMPROVEMENT LOCATION SURVEY

OF PROPERTY LOCATED AT
8 SEELEY ROAD
WILTON, CONNECTICUT
PREPARED FOR
TIM AND LINDSEY GEITZ

RE: Cease and Desist
8 Seeley Road, Wilton CT 06897

POST SITE EVALUATION: 8 Seeley Road, Wilton, CT 06897

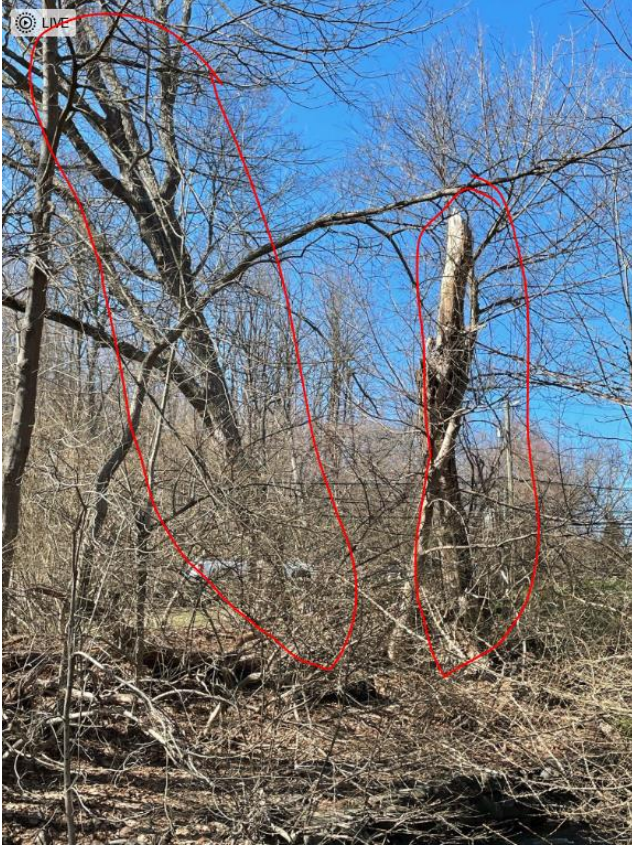
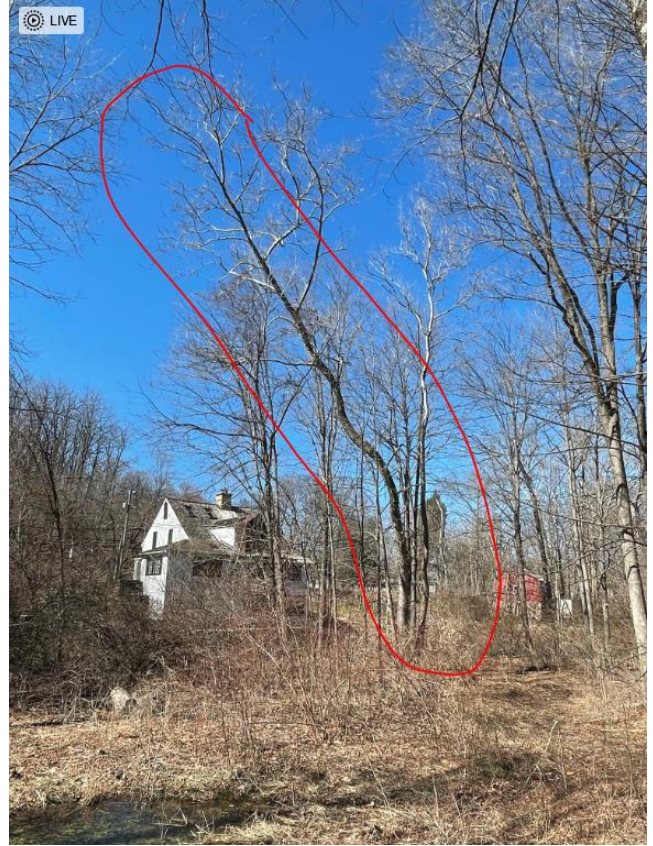
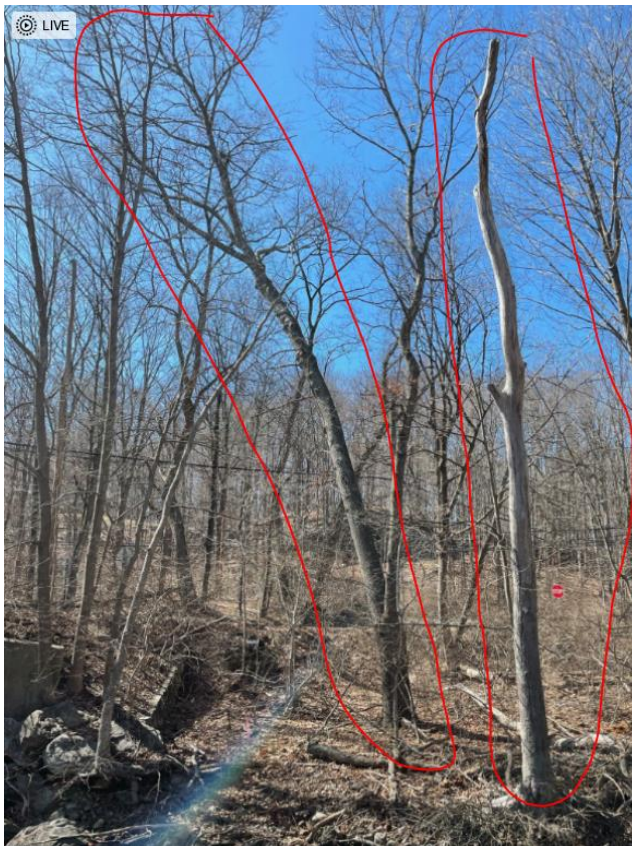
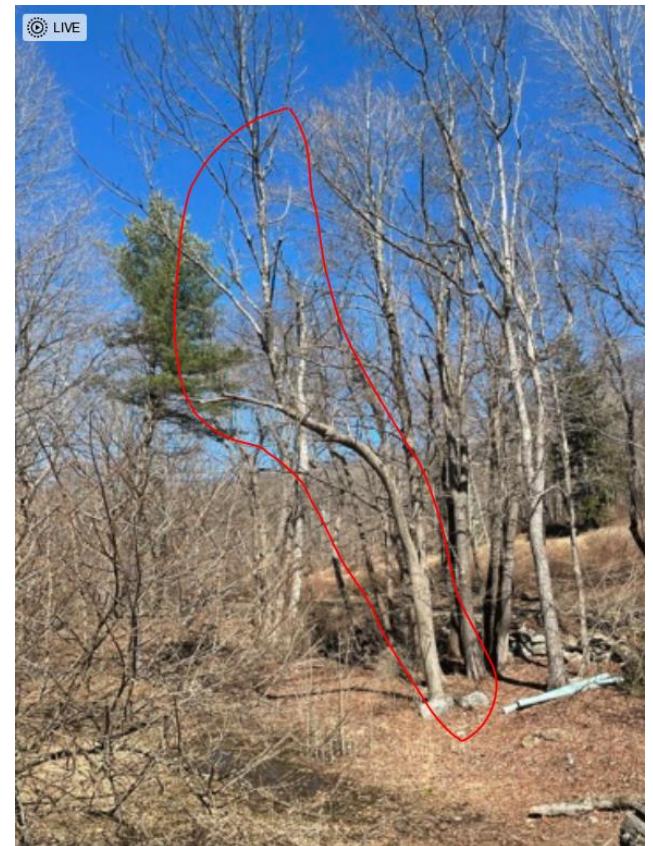
Our property has an abundance of trees that continue to fight to survive due to the overgrown canopy that exists. Below are a number of images of the surrounding trees that have died, are struggling to survive and are dangerous during storms but seem to be spaced far enough from our house if they fall.

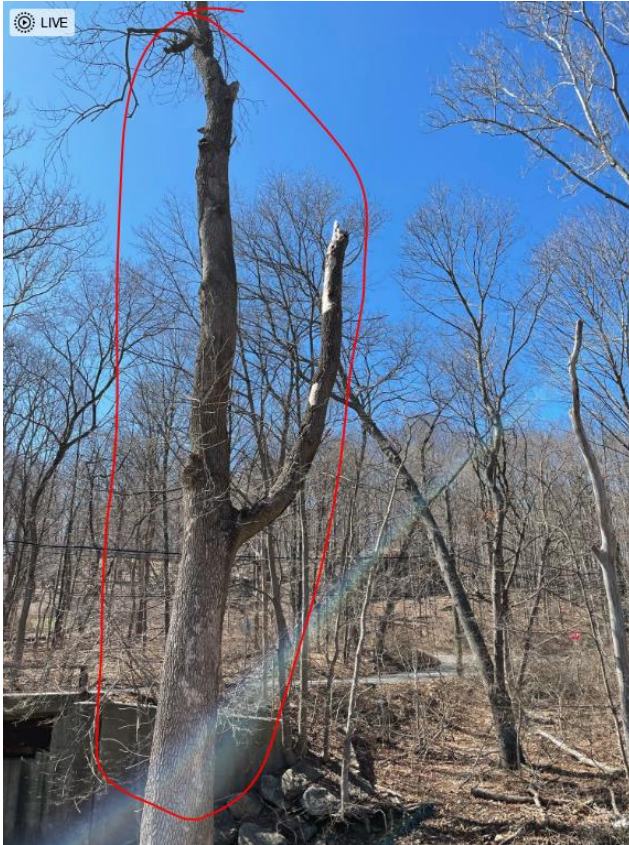
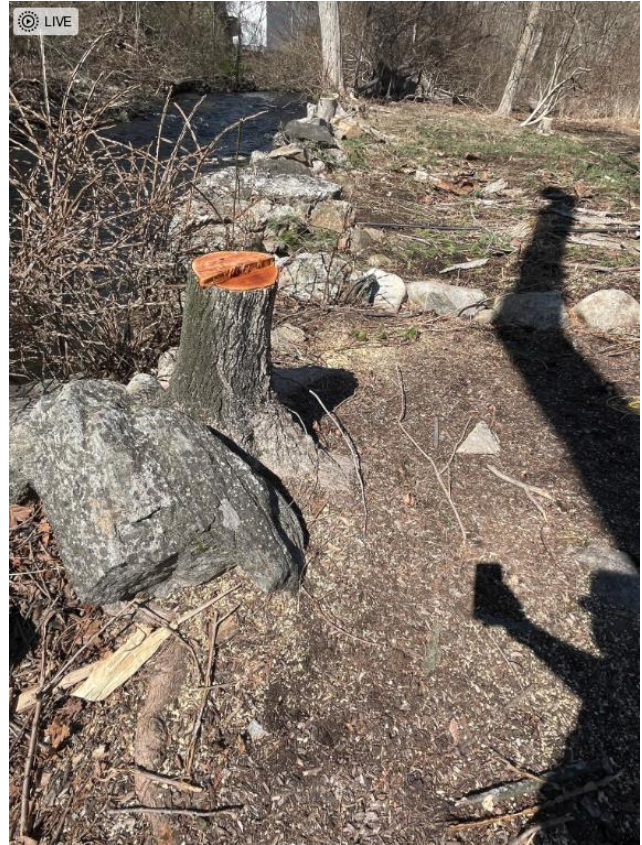
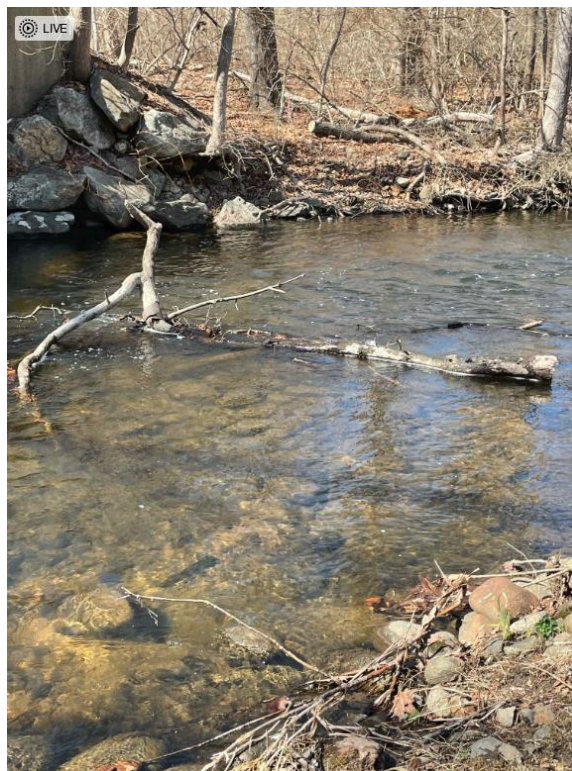
(top half of tree was split and left hanging due to a large branch above that fell from an adjacent tree during a storm)

Existing large tree that with broken large branches, branches have fallen and clipped the canopy of tree location # 2
COTTON WOOD, large branch from cottonwood is still in river, base of Cottonwood tree remains after cutting

After assessing the trees and up to my knowledge if we start from the front left next to river bridge on the right side of the standing Ash tree the Cottonwood tree the branches were damaged and dangerous to humans and potential property damage, as well as the standing Ash have several dead branches that need to be removed before some fishing person across the river gets hurt.

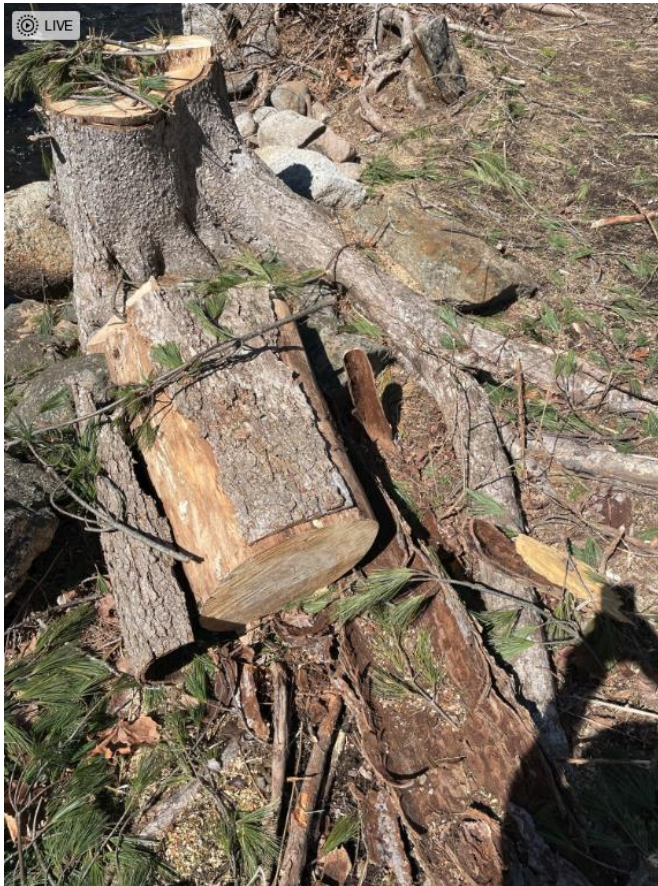
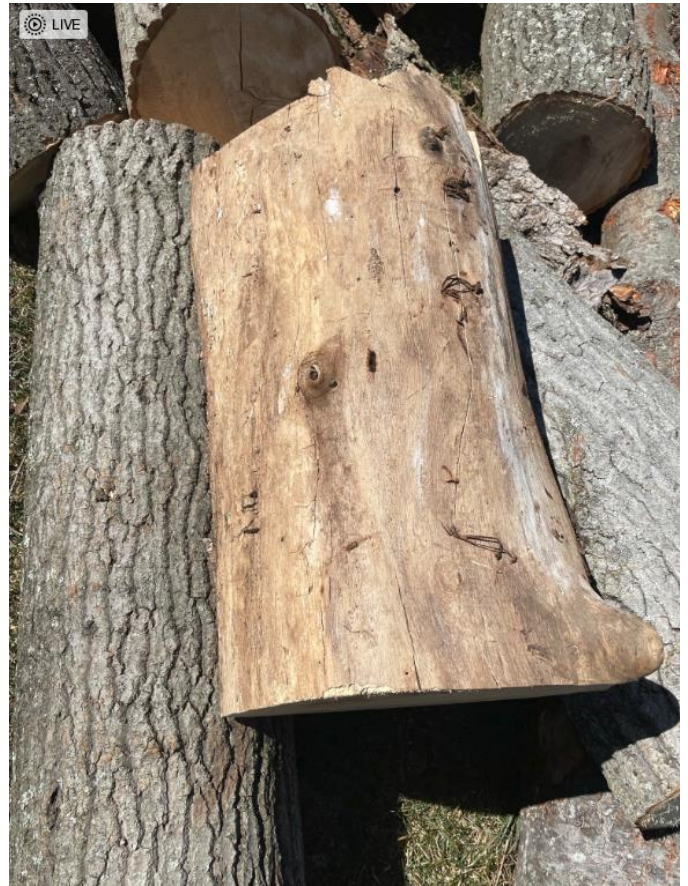
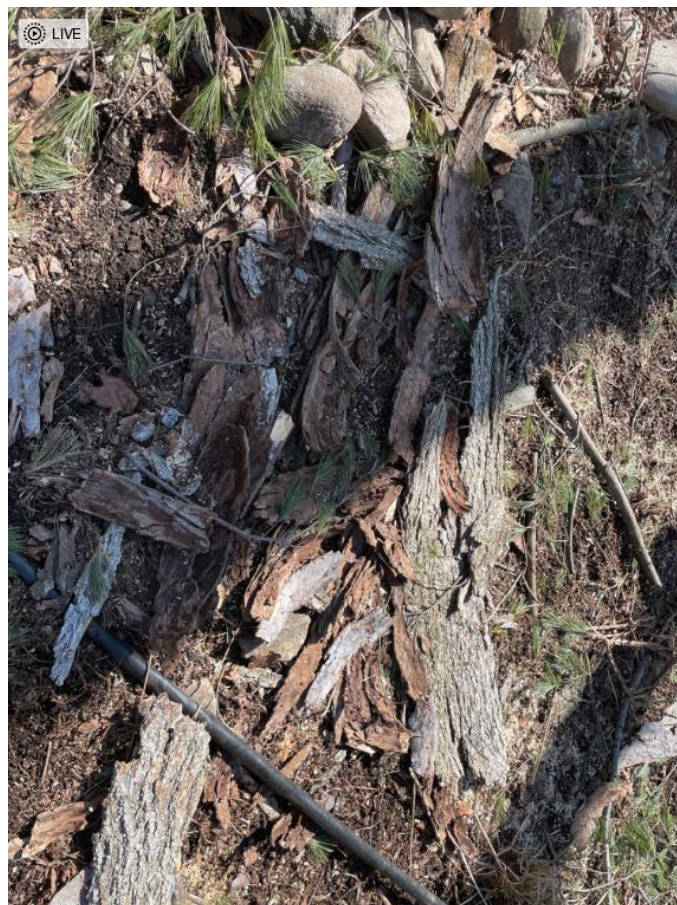
(tree has been dead for many years without any leaves - falling bark can be recognized)

Tree location # 3 DEAD ELM exposed roots, dead base, fallen bark remains from tree

The Elm Tree close to the river as most of us know about the disease is the main cause of their extinction. Unfortunately this is tree is another loss of its cause and was dead and dropping dead branches.

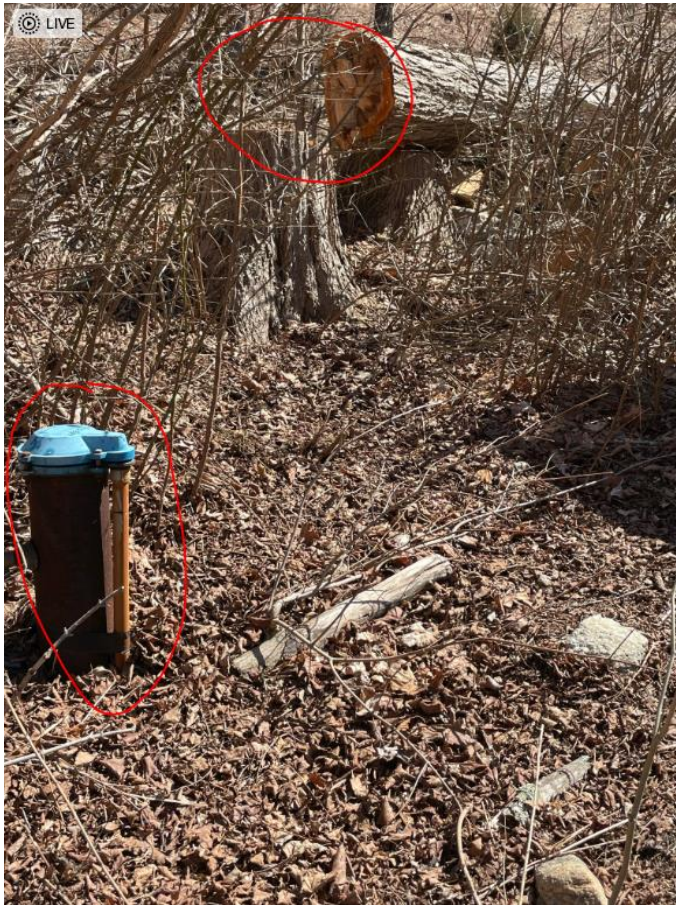
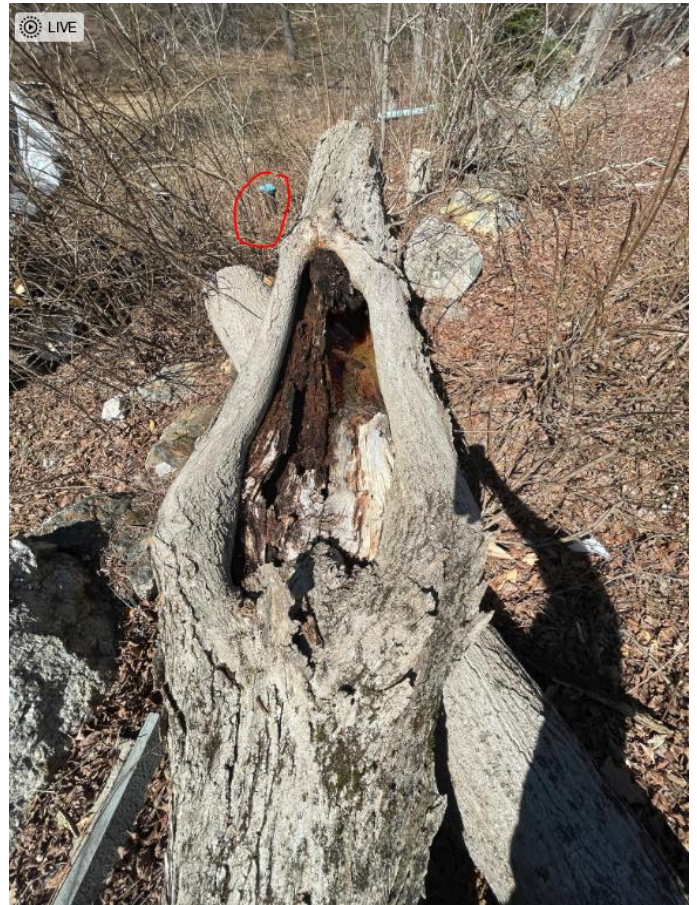
(tree was dead and rotted at base and leaning towards the house)

(tree was rotted at its base and leaning towards the house)

Tree location # 7 & # 8 DEAD MAPLE trees, rotted base near well location and rear corner of house

The two large mature Maples on the right corner of the house where leaning towards the house plus the trunk was damaged/hollow because they were next to the rails it might be where pruned all the time on the same side and leaving all the weight on the house side it was a very very dangerous to fall to the house. Also, the water well is next to it causing danger.

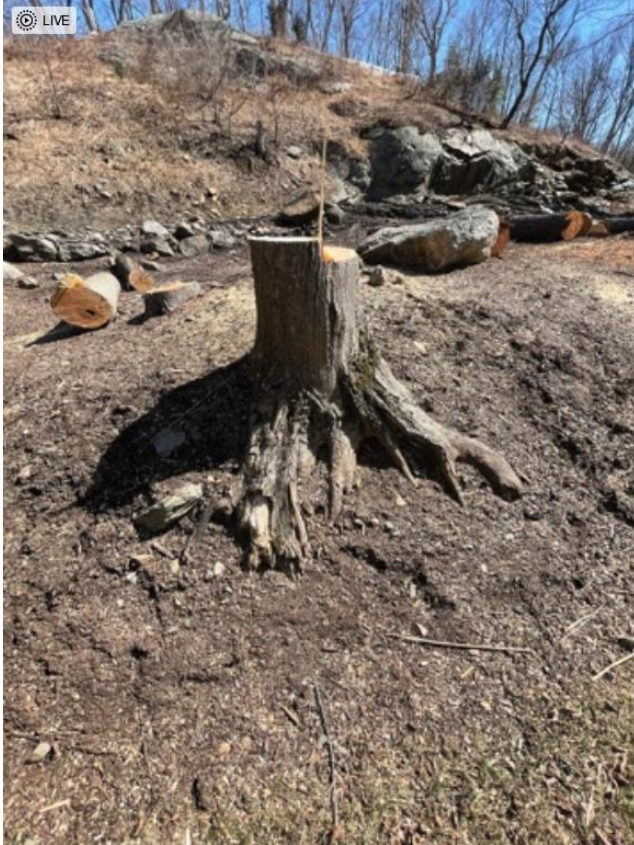
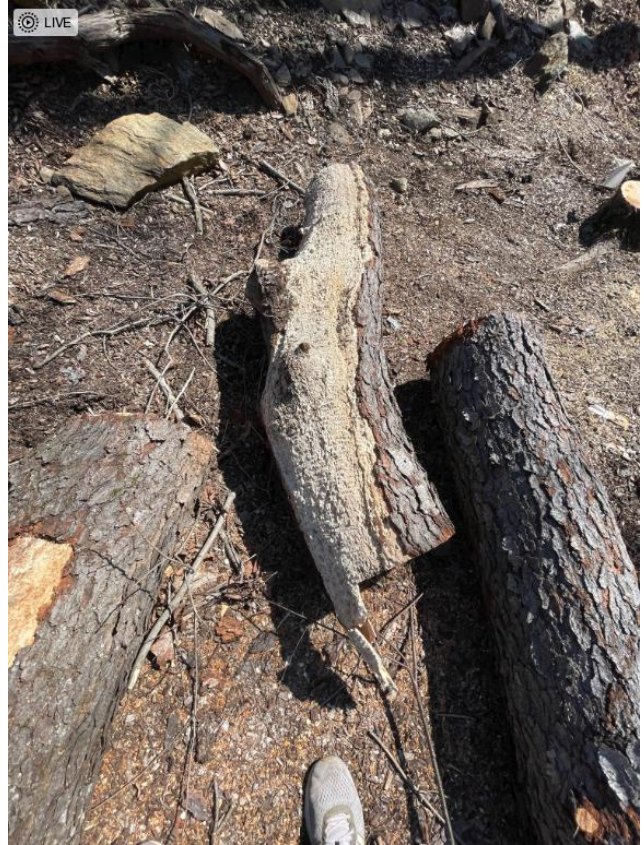
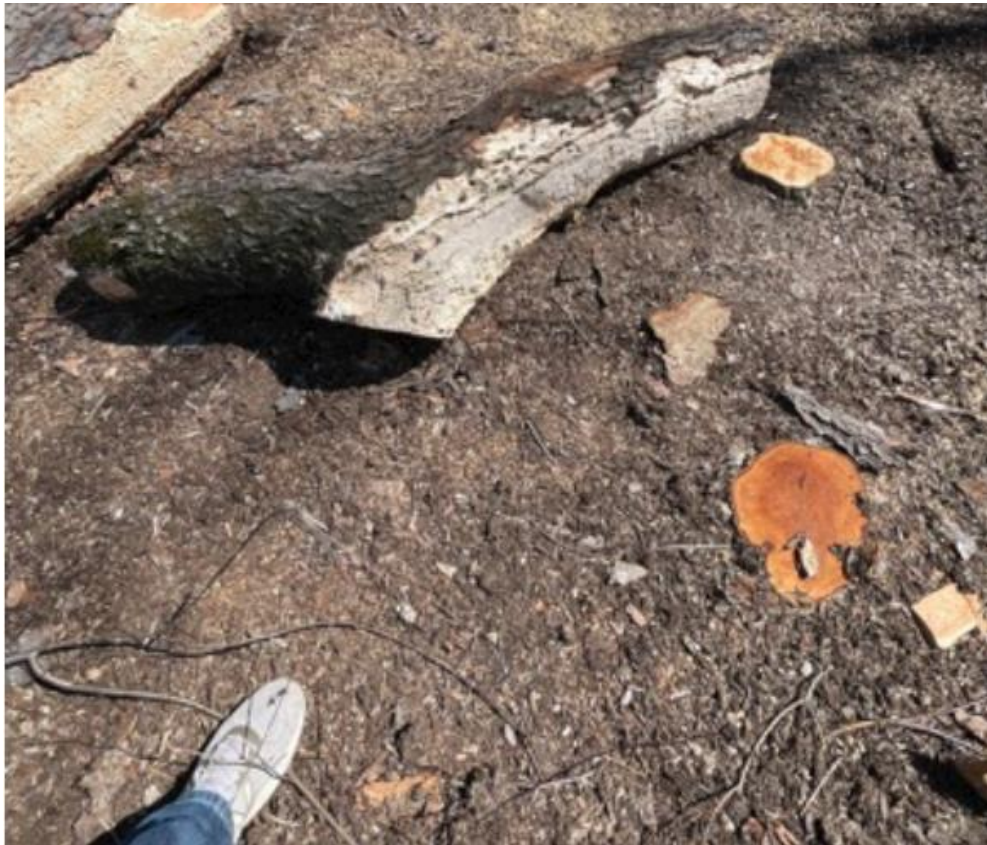
(tree has an exposed root system with many dead branches and was dangerously leaning towards that house)

(tree was crowded by two others, bare and was leaning towards the house and dangerous)

Tree location # 9 & # 10 BLACK CHERRY, exposed roots, close to house, dangerous, rotted branches and trunk

The Black Cherry next to the driveway right corner of the house most of the branches were dead and hanging to the driveway, potentially falling into a car or humans walking since this is the main entrance to the house the risk is higher for damage.

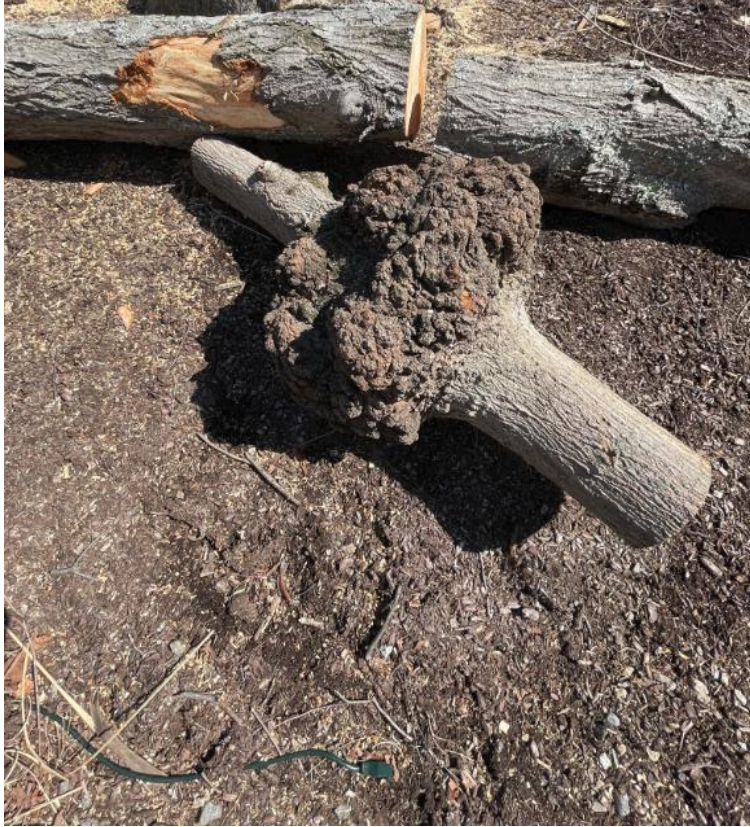
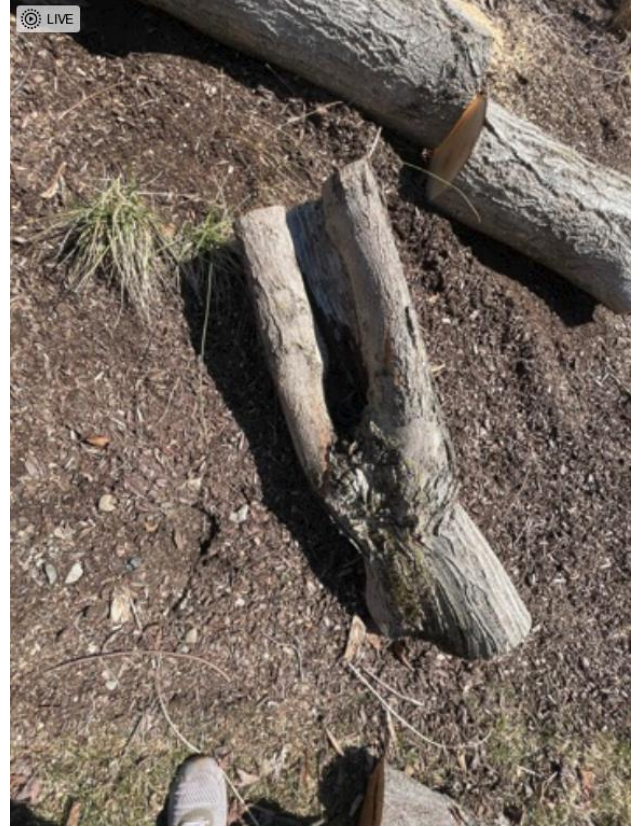
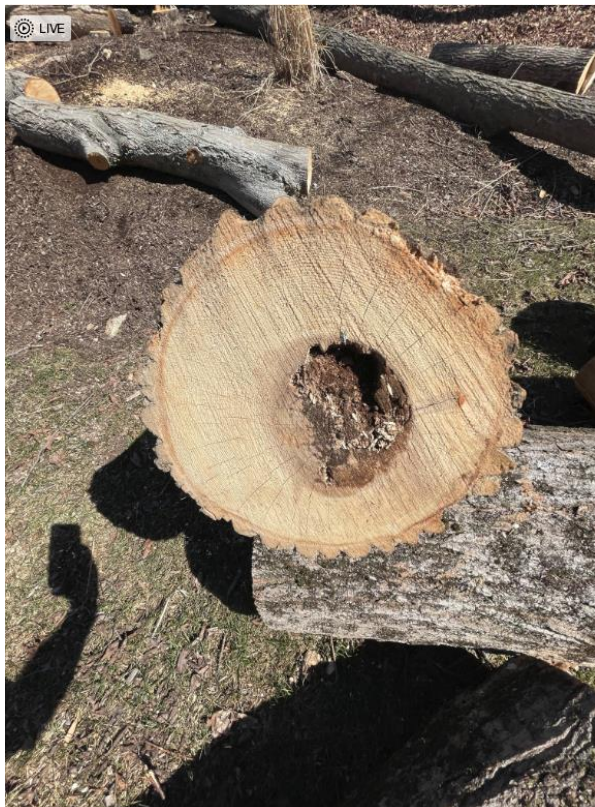
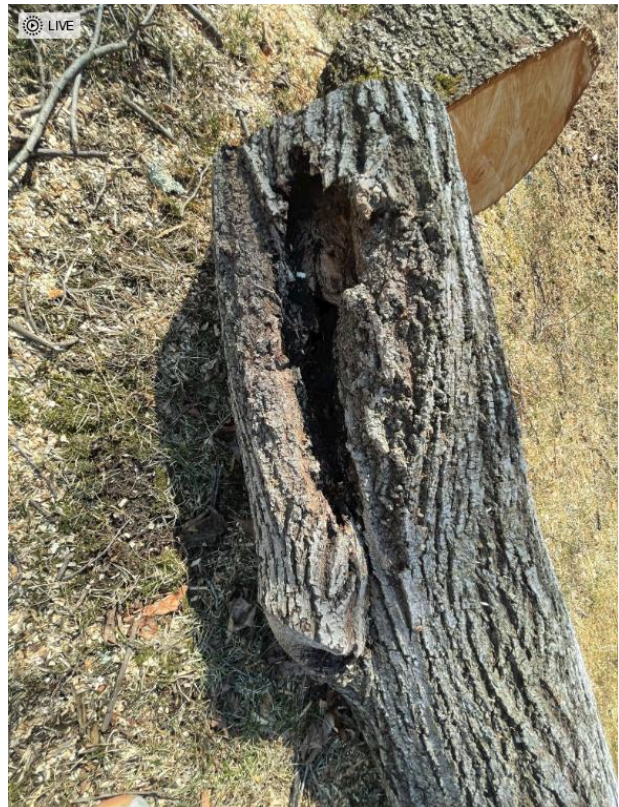
Miscellaneous cut trees from remaining tree locations - Tree location # 1 ASH TREE, Tree location # 4 TALL PINE, Tree location # 5 SRUCE TREE, Tree location # 6 MAPLE TREE, Tree location # 11 BLACK CHERRY hollow, rotted, diseased & dead bases

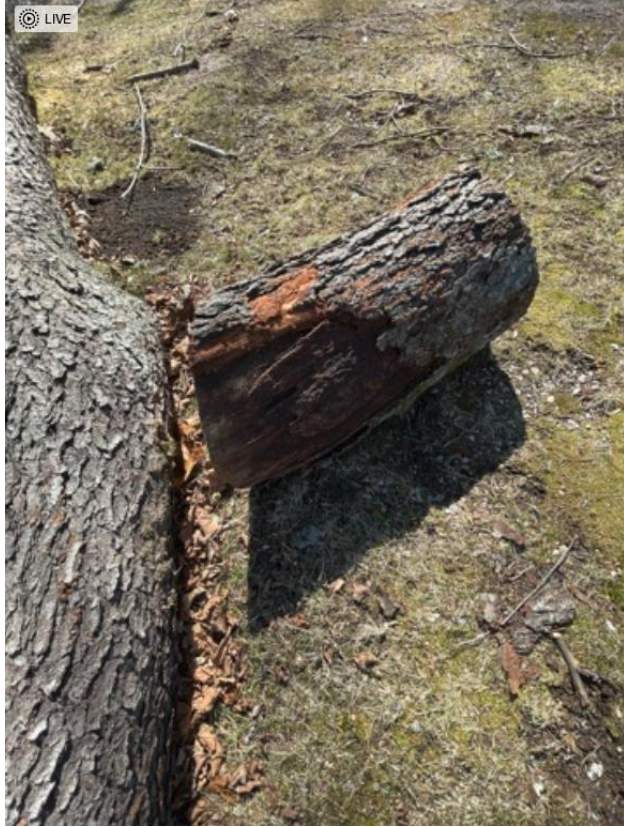
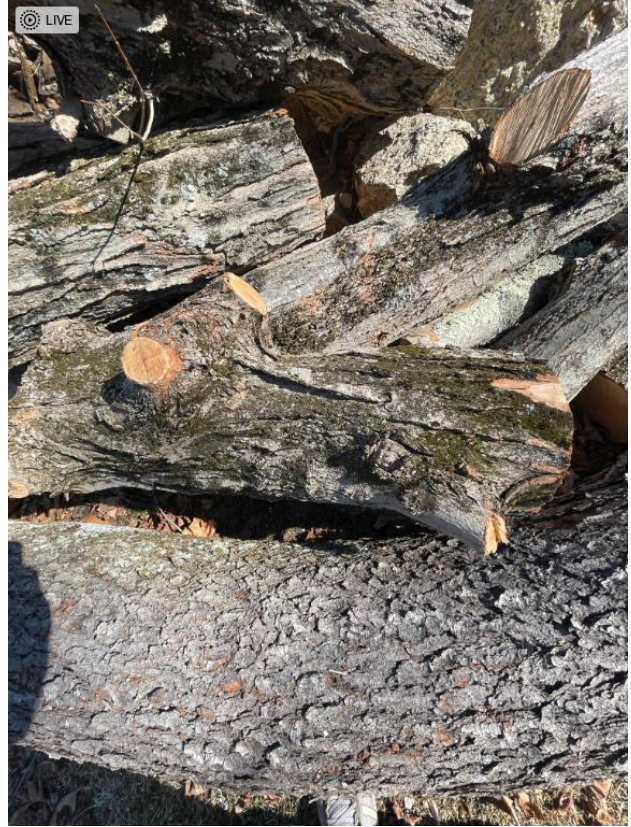
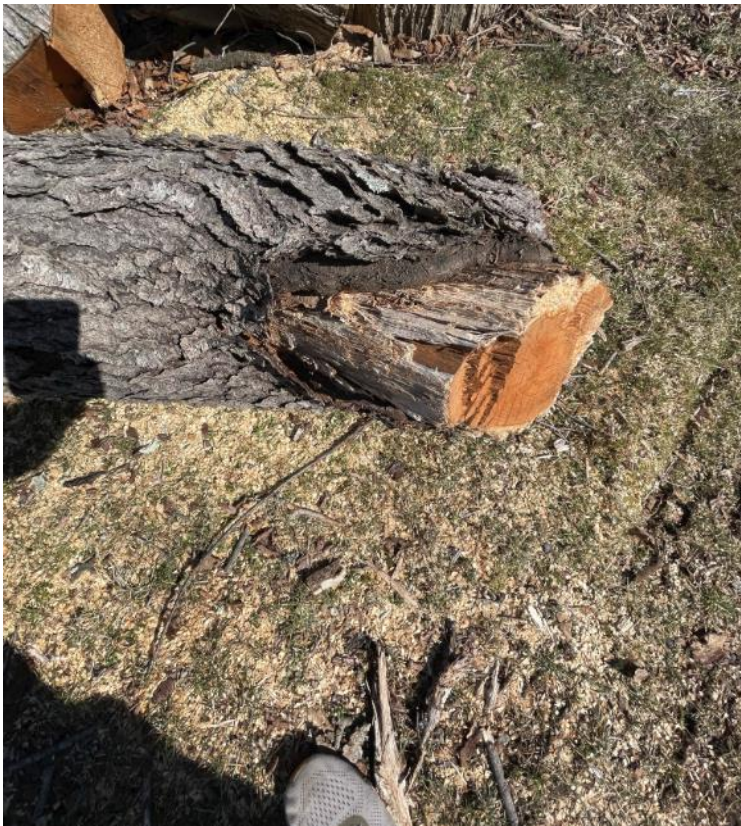
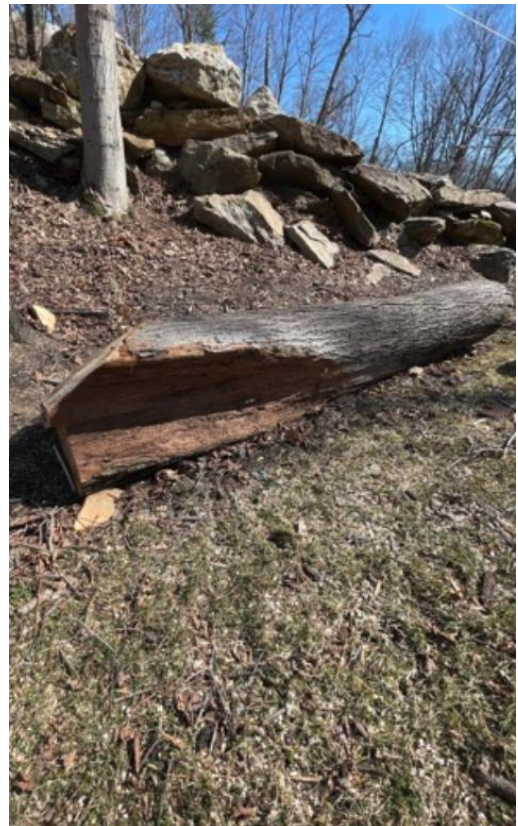
Miscellaneous cut trees from remaining tree locations - Tree location # 1 ASH TREE, Tree location # 4 TALL PINE, Tree location # 5 SRUCE TREE, Tree location # 6 MAPLE TREE, Tree location # 11 BLACK CHERRY hollow, rotted, diseased & dead bases

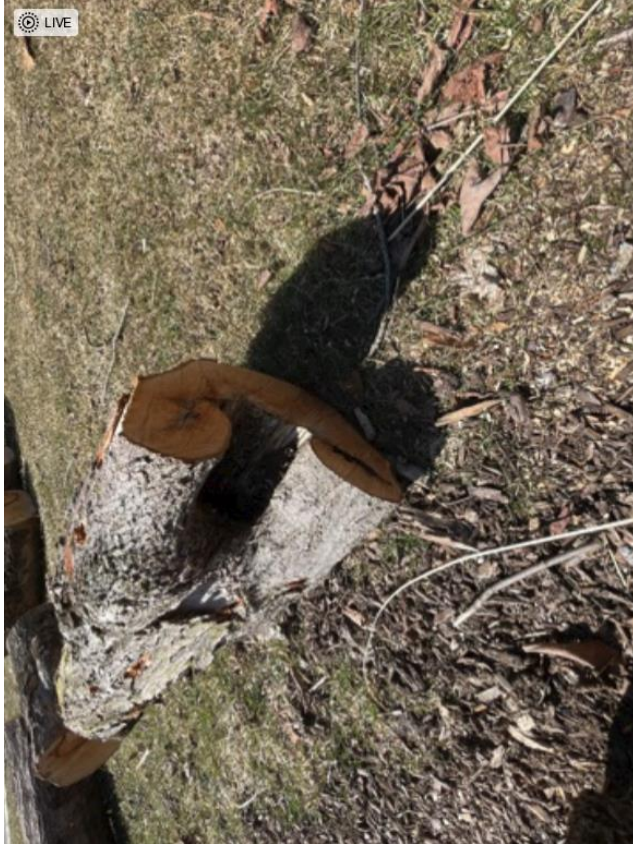
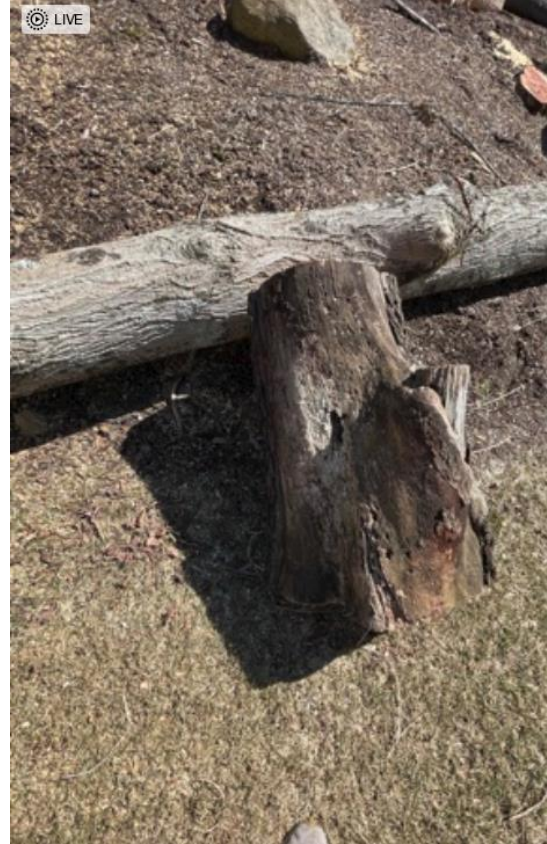
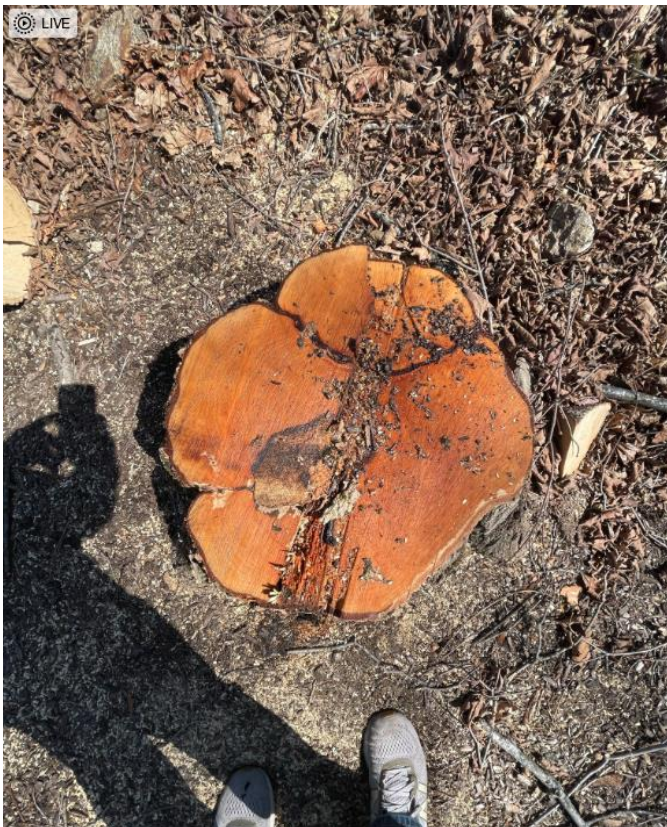
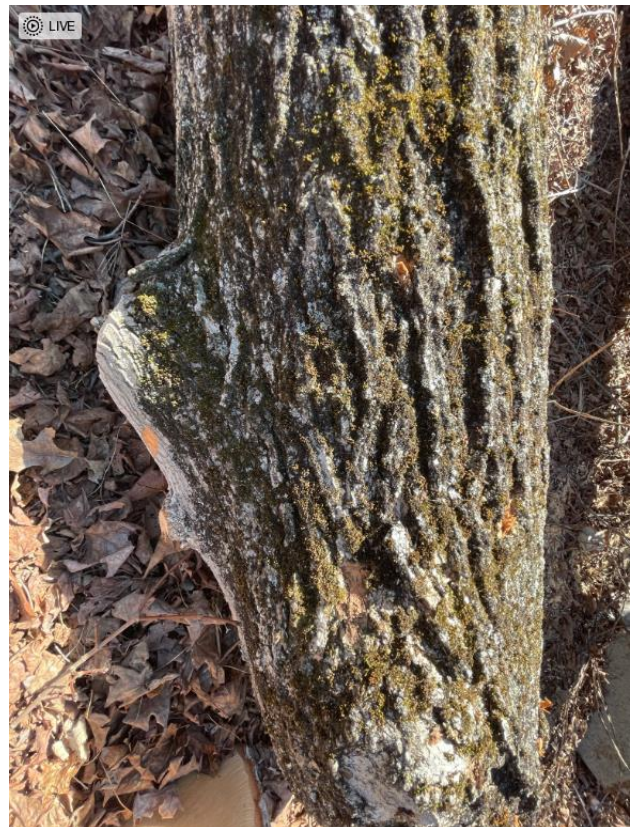
Miscellaneous cut trees from remaining tree locations - Tree location # 1 ASH TREE, Tree location # 4 TALL PINE, Tree location # 5 SRUCE TREE, Tree location # 6 MAPLE TREE, Tree location # 11 BLACK CHERRY hollow, rotted, diseased & dead bases
