## APPLICATION FOR A MINOR REGULATED ACTIVITY

**Narrative for proposed site improvements to 195 Sharp Hill**  
**Prepared By: Greg Ruhnow**  
**Phone: 810-623-3187**

Re: Tree Risk Assessment of select trees at 195 Sharp Hill Road

## Tree Assessment Report

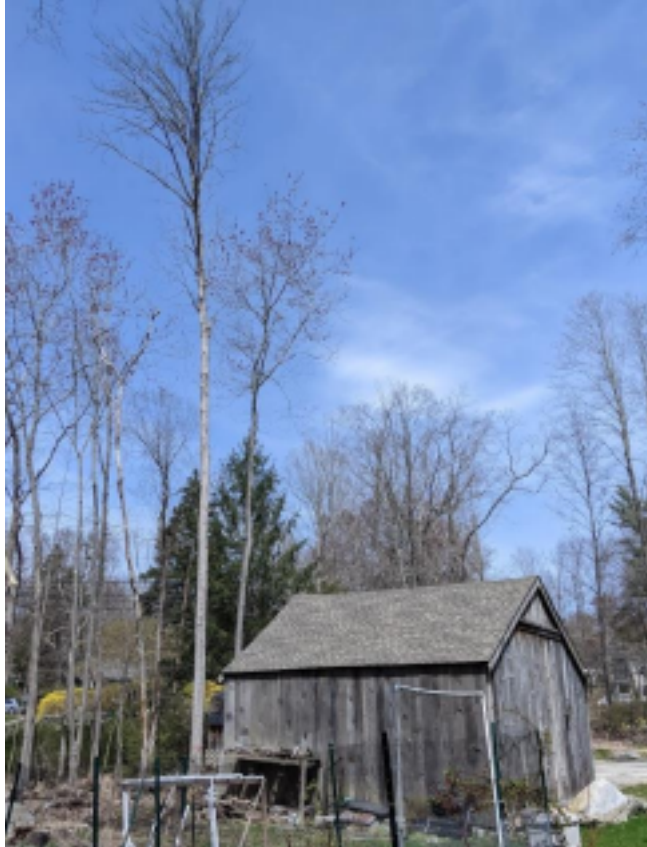
**Tree #1 American White Ash 14"** in diameter located right back of the Garage.

**Targets:** If the tree were to fail it could strike the Garage, the driveway, and the parking area. These areas are occupied frequently throughout the day.

**Tree conditions:** Tree is infested with the tree killing beetle Emerald Ash Borer as evident by “D” shaped exit holes, larval galleries under the bark and woodpecker damage. Tree is declining rapidly if not already dead.

**Risk Assessment:** The consequences of part of the tree failing are Significant due to its proximity to the targets, the likelihood of failure is Very Likely therefore the tree risk is *High*.

**Options/recommendations for mitigations of risk:** Removal of the tree is the only viable option for mitigation of the risk posed by this tree. The infestation of beetles is too far along to be successfully treated with insecticides. Some urgency in the removal is warranted due to the history of ash trees failing soon after they

**Residual Risk after mitigations:** The risk is removed if the tree is removed.

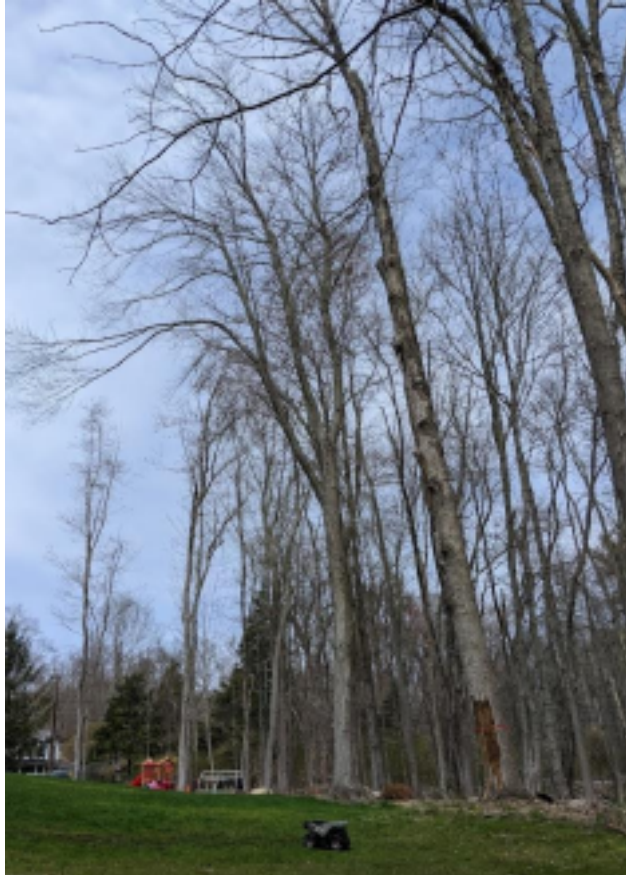
**Tree #2 American White Ash 22"** in diameter located on the east edge of the yard.

**Targets:** If the tree were to fail it could strike the children's play yard, deck, and the house. The play area and deck are occupied occasionally, and the house constantly.

**Tree conditions:** Tree is infested with the tree killing beetle Emerald Ash Borer as evident by "D" shaped exit holes, larval galleries under the bark and woodpecker damage. Tree is declining rapidly if not already dead.

**Risk Assessment:** The consequences of part or all of the tree failing are Significant due to its proximity to the targets, the likelihood of failure is Very Likely therefore the tree risk is *High*.

**Options/recommendations for mitigations of risk:** Removal of this High risk tree is the only viable option for mitigation of the risk posed by this tree. The infestation of beetles is too far along to be successfully treated with insecticides. Some urgency in the removal is warranted due to the history of ash trees failing soon after they die.

**Residual Risk after mitigations:** The risk is removed if the tree is removed. Tree should be reassessed in 3 months if it is not removed.

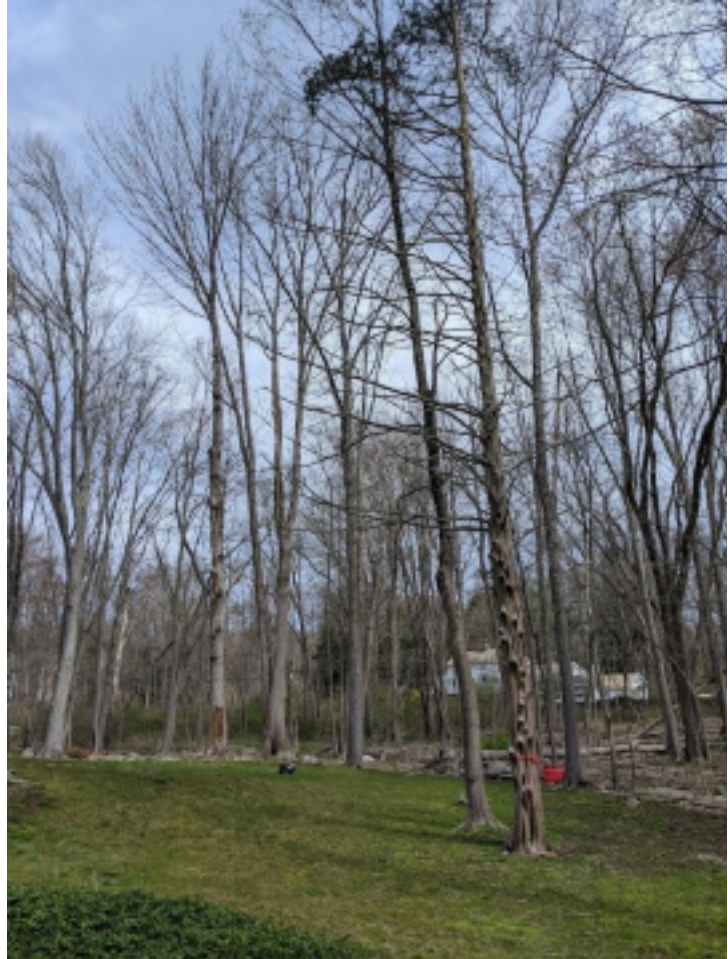
**Tree #3 Red Cedar 13"** inches diameter located in the side yard

**Targets:** If the tree were to fail it could strike the back yard, deck and stairs to the deck. All are occupied occasionally throughout the day.

**Tree conditions:** Tree is 95% dead, with extensive rot at the base. The roots are not strong enough to hold the tree steady in a light breeze. Observed movement of the base.

**Risk Assessment:** The consequences of part or all of the tree failing are Significant due to its proximity to the targets, the likelihood of failure is Very Likely therefore the tree risk is *High*.

**Options/recommendations for mitigations of risk:** Removal of this High risk tree is the only viable option for mitigation of the risk posed by this tree.

**Reassessment:** Tree should be reassessed in 3 months if it is not removed.

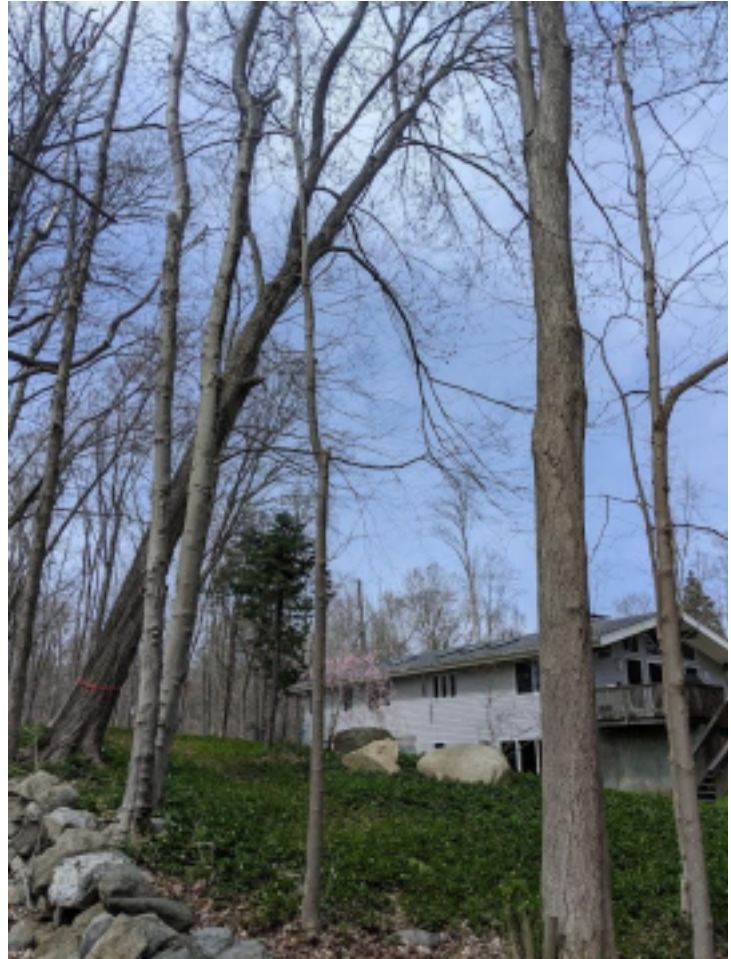
**Tree #4 Red Maple 23"** in diameter located along the back property line and leaning toward the house.

**Targets:** If the tree were to fail it could strike the house, the backyard, the back patio, and the deck.

**Site factors:** Stone wall on the opposite side of the lean has distorted the roots and compromises the root attachment.

**Tree conditions:** The tree leans at a significant 19 degrees toward the house. The tree exhibits poor taper, has a broken branch in the crown, and armillaria root rot fungus observed at its base.

**Risk Assessment:** The consequences of part of the tree failing are Significant due to its proximity to the targets, the likelihood of failure is Likely therefore the tree risk is *High*.

**Options/recommendations for mitigations of risk:** Pruning the tree to reduce its height to significantly reduce the risk is not possible because of the height of the crown. The lowest branch is about 35 ft from the ground. Pruning would not correct the lean or the poor taper. Root rot has likely compromised the roots. Therefore, it is recommended that this tree be removed to release understory trees that have better structure.

**Residual Risk after mitigations:** Successful mitigation would be removal of the tree. **Reassessment:** Tree should be reassessed in 3 months if it is not removed.

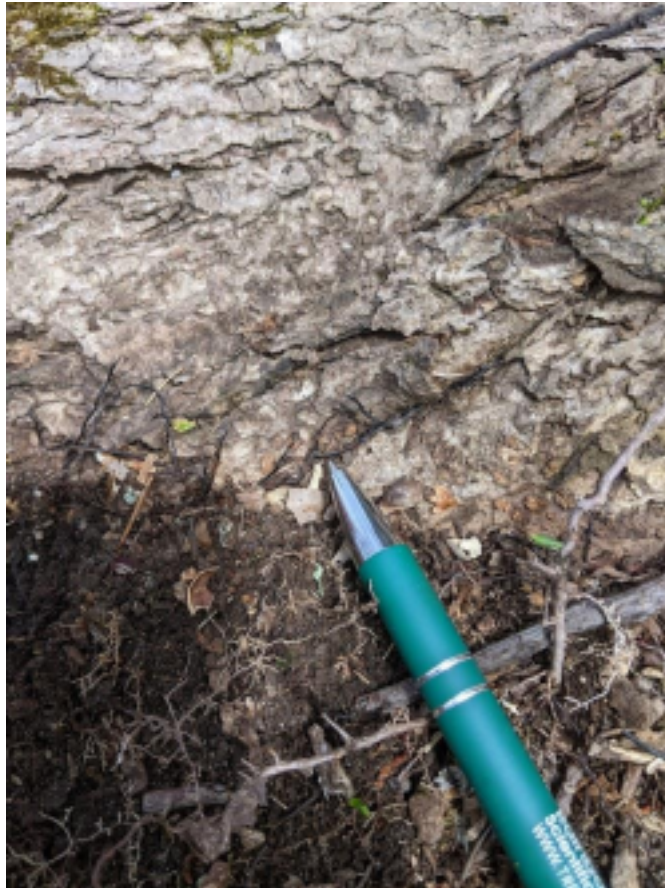
**Tree #5 Black Birch 11"** in diameter located in the back of the house.

**Targets:** If the tree were to fail it could strike the back yard, back patio, deck and house.

**Tree conditions:** Tree exhibits a severe 25 degree lean toward the house. Has poor taper and the first branch is 30 feet from the ground. Root rot fungus was observed at its base.

**Risk Assessment:** The consequences of part or all of the tree failing are Significant due to its proximity to the targets, the likelihood of failure is Probable and will highly likely hit a target when it fails therefore the tree risk is *High*.

**Options/recommendations for mitigations of risk:** Removal of this High-risk tree is the only viable option for mitigation of the risk posed by this tree. Poor taper and height of the lowest limb preclude effective mitigation by pruning or other means.

**Reassessment:** Tree should be removed.

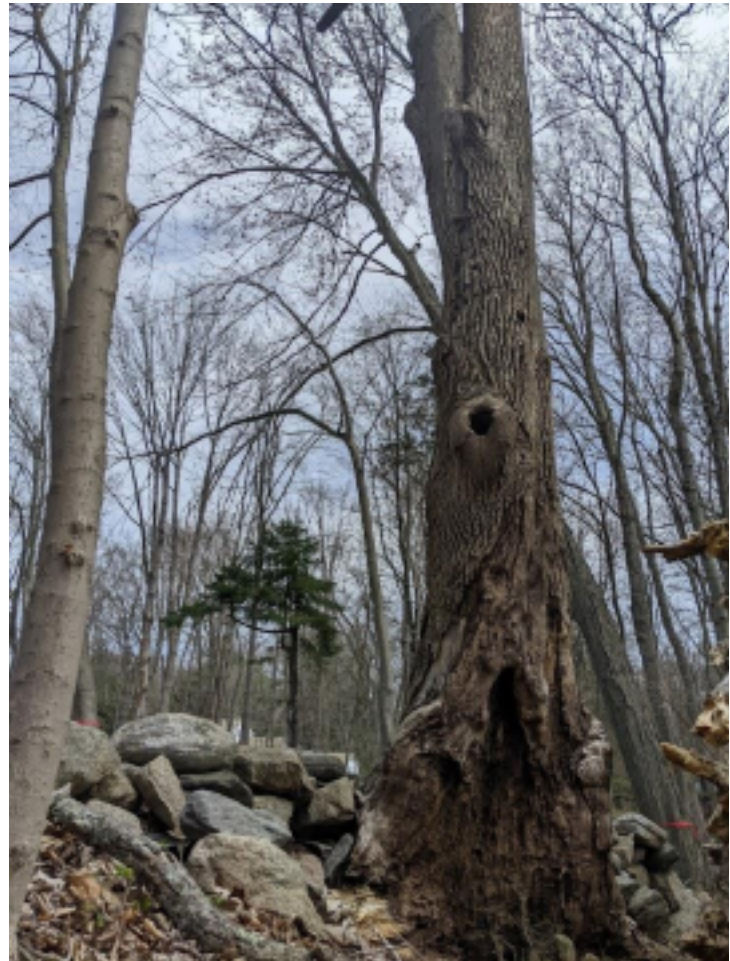
**Tree #6 American White Ash 26"** in diameter located in the stonewall in the back of the house.

**Targets:** If the tree were to fail it could strike the back yard, back patio.

**Site factors:** Tree is standing in the stone wall; the back half of the tree has already fallen.

**Tree conditions:** Tree is dead with severe decay on the back side and slight lean toward the back yard.

**Risk Assessment:** The consequences of part or all of the tree failing are Significant due to its proximity to the targets, the likelihood of failure is Immanent therefore the tree risk is *High*.

**Options/recommendations for mitigations of risk:** Removal of this High-risk tree is the only viable option for mitigation of the risk posed by this tree.

**Reassessment:** Tree should be removed.

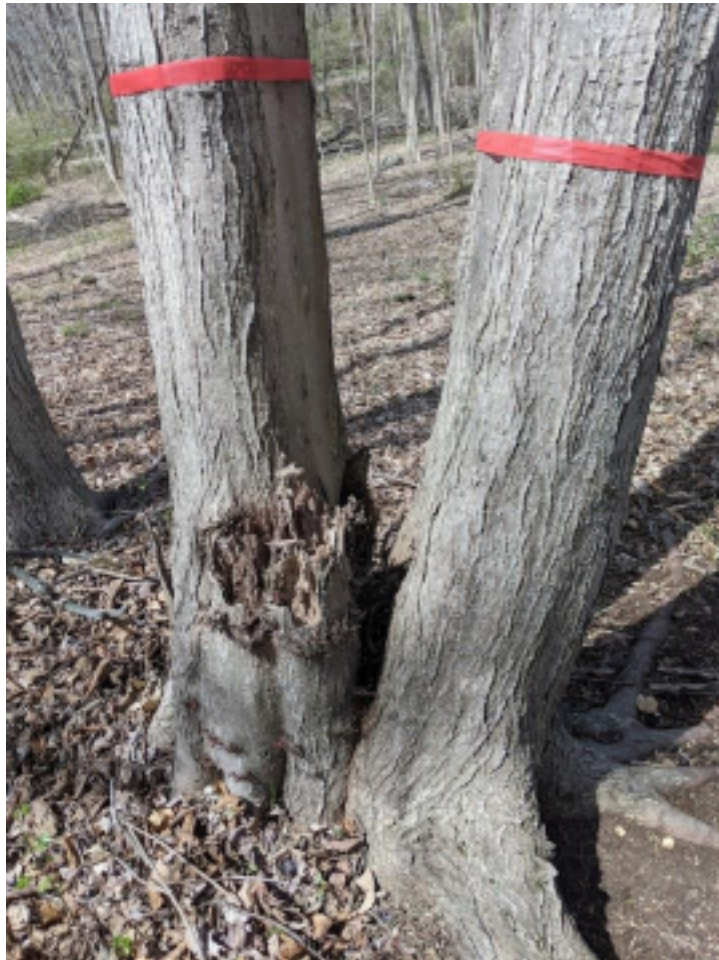
**Tree #7 Red Maple Tree 11" and 12" double trunk** back right of the house

**Targets:** If the tree were to fail it could strike the house, the walkway, gardening area and back yard.

**Tree conditions:** This tree has basal decay including adventitious roots between the two trunks. The trunks exhibit poor taper are leaning and bending. There are broken branches in the crown, the crown is overextended.

**Risk Assessment:** The basal decay of this tree warrants its removal. Likelihood of failure is probable and the consequences are significant making the tree a high-risk tree.

**Options/recommendations for mitigations of risk:** Removal of this tree will serve the grove of trees well releasing the small native trees that wait in the understory and reduce future risks from an unsound tree.

**Reassessment:** No reassessment is warranted if the tree is removed.

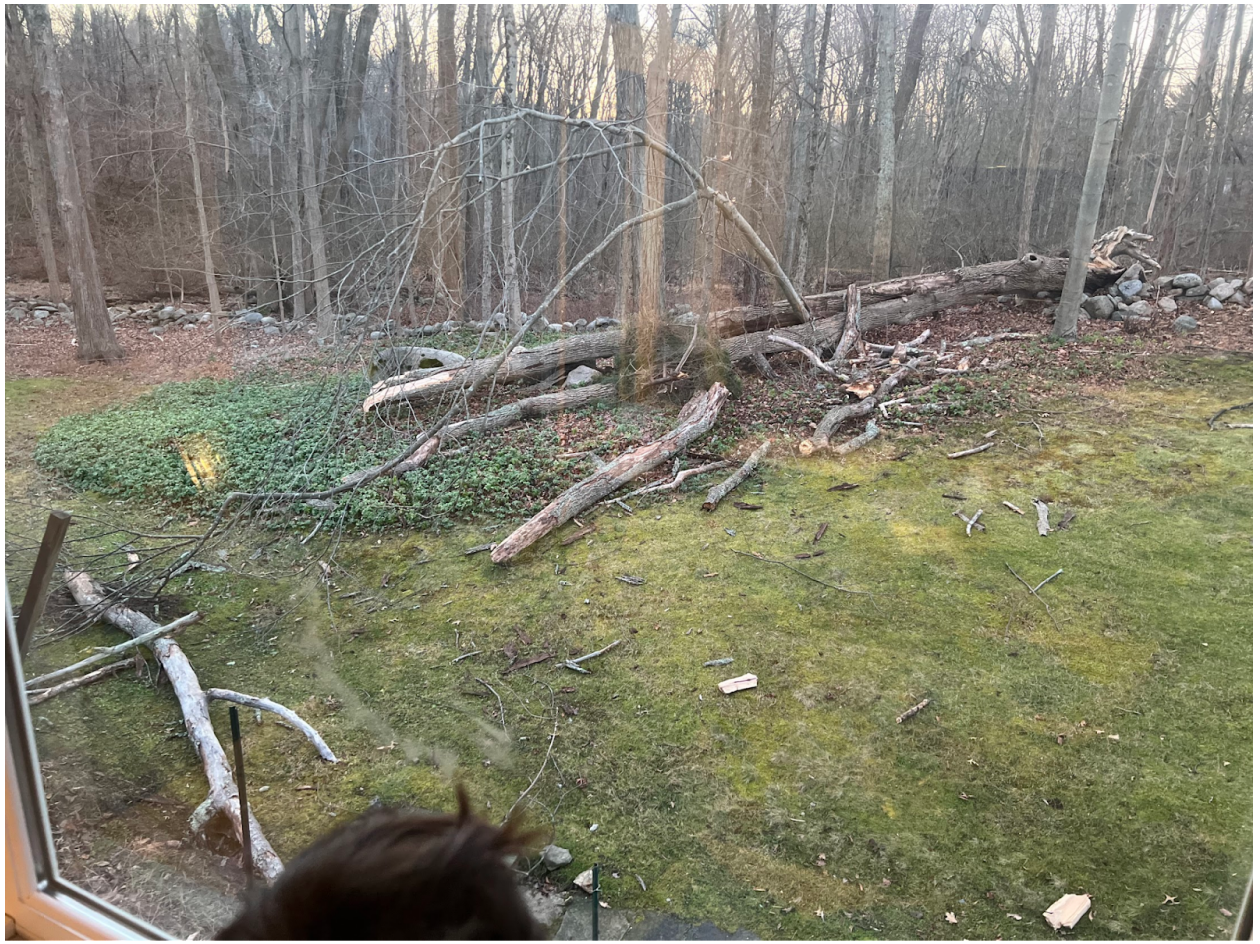
**Exhibit C**  
**Tree 6 Fallen of Natural Causes**
