McChord Engineering Associates, Inc.
Civil Engineers and Land Planners

June 16, 2020

Re: Engineering Summary
Proposed Culvert Repair
68 McFadden Drive, Wilton, CT
Map 85, Lot 13

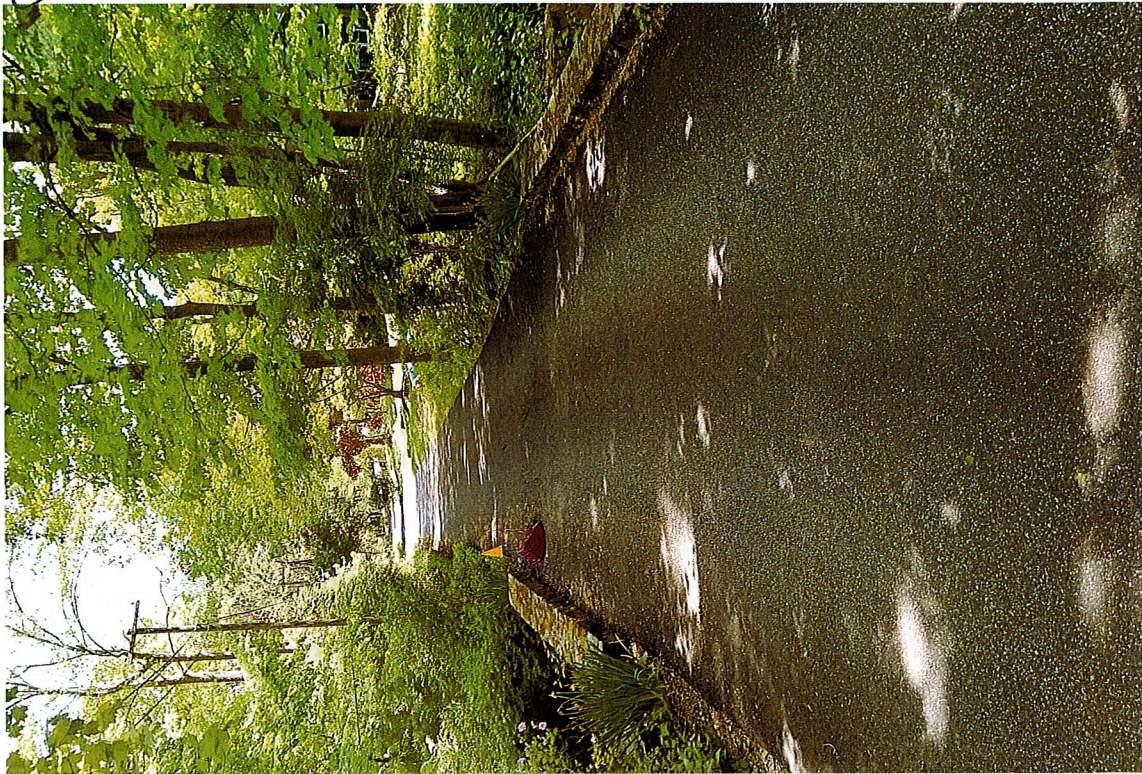
CULVERT CROSSING FOR SHARPS DRIVEWAY

Our inspection of the driveway culvert revealed that the south pipe arch is severely degraded. The entire flow line of the culvert has rusted out the culvert has begun to settle. The settling has opened up a large pothole in the driveway and a number of cracks have formed in the stone headwalls. The north pipe arch was generally intact, but moderate deflection was

noted and the asphalt lining was very worn. Some scouring was observed on the downstream outlet but otherwise no significant erosion was noted. The attached pictures highlight the conditions of the existing culvert.

The south pipe arch is too degraded to attempt to reline. The existing conditions are also not conducive to sleeve a new pipe through the old pipes. Therefore the best option is to replace the pipe arch completely. Due to the amount of effort involved to replace the pipes, both pipes should be replaced at the same time. Two 48" diameter HDPE pipes are proposed to replace the two pipe arches. The HDPE is more readily available and easier to work with than other pipe materials, and the 48" circular pipe will have a very similar hydraulic capacity to the pipe arches being replaced. The stone headwalls will be dismantled and rebuilt.
