Home Inspection Report

197 Catalpa Road
Wilton, CT 06897

Date of Inspection: 10/13/2020

Inspection No. 27233-4300

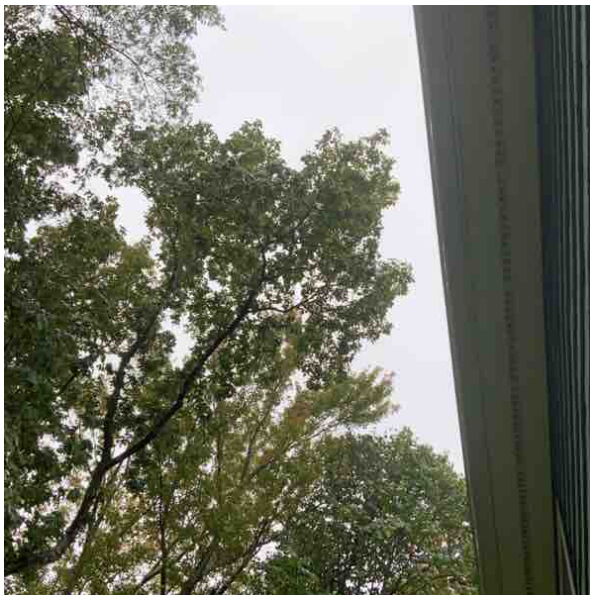
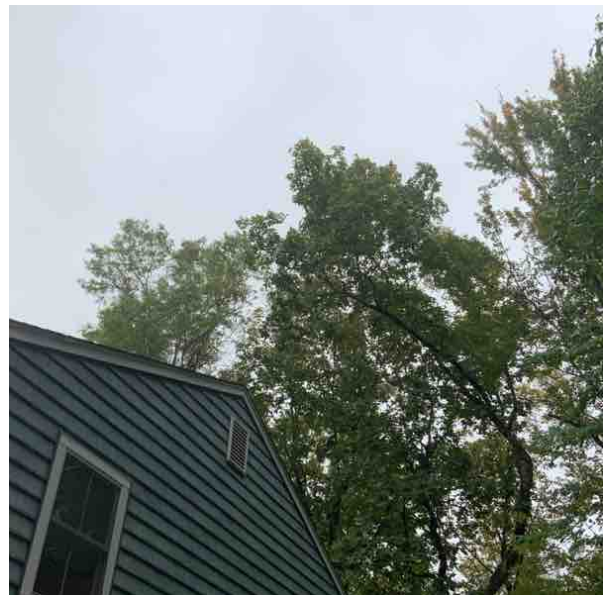
2.3.3 Several large trees lean toward, or have branches that overhang the home. Encroaching branches should be pruned to prevent broken limb or wind damage. Trees leaning toward or otherwise in close proximity to the home should be further evaluated by an arborist in advance of purchase to assess health and to determine scope / urgency / cost of any tree work or removals that may be needed in the short term. **(Exterior Rear)**

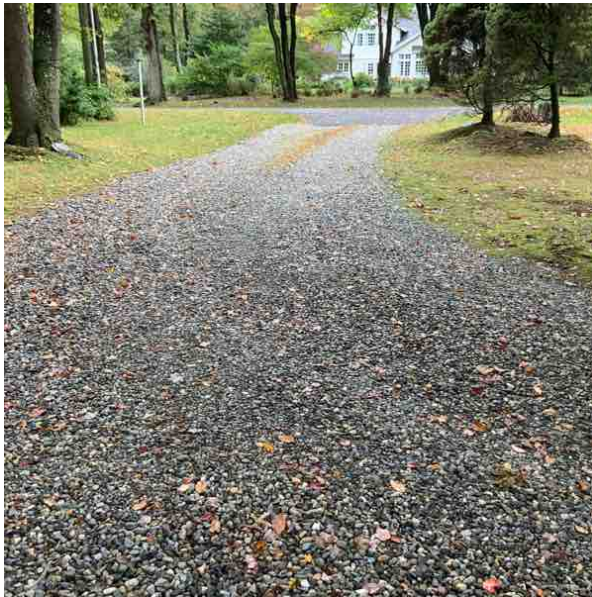
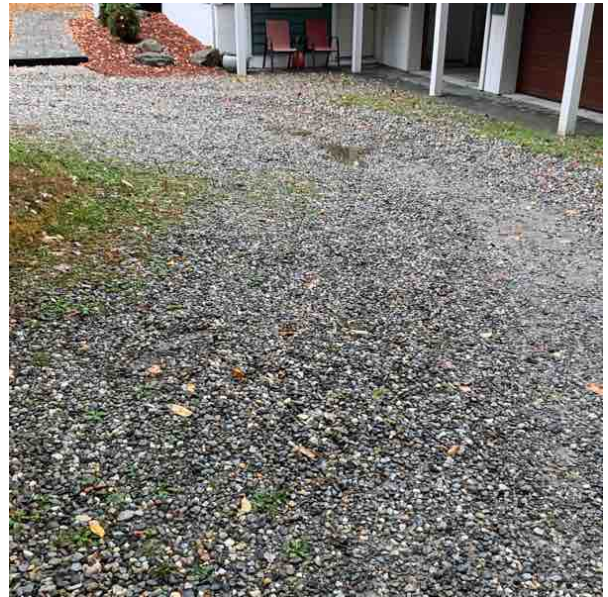
2.5.2 The gravel driveway is due for grooming and replenishment. (Exterior Front)

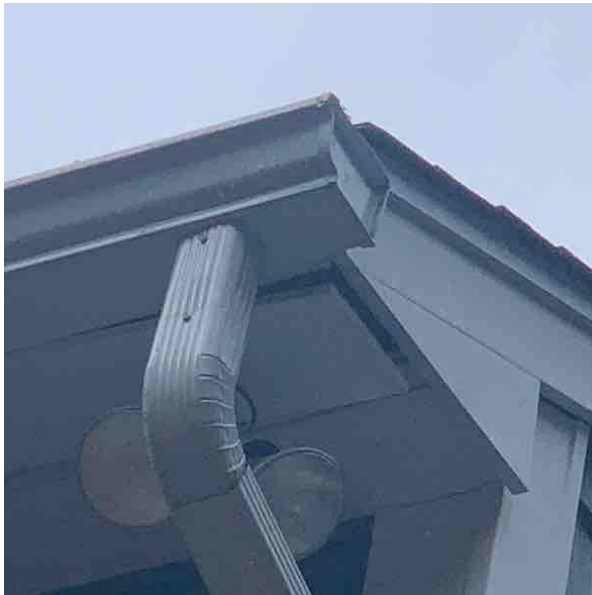
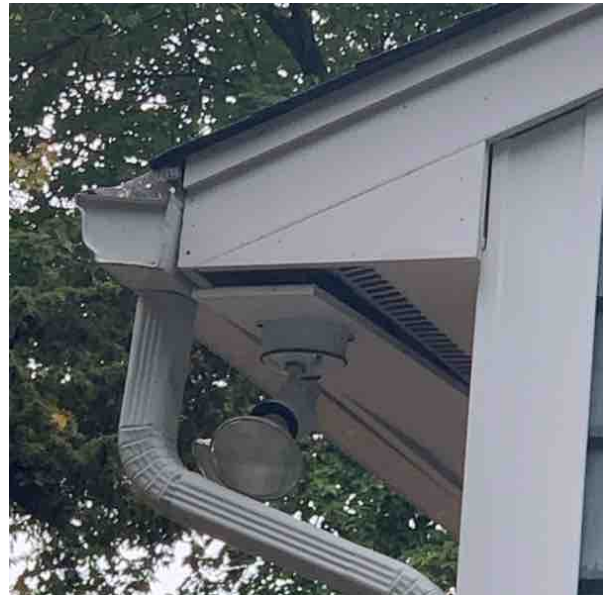
3.4.2 Recommend re-securing the loose / hanging soffit to prevent water, vermin, and insect intrusion and to prevent possible damage to the exterior lighting fixture and wires resulting in a safety hazard. Consult with a carpenter for scope of work. (Exterior Front)

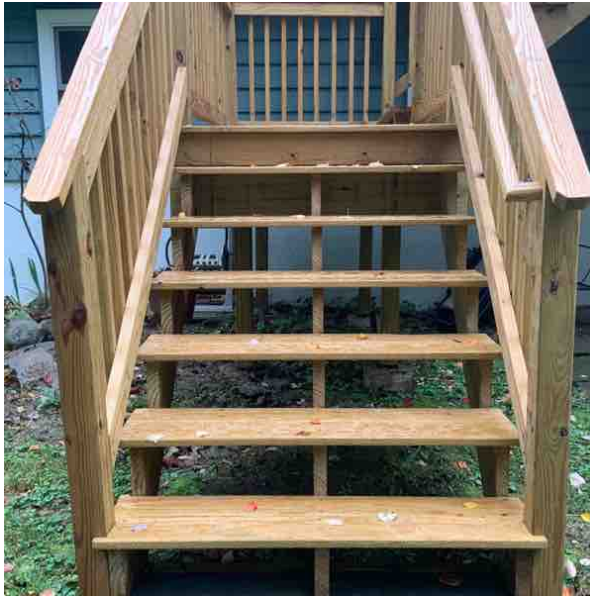
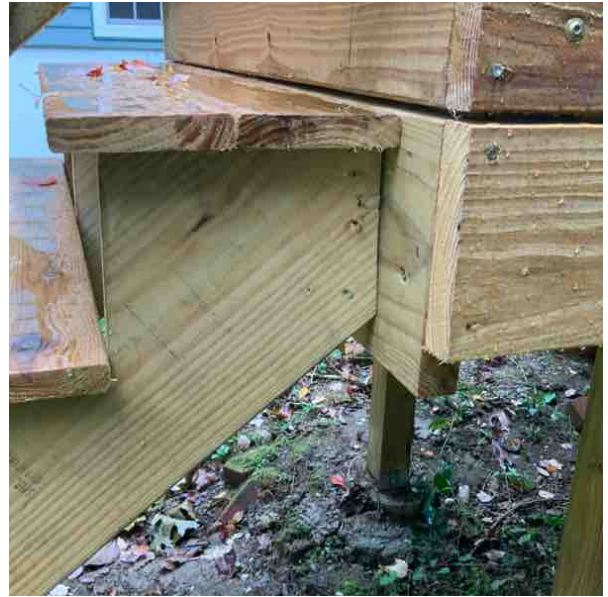
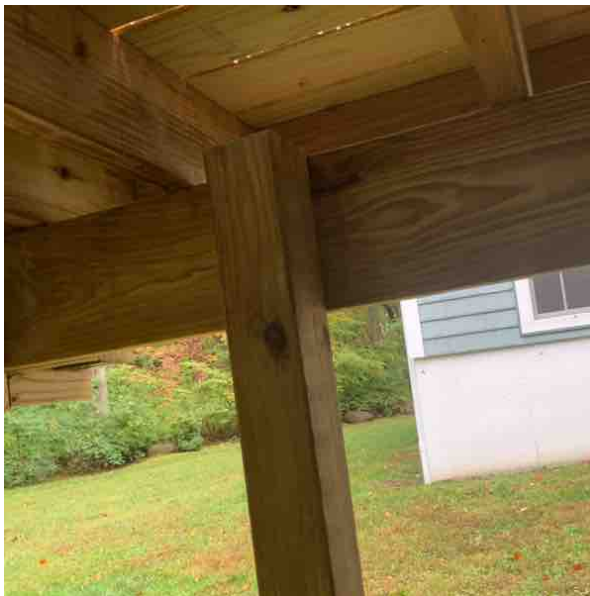
3.9.2 Deck, rail and stair requirements have improved continually due to inadequate building practices and materials. Unless new and properly constructed, few decks meet current safety and construction standards. For enhanced safety, you are advised to consult with a carpenter to repair the following deficiencies and all other best practices outlined in DCA-6: The Residential Wood Deck Construction Guide:

- open stair risers that pose a potential slip-and-fall hazard;
- lack of secure attachment between deck stair and deck assembly that may result in detachment from deck;
- main beam members are attached to the sides of the support posts, in lieu of bearing on top, which may result in deck detachment from the posts. **(Exterior Rear)**

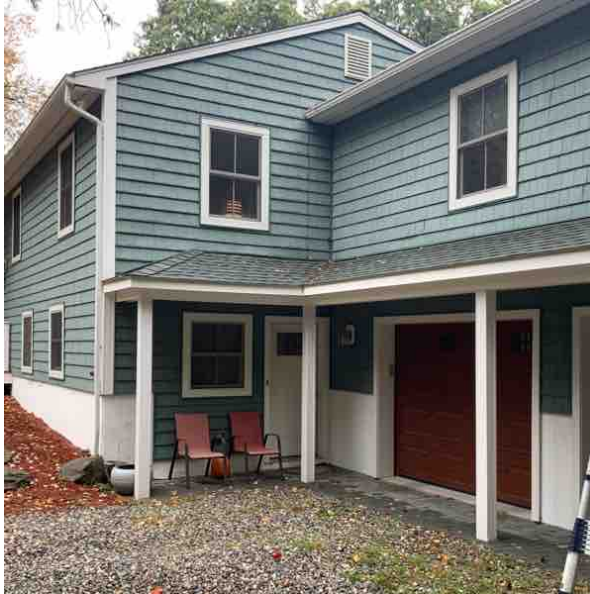
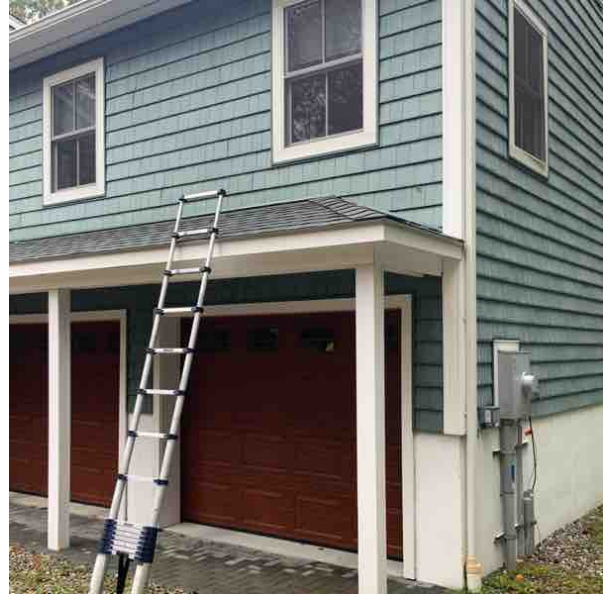
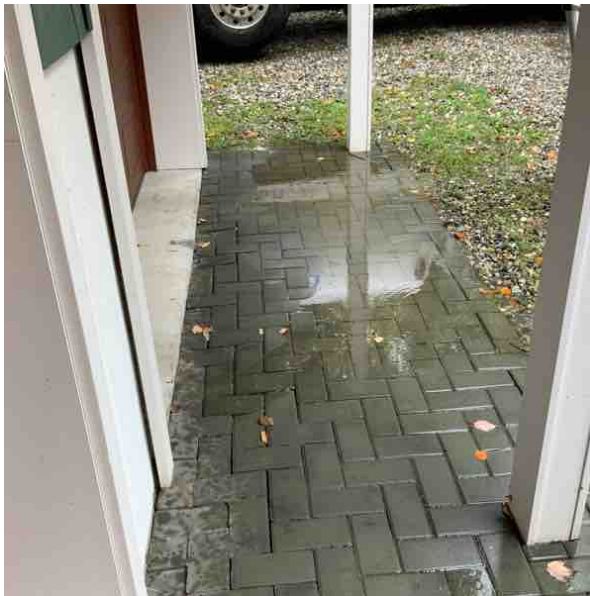
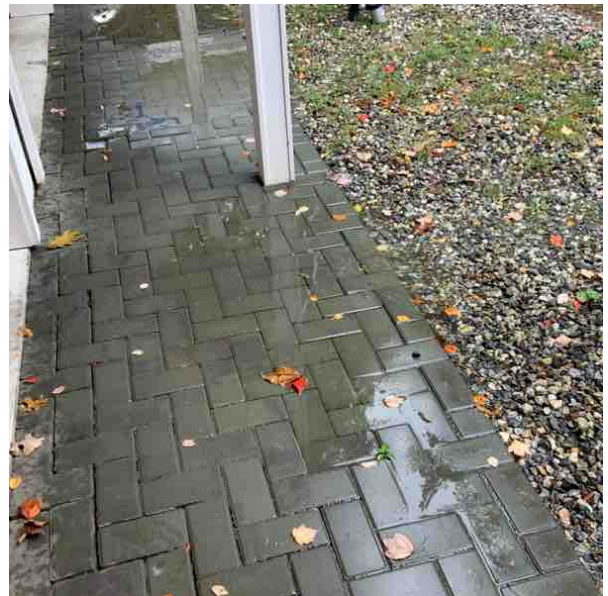
4.5.4 Consider installation of a gutter system at the garage roof or installation of a drain at the garage apron to properly direct water away from the structure and prevent water intrusion into the home. Water was observed to be pooling in front of the garage at the time of inspection.

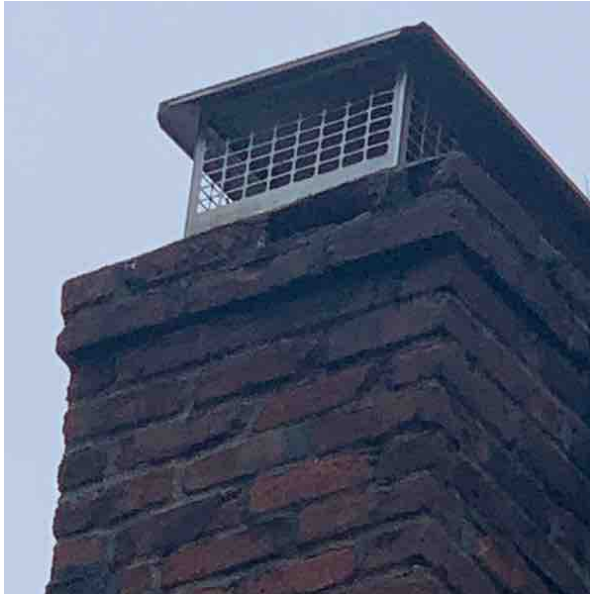
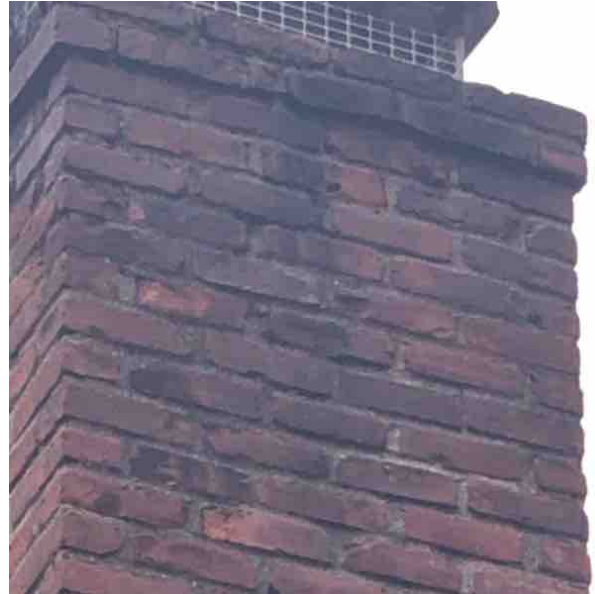
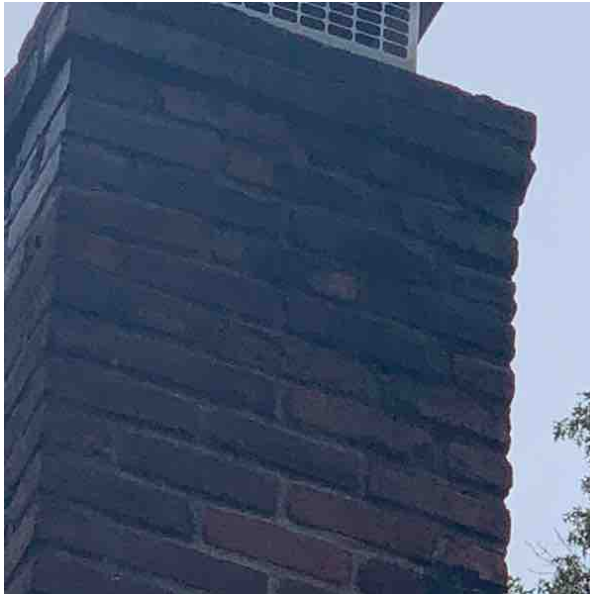
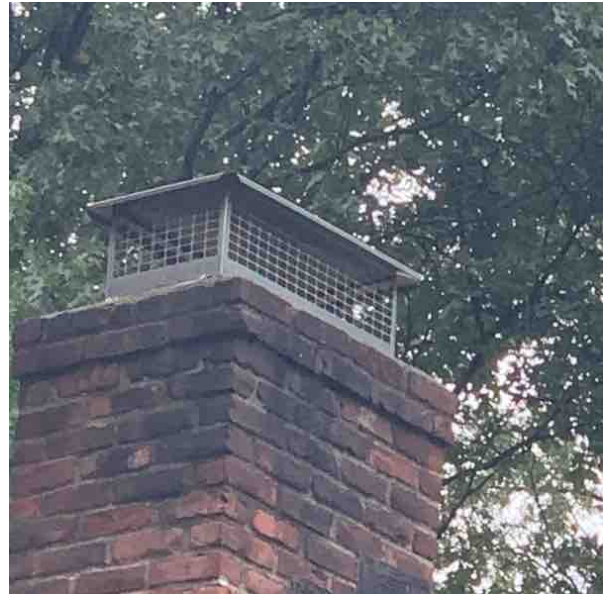
4.6.2 Noted spalling damage and open mortar joints on the chimney bricks attributable to water penetration and freeze / thaw damage. Recommend mortar re-pointing repairs and coating the chimney brick with a vapor permeable water repellent to prevent further deterioration. Consult a chimney expert for application of Chim-Saver or similar.

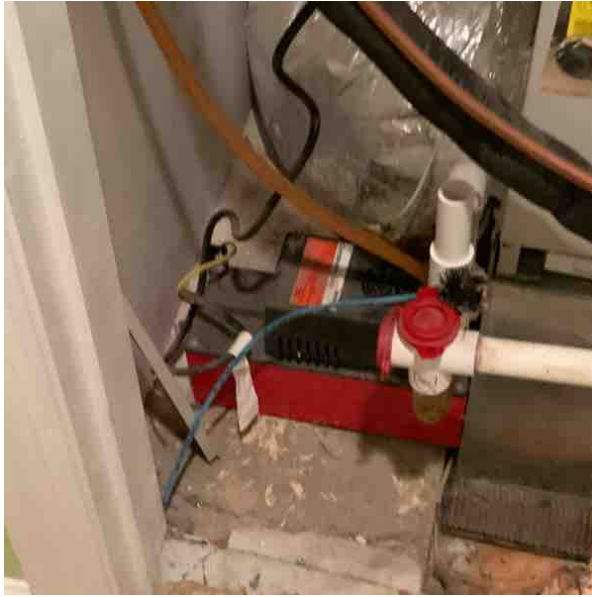
9.5.1 Recommend installation of an emergency overflow drain pan under the finished basement condensation pump to avoid flood damage in the event of leak situations. **(Basement)**

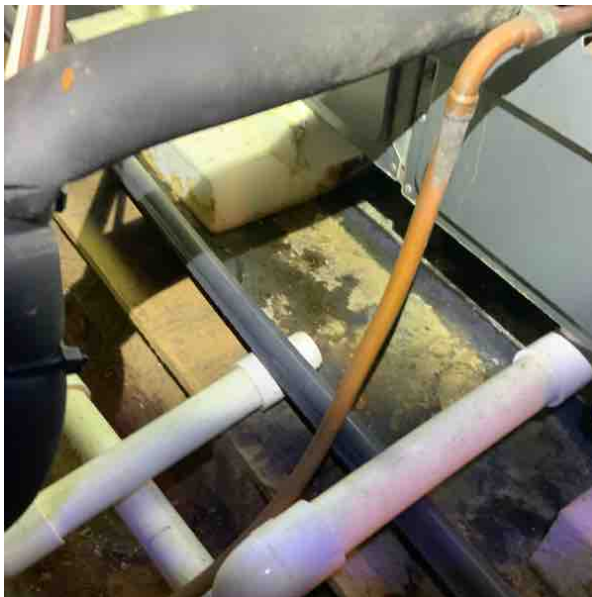
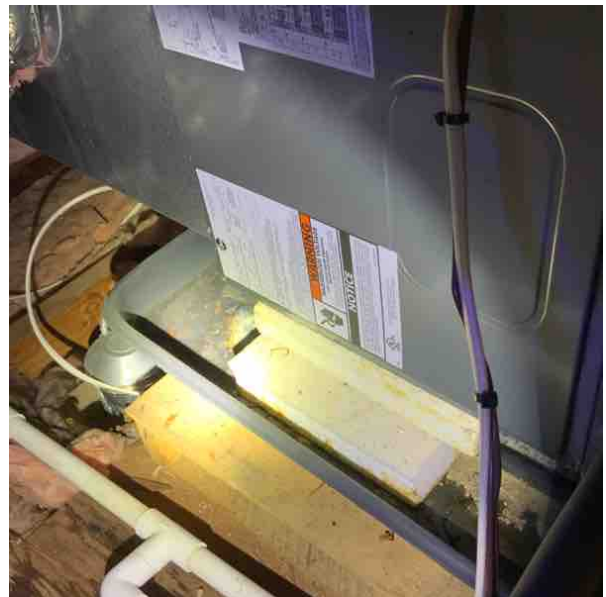
9.5.2 There is corrosion in the attic air handler overflow drain pan indicating a past or current leak. Recommend HVAC evaluation for proper operation prior to air conditioning season to prevent overflow, secondary damage or loss of function.

Recommend installation of the missing condensation drain pan shut-off float switch to avoid potential for floods in the event of condensation drain line clogs. **(Attic)**

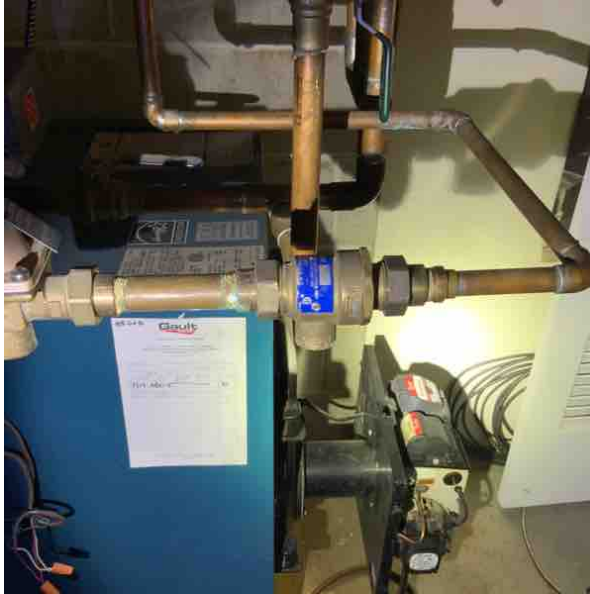
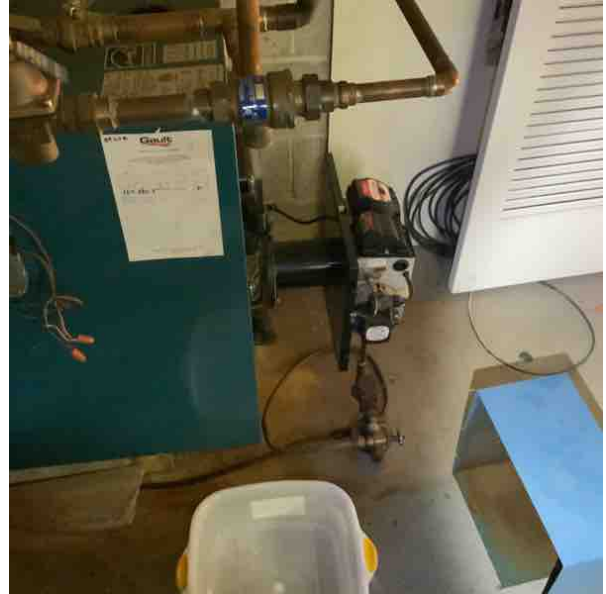
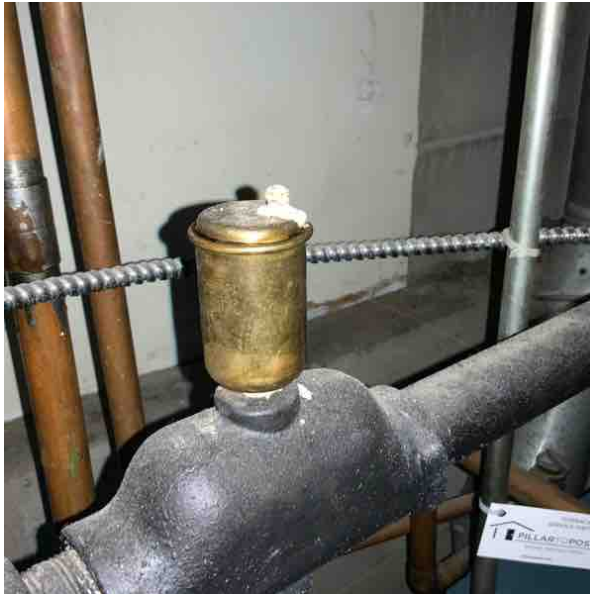
9.6.4 Boiler System Repairs: recommend the following repairs to the boiler and component parts for enhanced reliability and safety:

- replace the leaking backflow preventer valve;
- install the missing discharge tube on the backflow preventer valve to within six inches of the floor;
- replace the leaking / clogged air vents. **(Basement)**

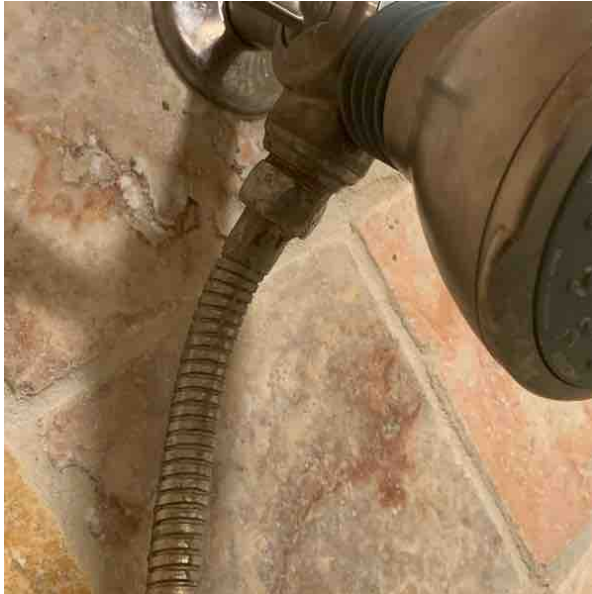
10.10.5 Repair the leaking shower head to avoid waste water loss and for enhanced shower pressure.
(Master Bedroom / En Suite)

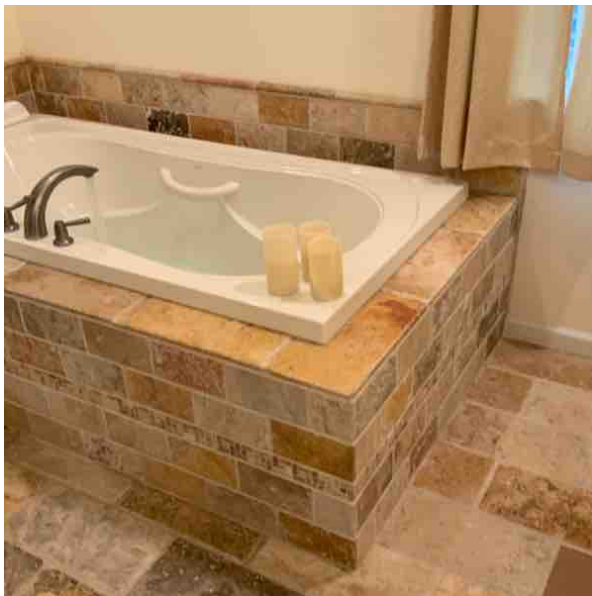
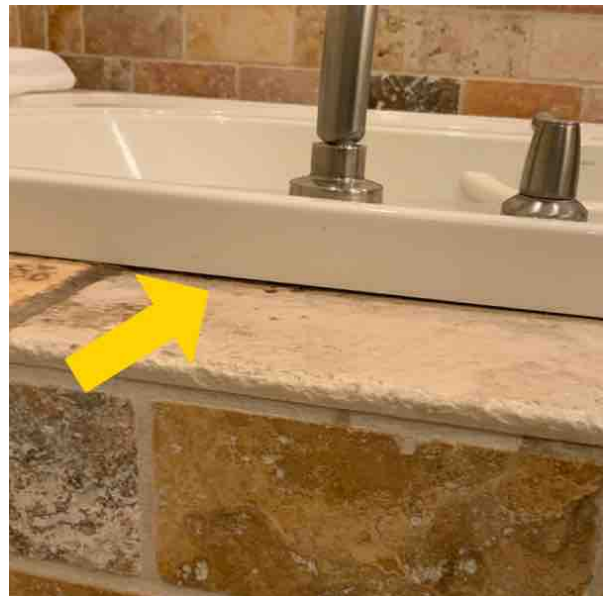
10.10.6 Recommend re-caulking around the jetted tub where it meets the tile to eliminate the potential for water seepage resulting in damage to the surrounding areas. Additionally there is no motor access for the jetted tub. Recommend installation. (Master Bedroom / En Suite)

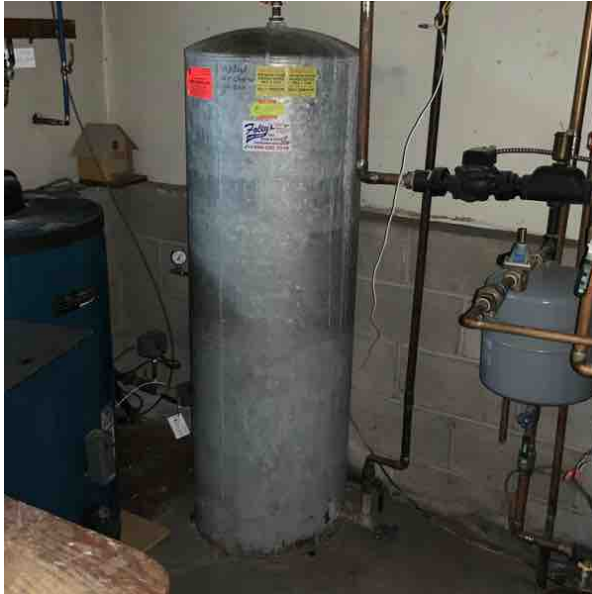
10.13.1 The typical service life for a galvanized well water storage tank is approximately 25 years. Galvanized storage tanks require annual maintenance to re-pressurize the tank. This tank appears to have achieved its reliable service life. Anticipate near term replacement with a modern bladder-style tank for reduced maintenance. **(Basement)**

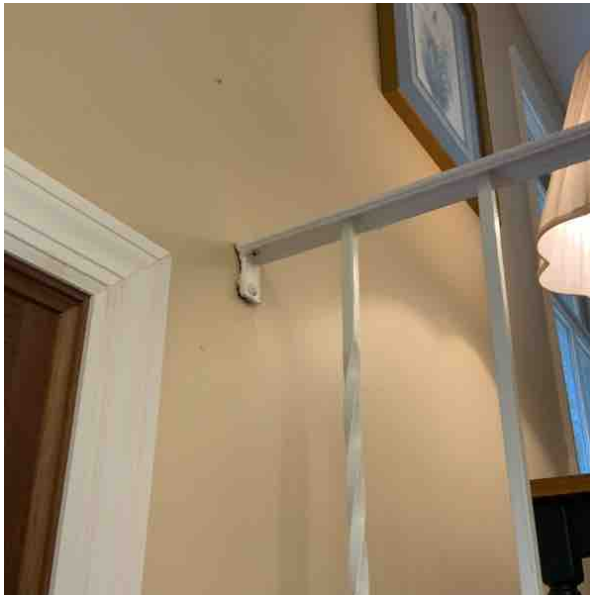
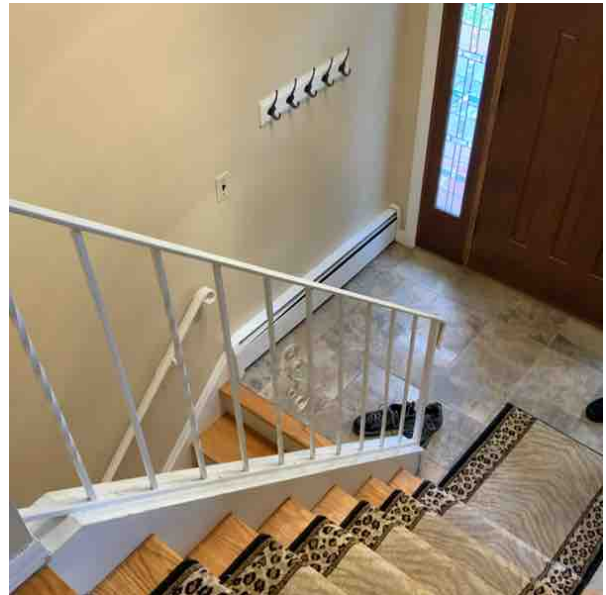
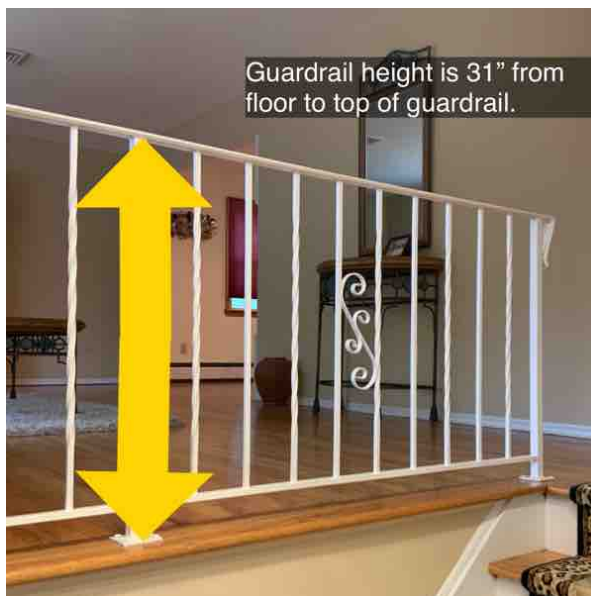
11.7.1 Secure the loose guardrail and railing to reduce potential for safety / trip hazards and damage to the railing. The low guard rail (31") at the second floor hallway is considered a fall hazard for taller individuals. Consider replacement guardrail for enhanced safety to standard height of 36 inches.
(Entrance Foyer)

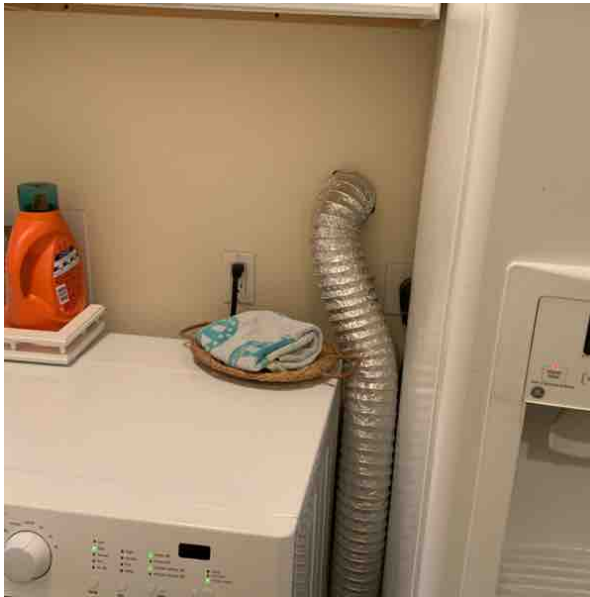
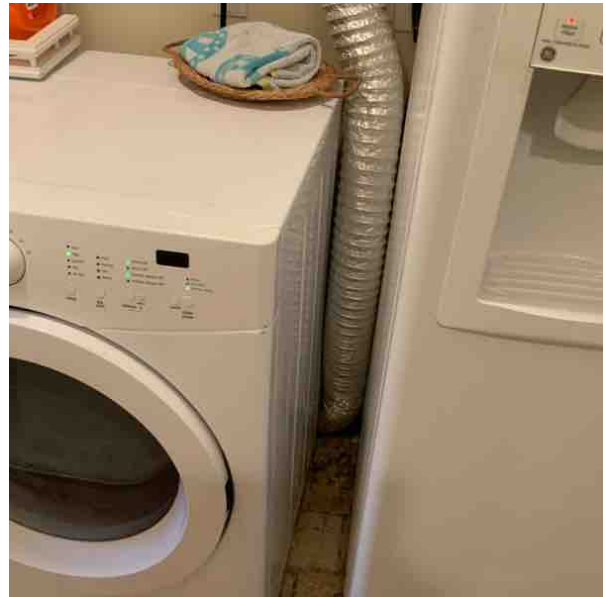
13.3.2 For enhanced protection against lint build-up and possible dryer fire, we recommend you replace the corrugated dryer exhaust with a rigid, smooth wall metal duct no longer than 25 feet with no more than two elbows. According to industry and municipal sources, thousands of fires per year are caused by clogged and improper, corrugated vents resulting in loss of life and millions of dollars of property damage. (UL, CPSC, Assn. of Appliance Manufacturers, IRC) **(Laundry)**
