PROPERTY CONDITION ASSESSMENT

ANNEX/ANIMAL SHELTER

238 Danbury Road
Wilton, Connecticut

Marx|Okubo Job No. 23-2104

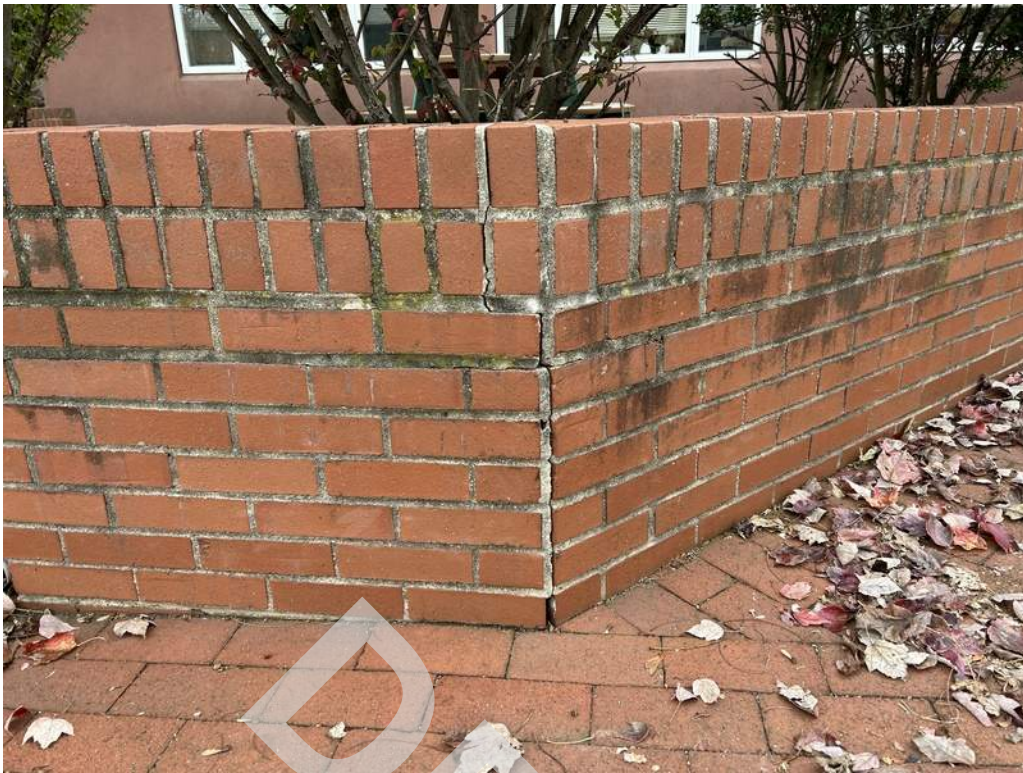
3 - Deteriorated mortar was observed at the brick garden wall, adjacent to the patio.

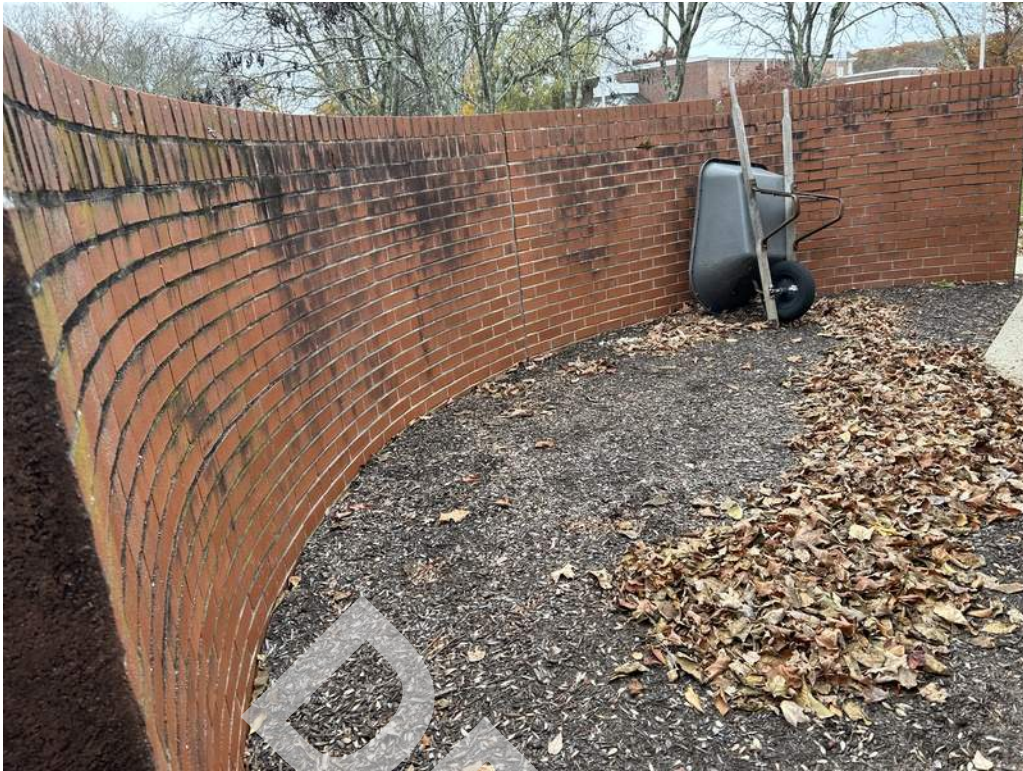
5 - Staining and deteriorated mortar was observed at the brick garden wall along the east façade.

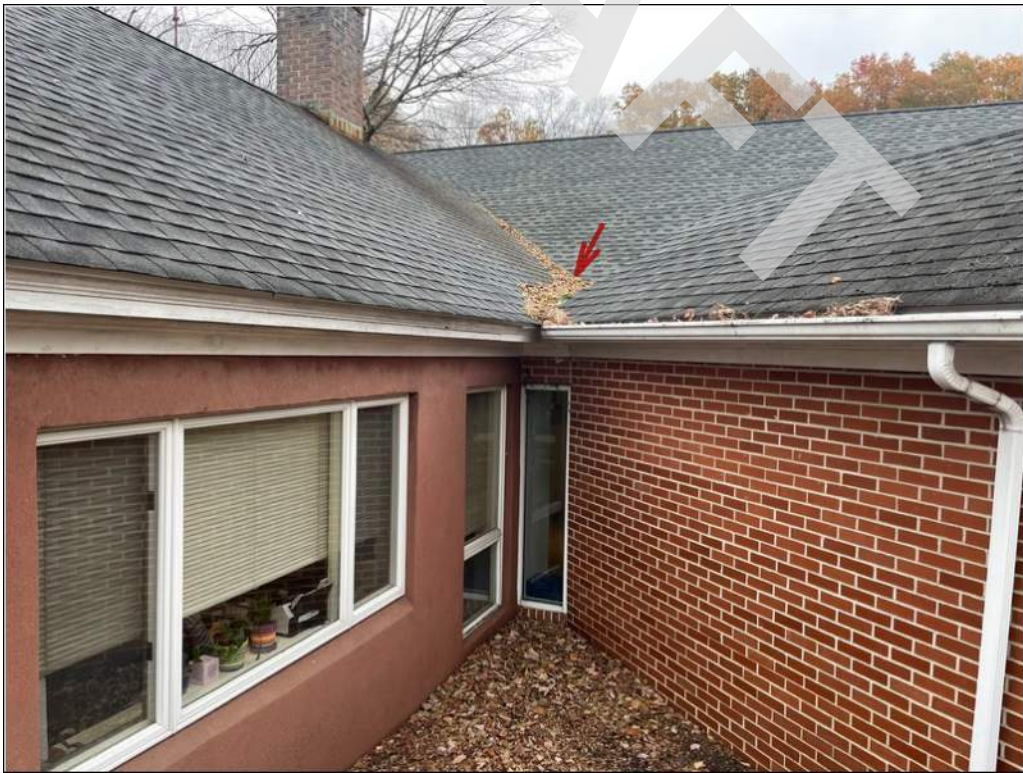
Building Integrity: The Annex building is provided with sloped roofs covered with asphalt shingles. It was noted and reported that localized areas below the roofs occasionally have water leaks along the valley near the drop box entrance, as well as below the steel trusses in the public entrance area. Based on information provided, the annex building west wing roof was replaced around 1990, and the remaining sloped roof areas in the annex building were replaced in 1984. Perform a phased asphalt shingle roof replacement when the roofs reach the end of their useful life. Budget includes inspecting and repairing any underlying damages that have lead to the water intrusion.	5,000	SF															Priority 2 - Potentially Critical.

6 - Annex building roof consists of asphalt shingles. Interior areas below the roof valley had instances of water intrusion.

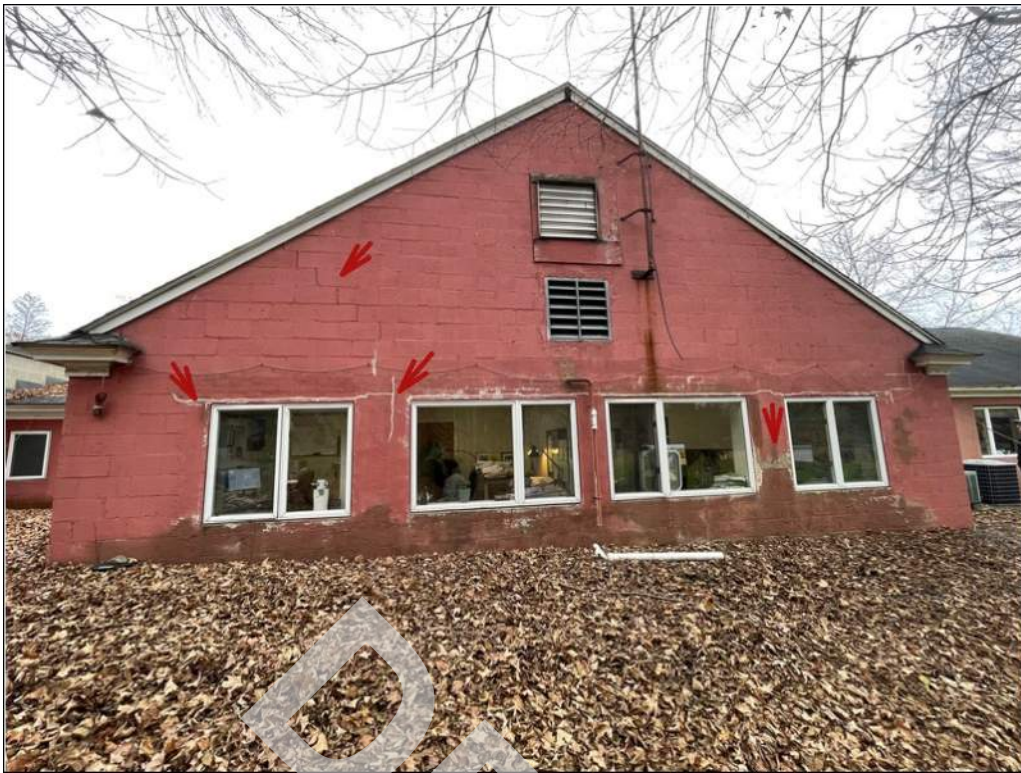
#	Item	QTY	Unit	Unit Cost	EUL	EFF Age	Year 1	Year 2	Year 3	Year 4	Year 5	Year 6	Year 7	Year 8	Year 9	Year 10	Total Cost	Comments
7	🔴 Building Integrity: Annex building and animal shelter facades consist of brick masonry walls, concrete masonry unit (CMU) walls and stucco. CMU and stucco walls along the north side of the building are in fair condition. Damages at the CMU walls include stepped cracking, eroded CMU surfaces and eroding mortar joints. Stucco surface damages include cracking and erode areas. Perform a CMU mortar joint and stucco repair program. Budget represents approximately 20% of the surfaces.	2,000	SF															Priority 3 - Necessary – Not Yet Critical.
8	🔴 Appearance: Exterior facades throughout the Annex and Animal Shelter have peeling paint finishes, debris, and organic growth stains. Power wash all exterior wall surfaces after repairs have been completed. Surfaces include soffits, trim, gutters, downspouts, signage, doors, aluminum frames, masonry, and stucco.	6,000	EA															Priority 4 – Recommended.

7 - Localized areas of the CMU (concrete masonry unit) facade have stepped cracking, cracked mortar joint and cracked units along the window lintel. Parging coat is peeling along the base CMU courses. Windows are in poor condition.

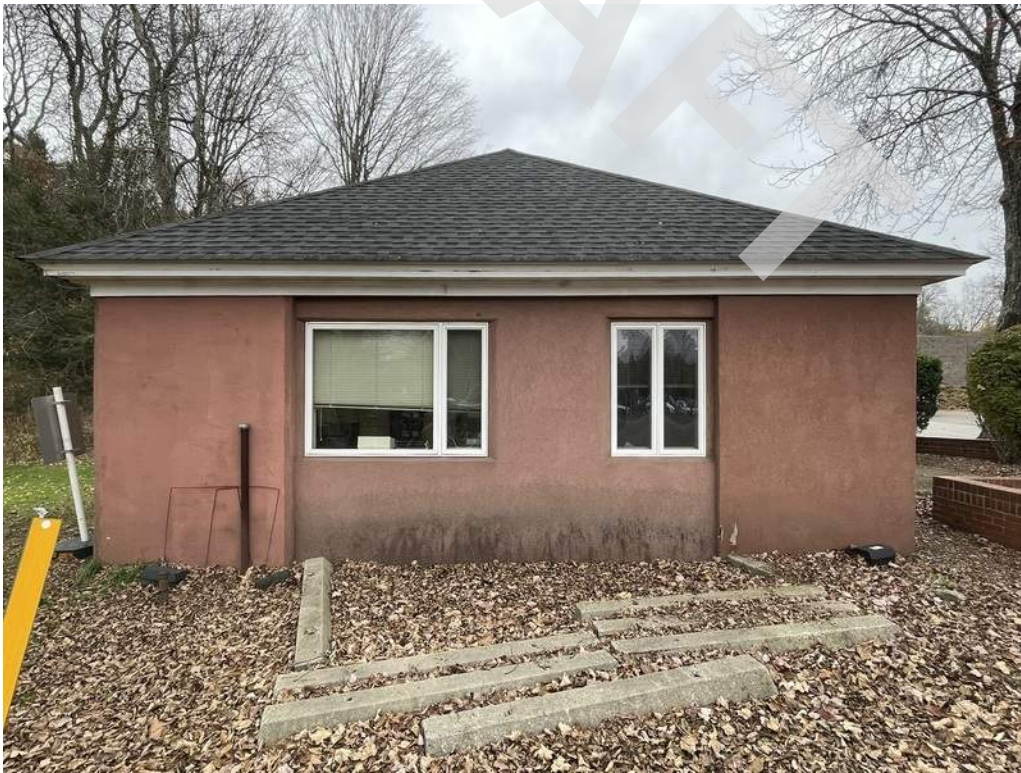
8 - Exterior surfaces along the façade have peeling paint finishes, debris accumulation, and organic growth stains.

9	🔴 Appearance: Following the façade repair program, prepare surfaces for painting and paint throughout. Scope to include soffits, trim, gutters, downspouts, signage, doors, aluminum frames, masonry, and stucco.	4,500	SF															Priority 4 – Recommended.
10	🔴 Building Integrity: Windows replacements along the façades were reportedly installed during the 1984,1985 and 1990 renovations. The two quarter round windows along the south façade of the Annex building have interior condensation. Replace insulating glass units and frames. Remaining windows throughout the Annex and Animal Shelter are in fair to poor condition, and are in need of replacement. Perform a phased comprehensive window replacement program of all windows throughout the building, when units reach the end of their useful life. It was reported that the quarter round windows were originally designed for a meeting space that is no longer there, therefore, consideration could be given to eliminating the quarter round windows to reduce costs.	50	EA															Priority 2 - Potentially Critical.

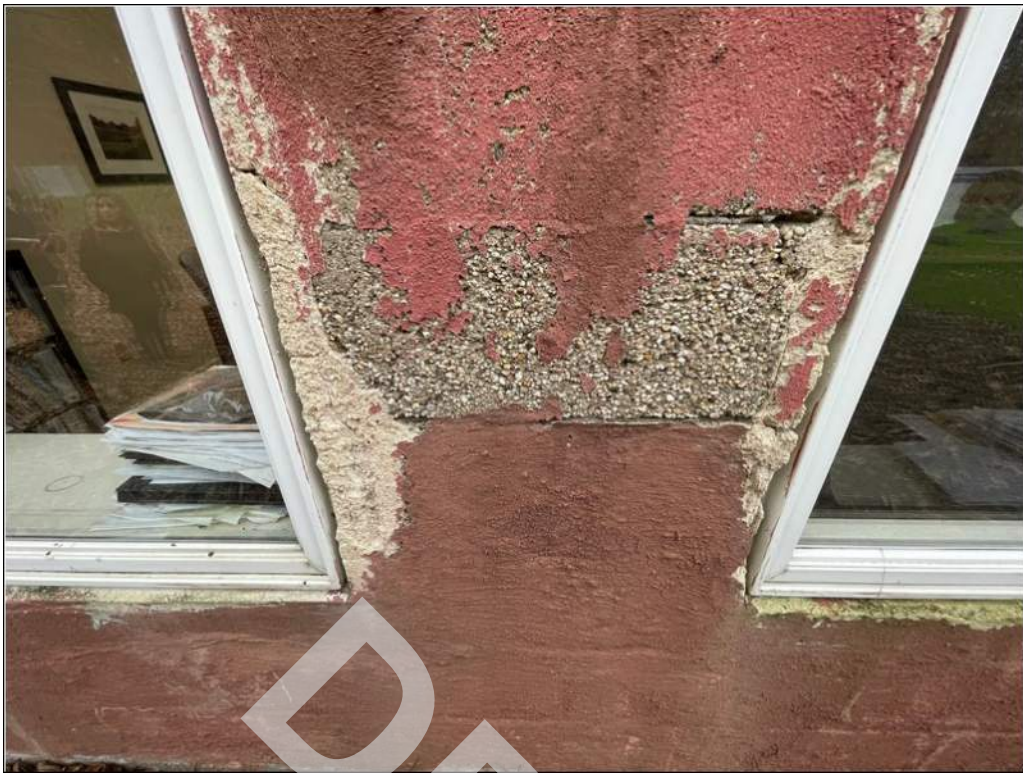
9 - CMU finishes and mortar joints along the facade are deteriorating.

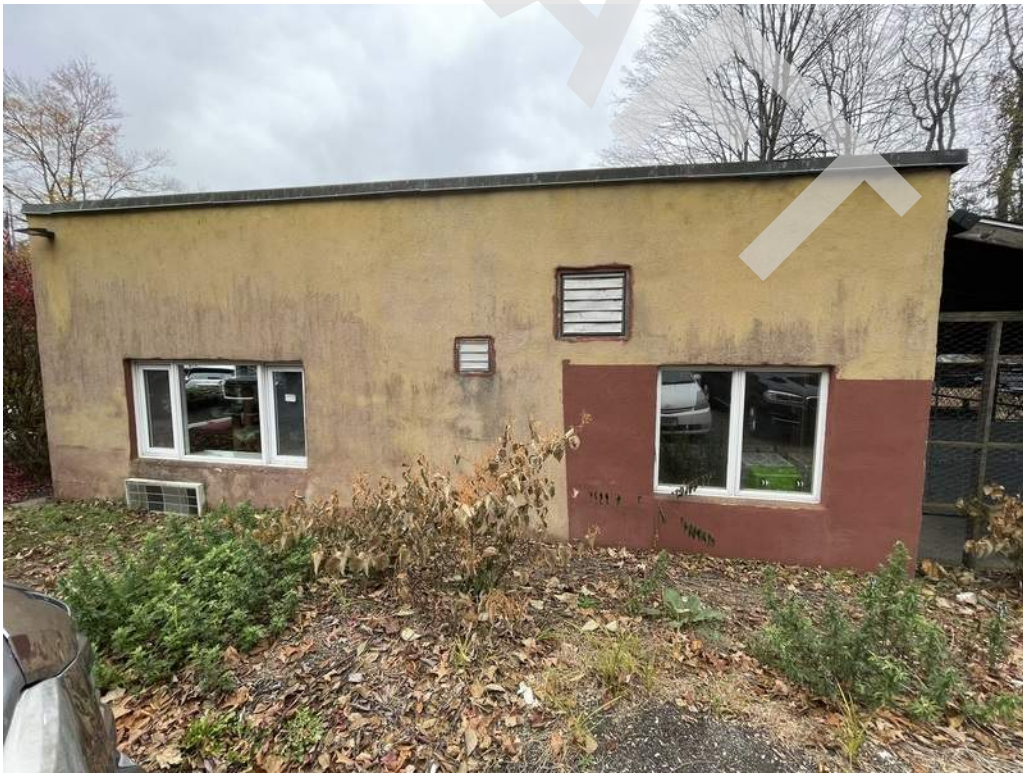
10 - Exterior wall finishes at the animal shelter stucco facade are in poor condition.

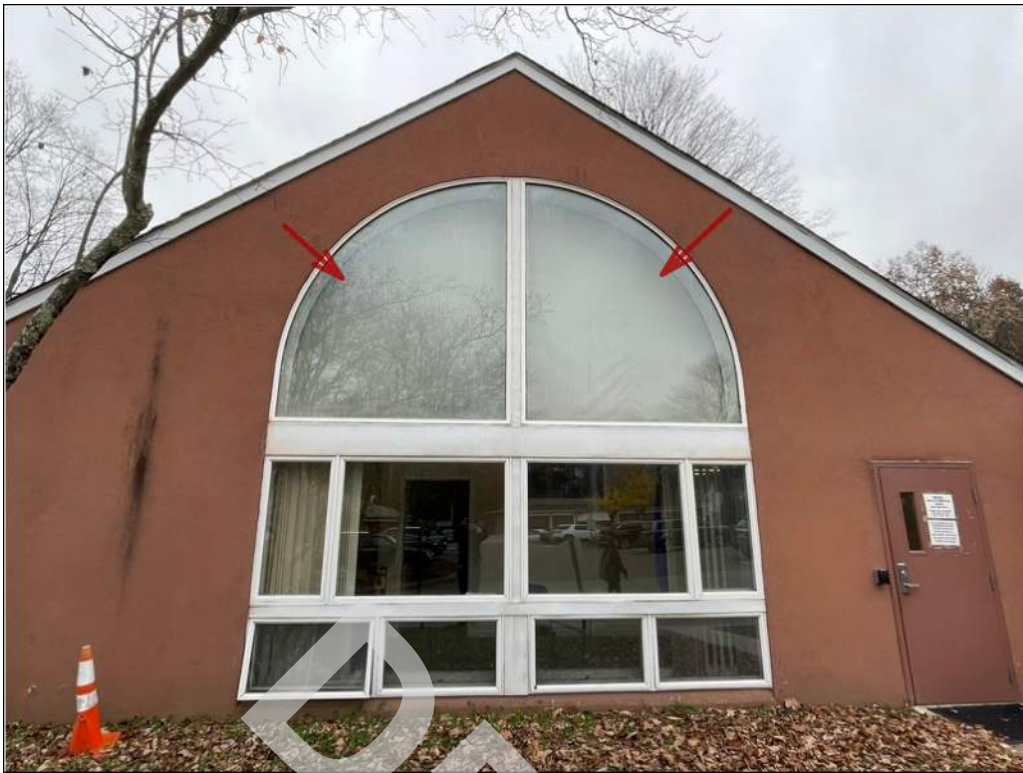
11 - Quarter circle window units along the south facade have failed.

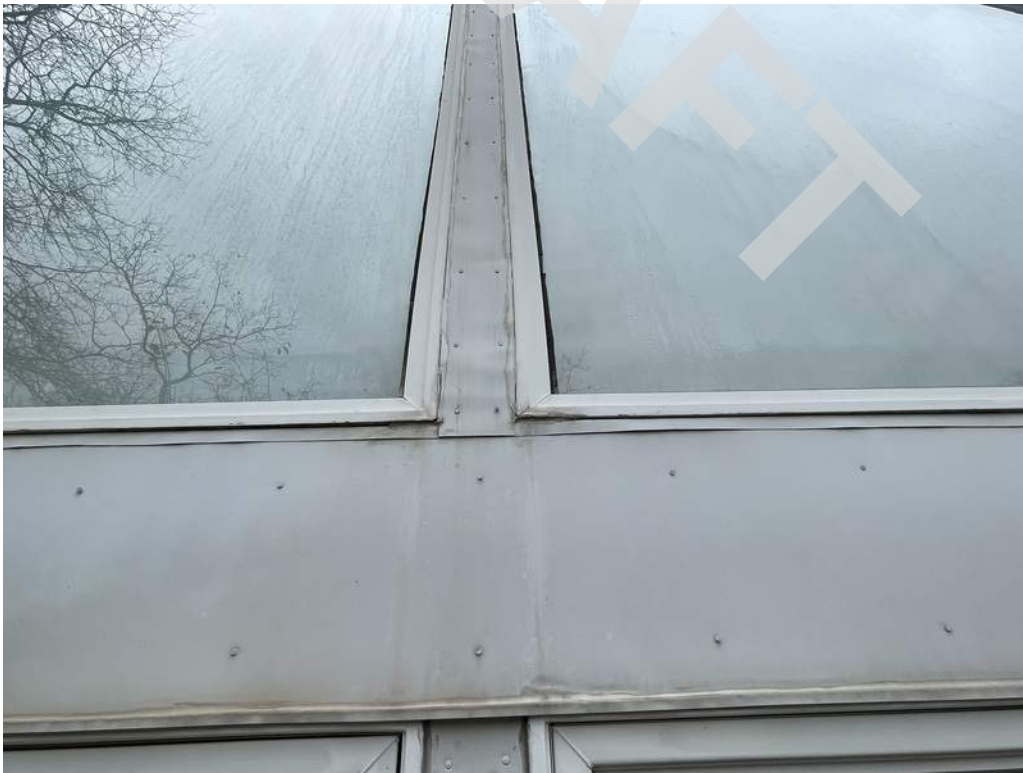
12 - Insulating glass units within the quarter round windows have failed and have internal condensation.

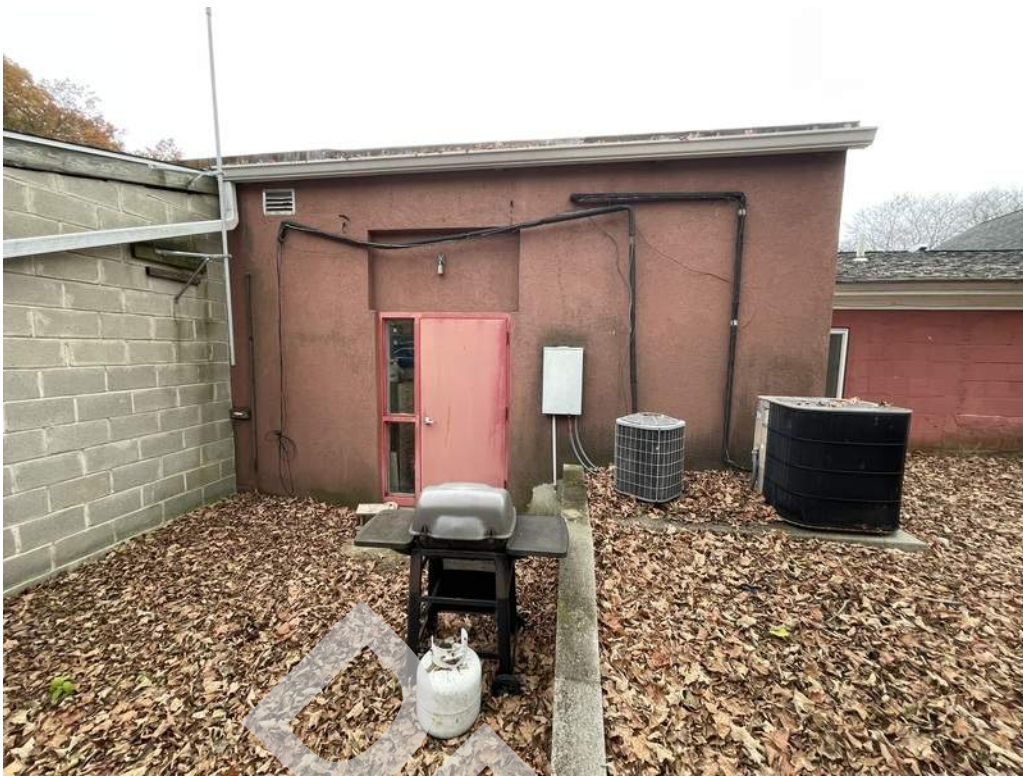
15 - Exterior surfaces along the north facade egress door are in poor condition.

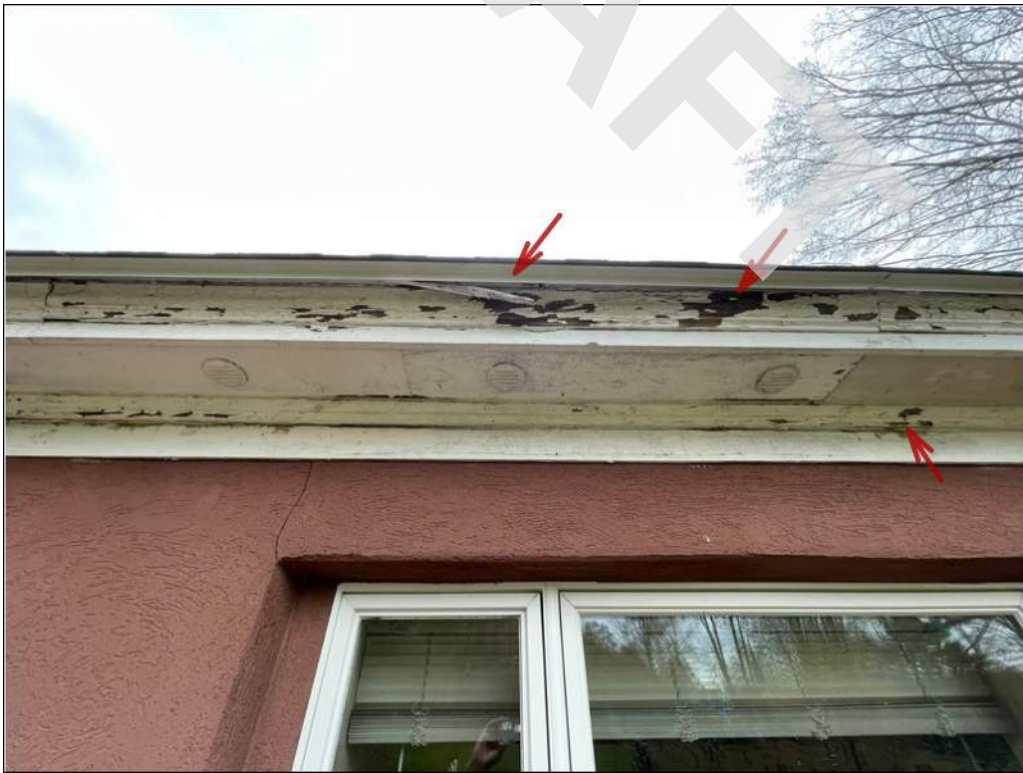
16 - Wooden trim and soffits along the roof perimeter are in poor condition. Wood has rotted and paint finish is peeling.

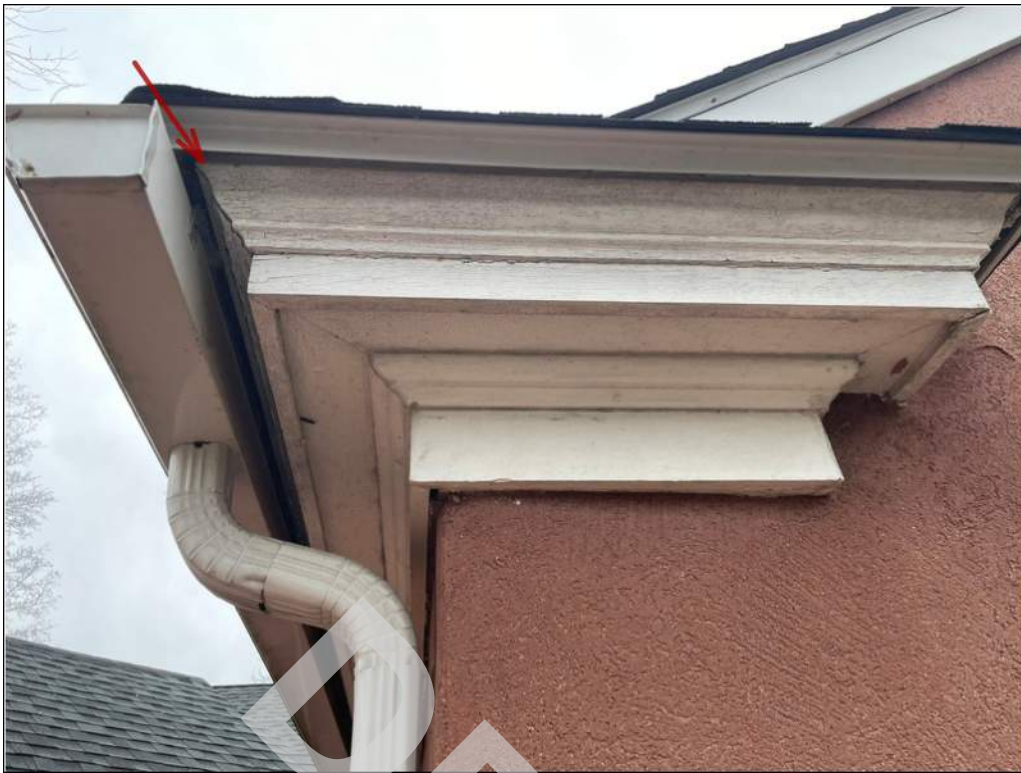
17 - Wood trim paint finishes are cracking.

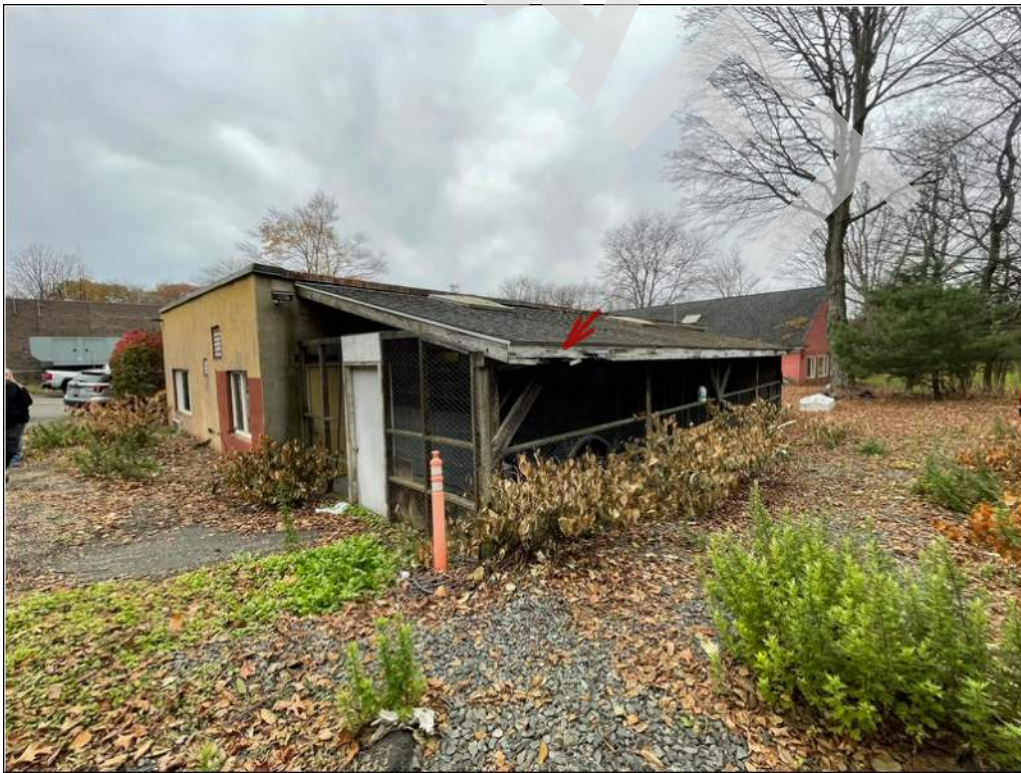
18 - Wood trim around the animal shelter kennel roof has rotted.

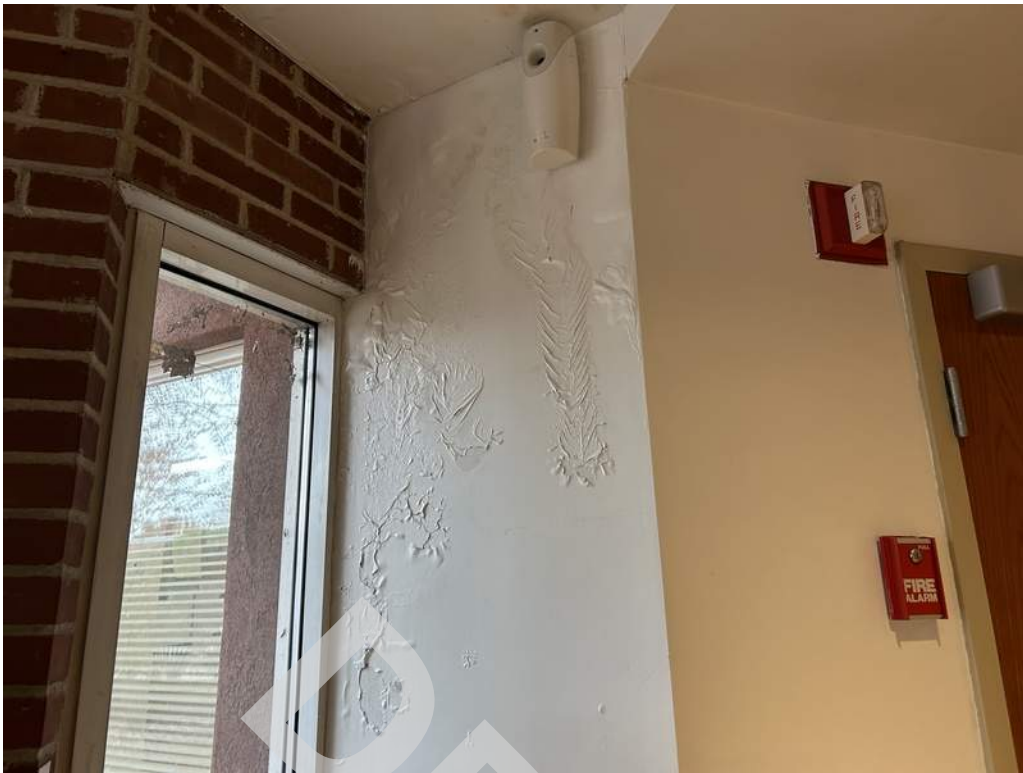
INTERIOR IMPROVEMENTS																		
16	Appearance: Interior finishes were observed to generally be in fair to good condition. The age of the finishes is unknown; however, deteriorated paint due to previous leaks that have been addressed and damaged vinyl composite tiles was observed at localized areas throughout the building. Perform localized repairs early in the term and continue with phased replacement of interior improvements as conditions warrant due to wear and tear with age. The budget assumes approximately 20% of the total square feet. Interior finishes consist of painted gypsum wall and ceiling boards; suspended ceilings with acoustic tiles; vinyl, carpet, or tile floors.	1,100	SF															Priority 3 - Potentially Critical
17	Appearance: Currently, a public entrance is provided through the main vestibule on the southeast side of the building. It was reported configuration of a new public entrance is in progress. Revised drawings provided include a new public entrance along the east façade, counters, office, and a sidewalk leading to the entrance. It is our understanding the drawings have been submitted for permit approval and are in review. According to town staff, the budget could be in the order of approximately, \$32,000; however, no proposal was provided for review. Marx Okubo recommends that the budget include a contingency for unforeseen field conditions.	1	LS															Priority 4 - Recommended.

21 - Instances of paint peeling at isolated areas was observed at the facility.

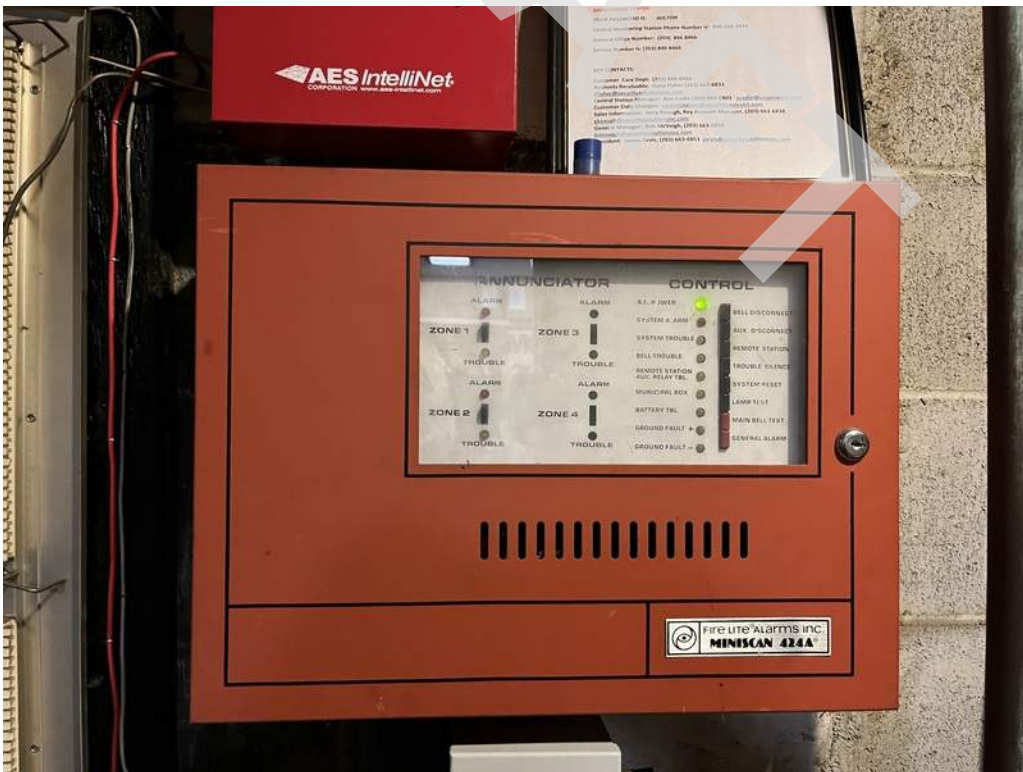
26 - The building is provided with a Miniscan 424 Fire Alarm Panel.

24	Life Safety Code Compliance: The Miniscan 424 was reportedly installed over 20 years ago and is obsolete. Replace the fire alarm panel. No fire alarm issues were reported by the client. The scope of work includes installation of a new fire alarm panel and fire alarm devices. Rewiring to system devices is not anticipated, nor is it included in the budget.	1	EA															Priority 2 - Potentially Critical.

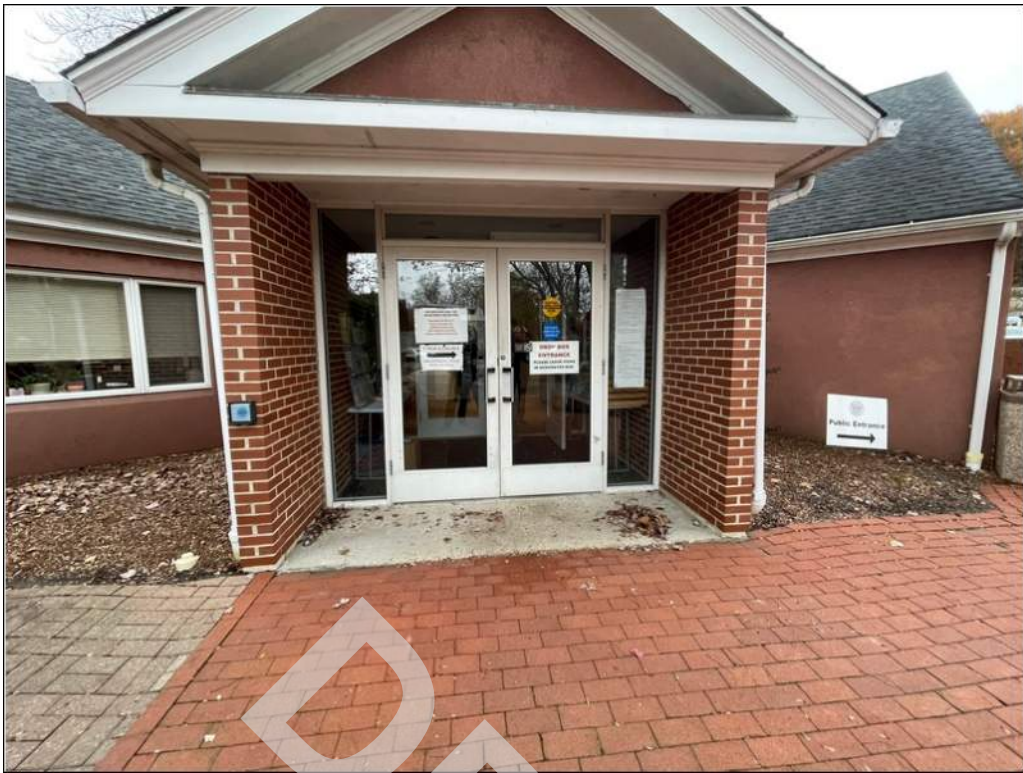
27 - Power assisted door at the drop box entrance is not operating.

3	Life Safety Code Compliance: Based on the results of the review by the fire life safety professional, provide exit signage and devices where required. Scope may include providing new exit signage, including wiring, pull station, and compliant hardware at egress doors. Quantity and final budget will be based on the results of the fire life safety review. A preliminary budget is provided for reference.	1	LS				Priority 1 – Current Critical.
4	Life Safety Code Compliance: Battery powered emergency lighting is provided throughout the annex building. Each light observed was tested to confirm it was functional. Two of the emergency lights in the hallway did not turn on when tested. Replace the non-functioning lights with new. It is recommended to regularly test all emergency lights.	2	EA				Priority 1 – Current Critical.
ACCESSIBILITY							
5	ADA: The drop box entrance is provided with a power assisted door with an actuator. The power assisted door was not operating during out visit. Additionally, door hardware was observed to be orbital at select spaces. Replace with lever type hardware to meet compliance and repair power assisted door hardware.	1	EA				Priority 1 - Current Critical.

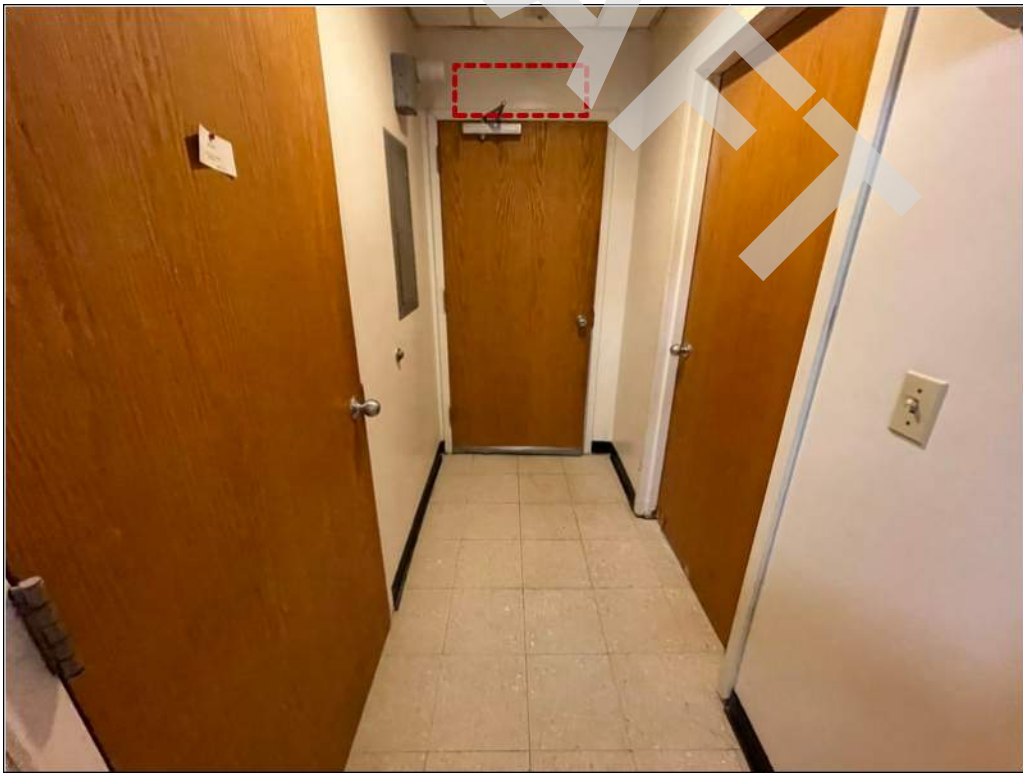
28 - Illuminated exit signs are not provided along the path of egress.

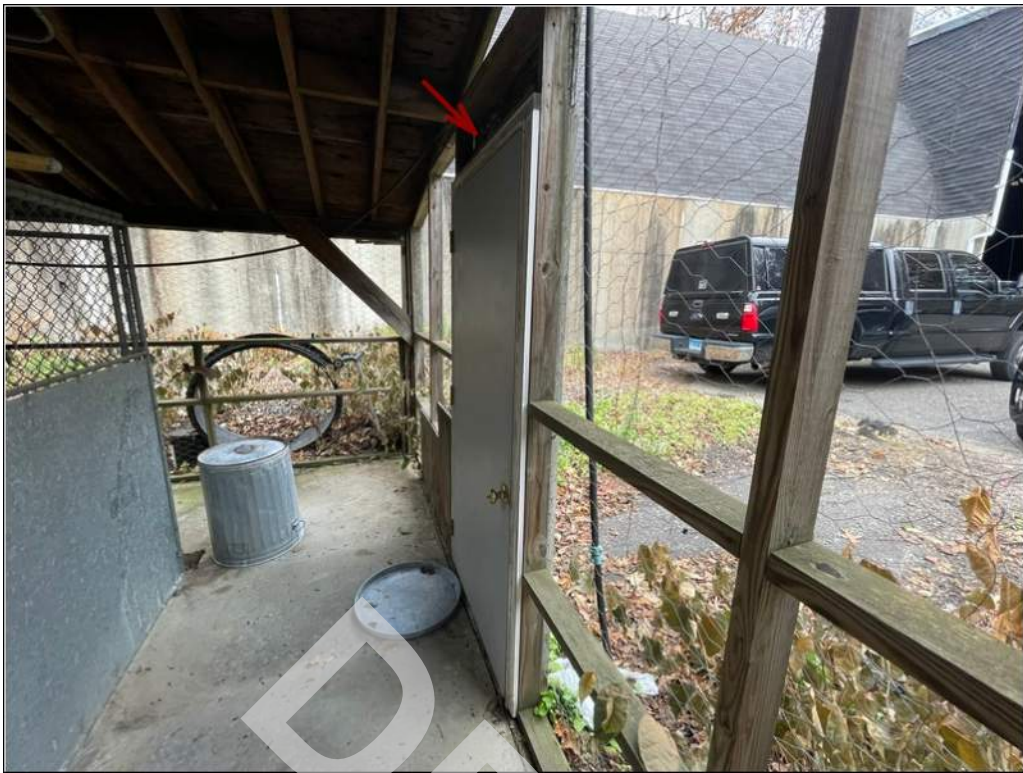
29 - Illuminated exit sign is not provided at the door exiting from the animal shelter kennel.
