FACILITY CONDITION ASSESSMENT

COMSTOCK COMMUNITY CENTER

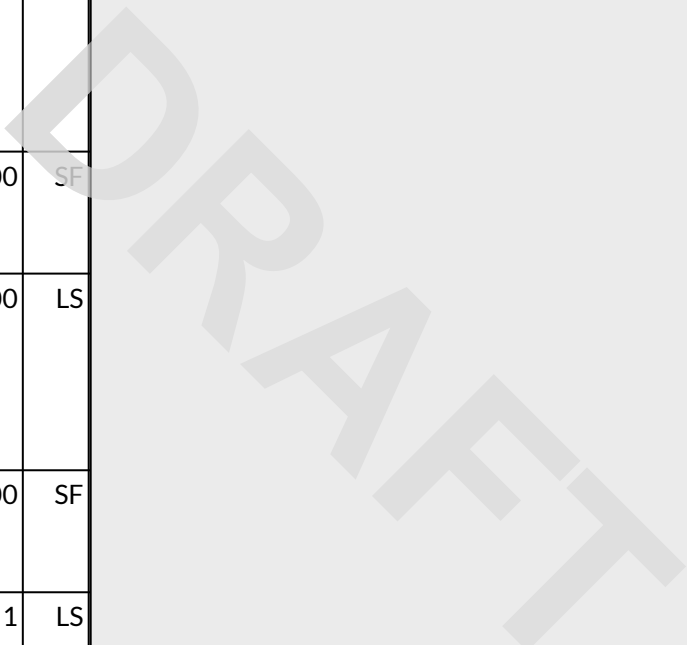
1. Opinions of cost are based on limited observations of readily observable conditions and available documentation. Determination of actual costs require competitive bidding by qualified contractors on a scope of work that may require development of repair documents by a qualified engineer or architect.
 2. Marx|Okubo is not an environmental consultant or evaluator of pest infestation. Opinions of cost exclude abatement of hazardous materials or remediation of pest infestations unless otherwise noted.
 3. This cost table is a supplementary document to the report and should be reviewed in conjunction with the full report and exhibits.
 4. Marx|Okubo's standard inflation rate for the purposes of the Capital Reserve Schedule is 3%. At the request of the Town of Wilton, the rate has been adjusted to 4%.

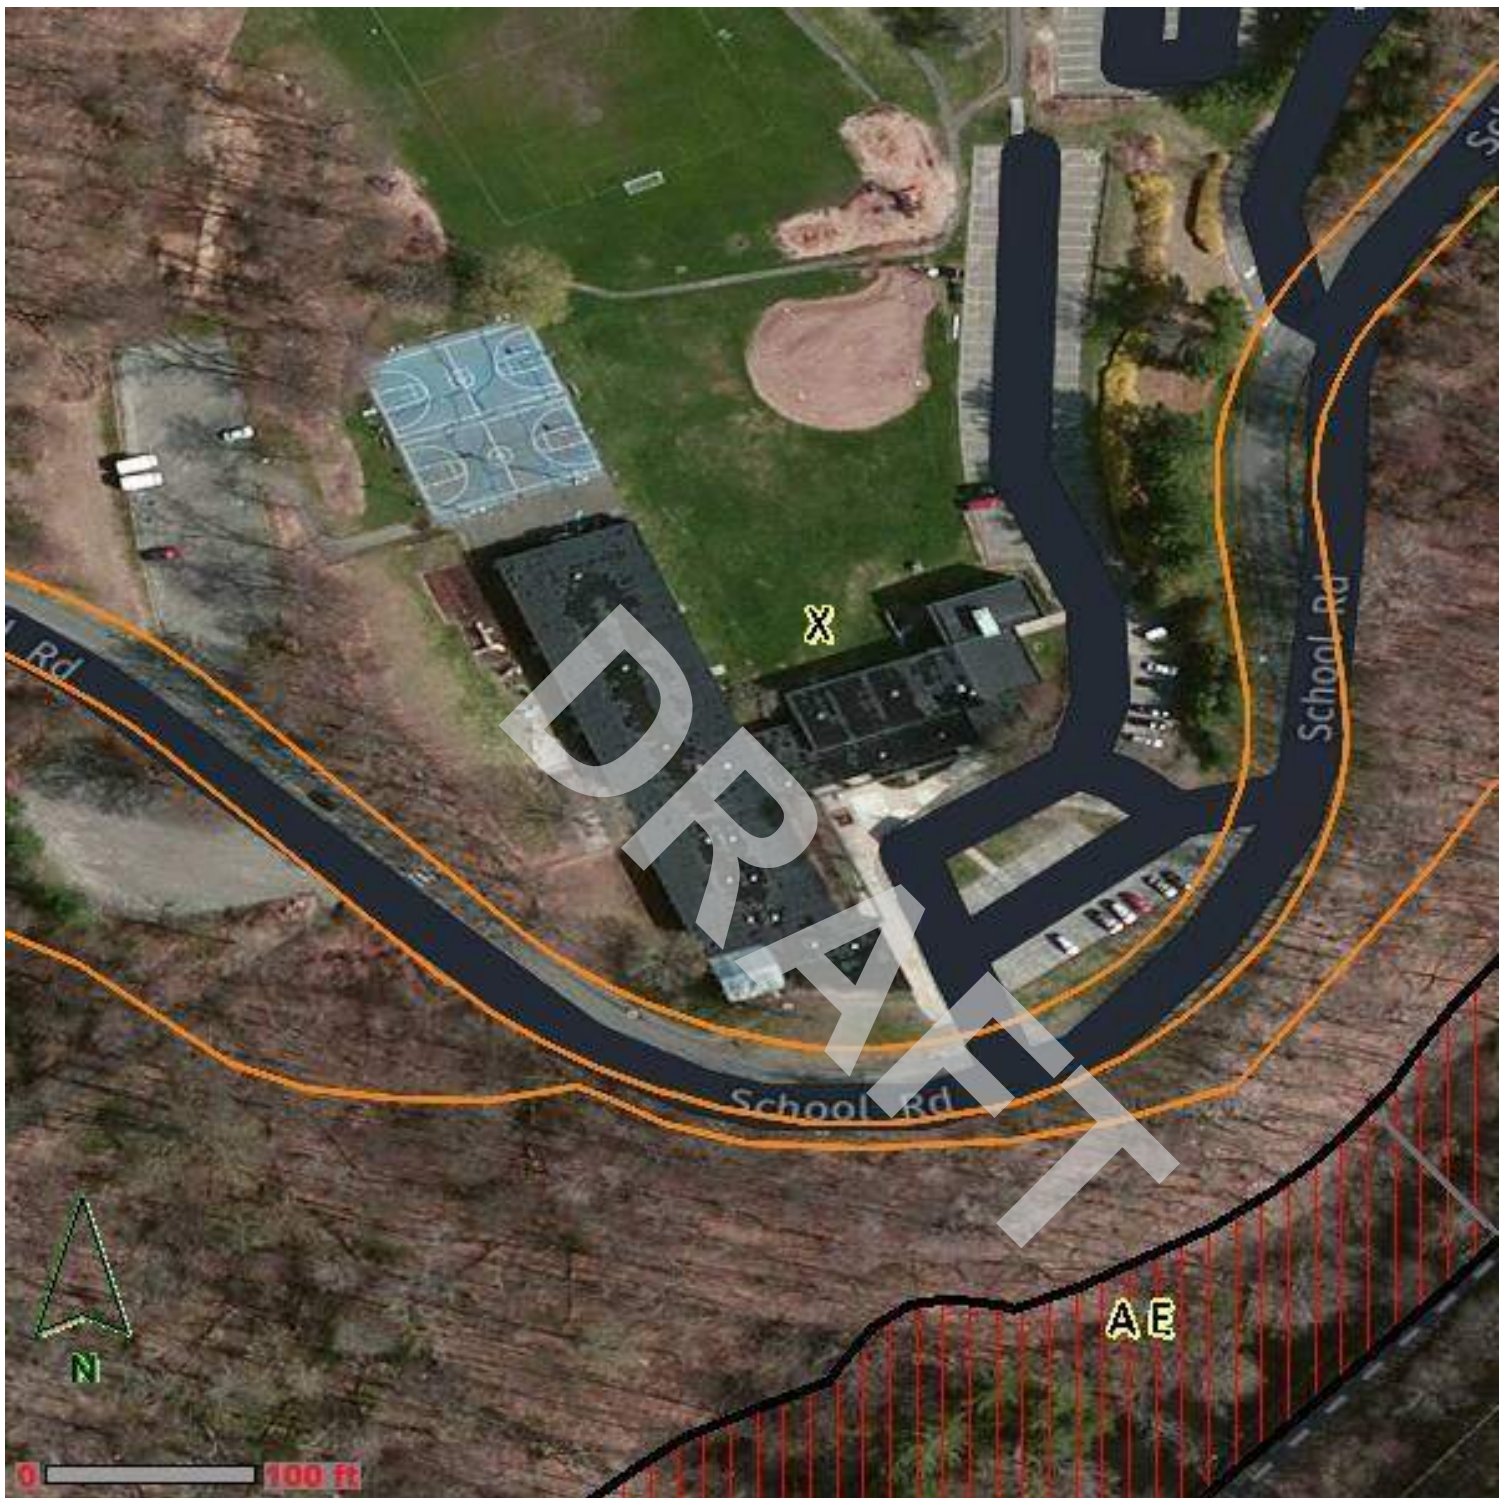
Flood Zones Legend	A Values	X500 /SHX / B	X / C
	D / NMA	V Values	Street

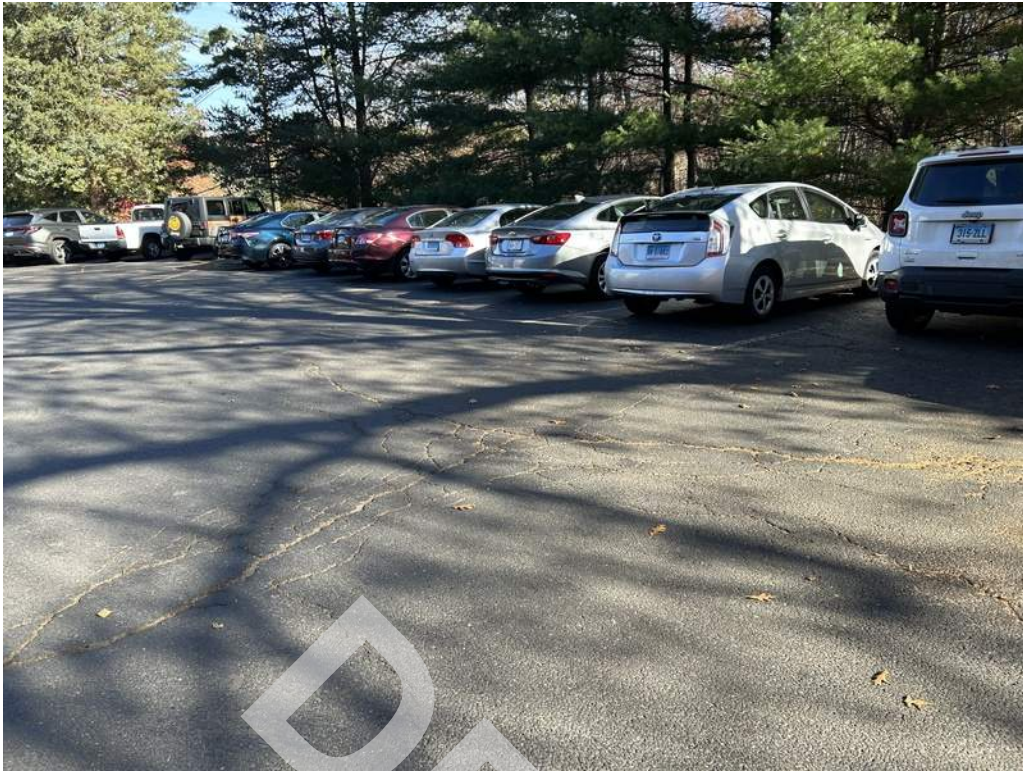
3 - The asphalt paved parking provided at the side of the building exhibits alligator and longitudinal cracking.

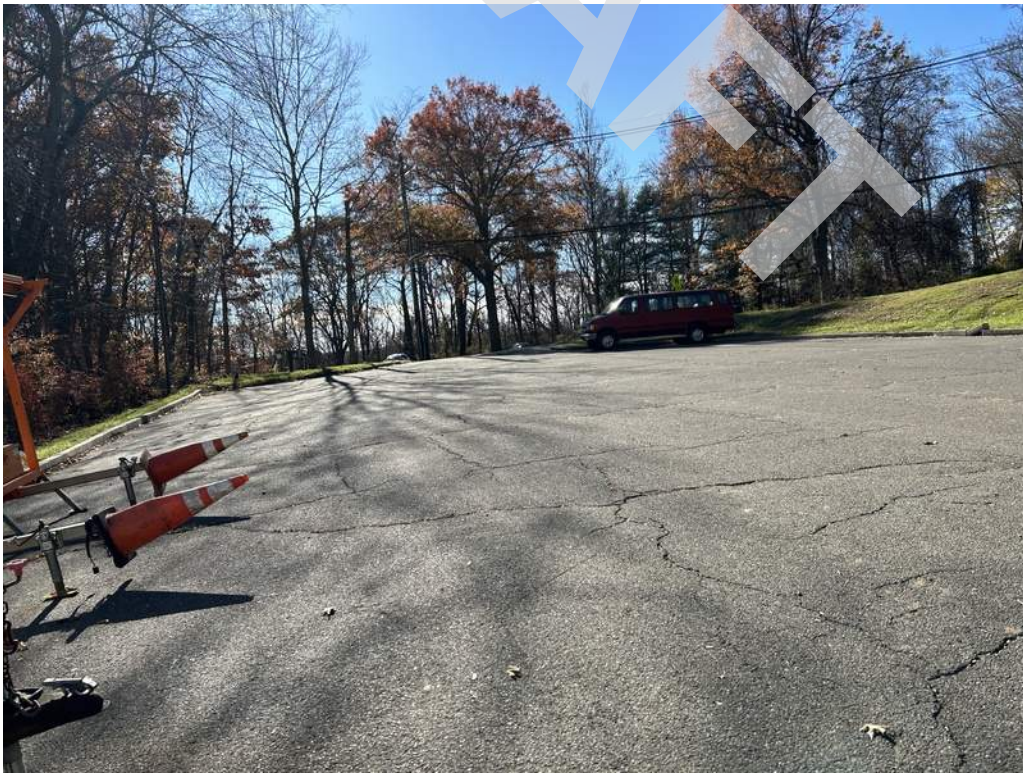
4 - One of the two additional parking lots exhibit cracking and damaged curbing.

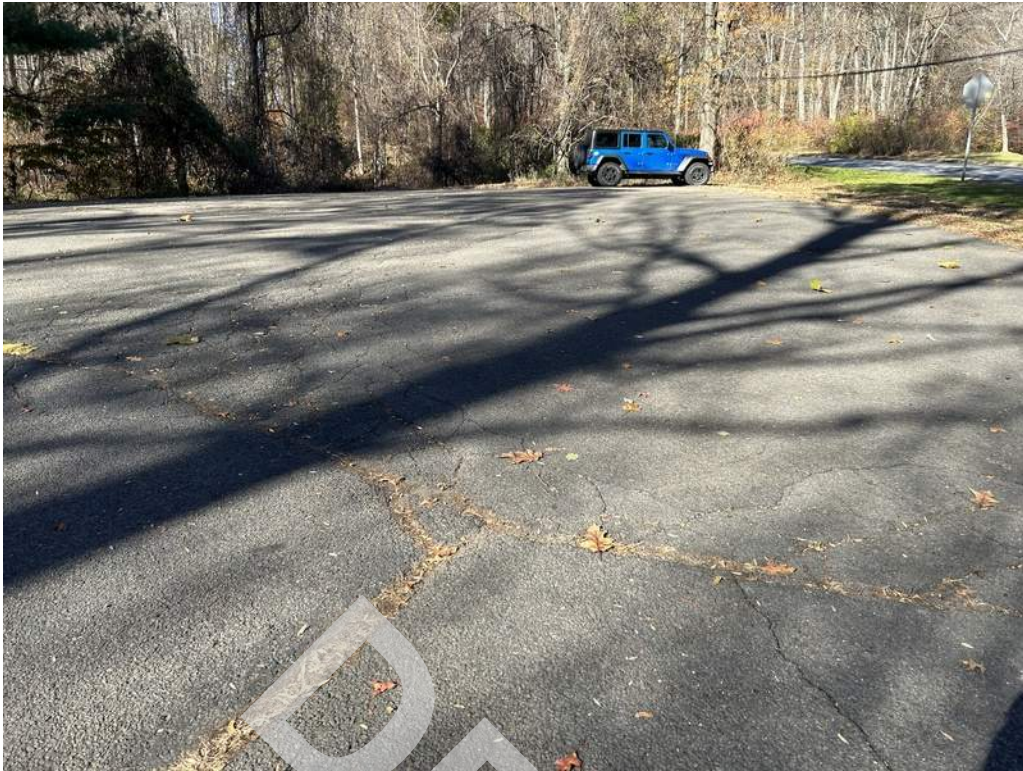
5 - Longitudinal and alligator cracking was observed at the second additional parking lot provided.

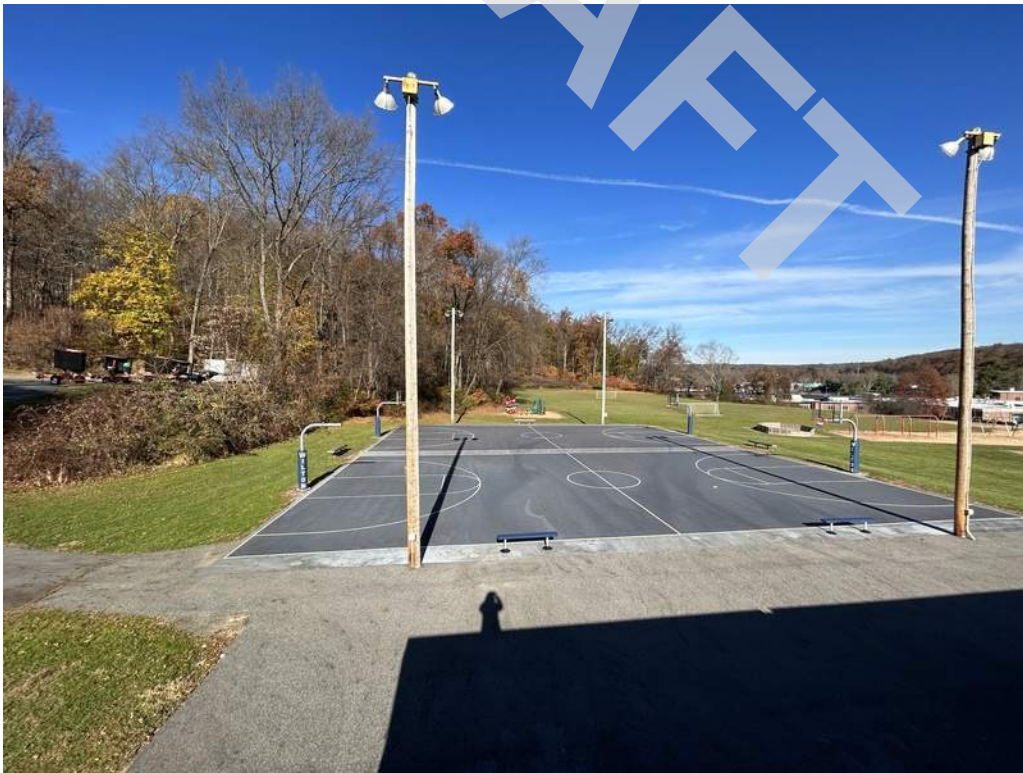
6 - Two basketball courts are provided at the rear of the building.

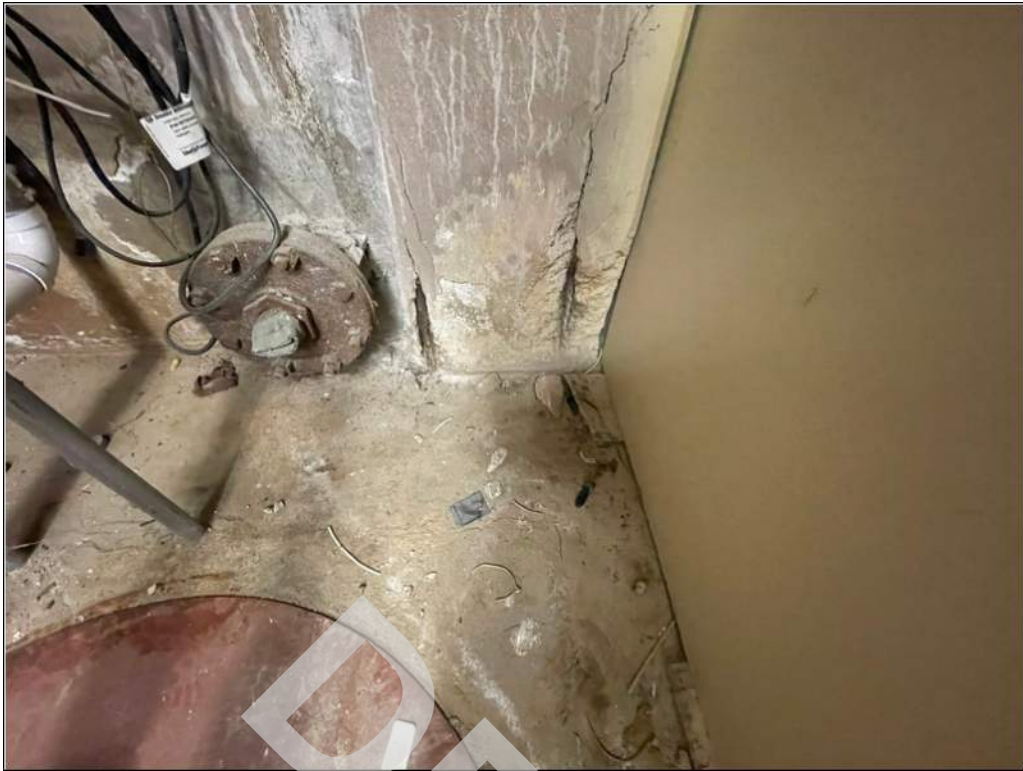
7 - Areas of the reinforced concrete foundation have cracked and spalled at the boiler room.

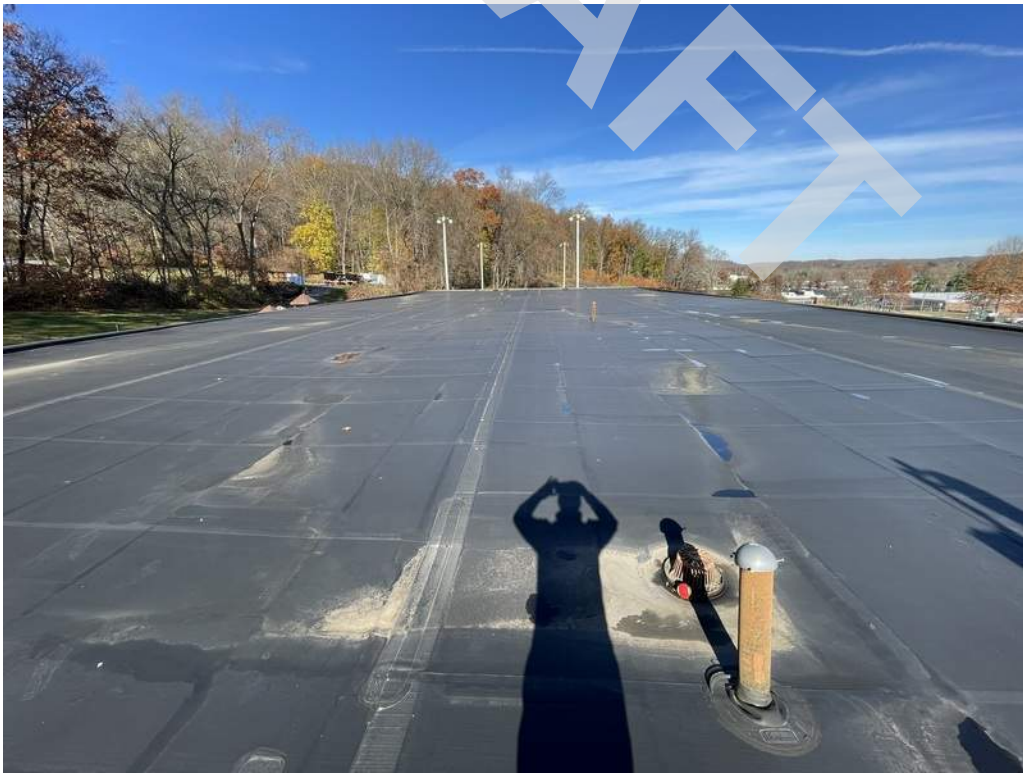
8 - The roofing system consists of an EPDM (ethylene propylene diene terpolymer) membrane.

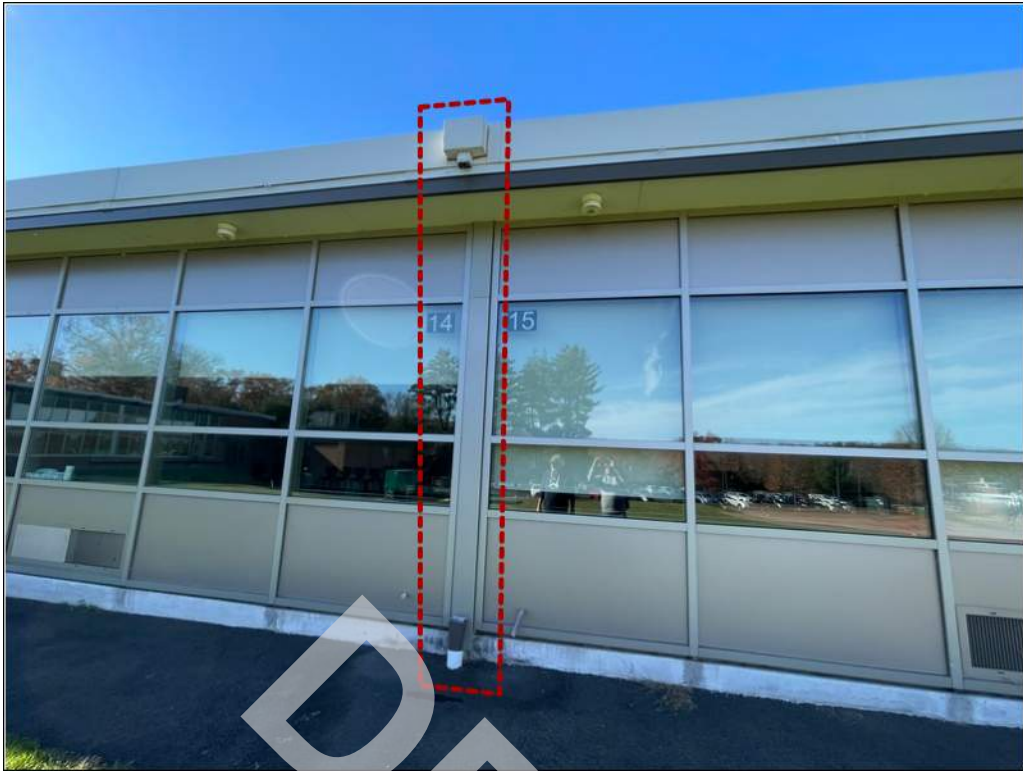
11 - The roof leader is missing.

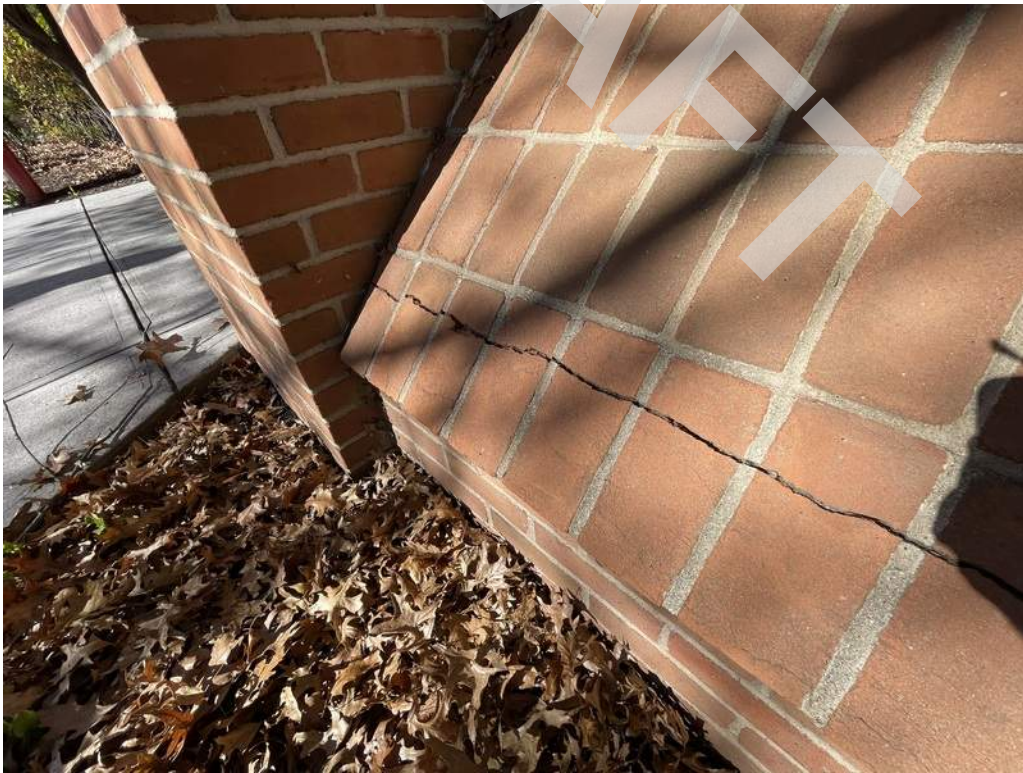
12 - Brick masonry units have cracked along the brick facade.

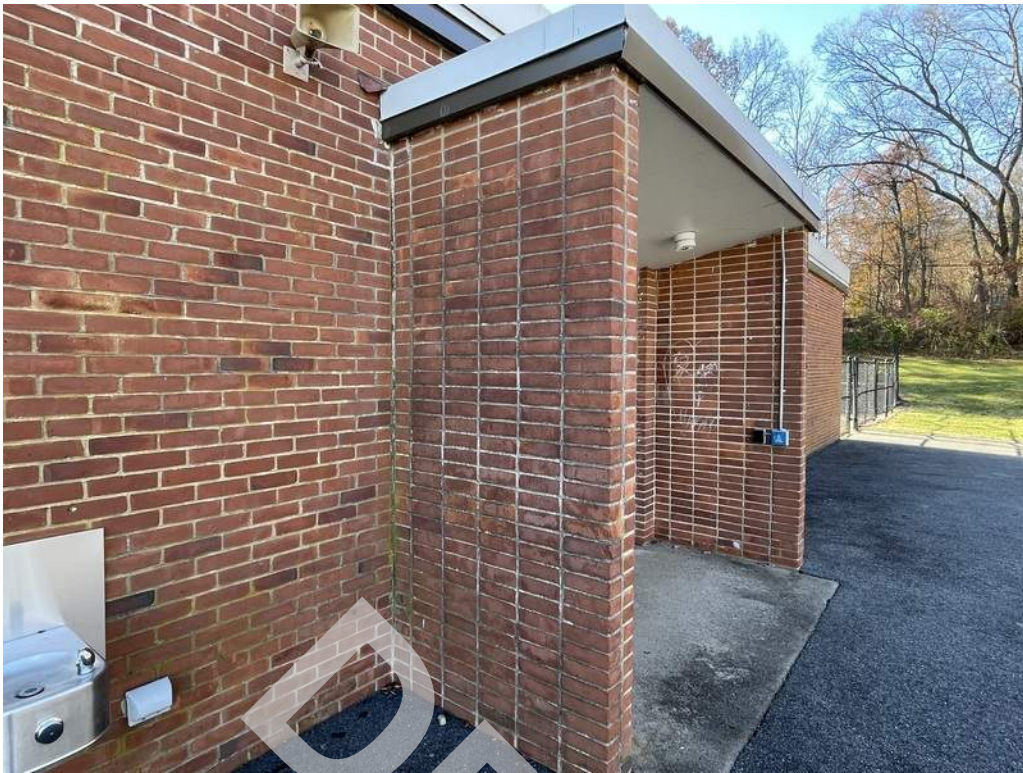
13 - Areas of the brick masonry unit wall have organic growth and deterioration at the mortar joints.

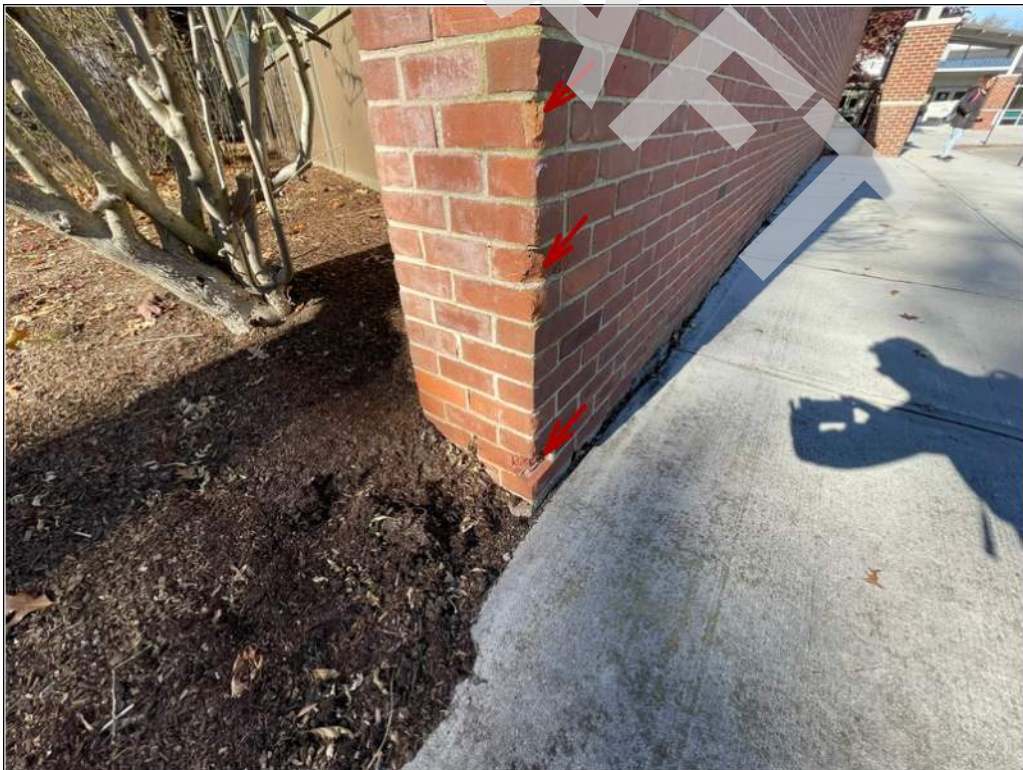
14 - Localized instances of brick masonry units are spalling.

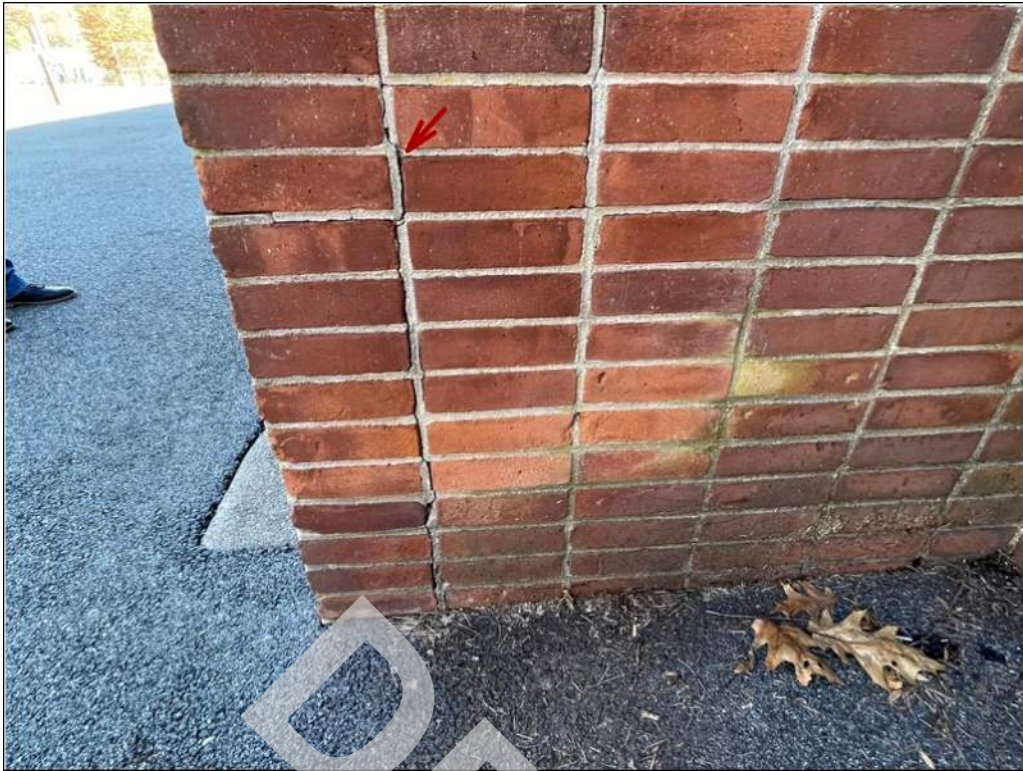
15 - Brick masonry unit mortar joints have cracked.

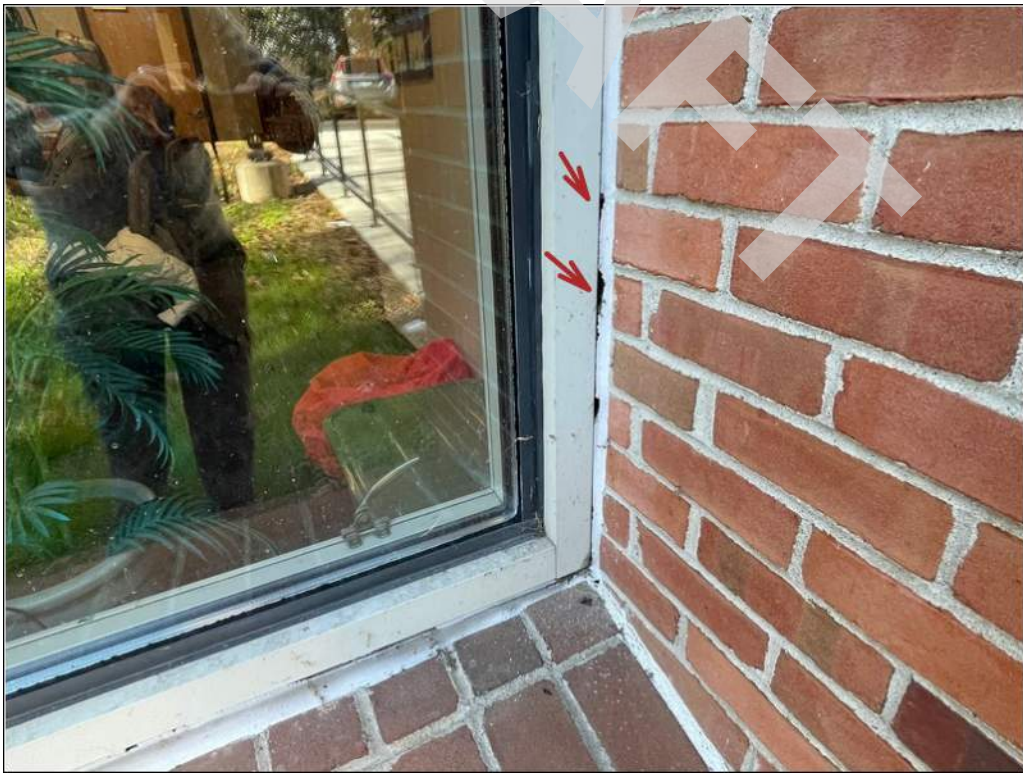
16 - Most perimeter joint sealant around windows has failed.

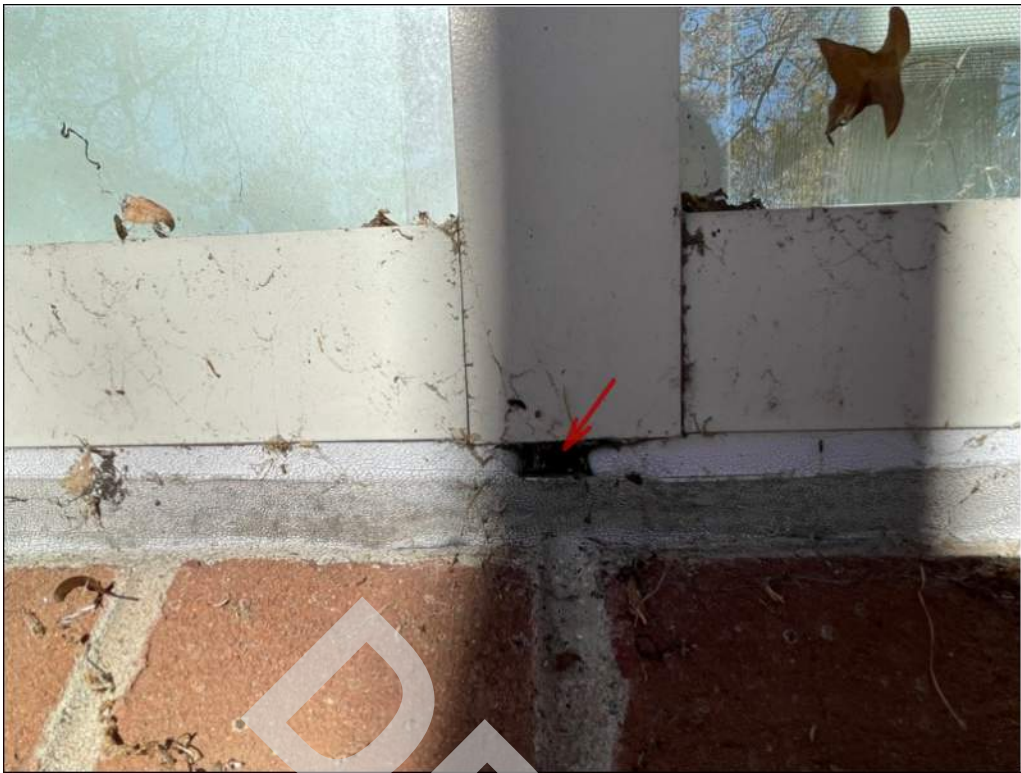
17 - Perimeter joint sealant along windows is in poor condition. Deficiencies include ruptured and crazed sealant.

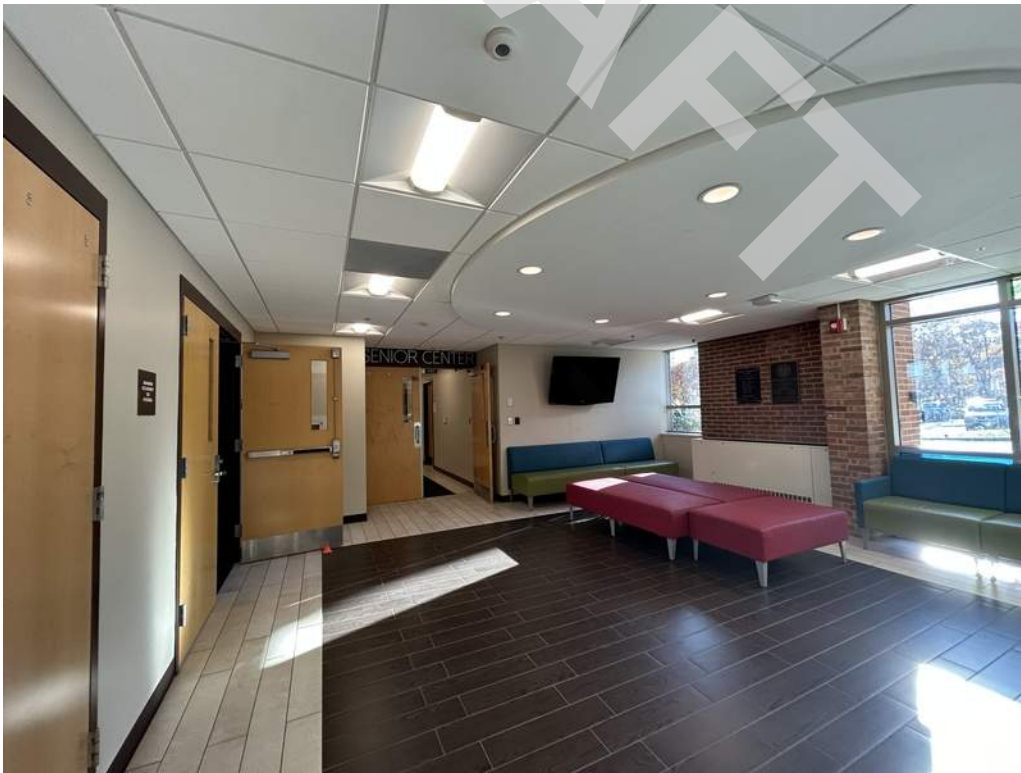
18 - Interior lobby finishes consist of painted gypsum wall boards and instances of brick, suspended ceilings with acoustic tiles, and tile floors.

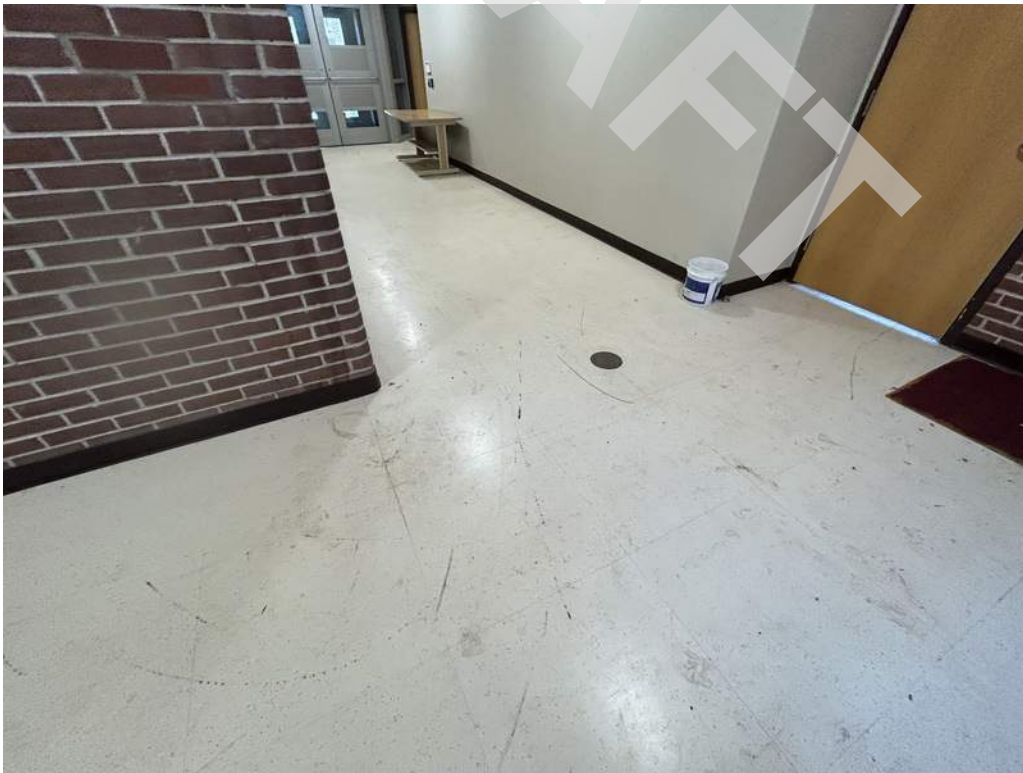
20 - Stained vinyl composite tiles were observed at the public corridor, on the south wing of the building.

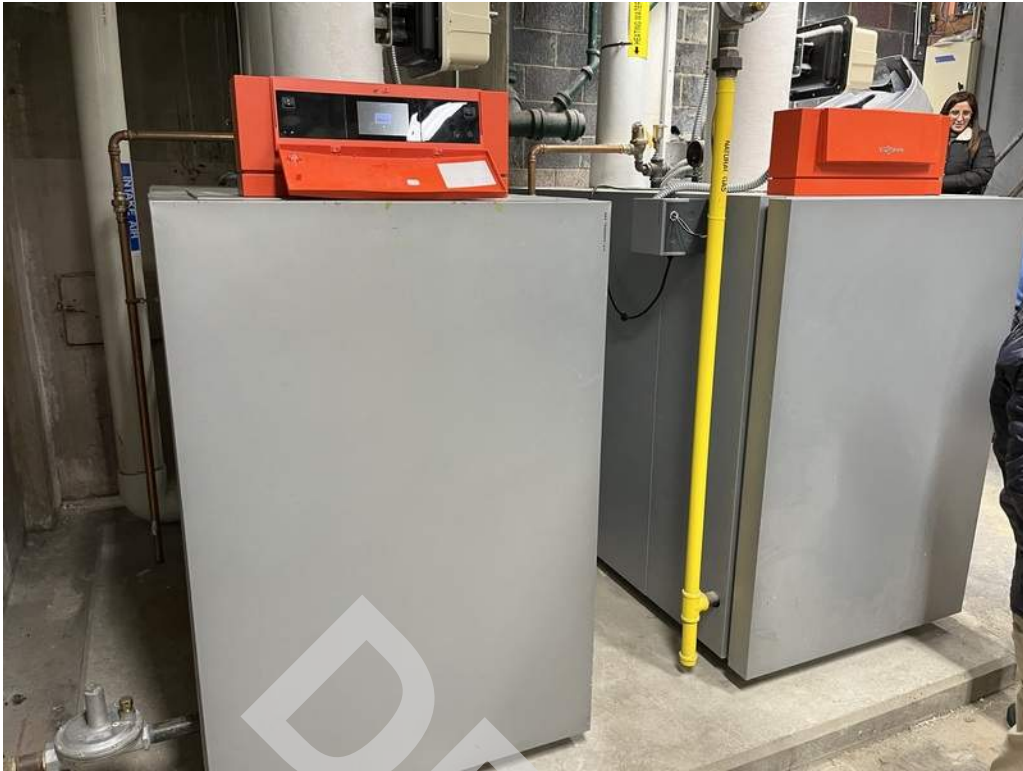
21 - Two natural gas fired boilers located in the lower level provide heating hot water throughout the building.

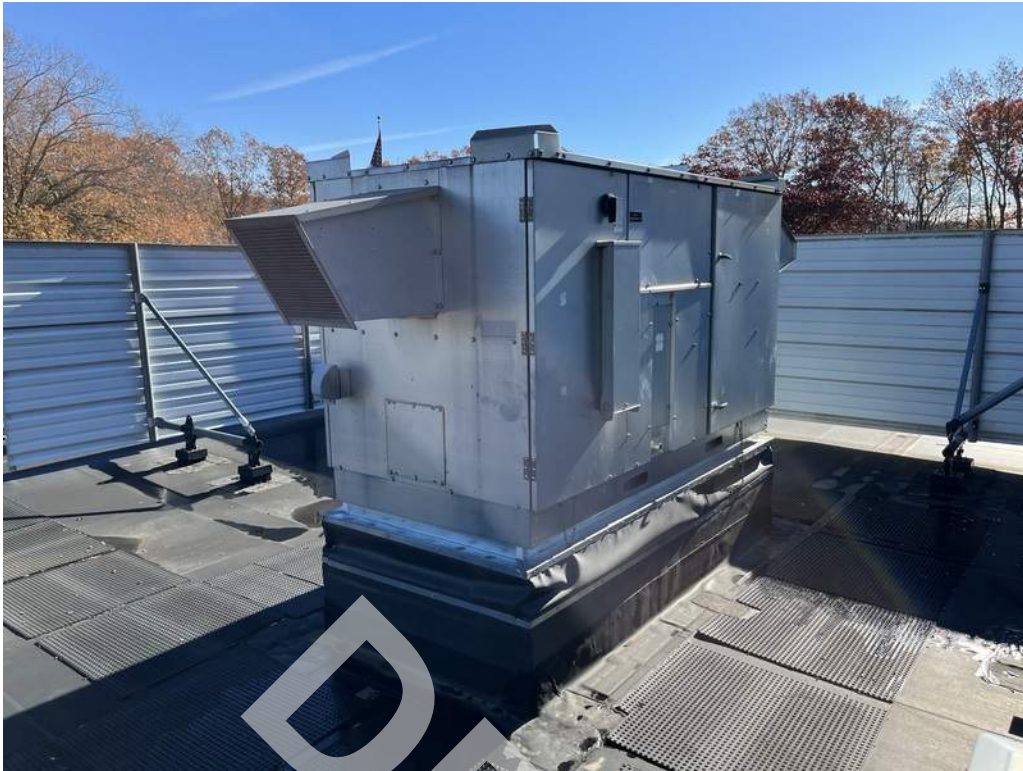
23 - An energy recovery ventilator provides conditioned ventilation air to portions of the building.

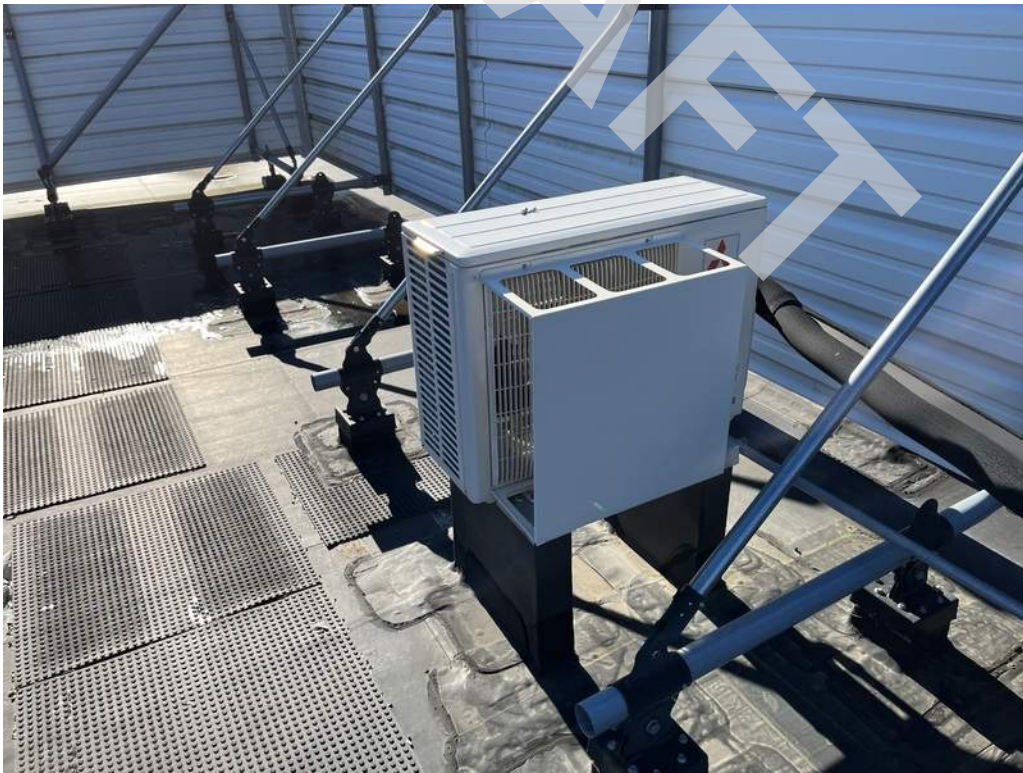
24 - Split system air conditioning units are located on the roof and provide cooling to portions of the building.

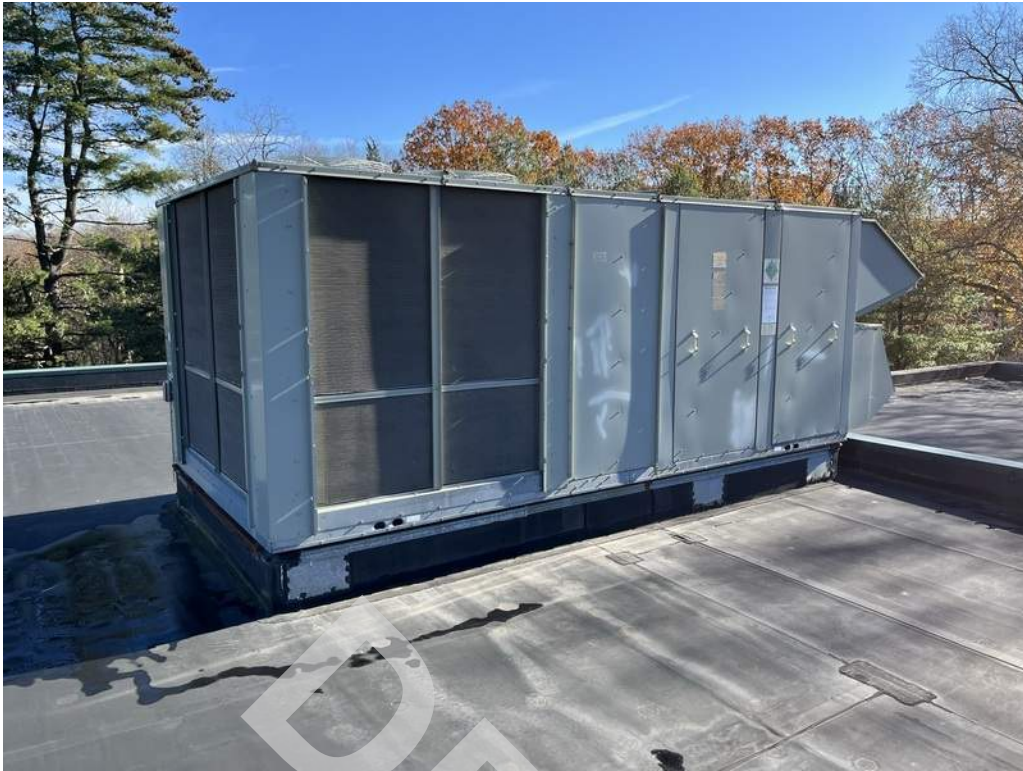
25 - Two rooftop packaged units (RTU) provide heating and cooling to portions of the building. One RTU is natural gas fired and the other is provided with a hot water coil that is fed from the boilers.

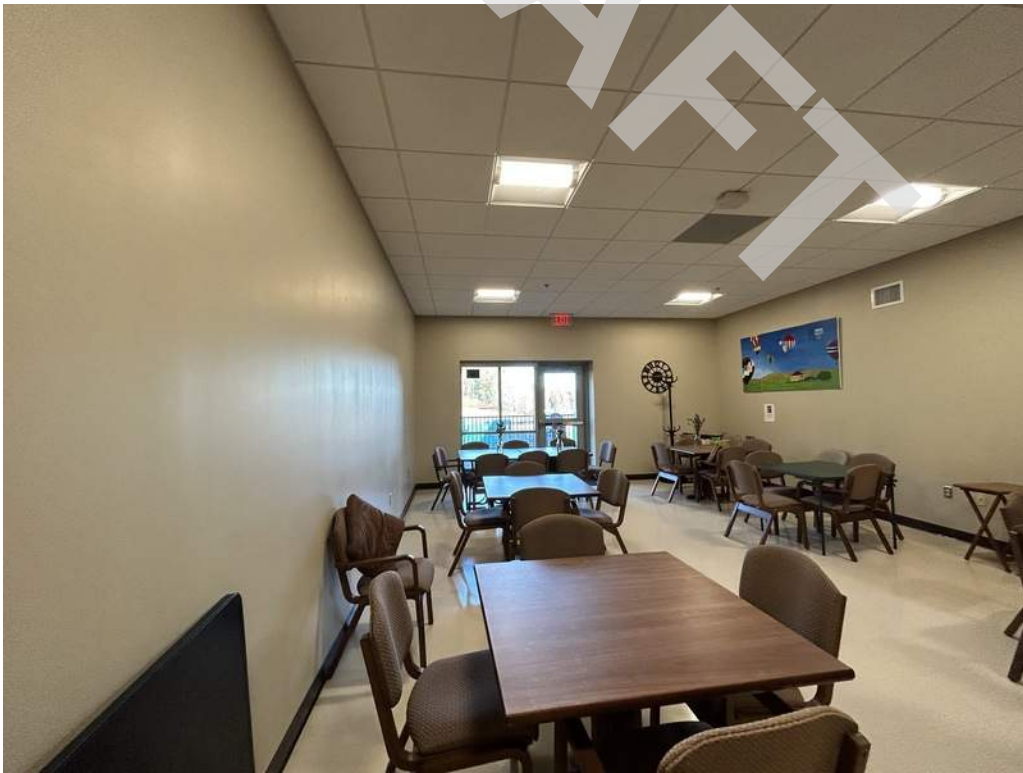
32 - Tables do not provided knee and toe clearance and inadequate clear floor space to the patio was observed at the Senior Center Café.

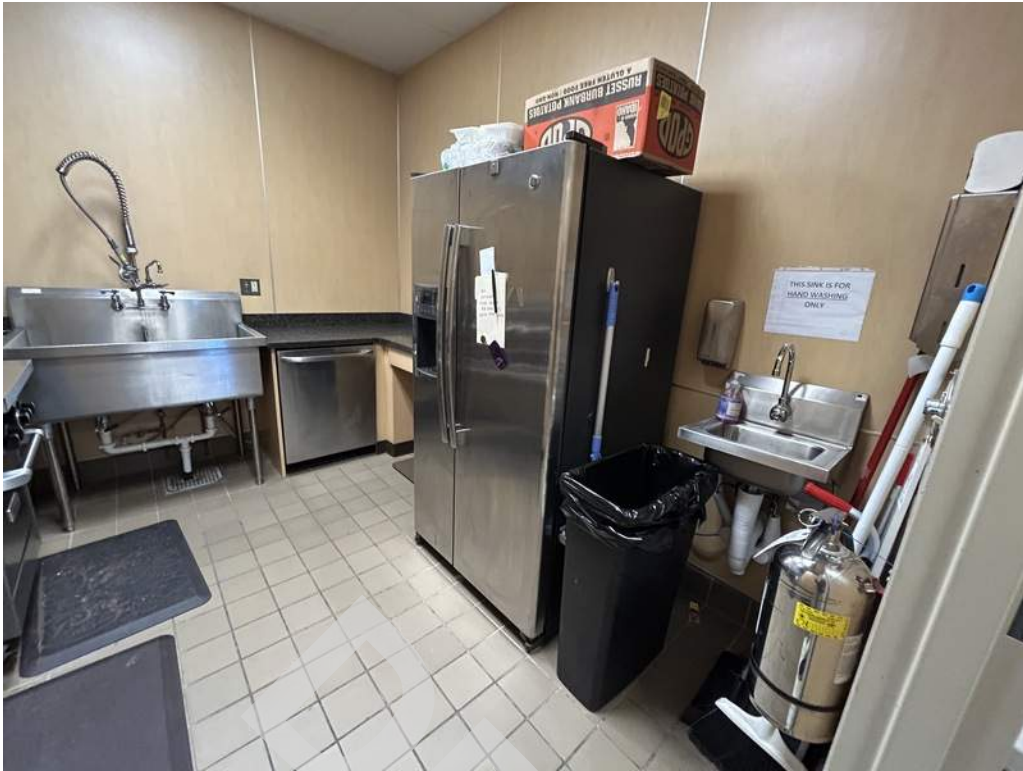
33 - Adequate clear floor space is not provided at the kitchen sink in the Senior Center Café.
