## FACILITY CONDITION ASSESSMENT

# FIRE HEADQUARTERS

238 Danbury Road  
Wilton, Connecticut

January 23, 2024

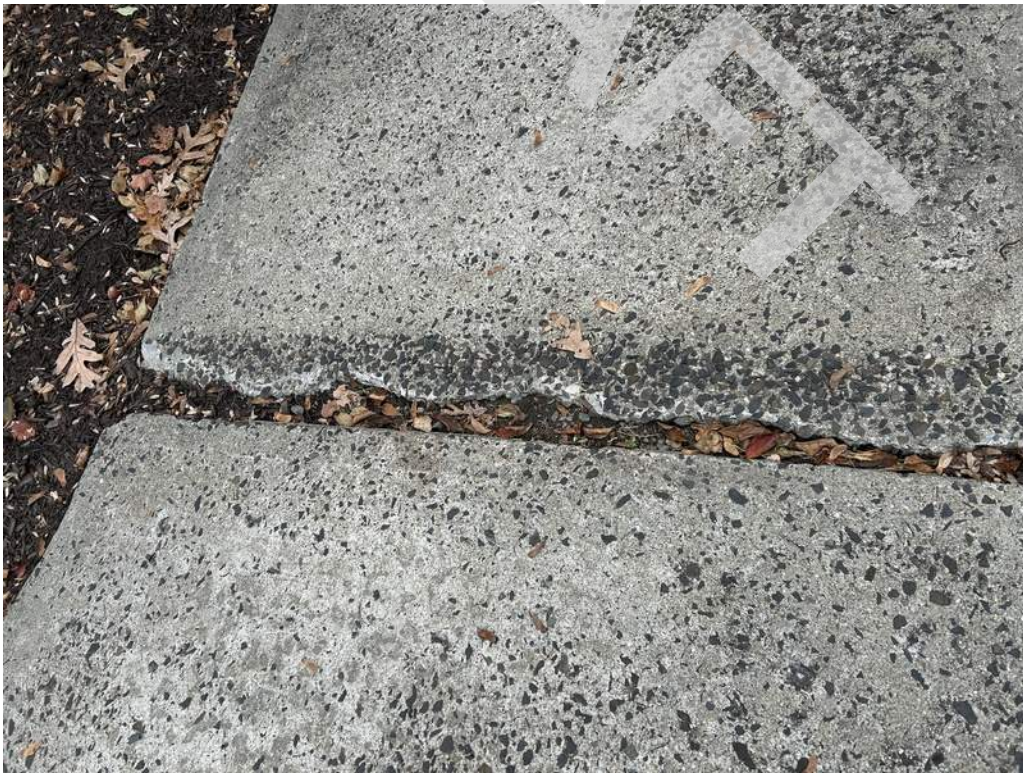
2 - Spalled concrete was observed at localized areas at sidewalks.

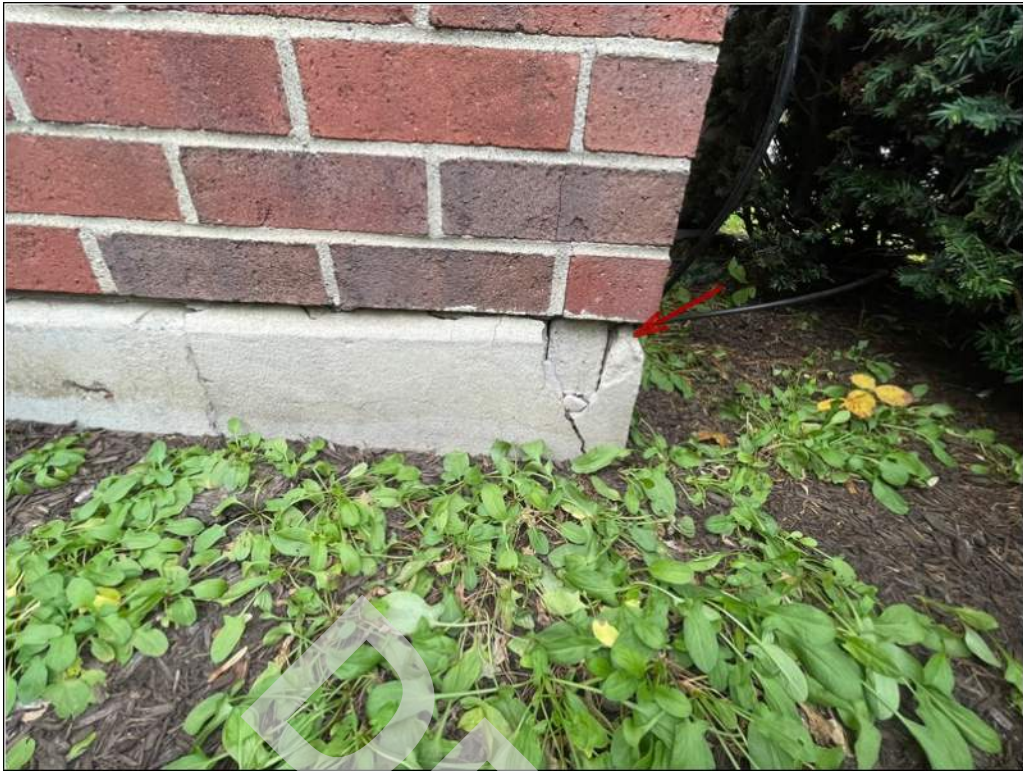
3 - Areas along of the cast-in-place reinforced concrete foundations walls have spalled and appear to have been previously repaired.

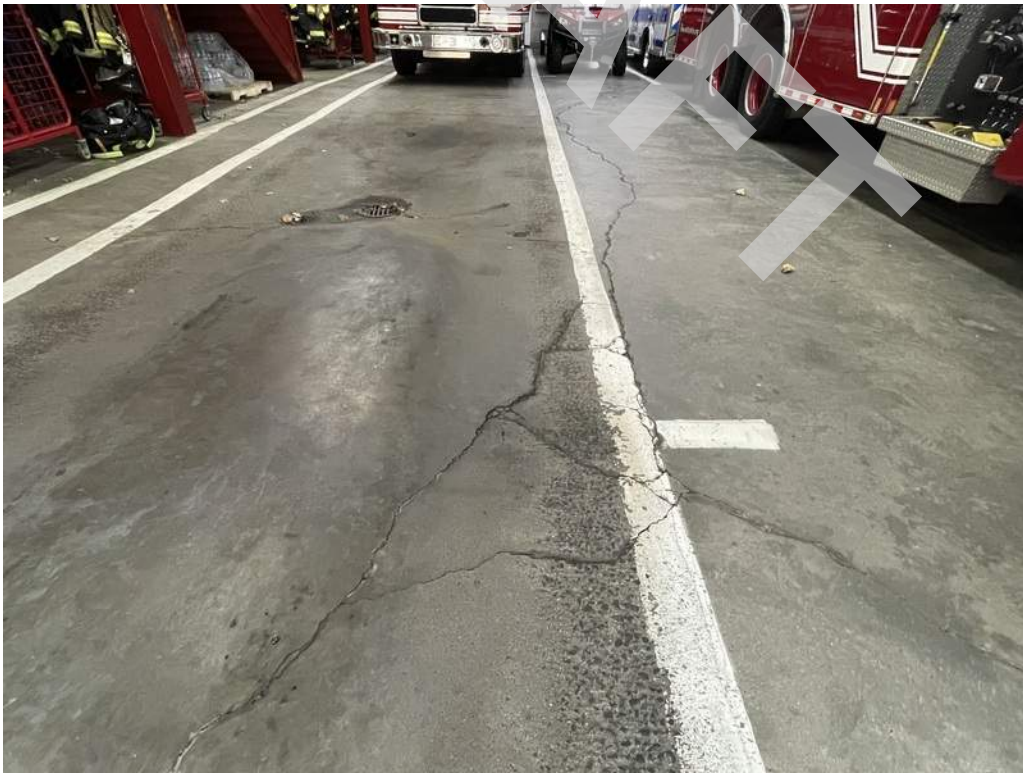
4 - The apparatus room slab on grade is uneven, has spalled, and has continuous cracks.

5	Building Integrity: Engage the services of an engineering firm to provide design documents and specifications for the apparatus room slab replacement.	1	LS															Priority 3 - Necessary - Not Yet Critical.
6	A budget is provided for design and construction contingencies related to the structural repair work.	1	LS															
<b>ENVELOPE AND EXTERIOR</b>																		
7	Ⓟ Building Integrity: Roof consists of a hip and valley configuration covered with asphalt shingles, reportedly installed in 2003. The roof appears to be in serviceable condition, with localized areas of organic growth and reported water intrusion instances at the mezzanine level. Perform localized repairs early in the term and replace the roof when it reaches the end of it's useful life.	14,000	SF															Priority 3 - Necessary - Not Yet Critical.
8	Ⓟ Building Integrity: It was reported that during high rain events, the roof gutters and leaders do not have an adequate capacity to handle the stormwater, and gutters occasionally overflow and cause damages to the system. Engage the services of a qualified company to review the conditions, prepare recommendations, calculations, and design a system that can handle the volume of rainwater.	1	LS															Priority 3 - Necessary - Not Yet Critical.

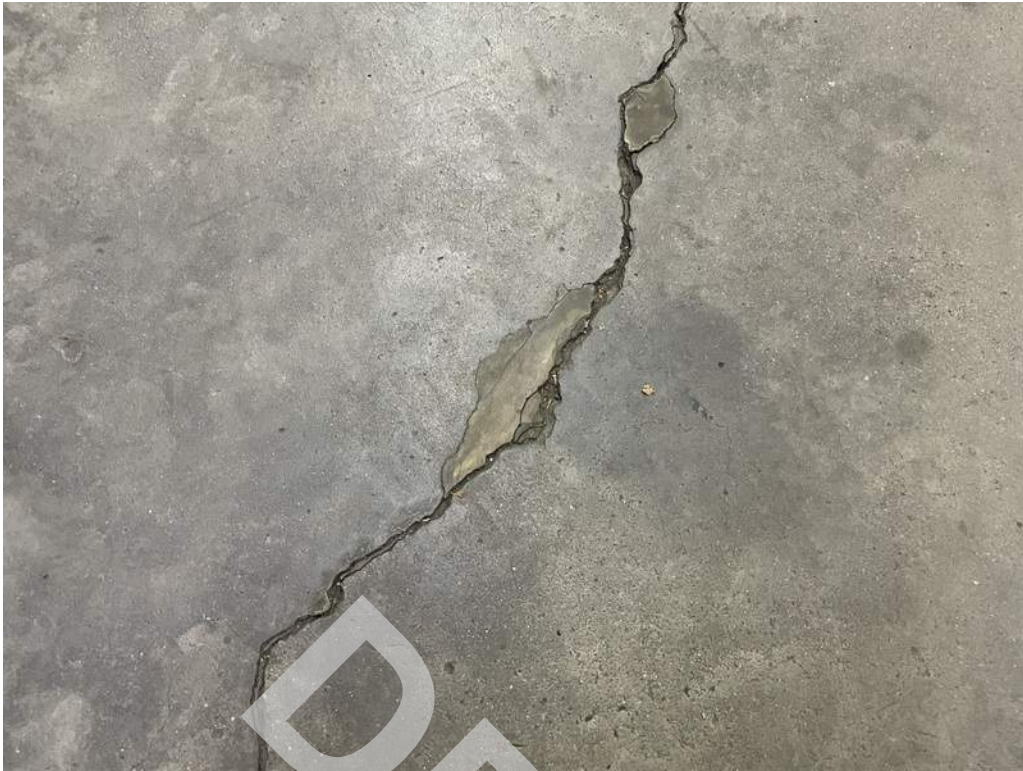
5 - Evidence of previously repaired cracks on the apparatus room slab on grade.

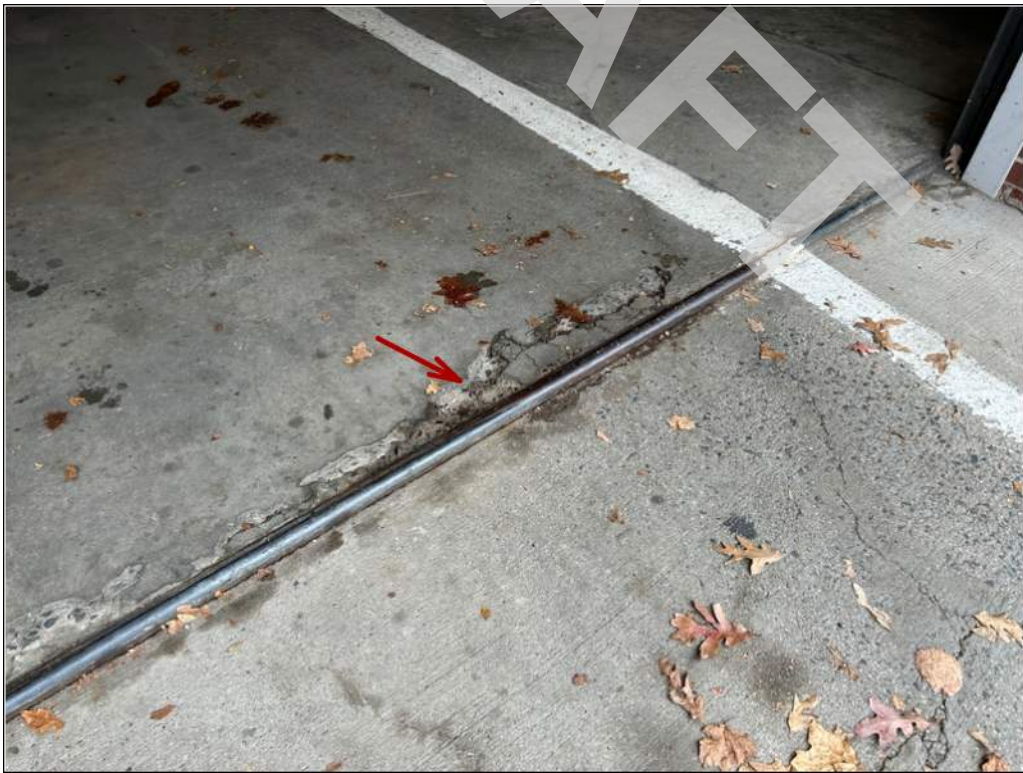
6 - Spalling along the base of an overhead door.

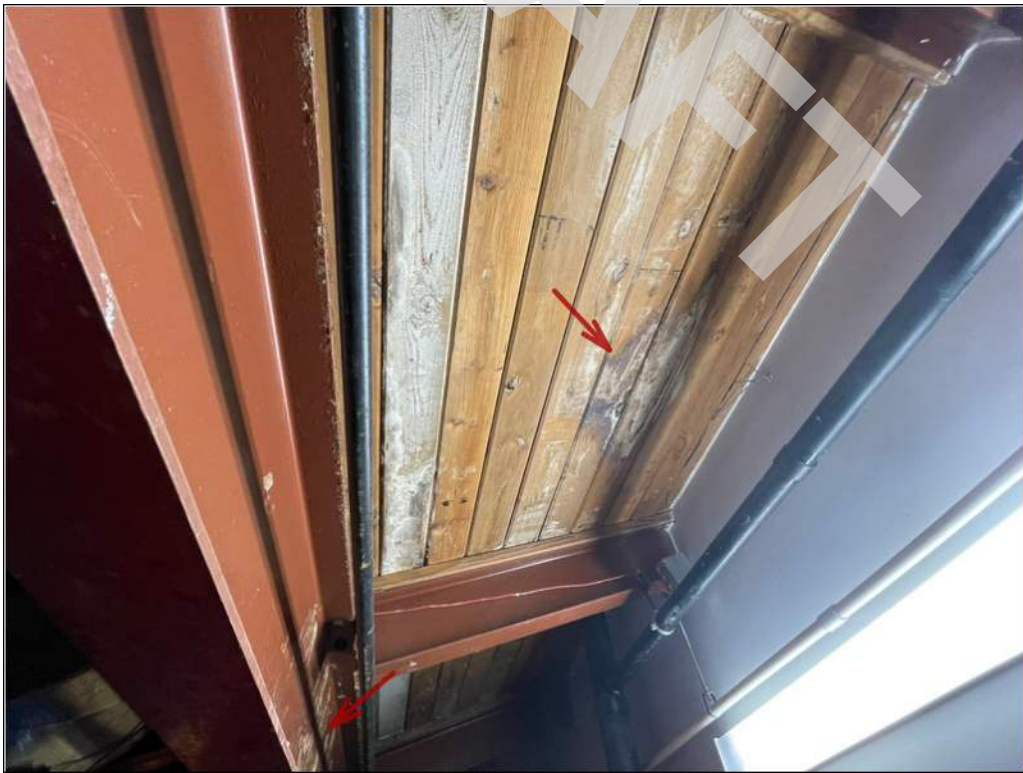
8 - Areas of noted and reported water intrusion at the mezzanine ceiling.

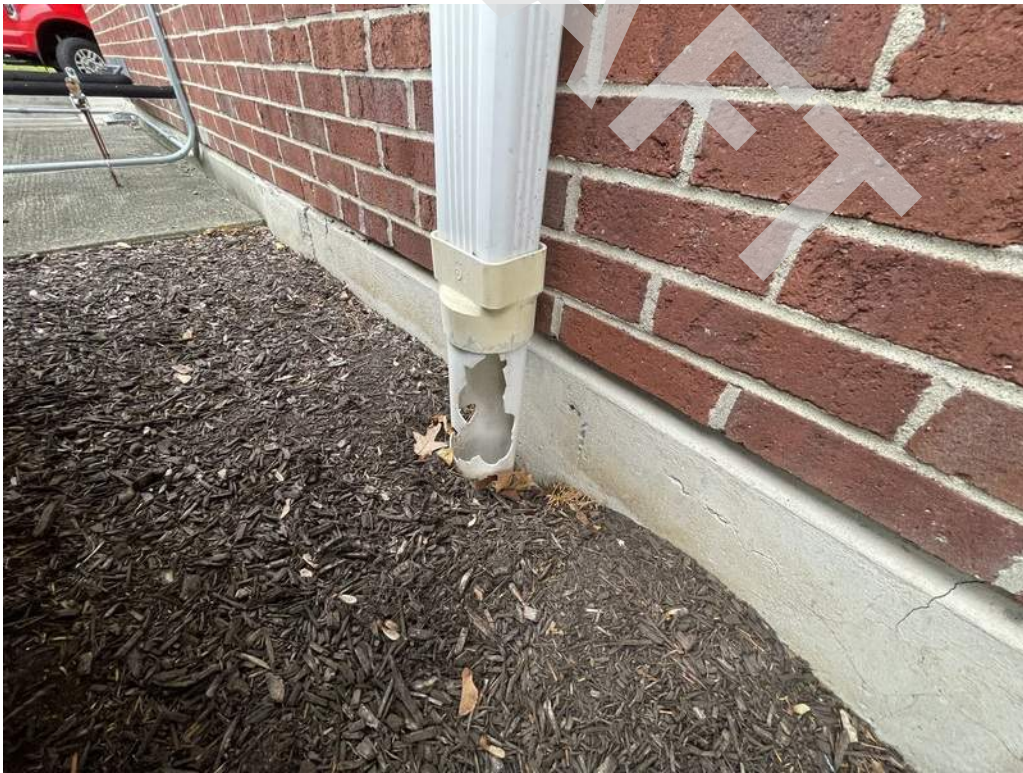
10 - Instances of the roof leader connection to the building's stormwater system are broken.

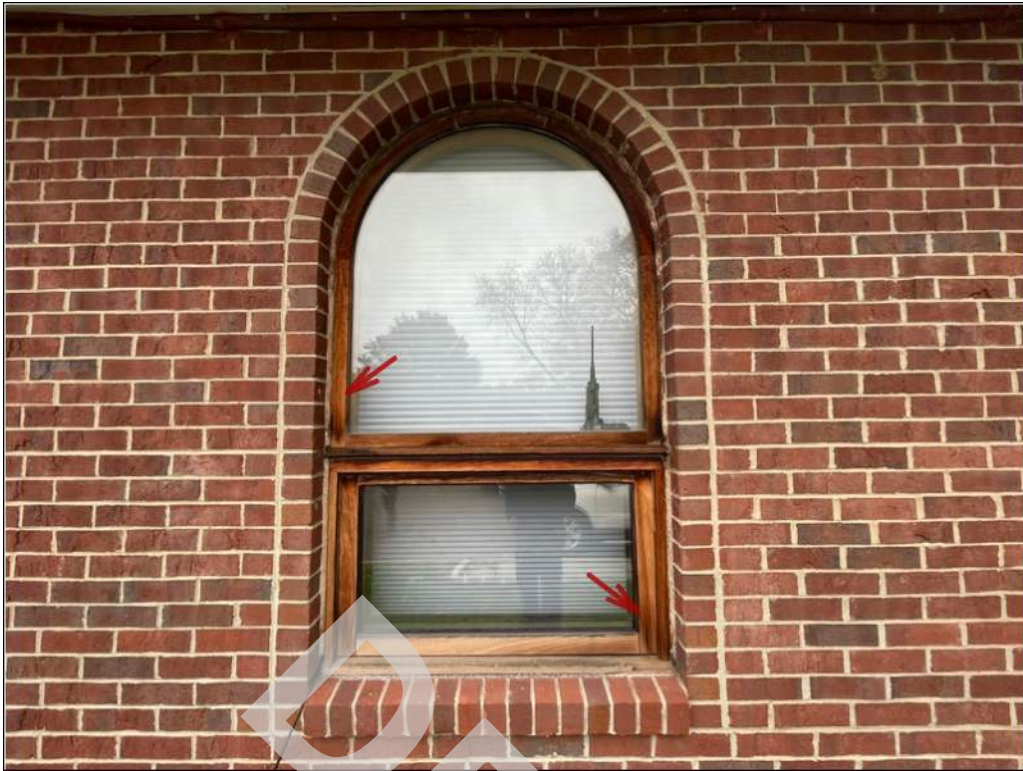
13	Ⓟ Building Integrity/energy: Windows throughout the building consist of a combination of fixed arched and operable rectangular wood framed assemblies with single pane glass, as well as metal framed windows at the dispatcher office, and appear to be original to the building. Wood surfaces through the frames have deteriorated and are in poor condition, and metal frames are starting to deteriorate. Perform complete window replacement program.	28	EA																Priority 3 - Necessary - Not Yet Critical.
14	Ⓟ Building Integrity: Exterior doors, selected door frames and steel lintel metal surfaces are in poor condition, with deficiencies consisting of surface corrosion and peeling finishes. Perform a comprehensive metal surfaces refurbishment program that includes removing corrosion, preparing for painting and painting with a corrosion resistant coating.	1	LS																Priority 3 - Necessary - Not Yet Critical.

11 - Wood framing surfaces at the operable and fixed windows throughout the building have worn out and are in fair condition.

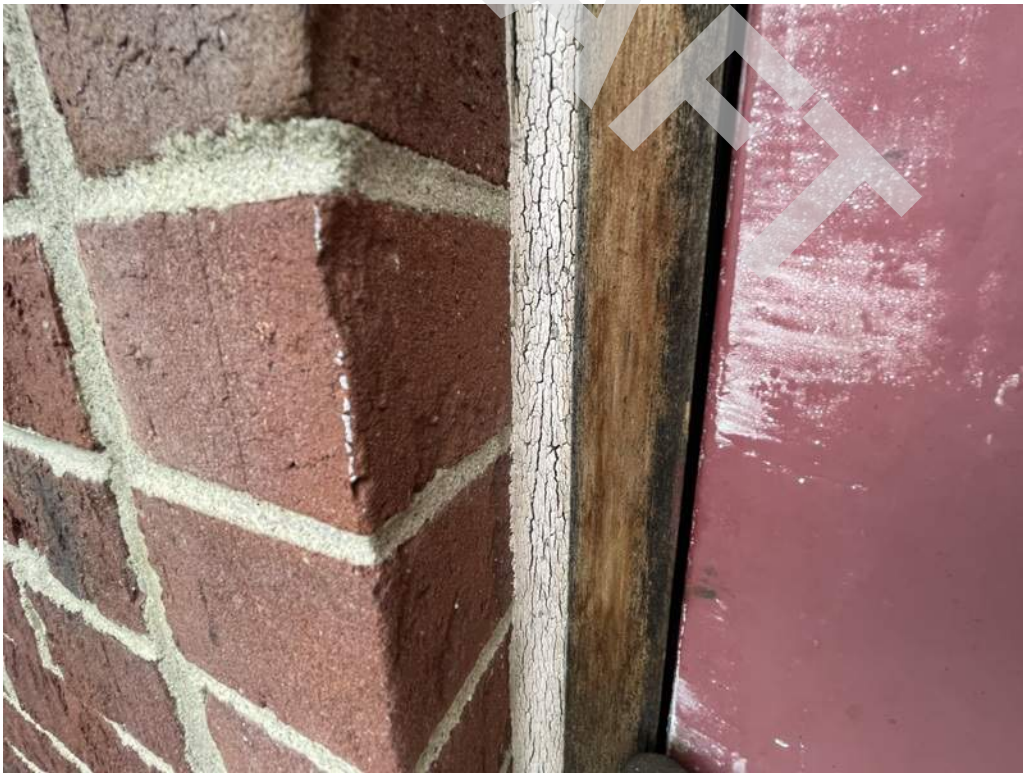
12 - Perimeter joint sealant has failed.

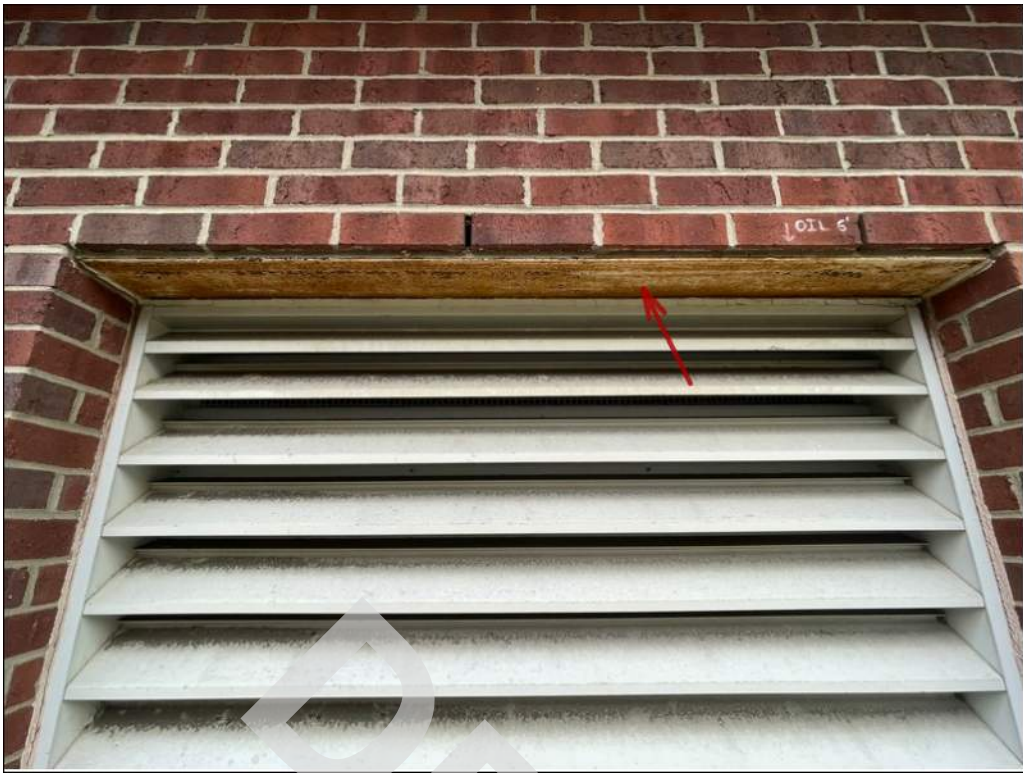
13 - Metal surface of the lintel at the louver opening has corroded.

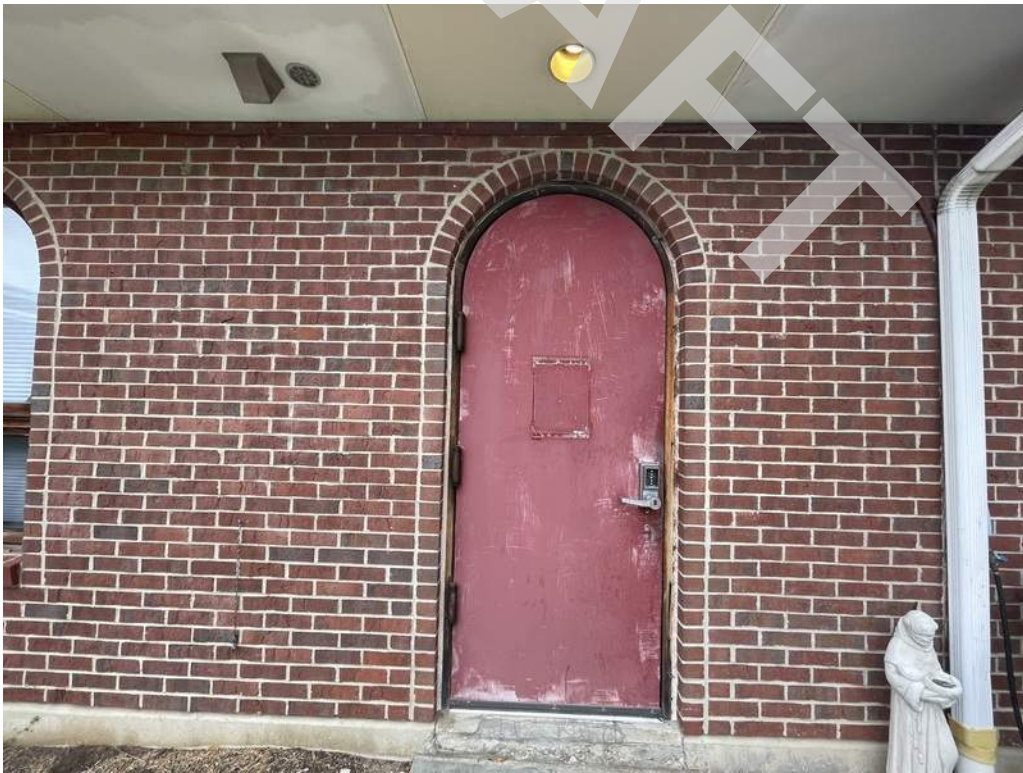
14 - Hollow metal door surface and finishes are in poor condition.

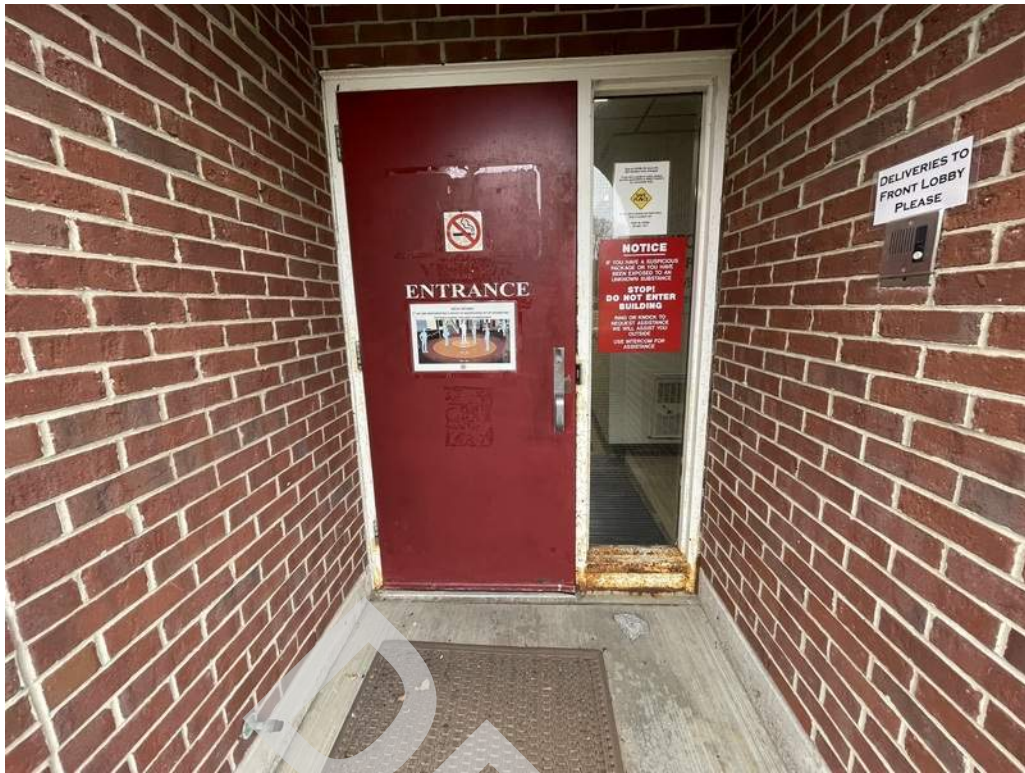
15 - Side light framing has corroded along the bottom. Hollow metal door surfaces are in fair condition.

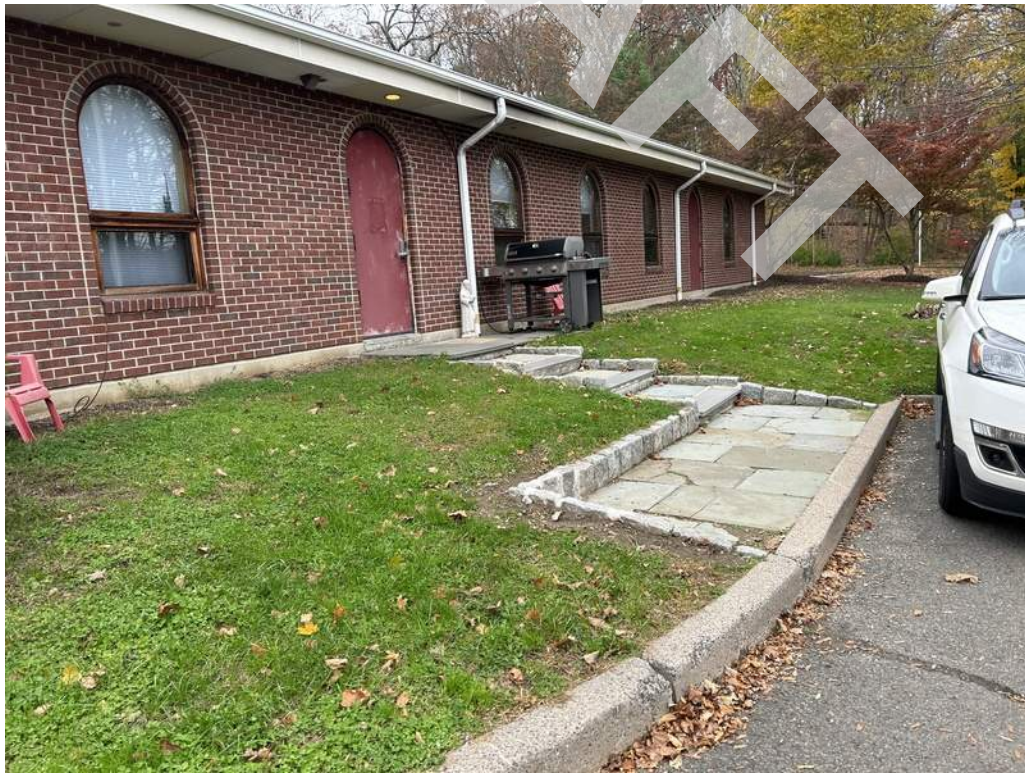
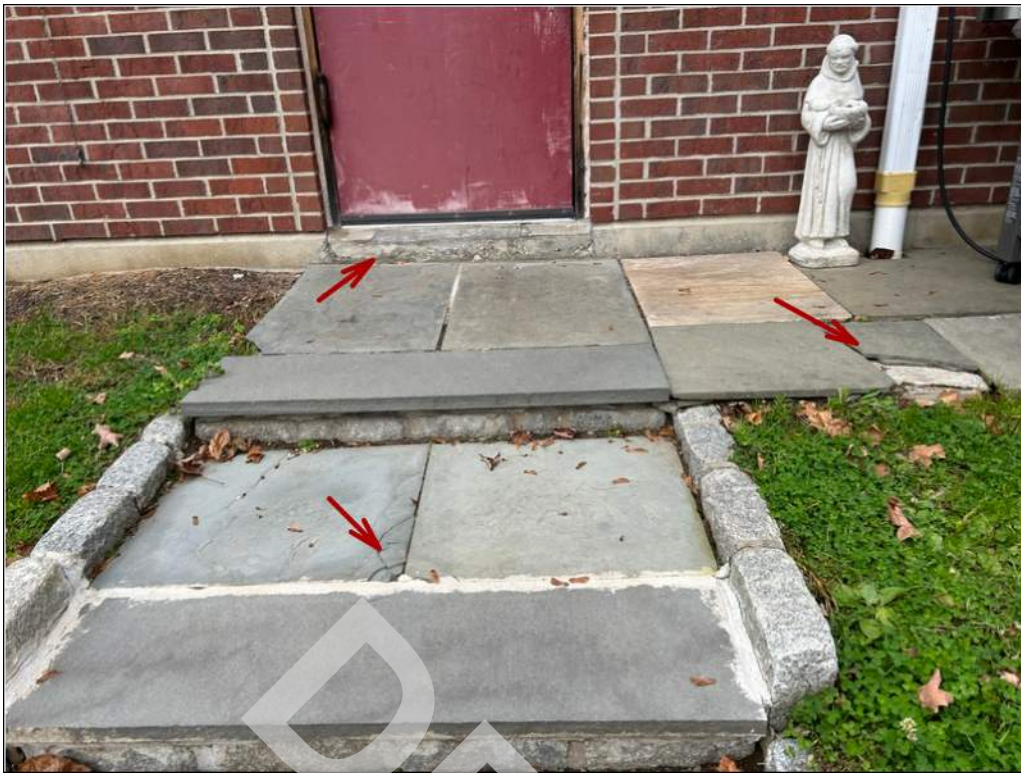
15	Ⓟ Building Integrity: A stone paver landing and stair is provided outside the door that exits from the volunteer meeting room. Stone pavers have cracked at the landing and treads, and handrails are not provided. Replace broken and cracked stone pavers, and provide handrails along the steps.	1	LS																Priority 2 - Potentially Critical.
16	A budget is provided for general contractor overhead, profit and general conditions.	1	LS																
17	A budget is provided for architectural/engineering fees.	1	LS																
18	A budget is provided for design and construction contingencies related to the envelope and exterior work.	1	LS																
<b>INTERIOR IMPROVEMENTS</b>																			
19	Appearance: Interior finishes were observed to generally be in fair to good condition. The age of the finishes is unknown; however, deteriorated floor finishes, and missing baseboards, was observed at localized areas throughout the building. Perform localized repairs early in the term and continue with phased replacement of interior improvements as conditions warrant due to wear and tear with age. The budget assumes approximately 20% of the total square feet. Interior finishes generally consist of painted gypsum wall and ceiling boards; suspended ceilings with acoustic tiles; vinyl, carpet, or tile floors.	2,500	SF																Priority 3 - Potentially Critical.

16 - Stone paver landing and steps are provided outside the volunteer meeting room exit door.

17 - Stone pavers have cracked and are missing pieces.

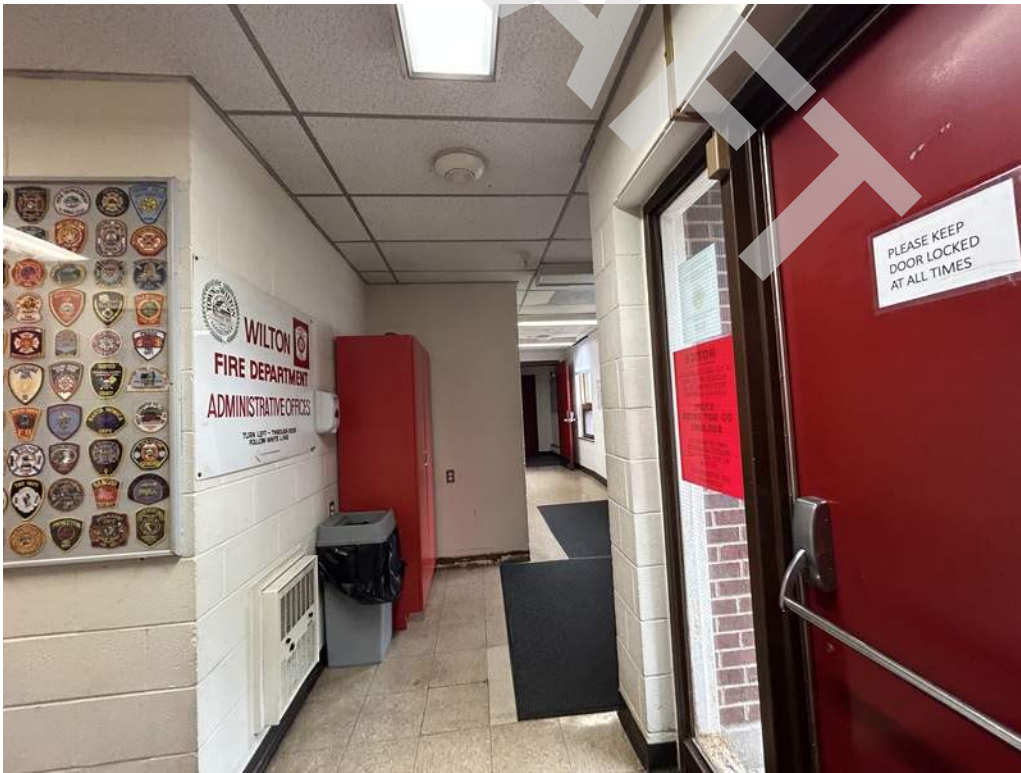
18 - Interior corridor finishes generally consist of painted gypsum walls boards or masonry, suspended ceilings with acoustic tiles, and vinyl composite tile floors. Chipped floor tiles and missing baseboards were observed.

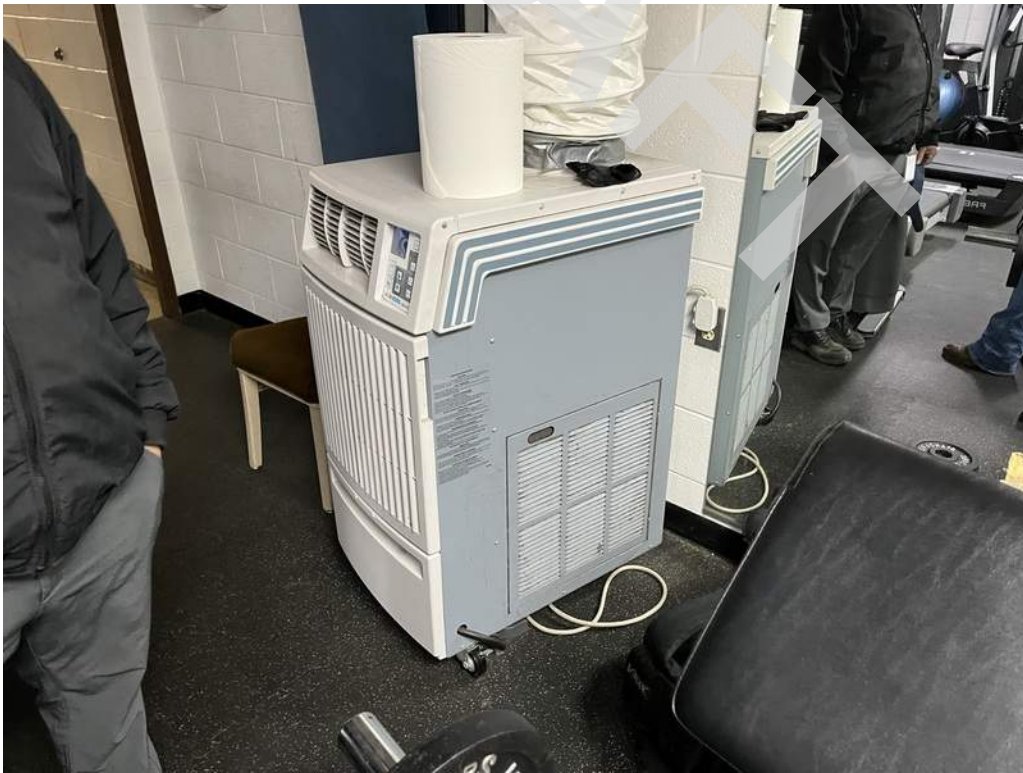
22	Building Integrity: A portable air conditioning unit is located in the gym. The systems has a capacity of one ton. Upgrade the unit with a new split system for dedicated cooling when it reaches the end of its service life or as maintenance costs dictate. The budget includes a new split system including an outdoor condensing unit as well as an indoor fan coil unit along with new refrigerant piping. The units was installed in 2007 and was manufactured by Movin Cool.	1	TON															Priority 4 - Recommended
23	Building Integrity: The team was informed of temperature control issues in the office area of the building. Additionally, the apparatus room is currently provided with unit hot water unit heaters. An upgrade to the building cooling system and heating in the apparatus room may result in better comfort, however, it could be invasive and will require engineering design, installation drawings, and general conditions. Engage an engineering firm to review existing conditions, determine necessary upgrade scope and equipment selections, and prepare design drawings for competitive bidding.	1	EA															Priority 4 - Recommended

20 - A portable air conditioning unit is utilized for supplemental cooling in the gym.

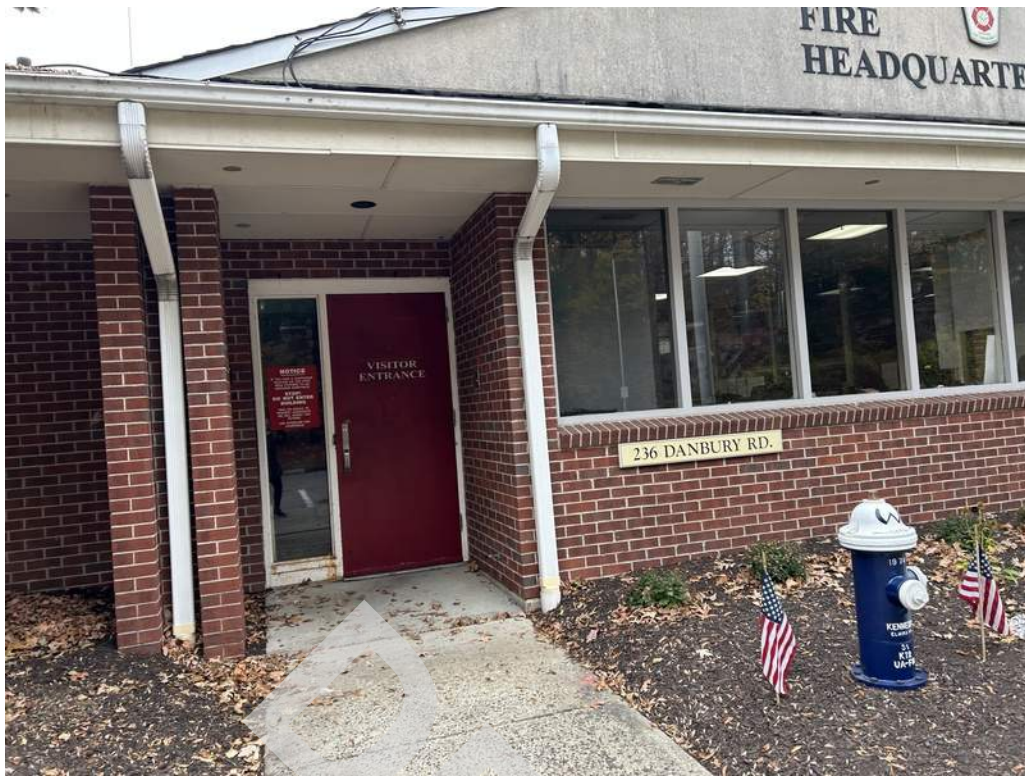
#	Item	QTY	Unit	Unit Cost	Replacement Percent	Immediate Total	Comments
<b>ACCESSIBILITY</b>							
1	ADA: The visitor entrance provided at the rear side of the building is non compliant as the threshold exceeds the allowable height. Replace threshold or modify finish surfaces to reduce effective threshold and meet compliance.	1	LS				Priority 1 - Current Critical.
2	ADA: Based on the Site Layout Plan provided, there are approximately 14 parking spaces serving the rear side of the facility. No accessible parking spaces were observed. Based on the total number of spaces provided a minimum of one van accessible parking spaces is required. Provide one designated van accessible parking space with complaint signage and curb ramp adjoining an accessible route.	1	LS				Priority 1 - Current Critical.
Total Repair Cost

27 - The visitor entrance provided at the rear side of the building is non compliant as the threshold exceeds the allowable height.
