## FACILITY CONDITION ASSESSMENT

# FIRE STATION NO. 2

707 Ridgefield Road  
Wilton, Connecticut

January 23, 2024

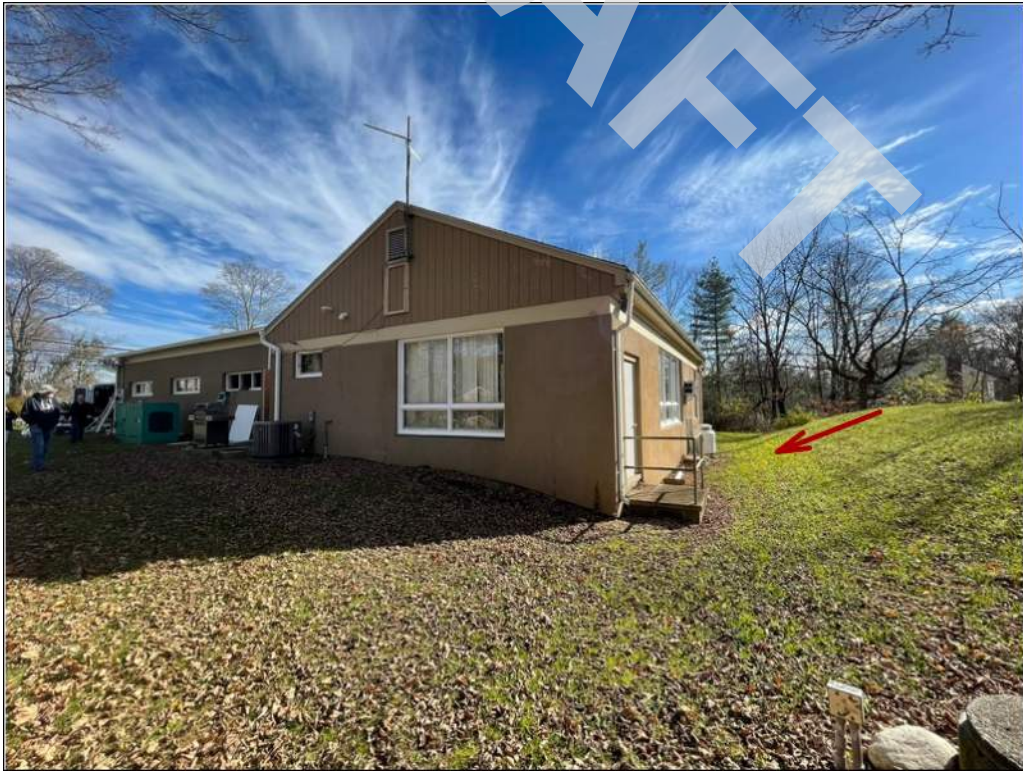
2 - Mound septic system is sloping towards the building's structure.

#	Item	QTY	Unit	Unit Cost	Replacement Percent	Immediate Total	Comments
<b>SITE</b>							
1	<p><b>P</b> Building Integrity: Based on information that M O had access to and site observations, the back of the site is provided with a mound septic system that slopes towards the building, and may direct surface water towards the building's foundation. Grade directly adjacent to the building does not slope away from the building. Regrade area adjacent to the building to divert water away from the building's structure.</p>	400	SF				Priority 1 - Current Critical.
<b>STRUCTURE</b>							
2	<p>Building Integrity - Advisory: Limited information regarding the building was provided for our review. Selected documents indicated certain roof framing deficiencies had been identified at the building's roof framing in the attic. It's unclear if the issues were resolved, and Marx Okubo did not have access to the attic. It is recommended to perform a comprehensive document review to determine if the item in question was resolved. Concurrently, a visual review of the attic is recommended by town personnel to determine if the repairs were completed. Engage the services of a structural engineer to review if the issue was not addressed.</p>	0	EA				Priority 1 - Current Critical.

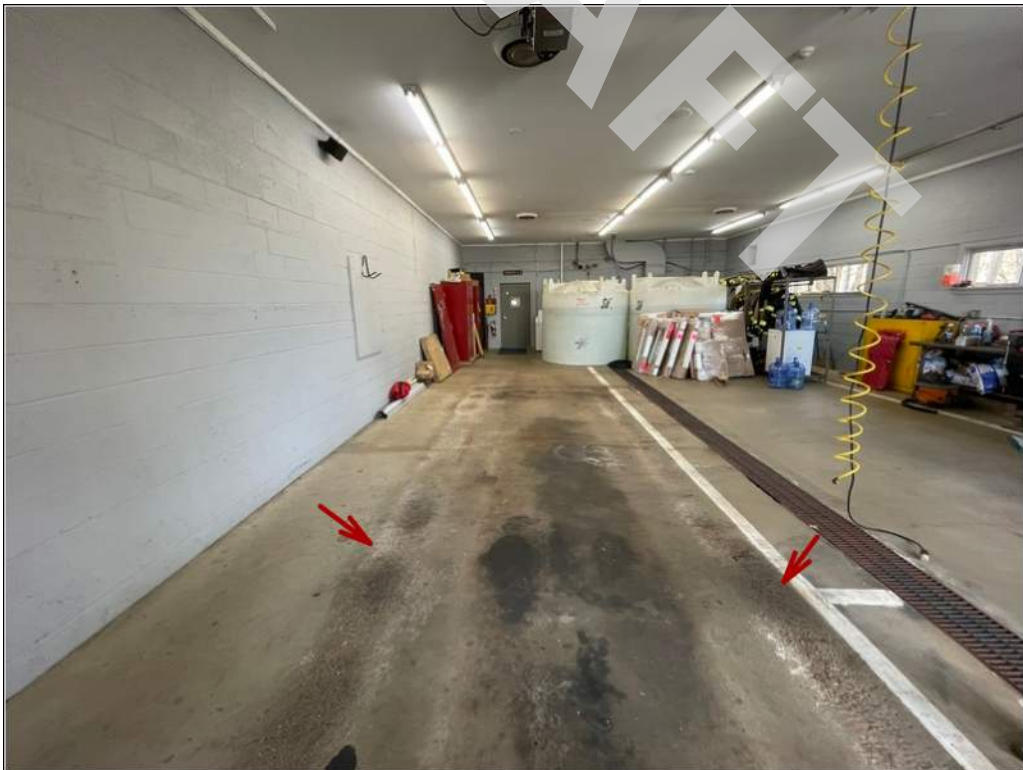
4 - Areas of the slab on the southern apparatus bay have spalled.

#	Item	QTY	Unit	Unit Cost	EUL	EFF Age	Year 1	Year 2	Year 3	Year 4	Year 5	Year 6	Year 7	Year 8	Year 9	Year 10	Total Cost	Comments
<b>STRUCTURE</b>																		
1	Ⓟ Building Integrity: Floor on the apparatus room consists of a cast-in-place reinforced concrete slab on grade. The south bay of the apparatus room slab has deteriorated and includes cracks and spalled areas. In addition, it was reported that the trench drain between the bays is not working properly. Perform localized repairs, including rebuilding the trench drain. Repairs represent approximately 25% of the slab.	400	SF															Priority 3 - Necessary - Not Yet Critical.
<b>ENVELOPE AND EXTERIOR</b>																		
2	Energy: Portions of the sloped roof could be considered for the addition of photovoltaic (PV) solar panels. Engage the services of a registered Structural Engineer to perform an analysis to determine if the structure can support the added loads of a PV system as well as a qualified party to perform a feasibility study, including a solar analysis. Based on the results of a preliminary structural and solar analysis, consideration could be given to the addition of PV panels on the roof. The results of the analysis will determine the system's limitations and requirements. PV solar panels can provide the building with a renewable, clean source of energy.	1	LS															Priority 4 - Recommended

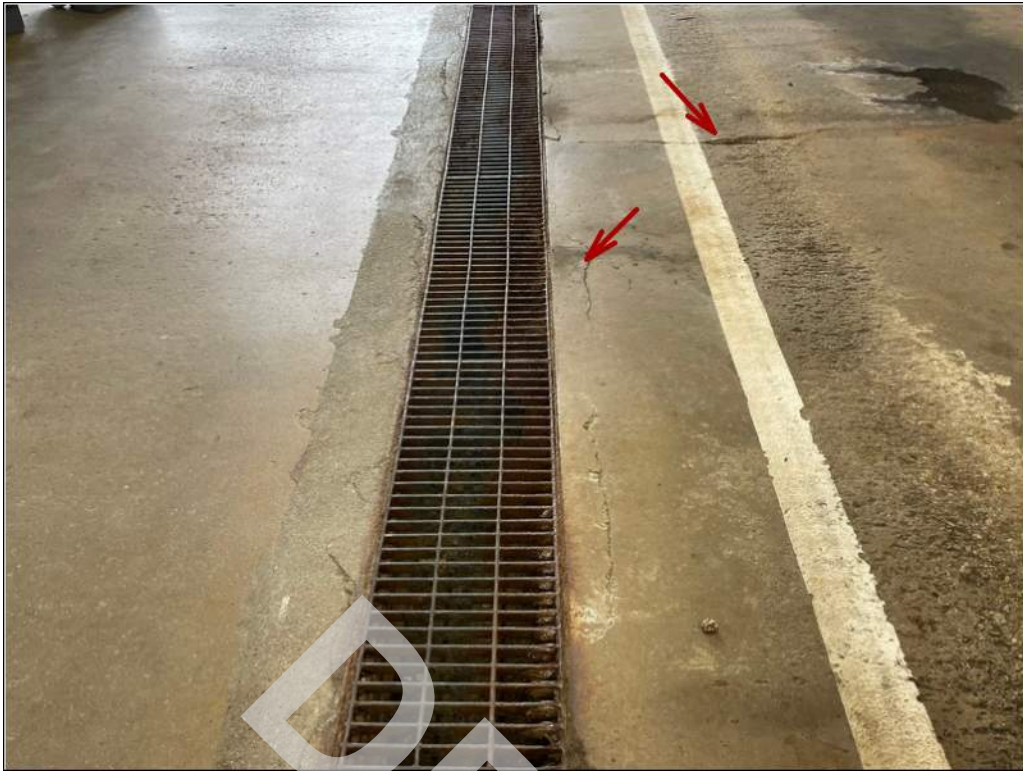
5 - Areas of the slab on the southern apparatus bay have cracked.

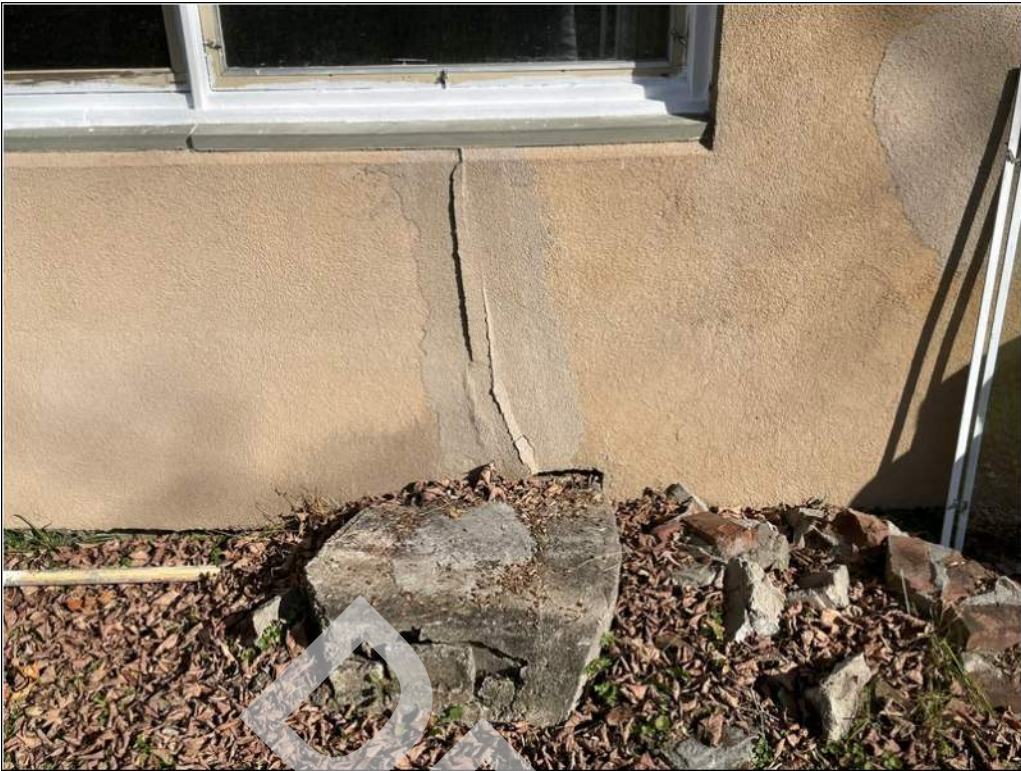
7 - Localized areas of the EIFS have cracked.

5	Ⓟ Building Integrity: The building facades consist of an EIFS (Exterior Insulation and Finish System). Localized areas of the EIFS have cracked. Patch and repair areas.	200	SF															Priority 2 - Potentially Critical.
6	Ⓟ Appearance: Façade surfaces have areas of organic growth and discoloration. Power wash all exterior wall surfaces, prepare for painting, and paint throughout.	2,000	SF															Priority 4 - Recommended.
7	Ⓟ Building Integrity: Egress along the west side of the building is through a concrete pad and steps with a metal pipe handrail. The metal handrail surfaces are corroded and the handrail does not extend beyond the last thread. Remove corrosion, extend the handrail, prepare for painting, and paint.	1	LS															Priority 3 - Necessary - Not Yet Critical.

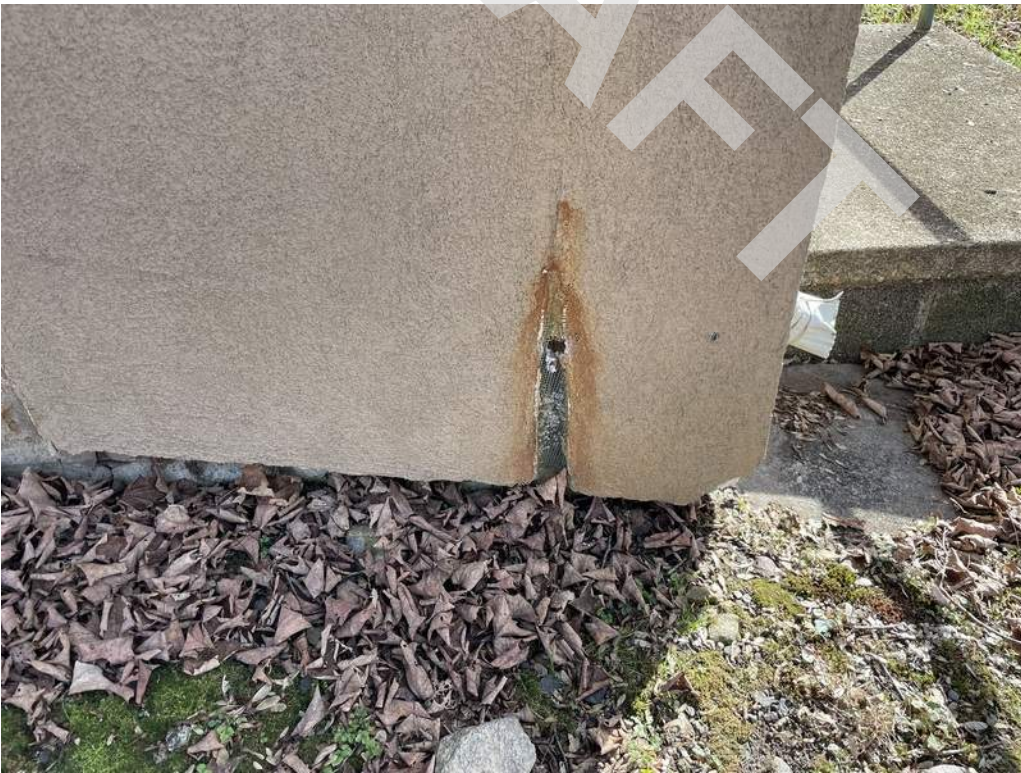
8 - Localized areas of the EIFS have eroded.

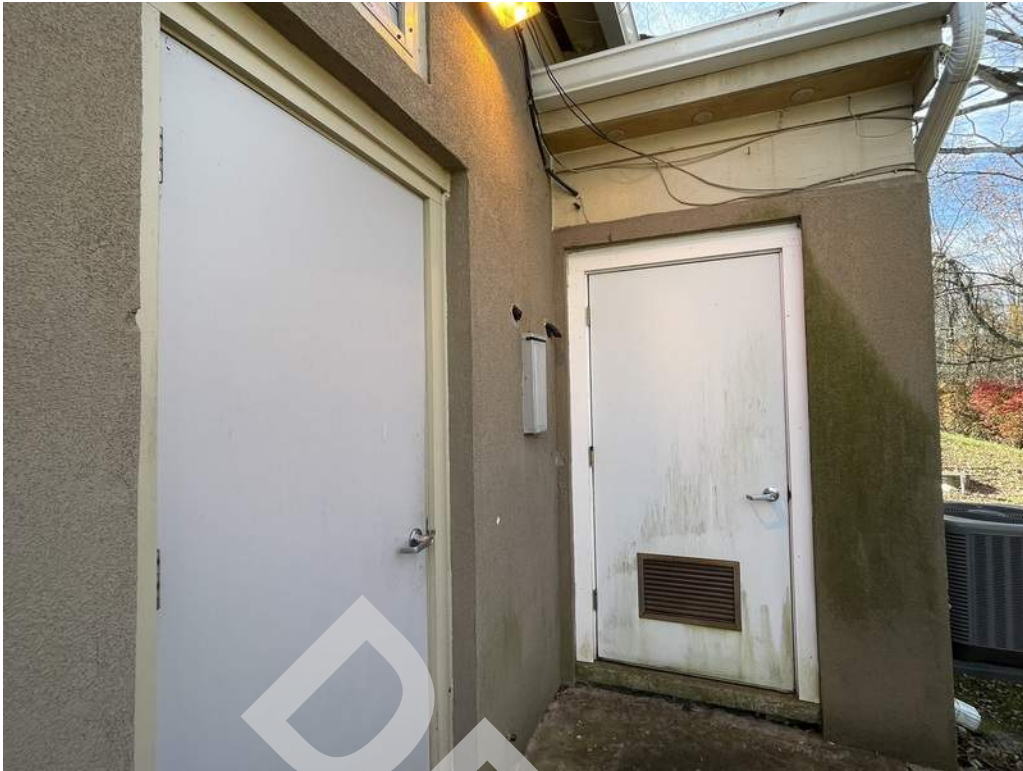
9 - Areas of the EIFS and doors have organic growth.

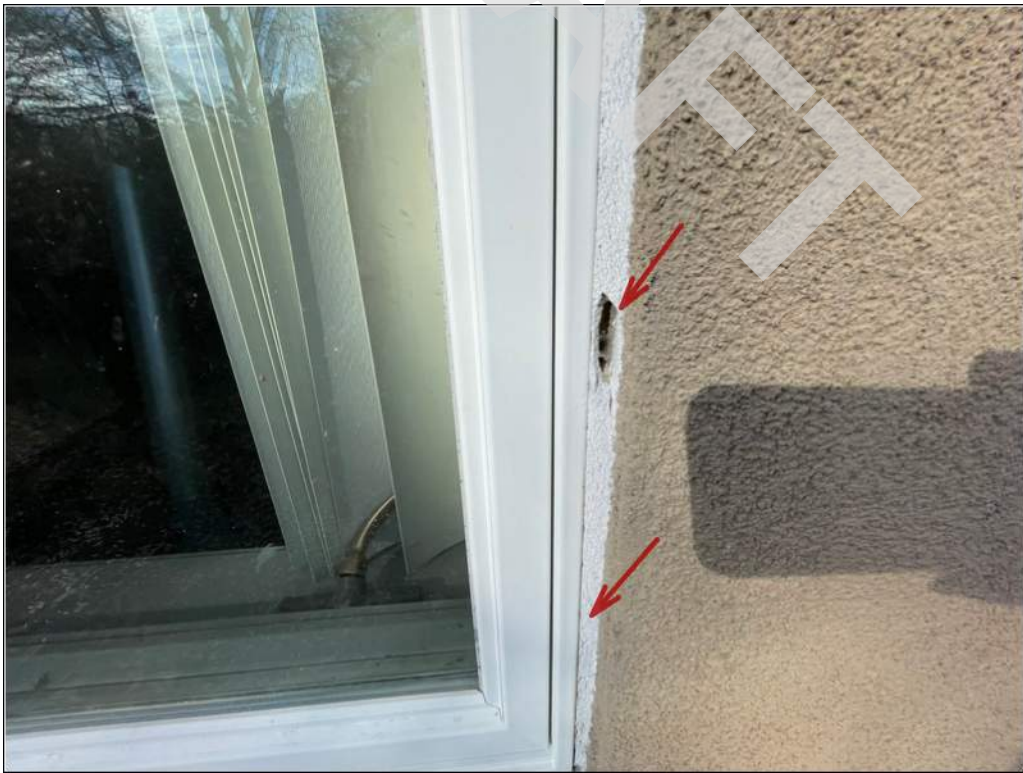
10 - Window perimeter joint sealant has failed. Surface is crazed and ruptured.

<b>ENVELOPE AND EXTERIOR</b>							
3	<p><b>P</b> Building Integrity: Perimeter joint sealant around the window and door openings in the addition is in poor condition. Sealant has crazed and ruptured. Remove and replace all joint sealant at the addition openings.</p>	1	LS				Priority 1 - Current Critical.
<b>CODE REVIEW</b>							
4	<p>Life Safety Code: Review exit signage locations and provide where missing.</p>	1	LS				Priority 1 - Current Critical.
Total Repair Cost

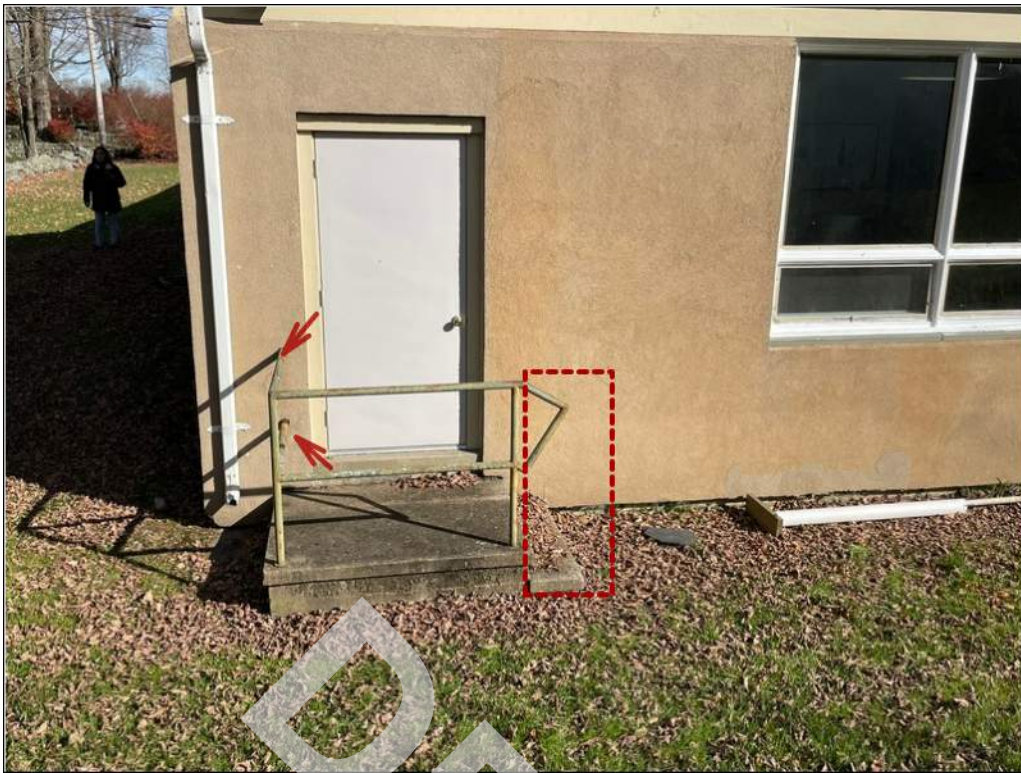
11 - Metal pipe handrail along the steps located at the west façade has corroded and does not extend beyond the last tread.

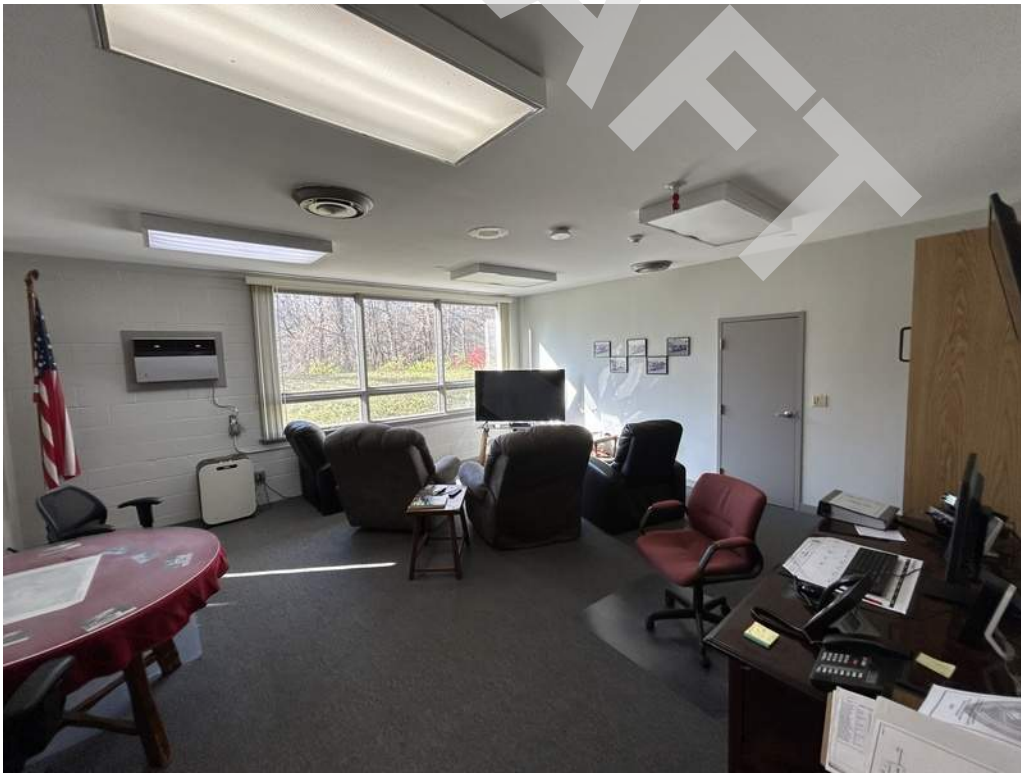
12 - Interior common space finishes consist of painted gypsum ceiling and wall boards and carpet floors. Exit signage directing occupants to the egress door along the west side of the building is not provided.

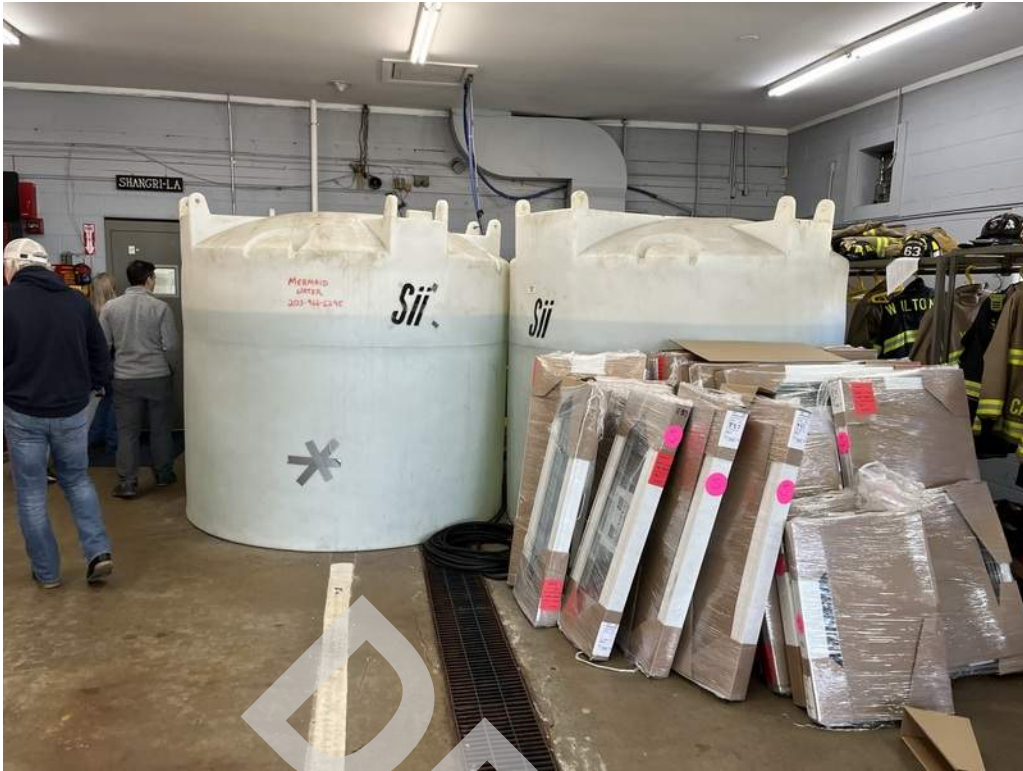
17 - Two water storage tanks located in the garage currently provide the building with domestic water.

10	Building Integrity: Domestic water is currently stored in two above ground storage tanks; it was reported that the private on-site well had failed and a replacement well was dug on an adjacent property which is no longer permitted to be used. Perform engineering analysis to determine the feasibility of providing a well on the property or connecting to a municipal water line. The scope of review could include environmental testing, review of existing conditions, and providing recommendations for repair scope.	1	EA															Priority 4 - Recommended
11	Building Integrity: Two water storage tanks currently provide the building with domestic water. It is recommended to remove these tanks and provide the building with an automatic means of water. The scope of work could include drilling a well, installing a well pump, trenching, running a new incoming water service, and connecting to existing domestic water piping in the building. Work of this magnitude would require engineering drawings and a budget could be in the range of \$50,000.	1	EA															Priority 4 - Recommended
