# FACILITY CONDITION ASSESSMENT

## G&B CULTURAL CENTER

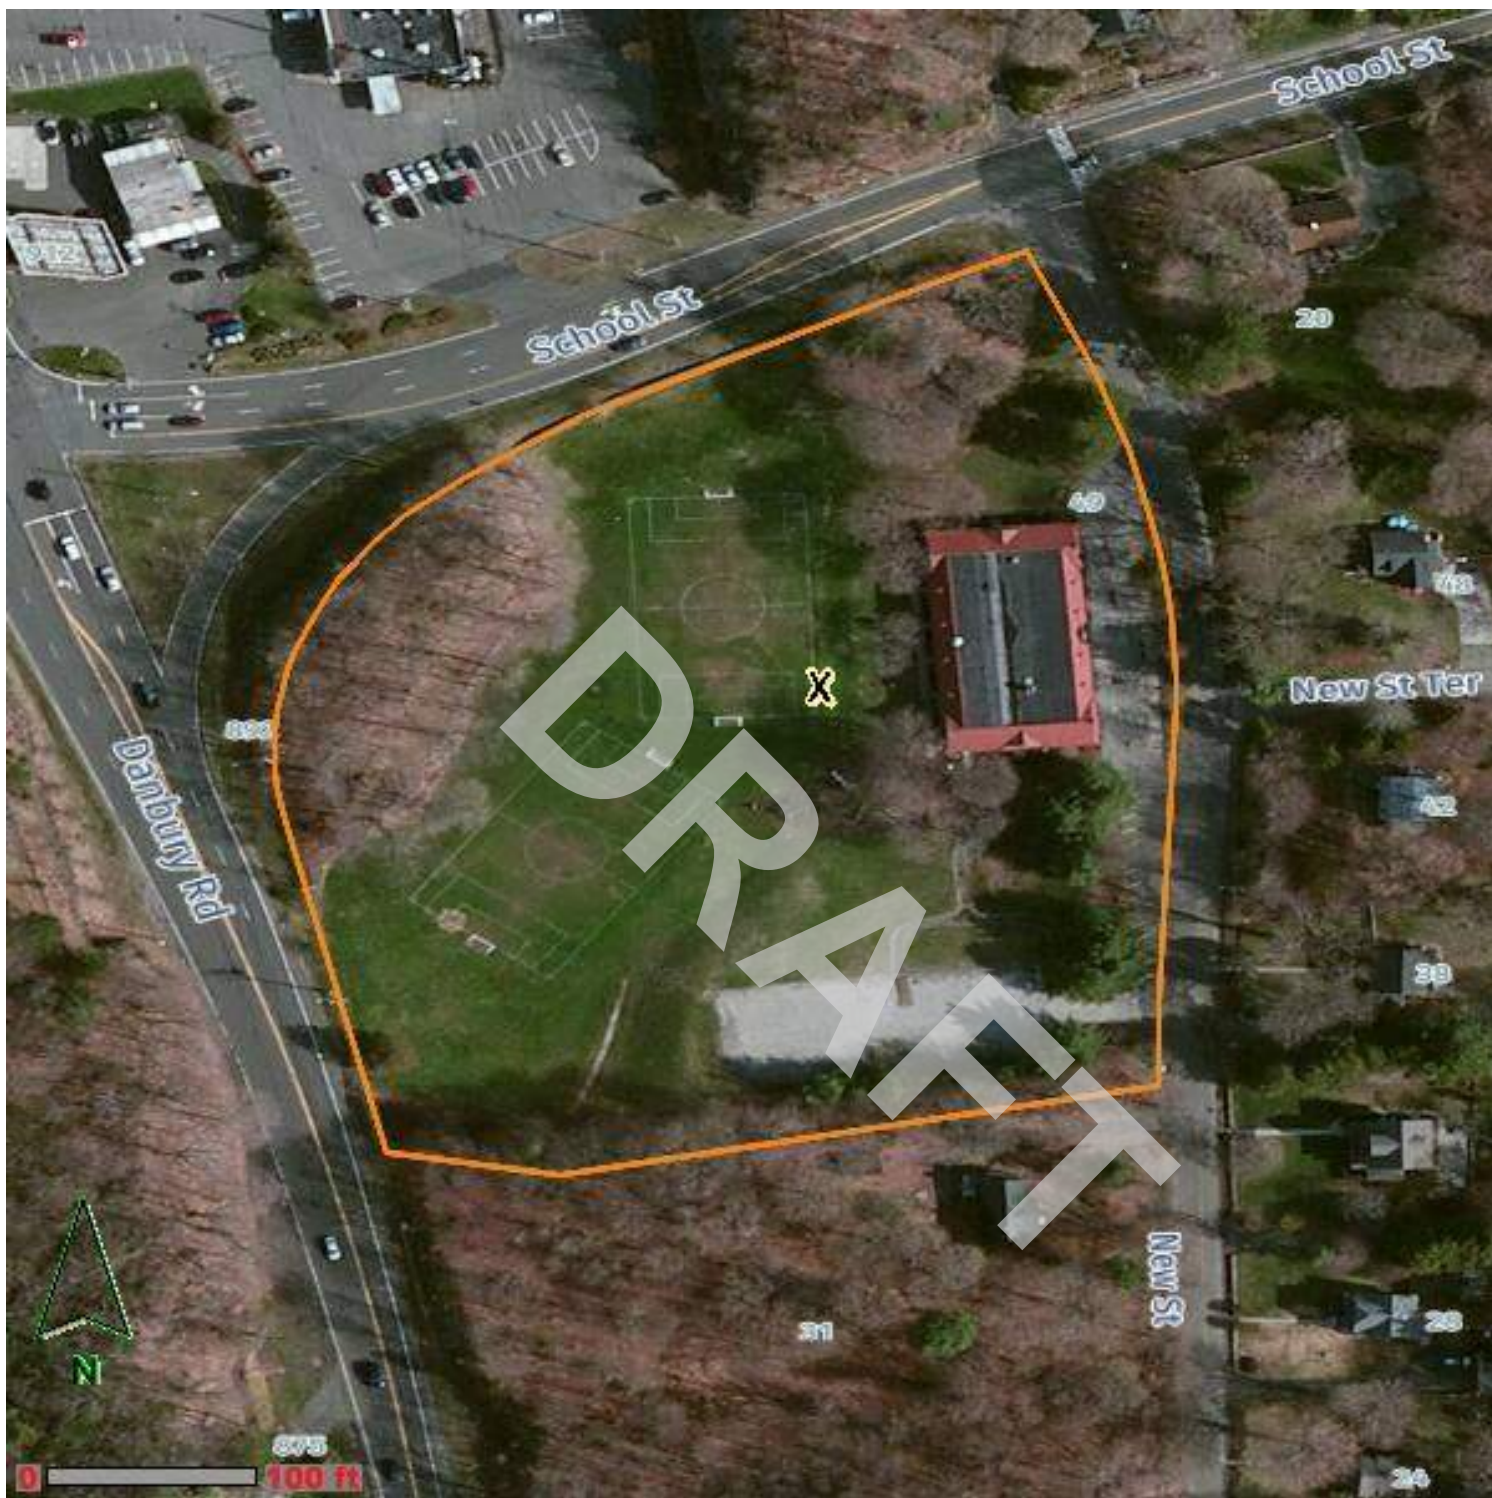
| <b>Flood Zones Legend</b> | A Values | X500 /SHX / B | X / C |

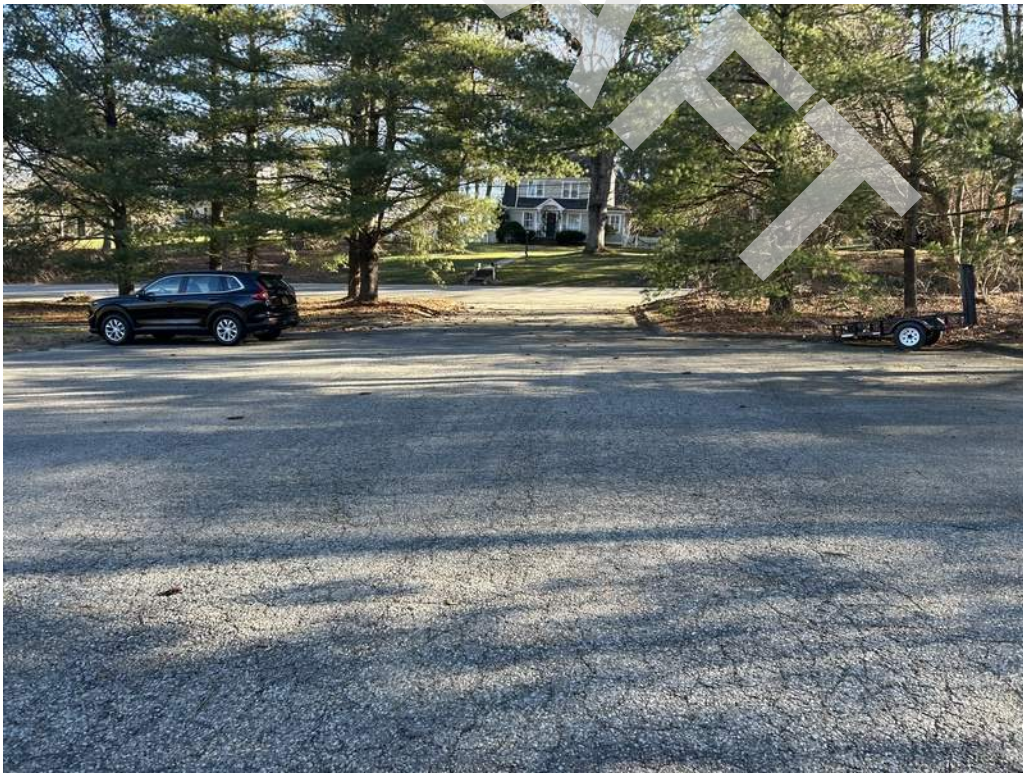
2 - The side asphalt paved parking area, along New Street, exhibits alligator cracking throughout.

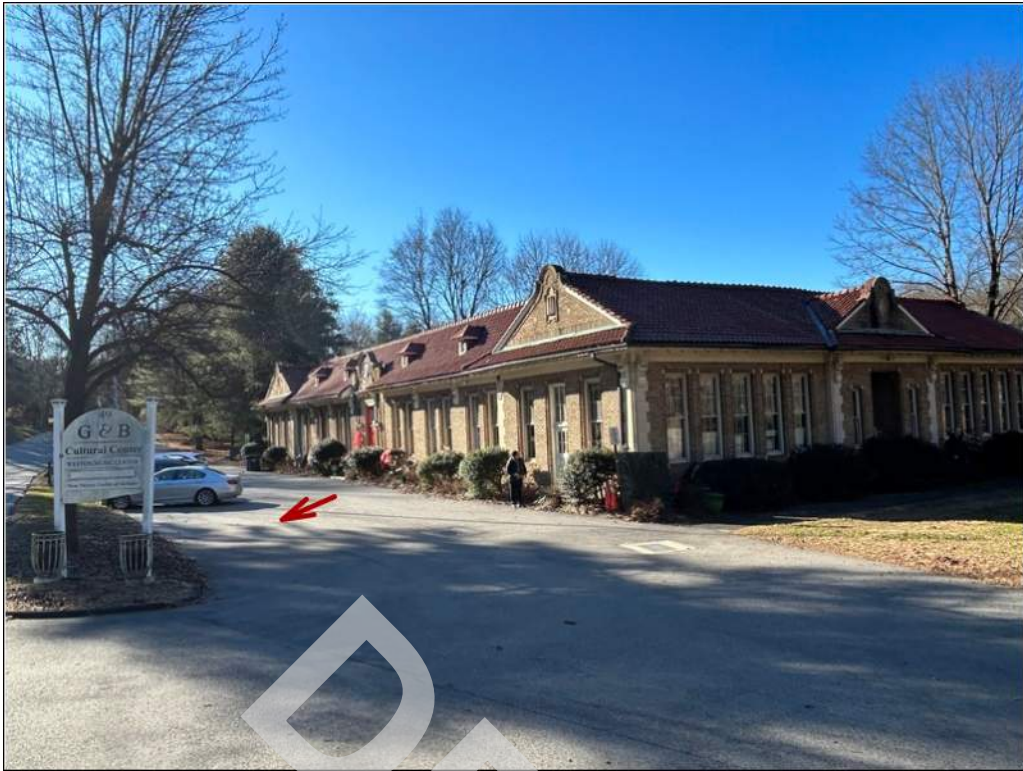
3 - Parking spaces in front of the building are not striped.

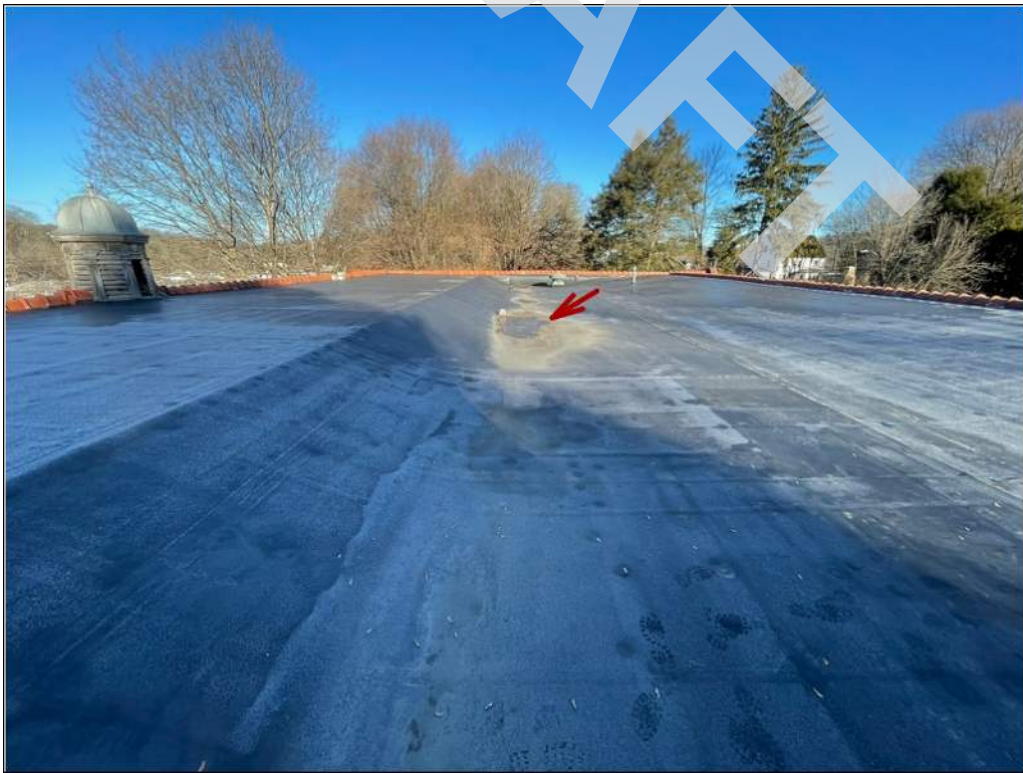
4 - Main roof consist of an EPDM (ethylene propylene diene terpolymer). Water ponding and debris accumulation was observed.

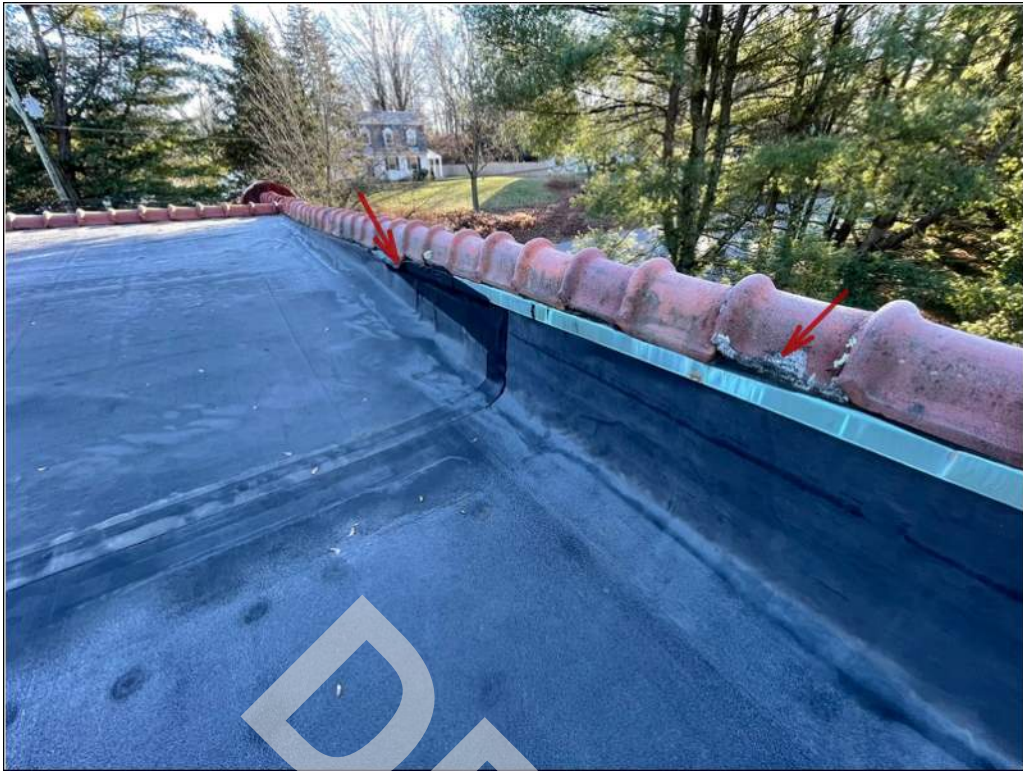
5 - Parapet coping consists of clay roof tiles with EPDM flashing and metal counterflashing. Clay roof tiles are in poor condition, some units are displaced and the EPDM parapet flashing is poorly installed.

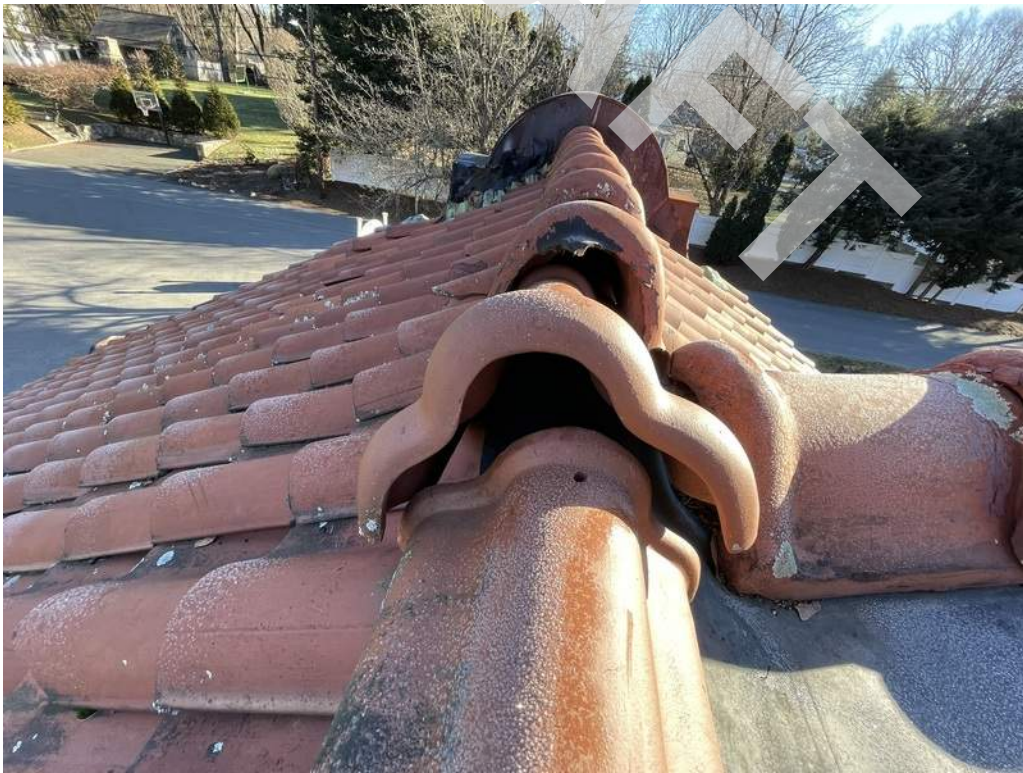
6 - Coping clay roof tiles have displaced.

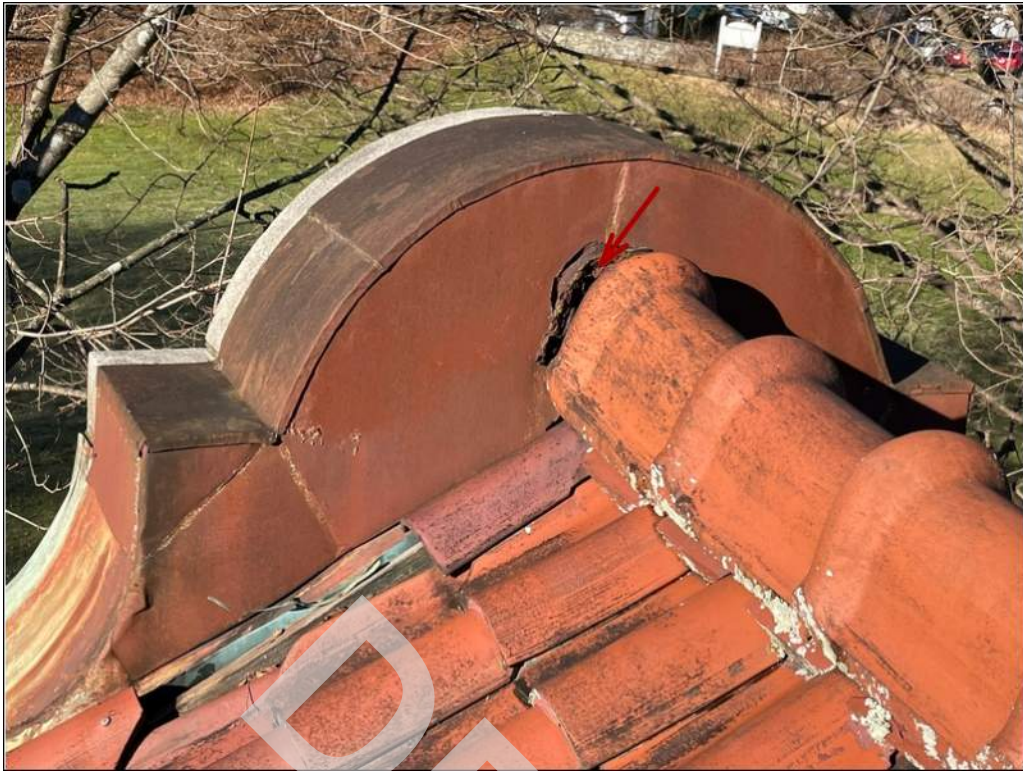
7 - Metal surfaces along the roof have corroded and have openings.

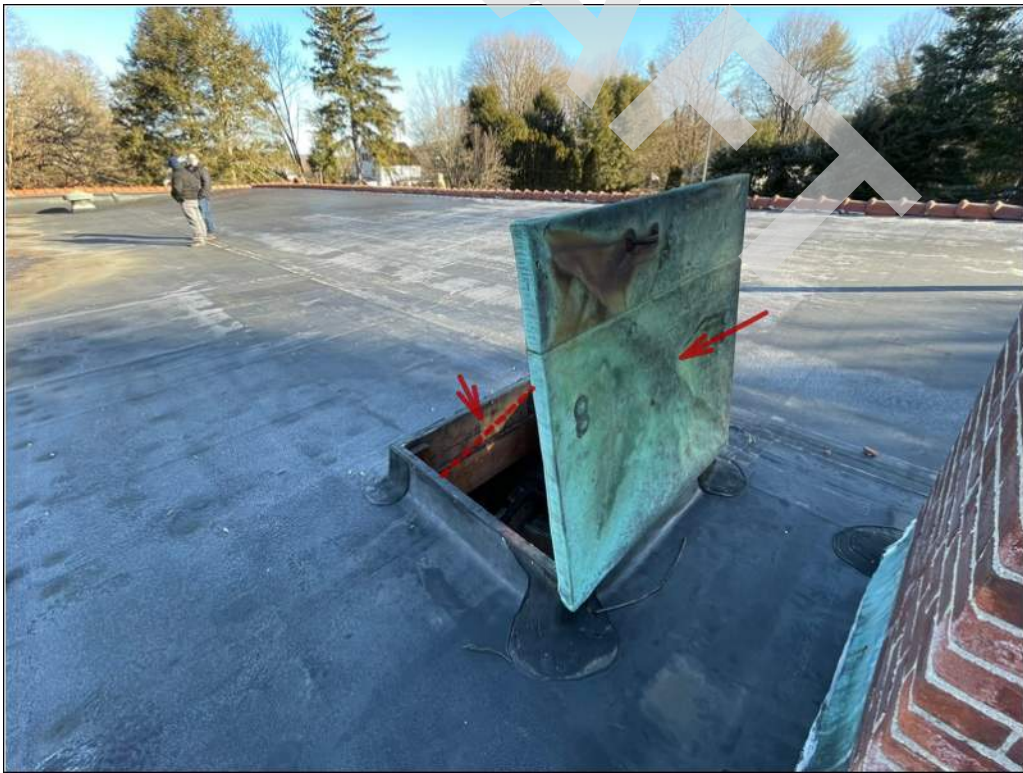
8 - Roof hatch is missing one hold open hardware and is in poor condition.

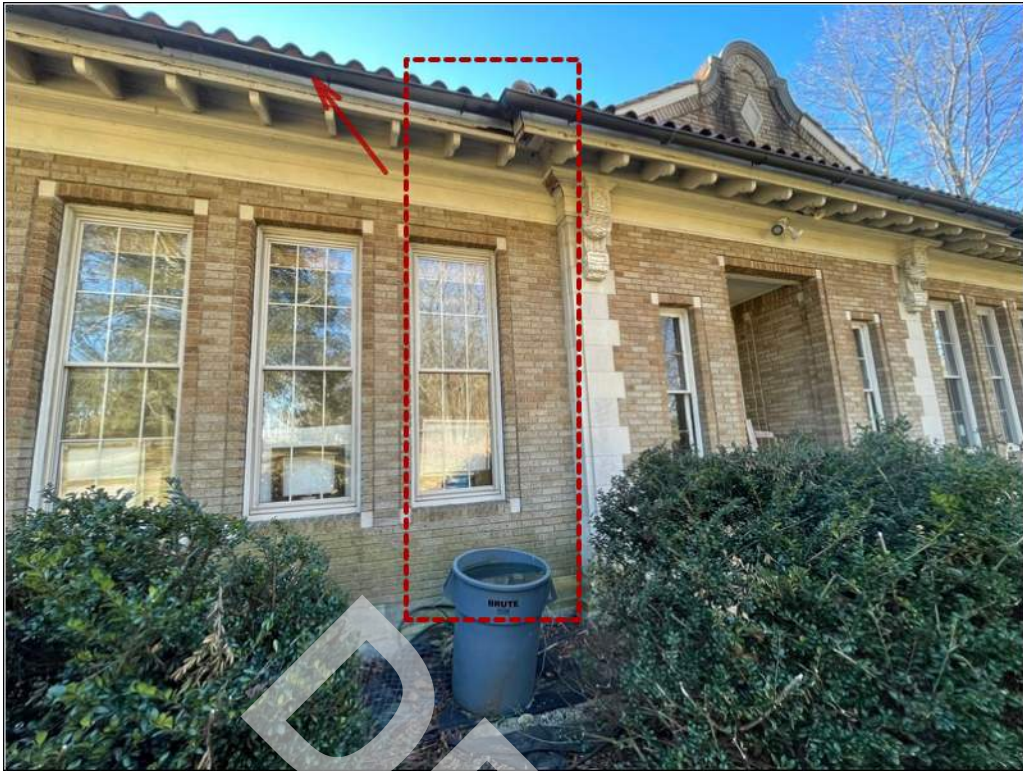
9 - Sections of the roof gutters are in poor condition and appear to be overflowing.

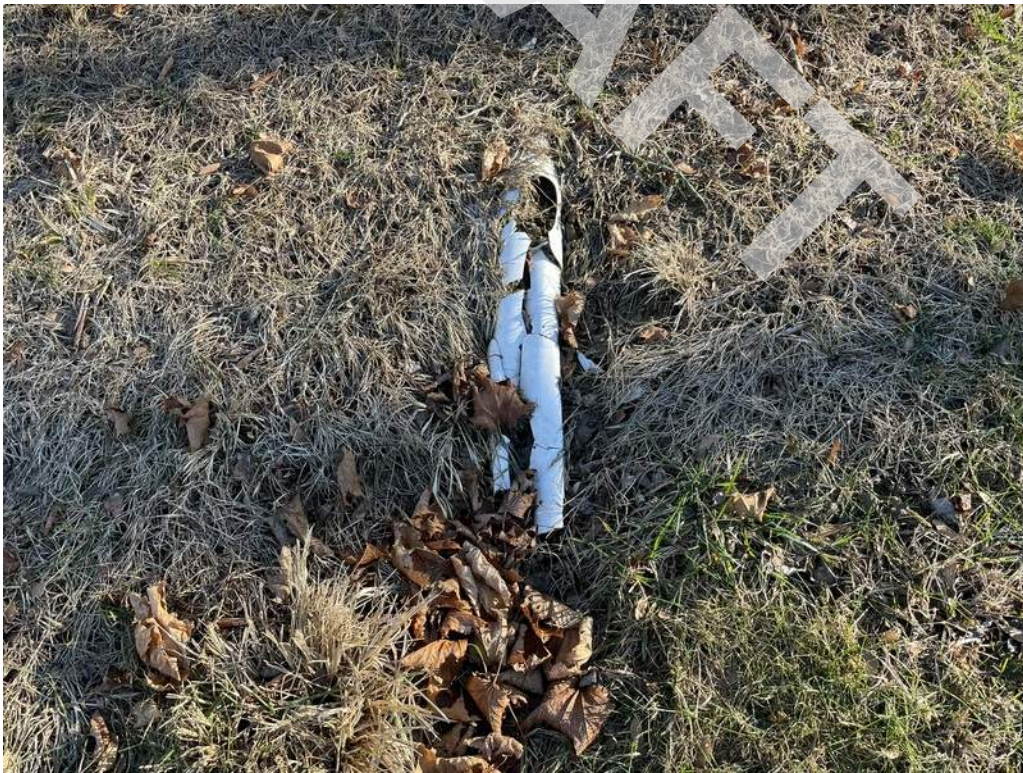
10 - Roof leader drain pipe extensions have failed.

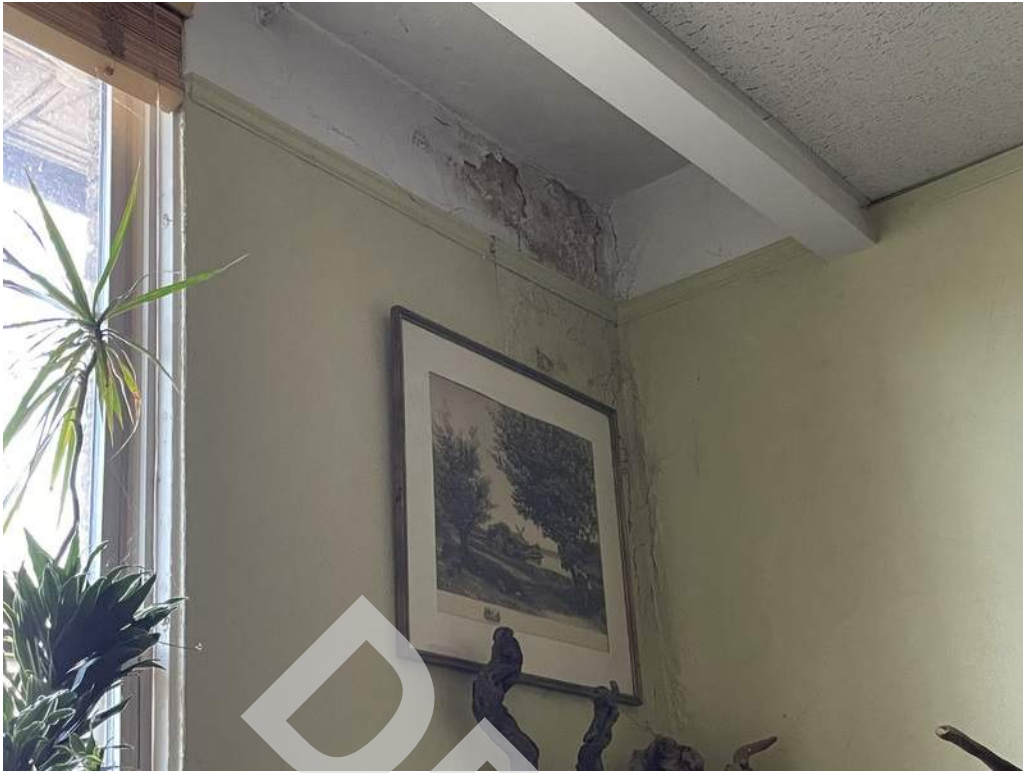
11 - Water intrusion through the roof has damaged the interior surfaces.

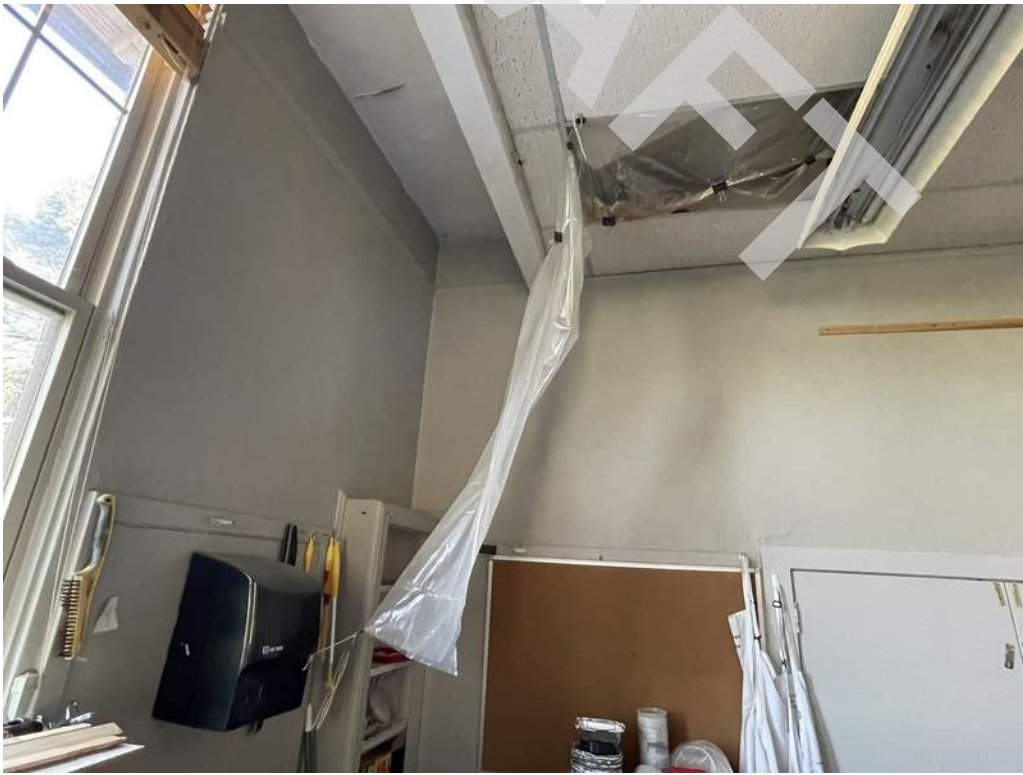
12 - Signs of active roof leaks coming down from the ceiling at one of the art studios.

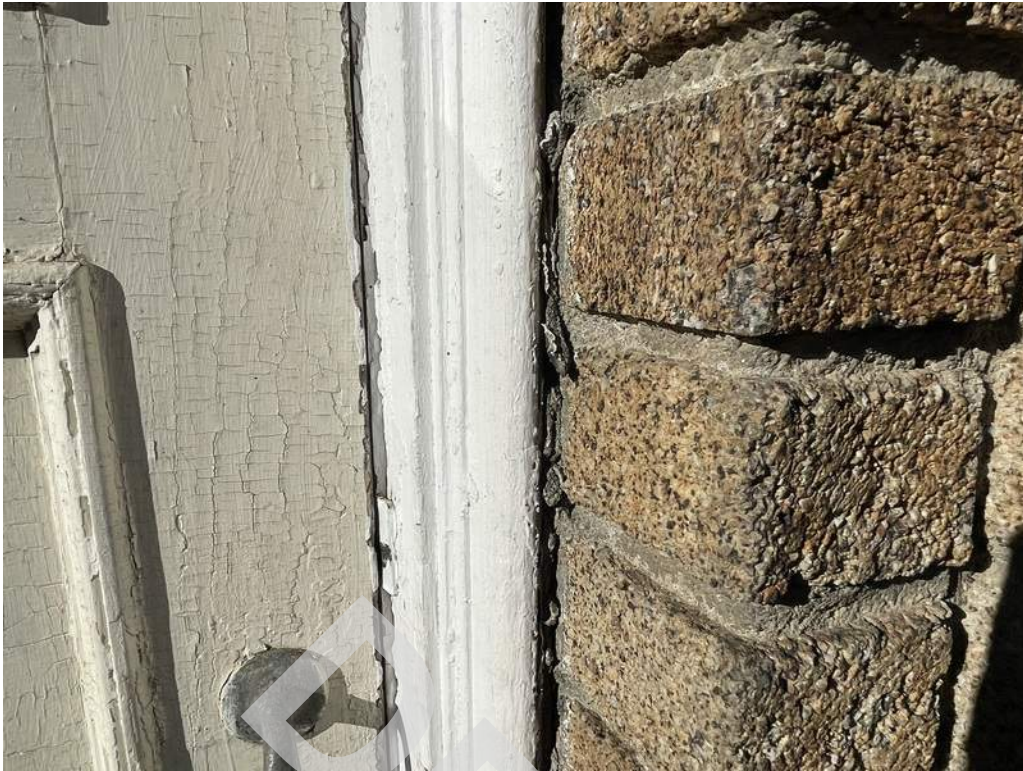
13 - Joint sealant along brick masonry openings has failed.

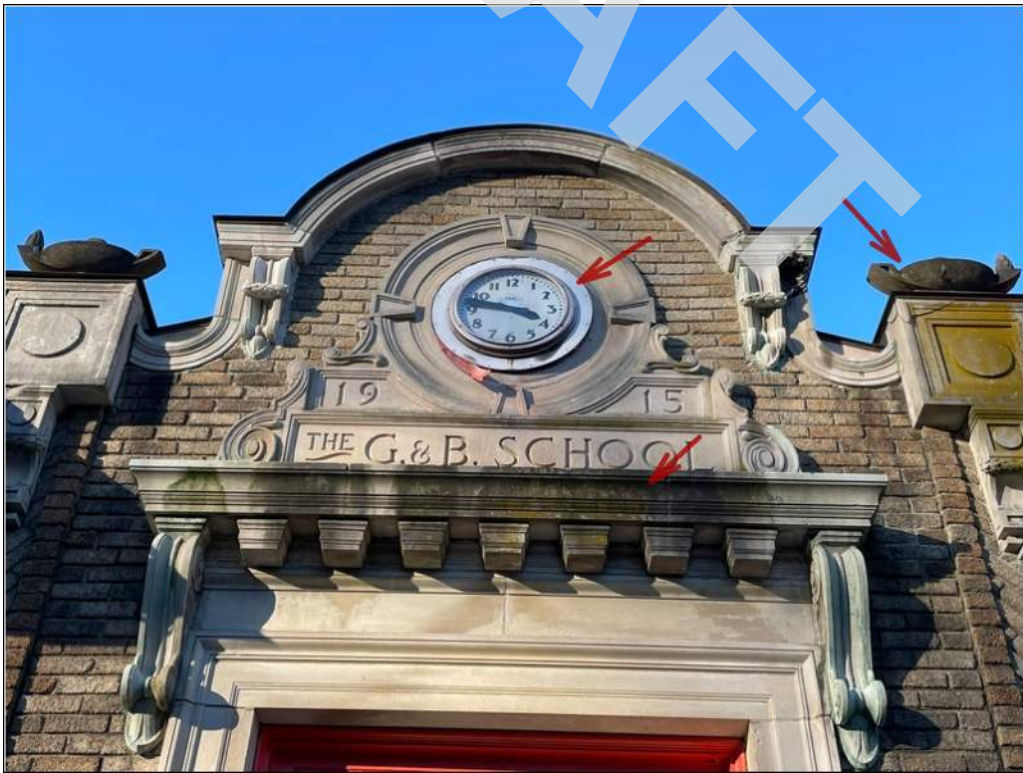
14 - Building clock is not working properly and appear to be in poor condition. Organic growth and build up stains are in the front facade stone.

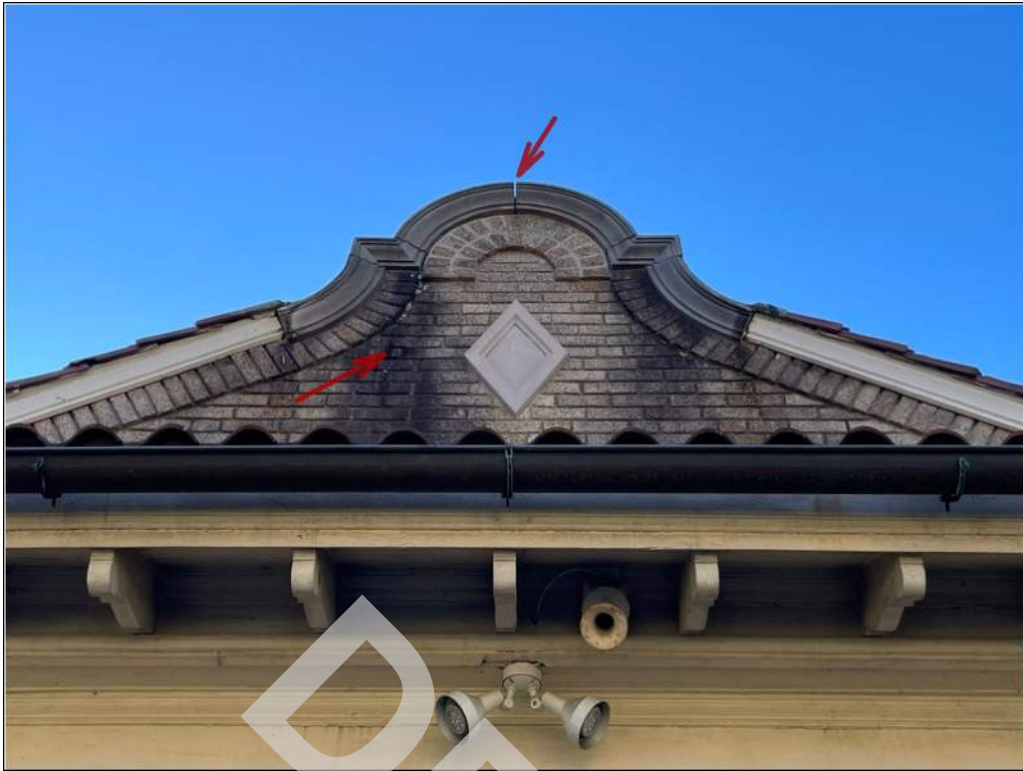
15 - Localized areas of mortar joints are missing or are in poor condition along the masonry brick and stone facades. Areas of the stone and brick masonry have organic growth and debris accumulation.

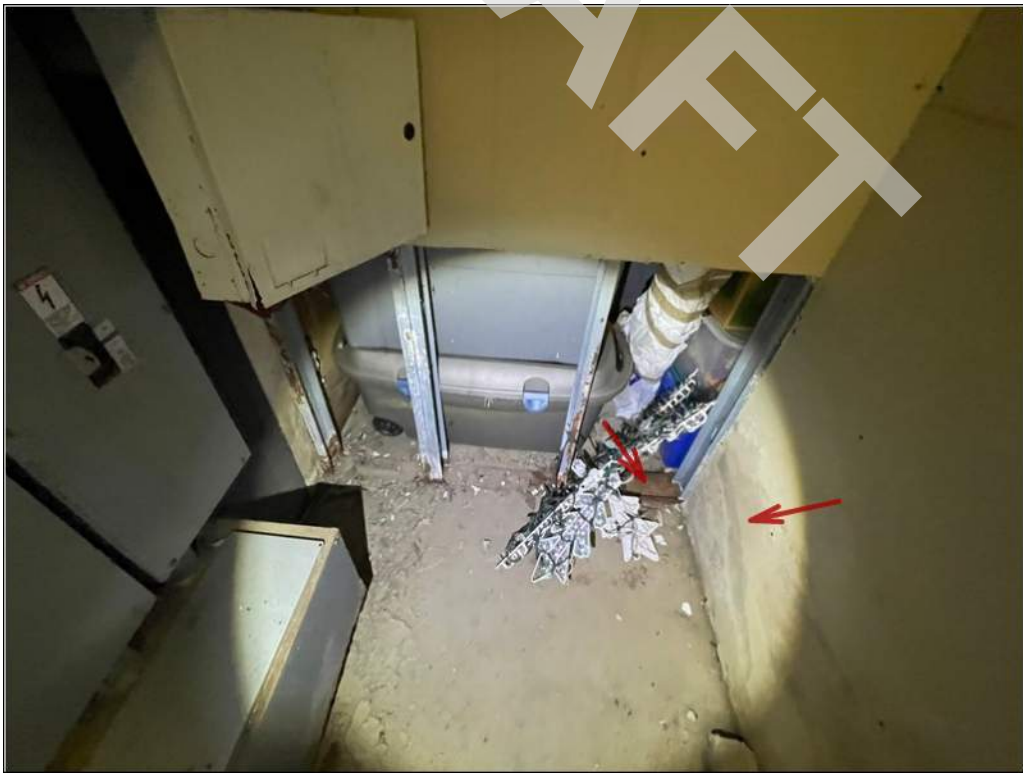
16 - Basement wall surfaces and wall framing metal components have water stains and corrosion due to water intrusion instances.

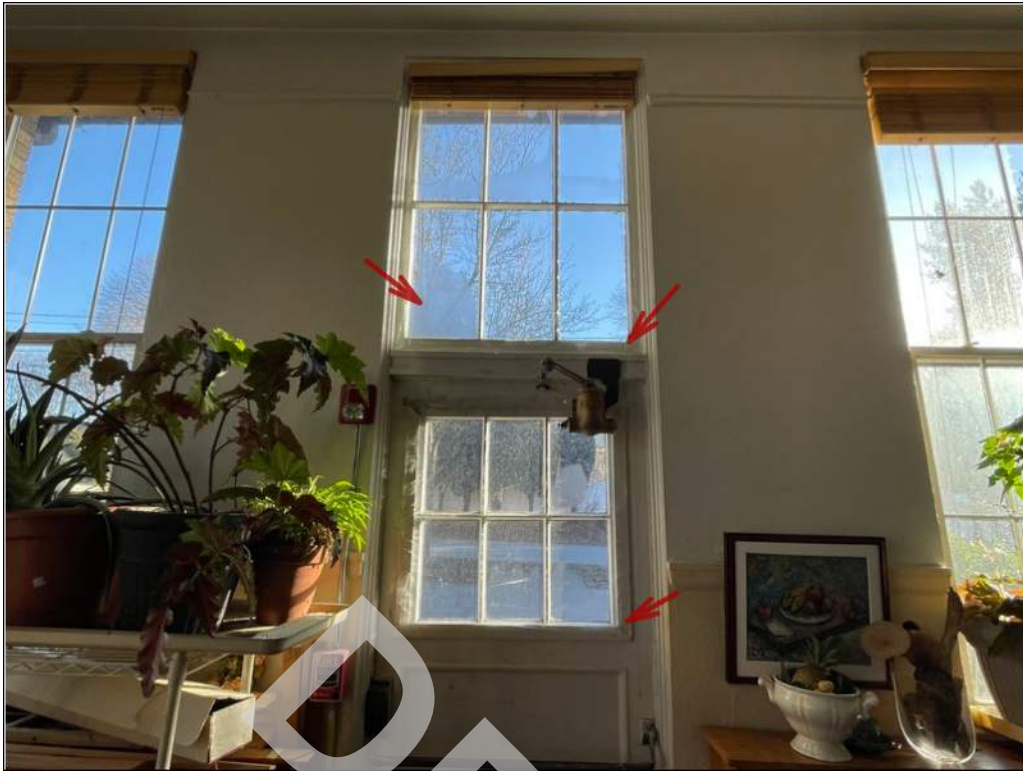
17 - Single pane glass window unit above the door and on the door leaf have condensation and have been covered with window films to reduce draft.

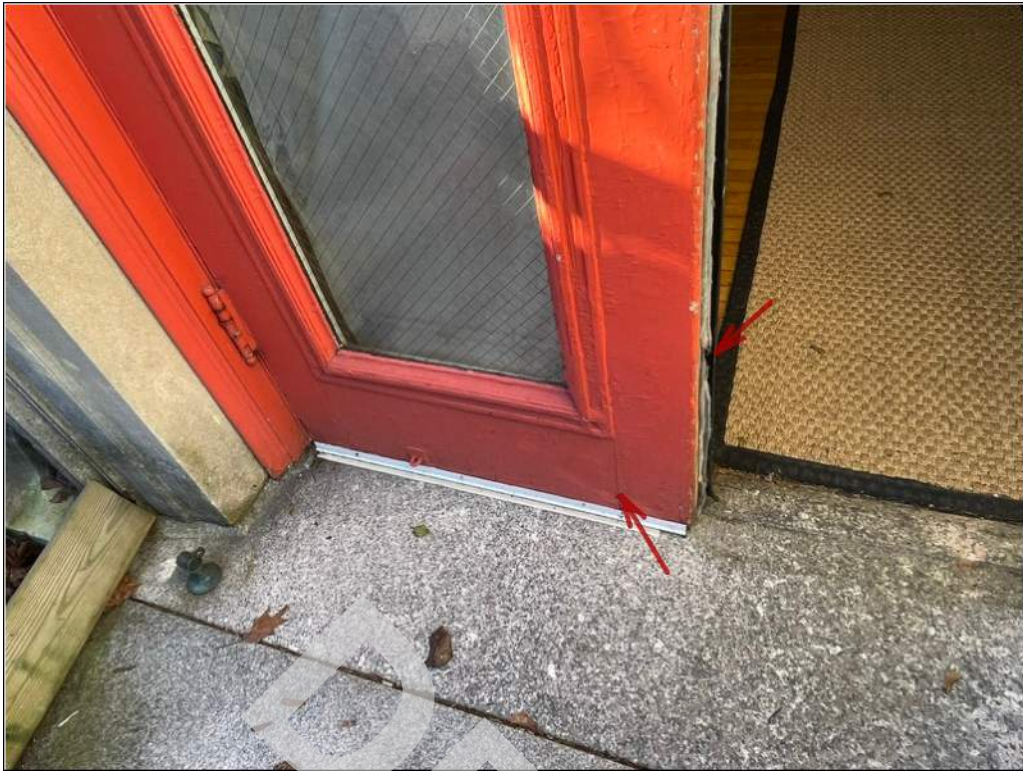
19 - Wood surface and weatherstripping are in poor condition.

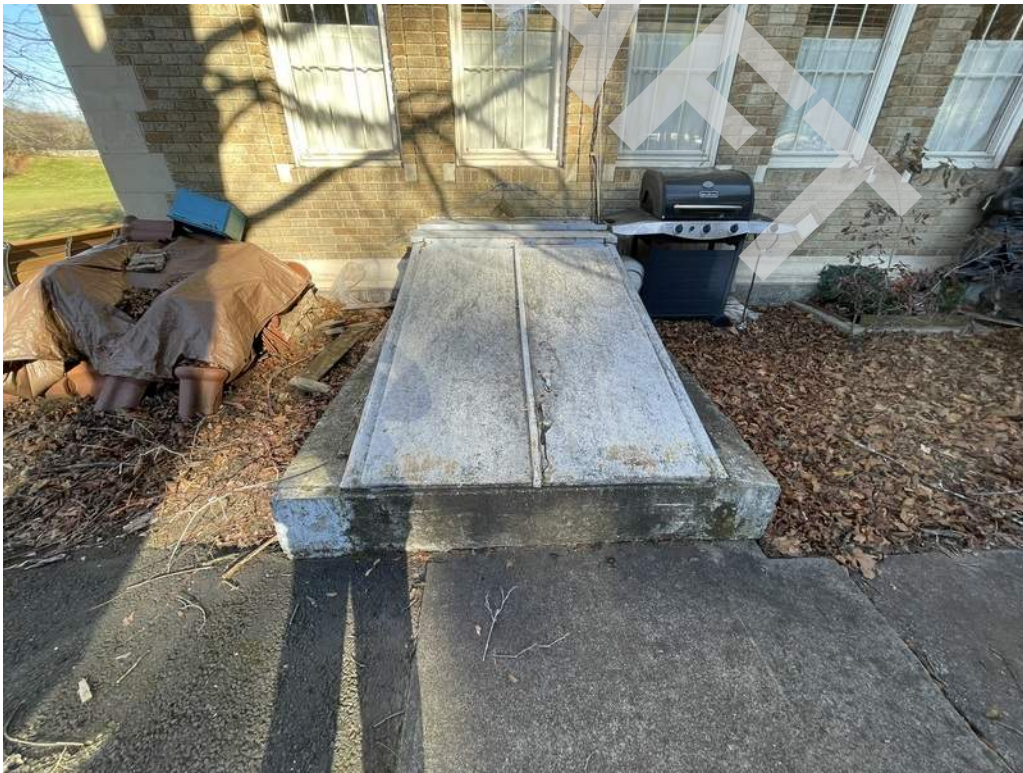
20 - Metal basement hatch door is in poor condition.

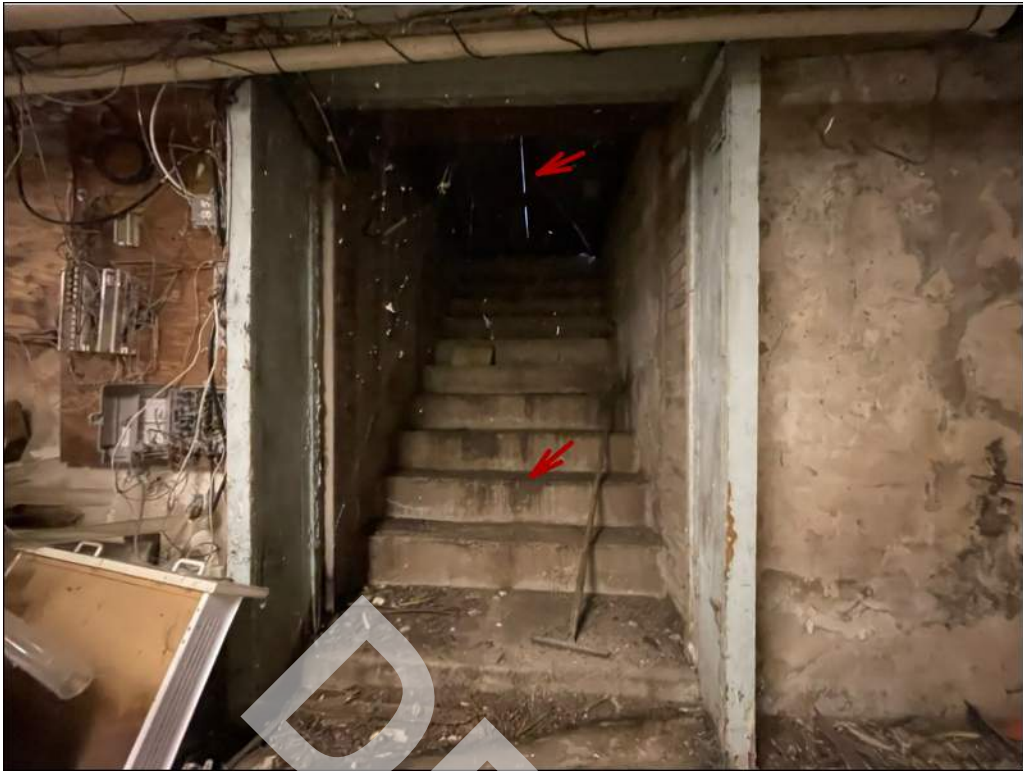
21 - Basement hatch door doesn't close properly and steps have signs of water intrusion.

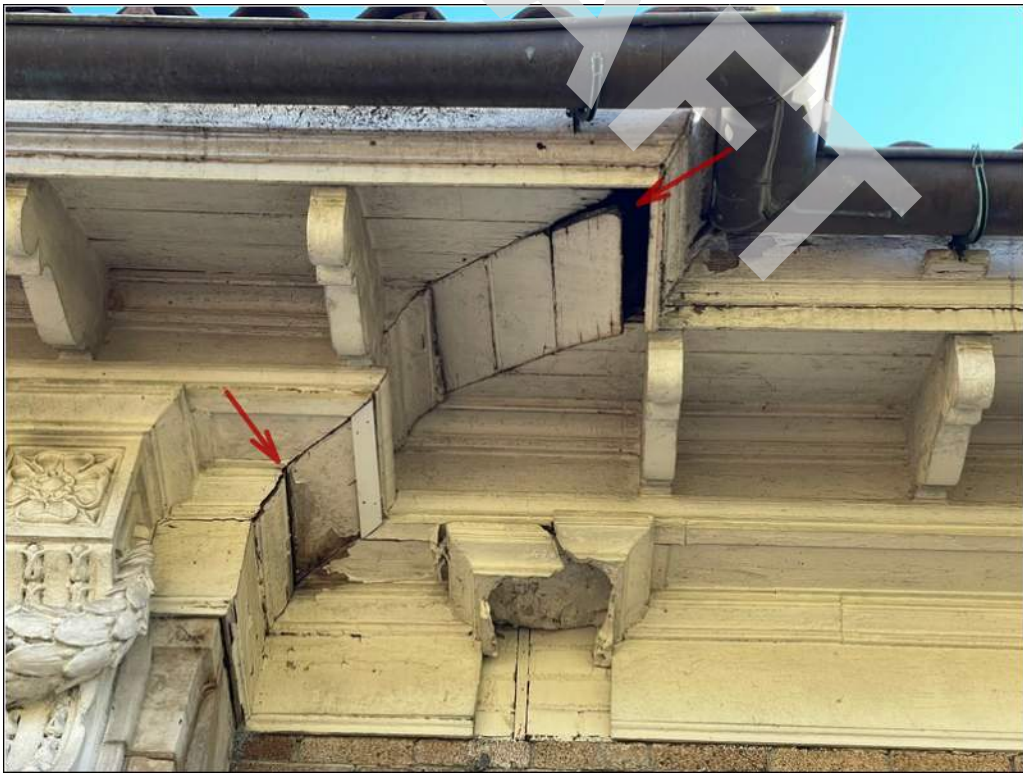
22 - Wood soffits and trim around the roof have displaced and open joints; paint finishes are peeling; wood surfaces are rotting and have missing pieces.

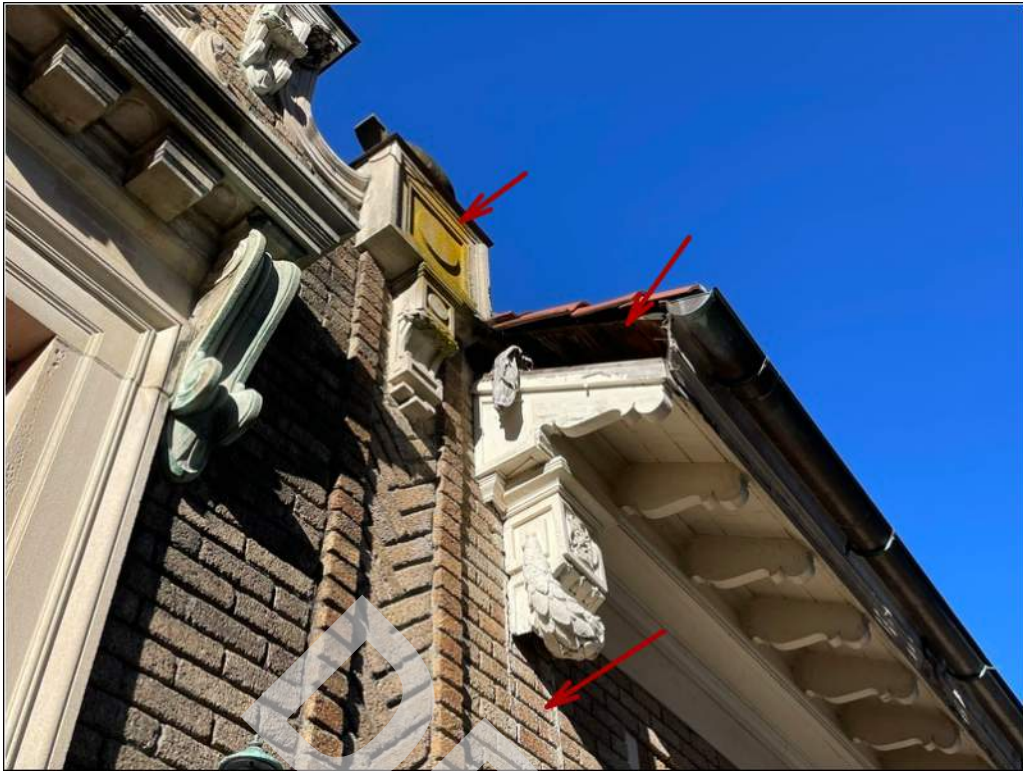
23 - Areas of wood trim around the roof are missing. Portions of the pilaster capitals have broken and are missing. Areas of the stone pilaster have organic growth.

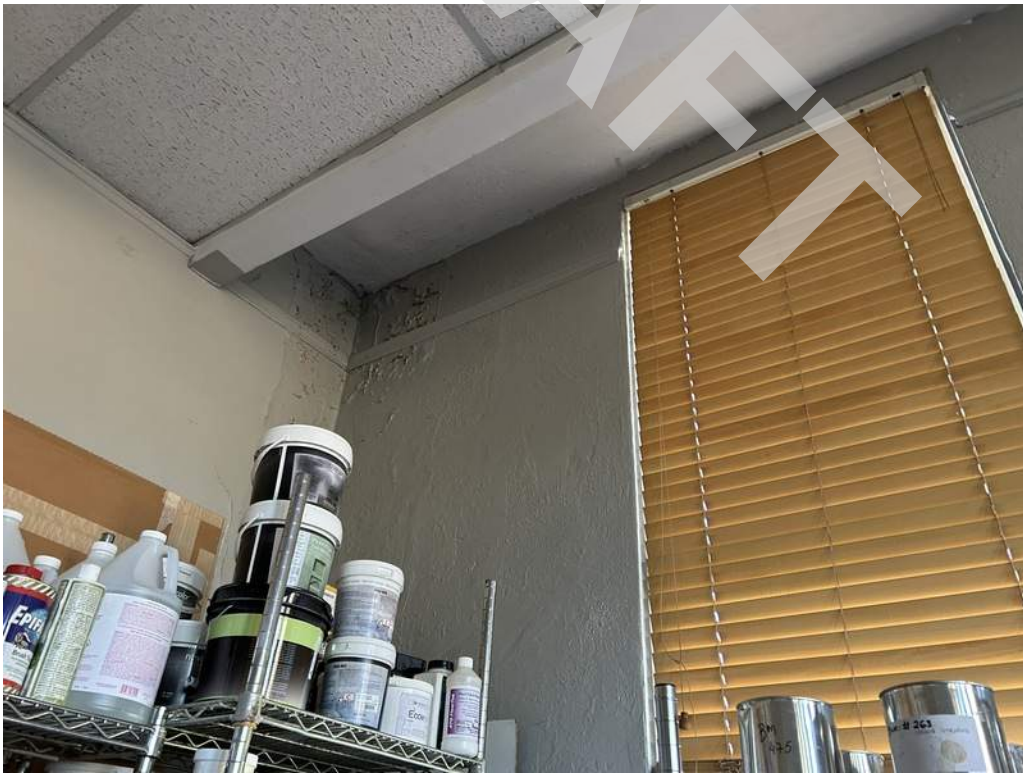
24 - Deteriorated paint was observed at the corner of Classroom 1AA.

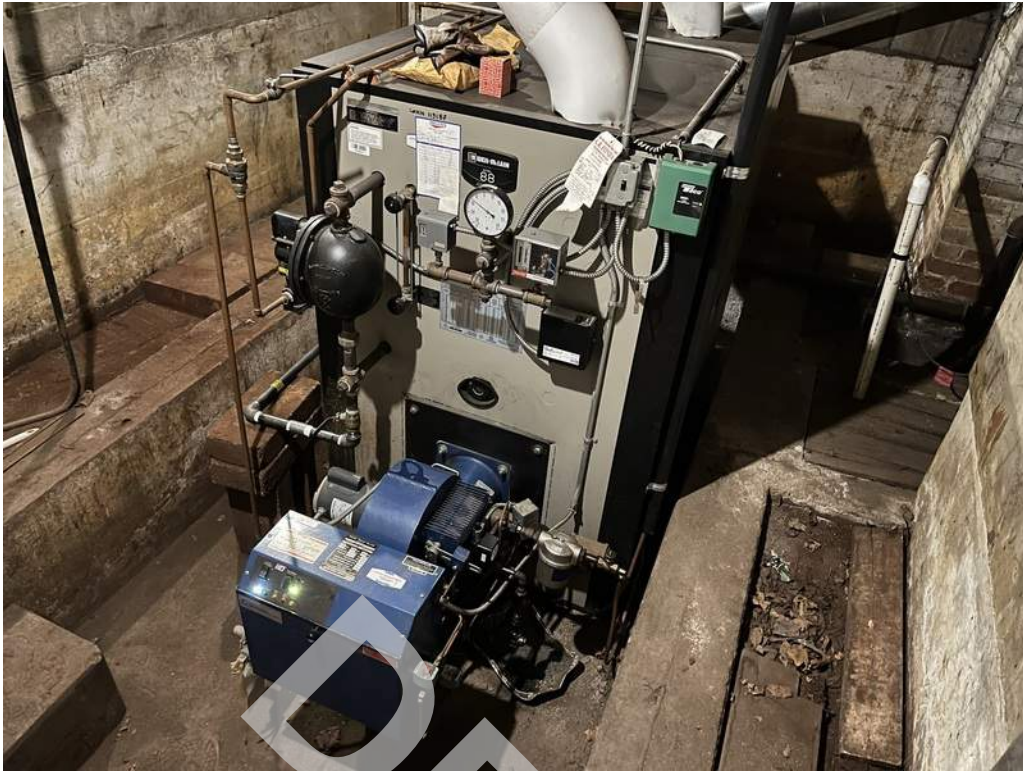
25 - An oil fired boiler located in the basement provides heating and domestic hot water throughout the building.

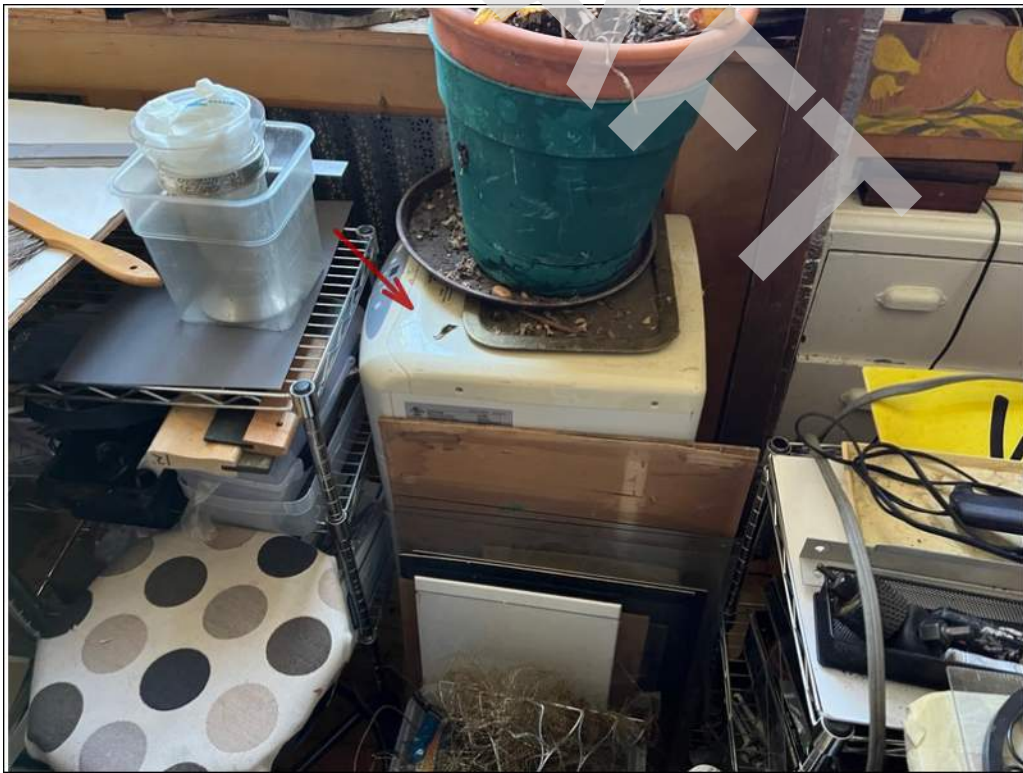
26 - Portable air conditioning units serving individual rooms provide cooling to portions of the building.

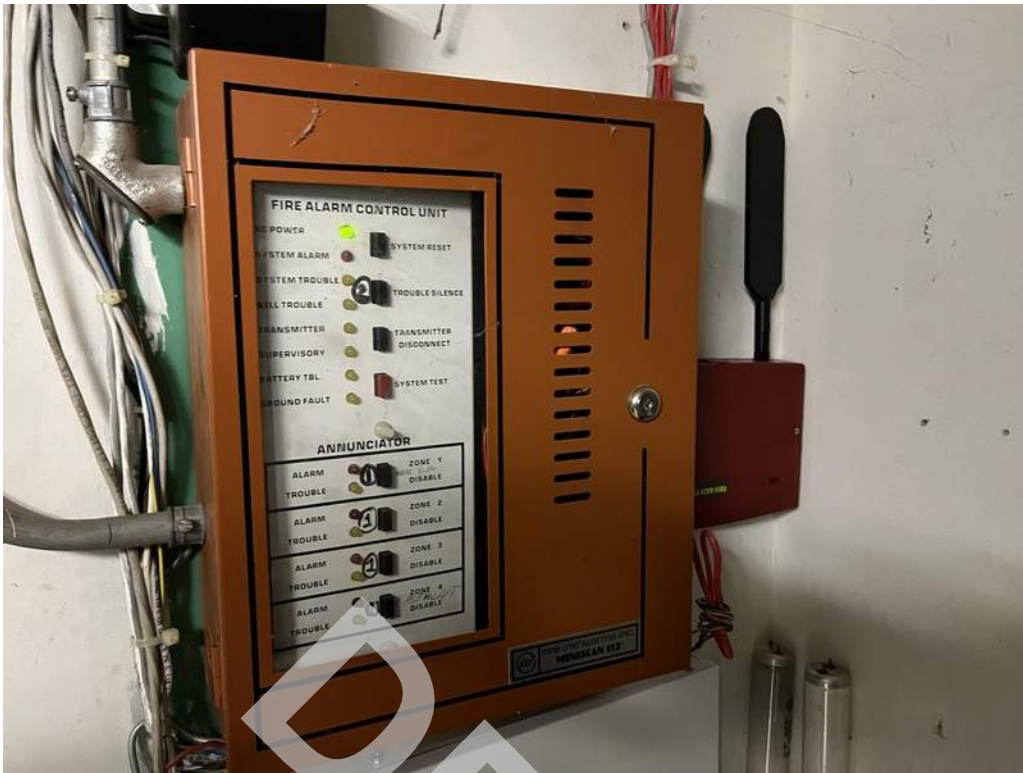
27 - The building is provided with a Miniscan 112 fire alarm panel.
