FACILITY CONDITION ASSESSMENT

HIGHWAY GARAGE

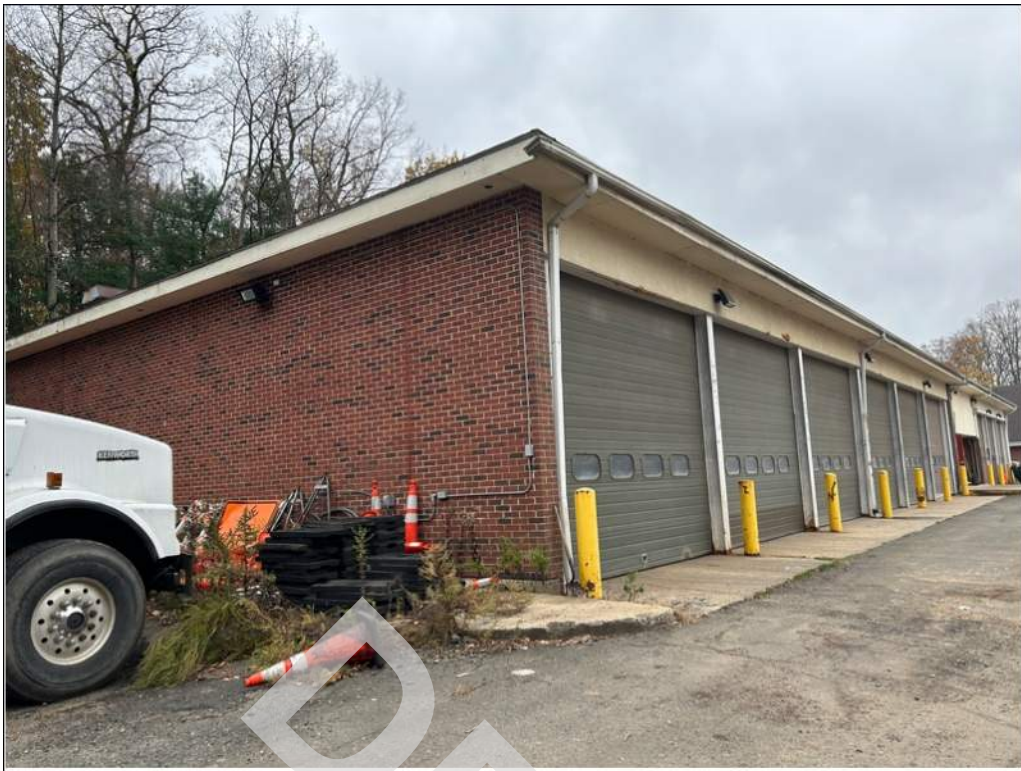
3 - Spalled concrete was observed at the concrete aprons and corrosion was noted as several bollards.

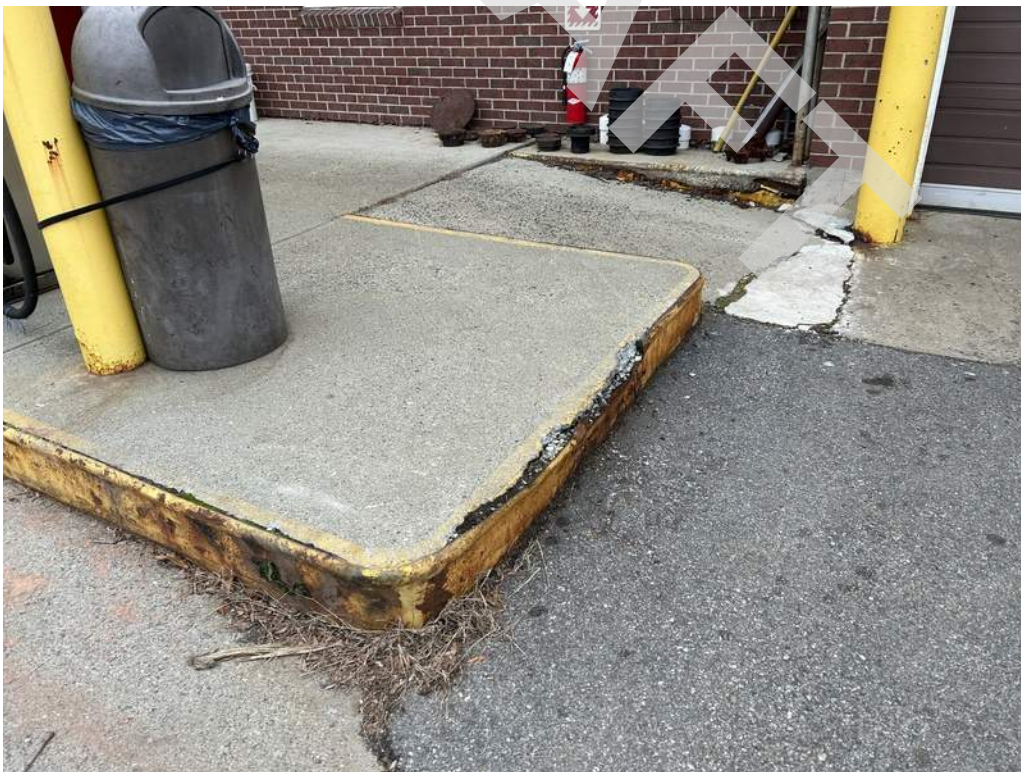
4 - Walkways exhibit concrete spalling and deterioration.

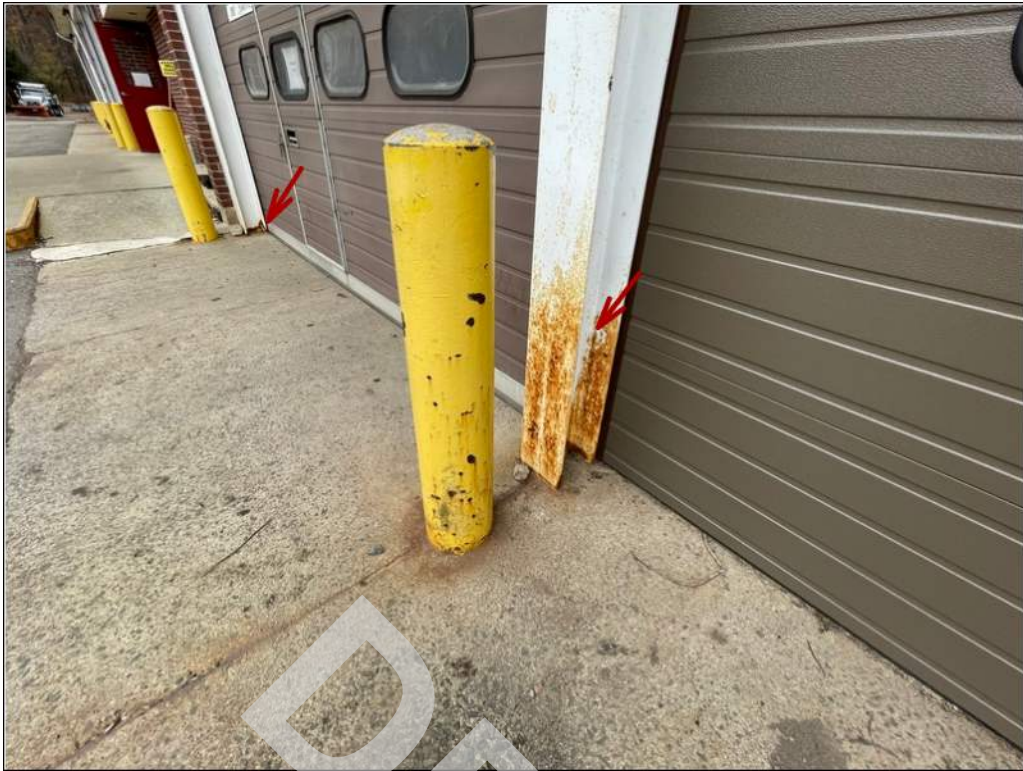
5 - Steel column surfaces have corroded.

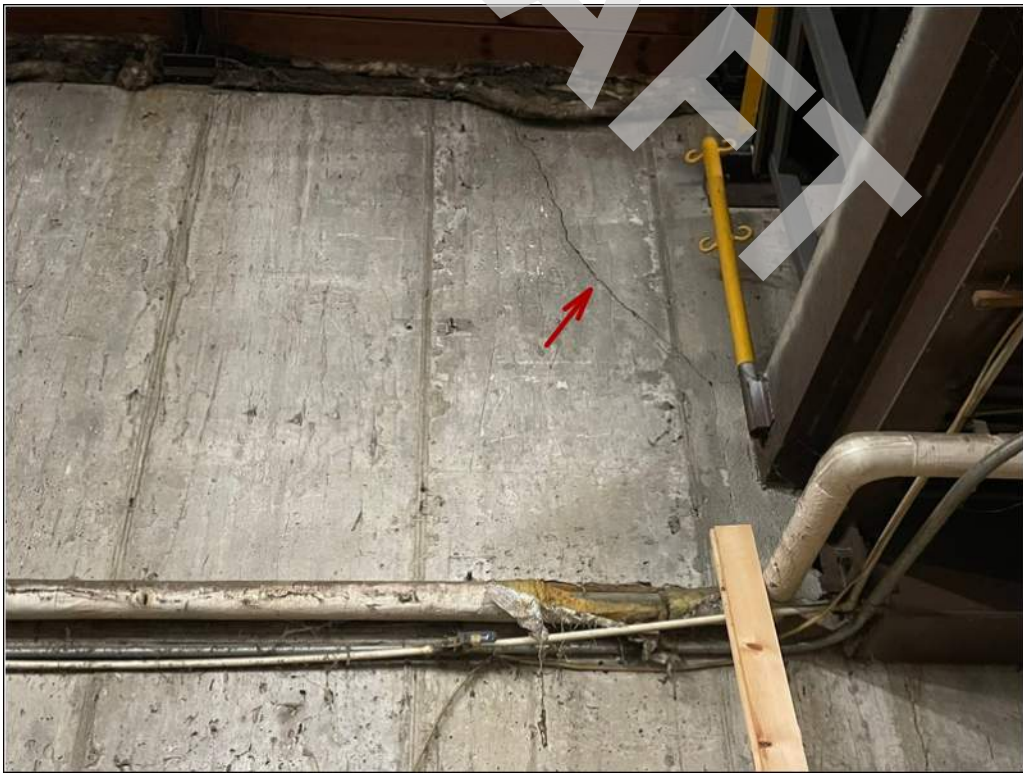
6 - Localized areas of the reinforced concrete wall have cracked.

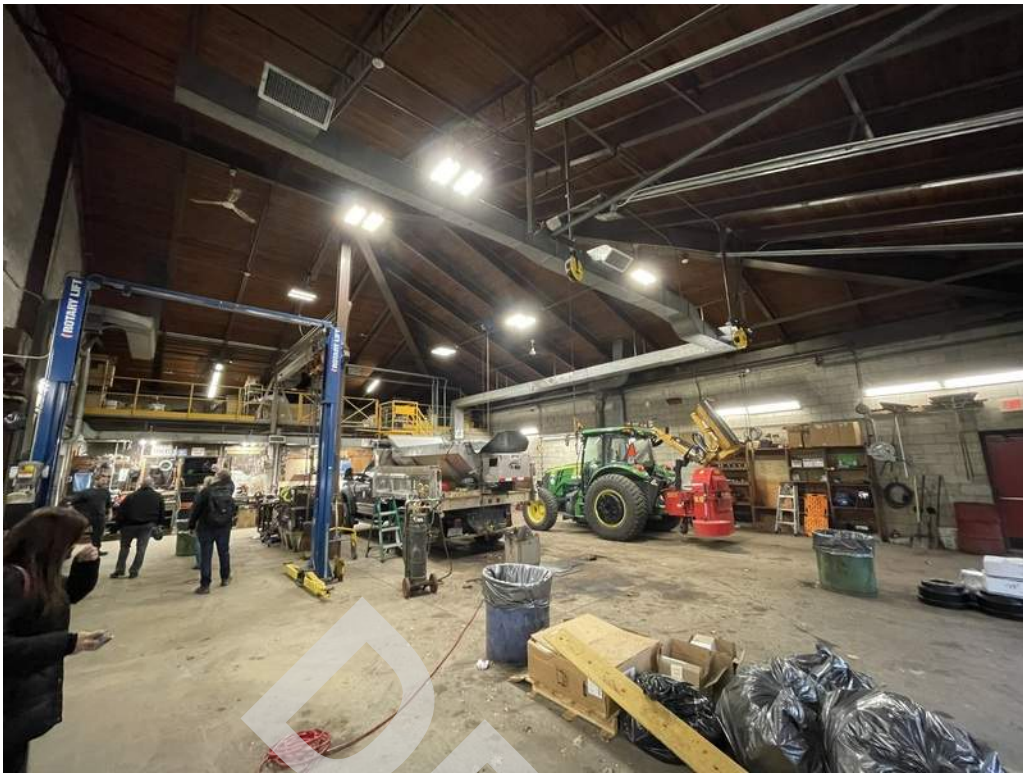
7 - Overview of the east side garage bays.

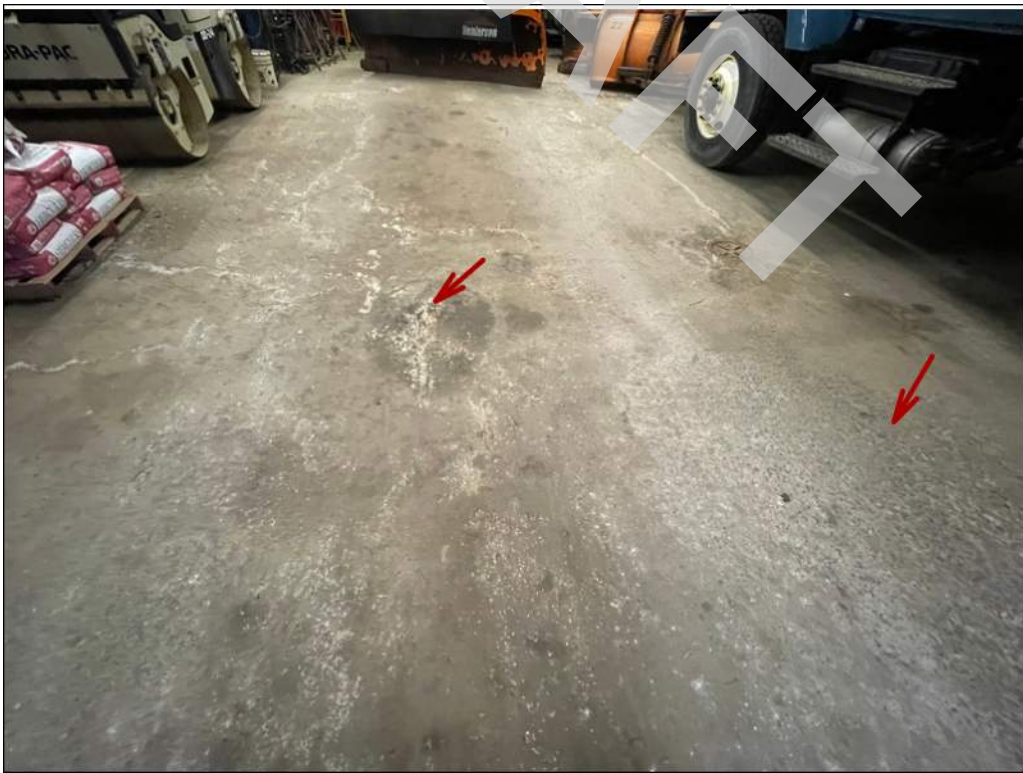
8 - Localized spalling and cracking has occurred along the concrete slab-on-grade.

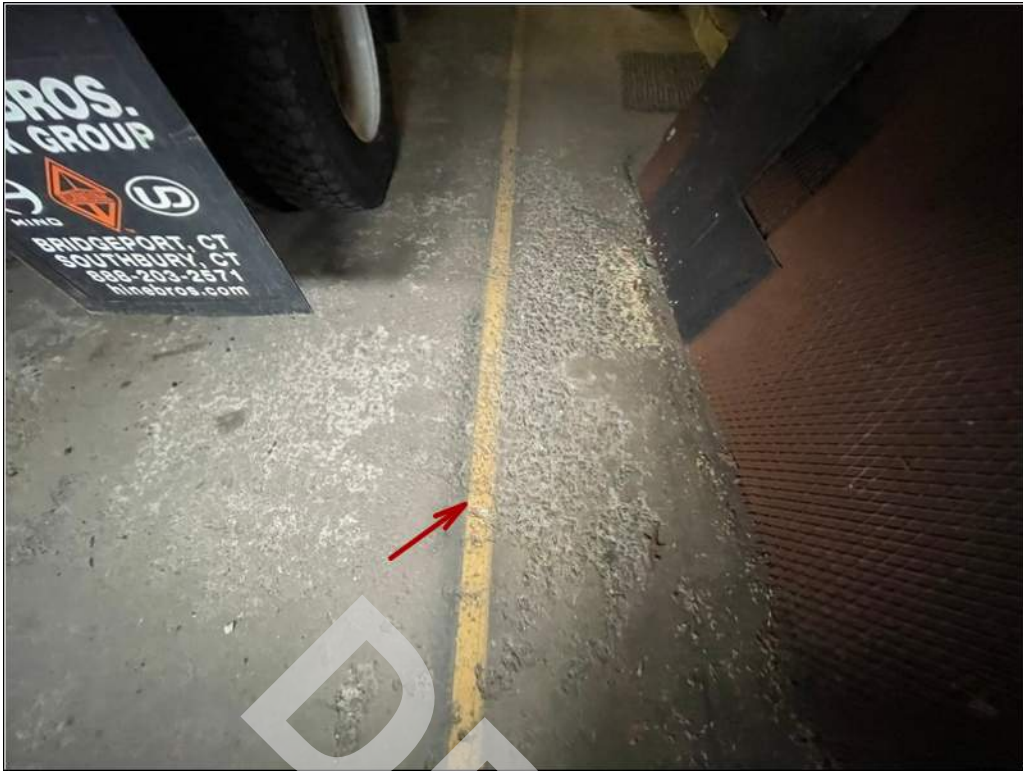
9 - Spalled areas along the slab surface.

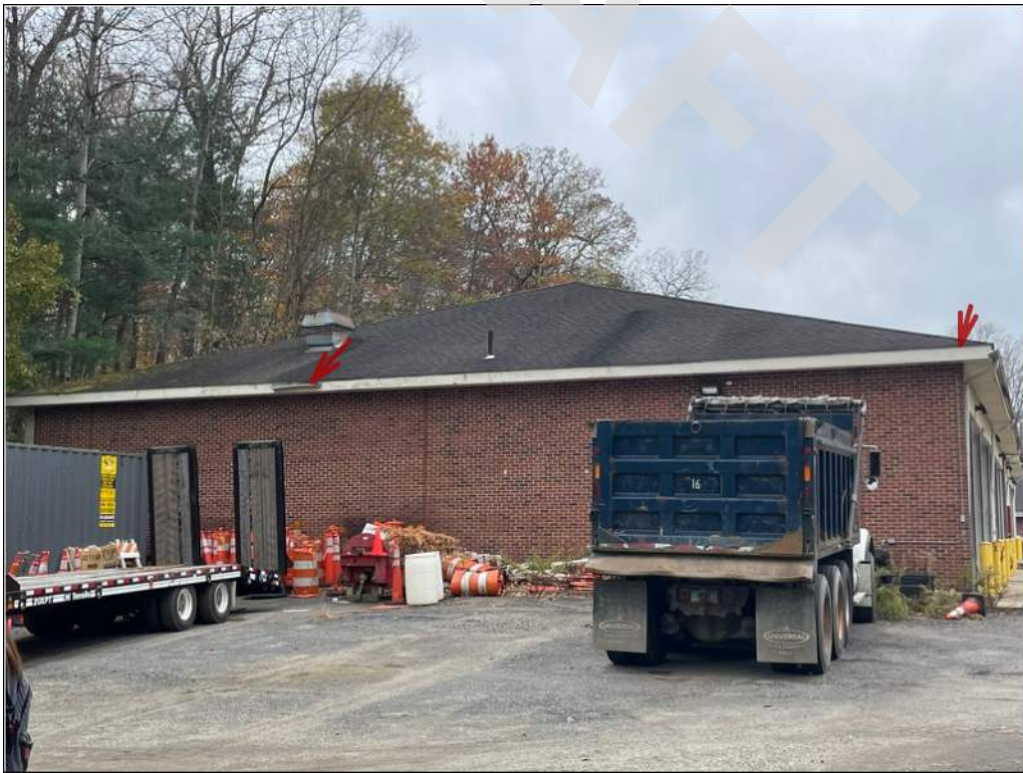
10 - Roof gutter is missing and fascia has damages along the east facade. Roof deficiencies include organic growth and stained asphalt shingles.

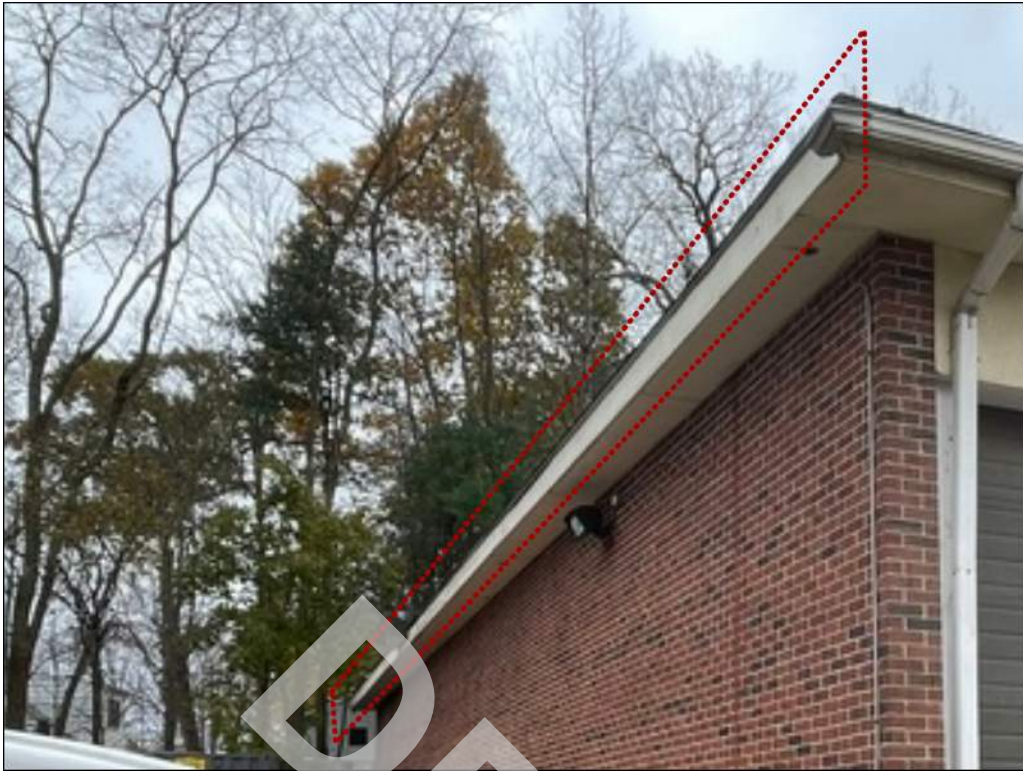
11 - Close up view of missing roof gutter along the east end of the building.

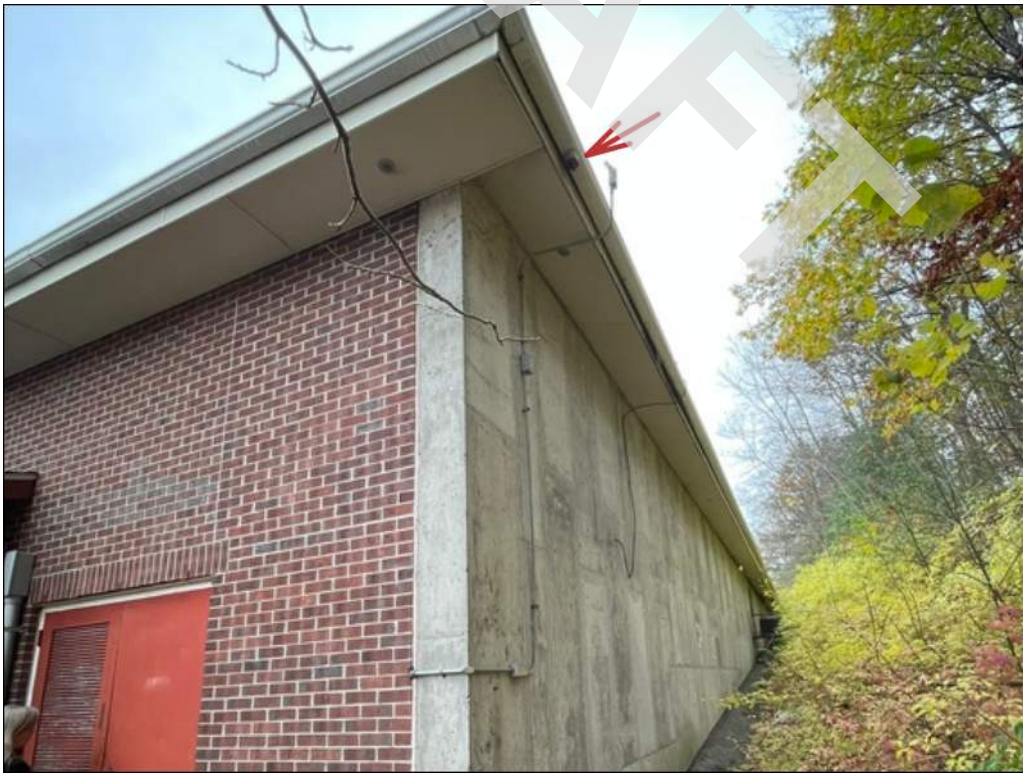
12 - A roof leader is missing along the south side of the building.

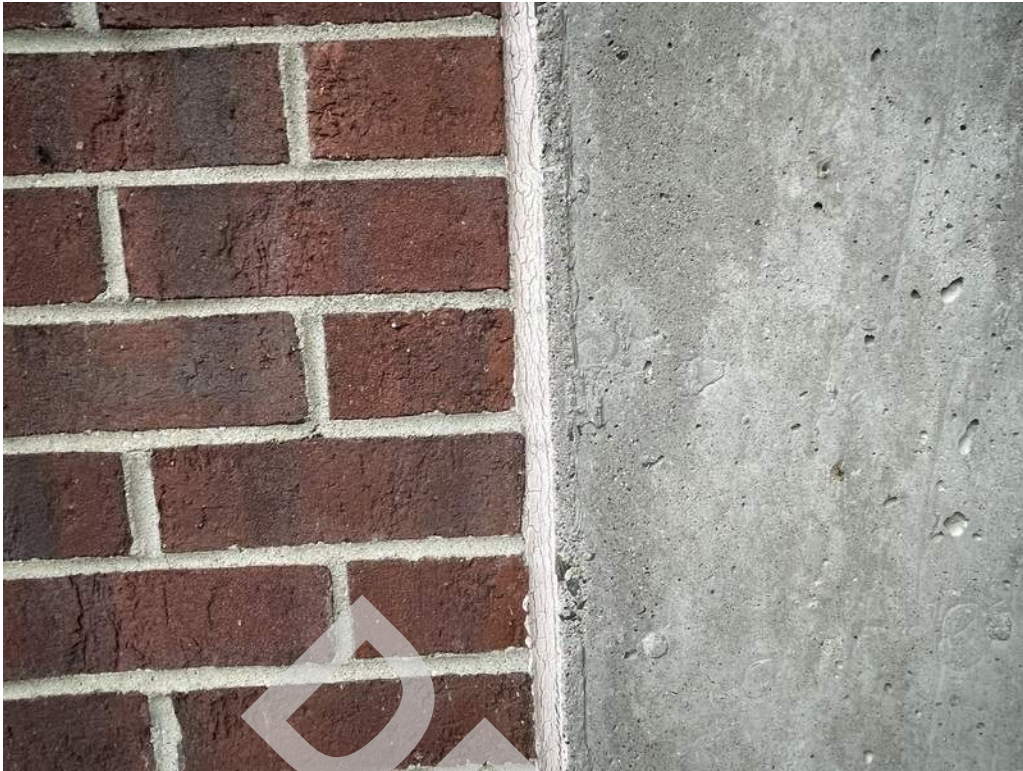
13 - The joint sealant between the brick masonry unit and concrete wall has failed.

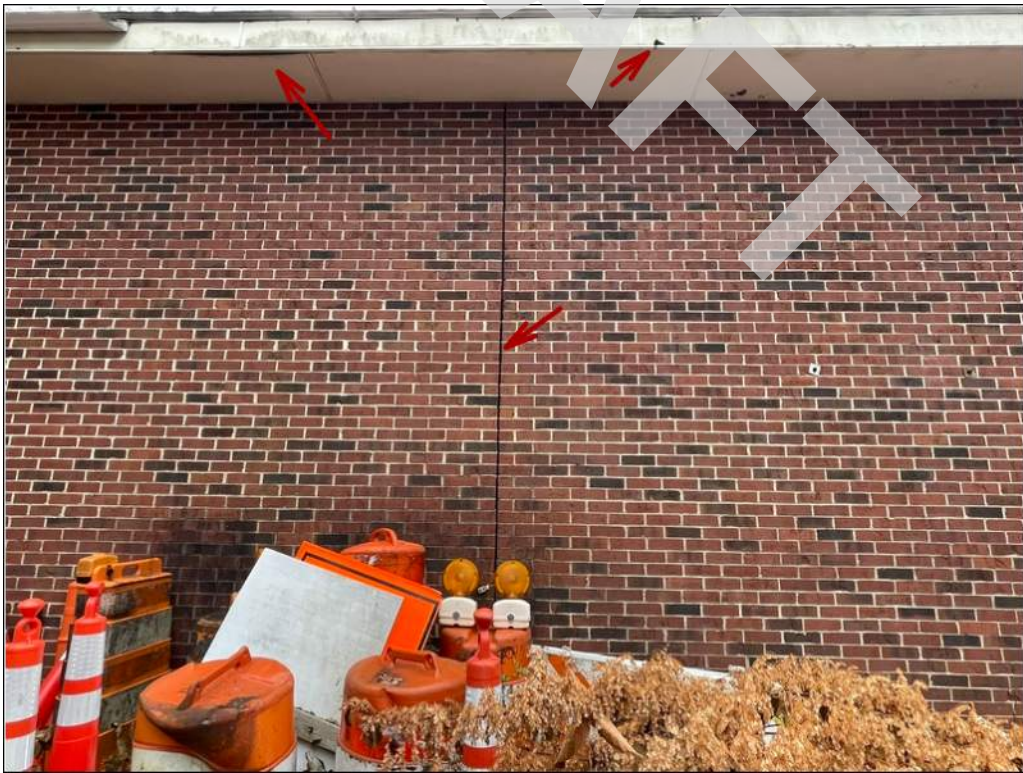
14 - Brick masonry unit wall control joint sealant is in poor condition. Soffit and fascia panels are aging.

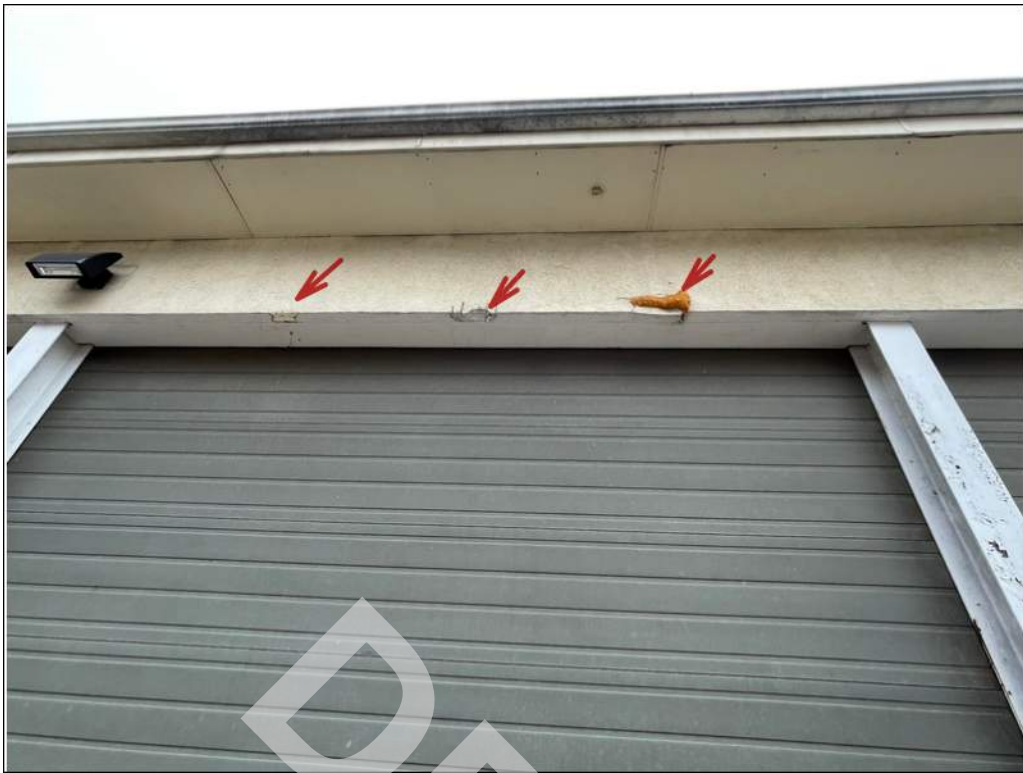
15 - Areas of the EIFS (exterior insulation finishing system) have been damaged.

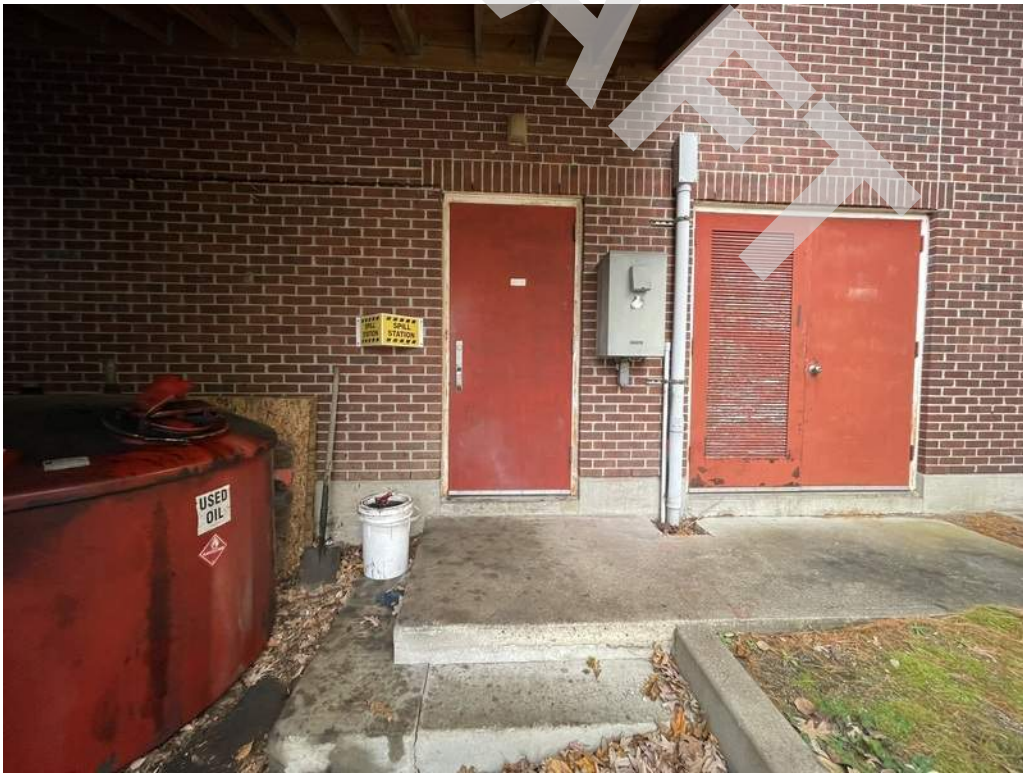
16 - Hollow metal frames and door surfaces are starting to corrode.

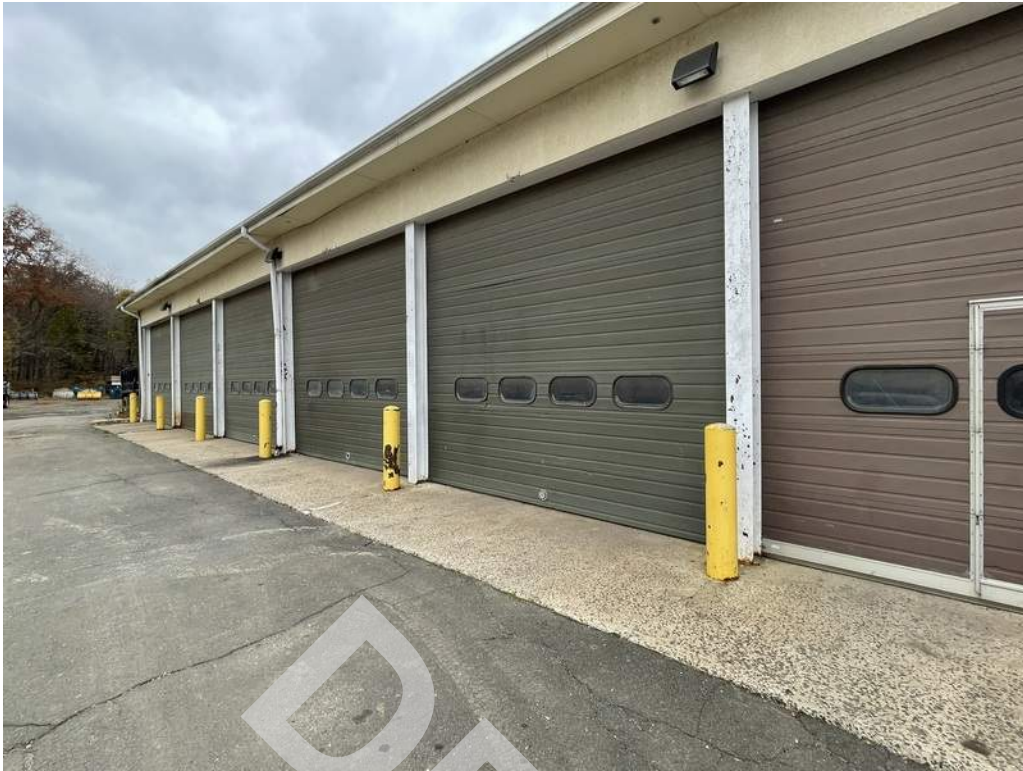
17 - Sectional overhead doors are provided at the garage.

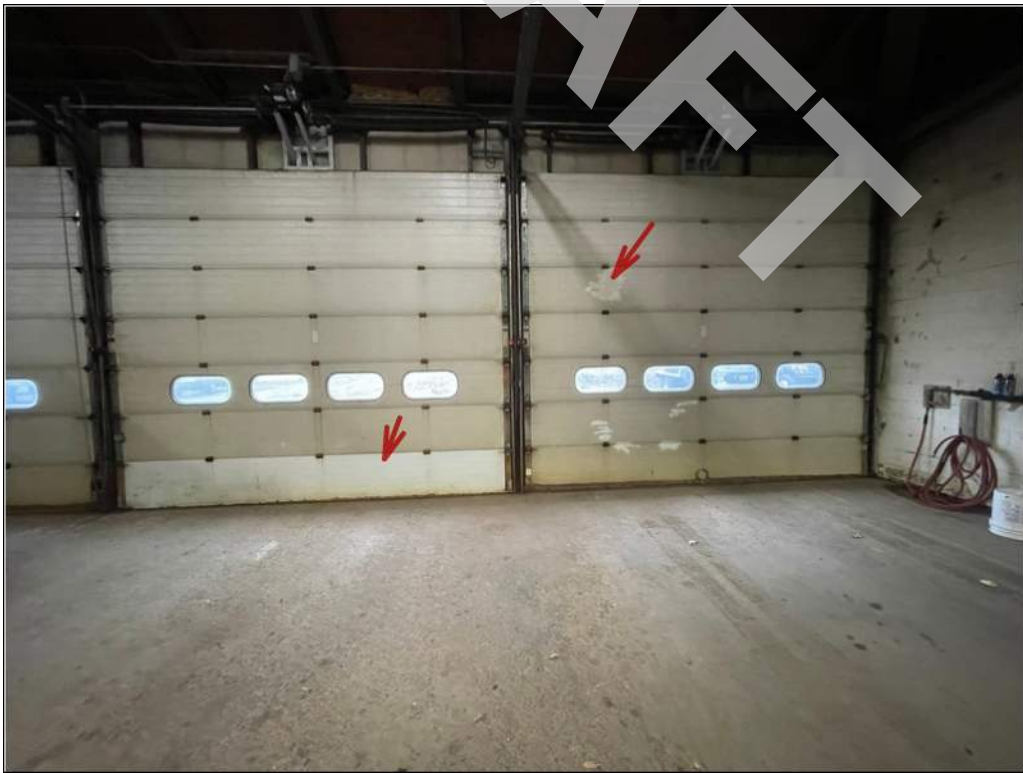
18 - Sections of the overhead doors have been replaced and repaired.

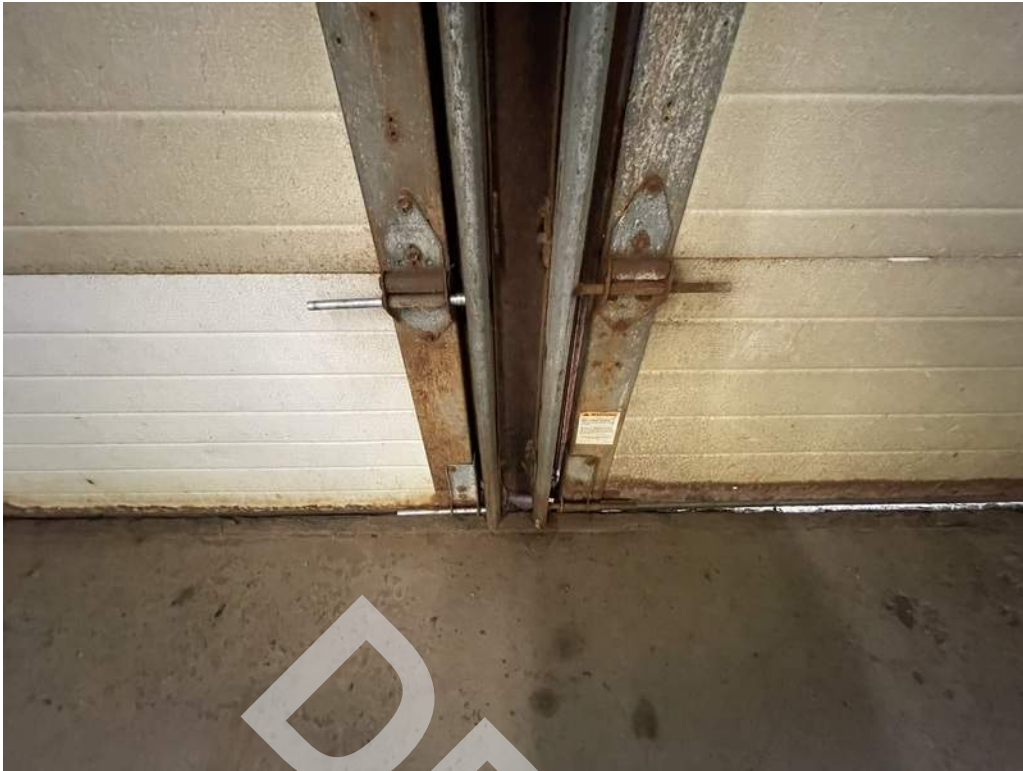
19 - Sectional overhead door metal components have corroded.

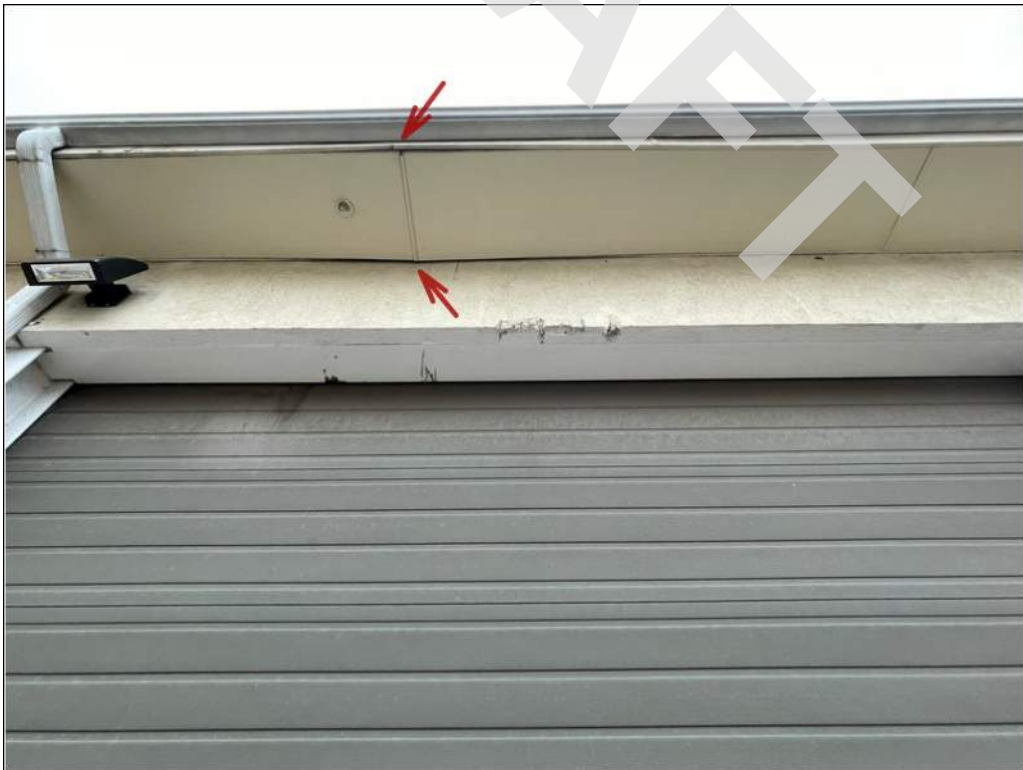
20 - Soffit and fascias are displacing.

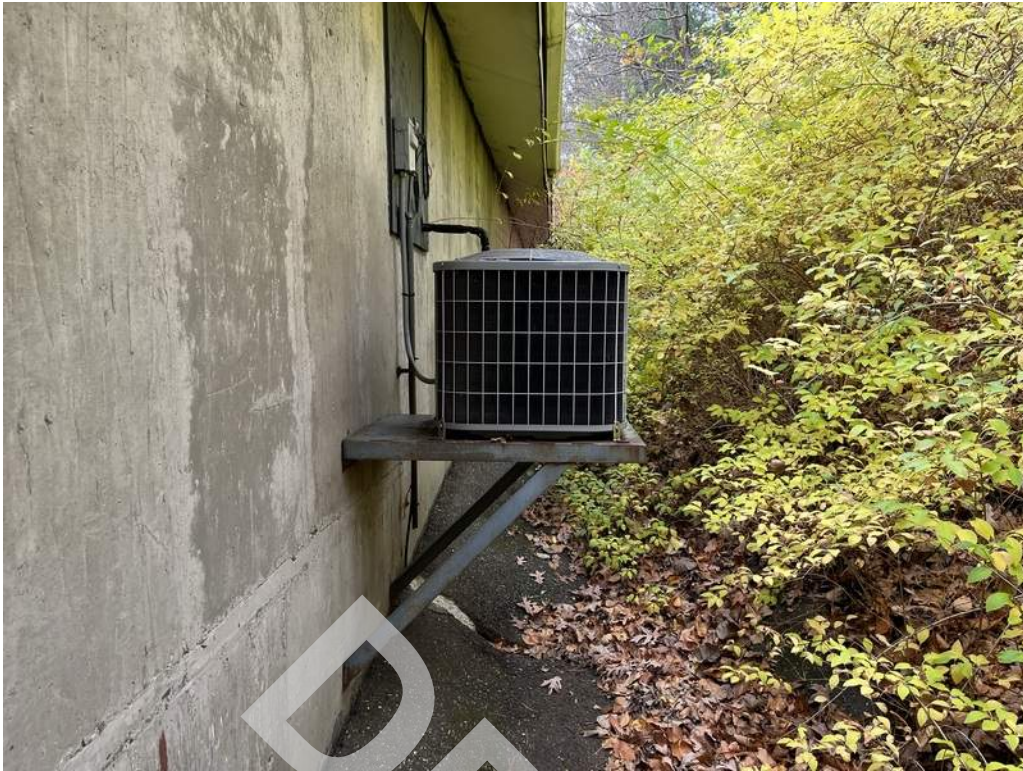
21 - A split system air conditioning unit located on the exterior of the building provides cooling to a portion of the building.

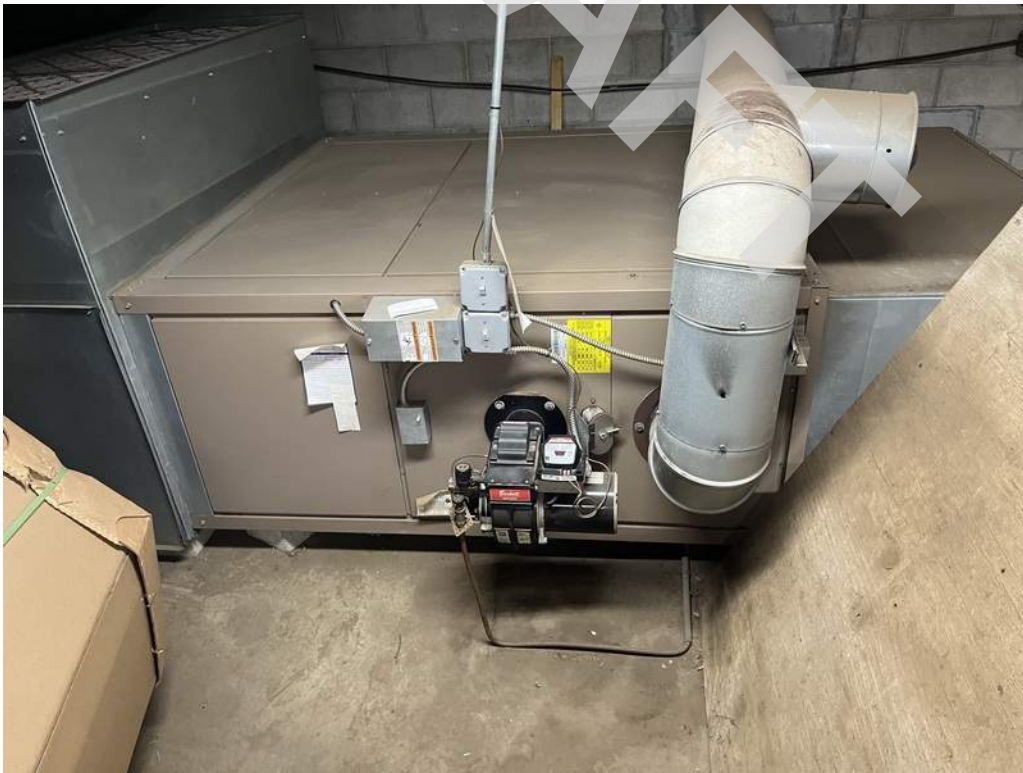
22 - Three oil fired furnaces located throughout the building provide heating throughout the building.
