FACILITY CONDITION ASSESSMENT

MERWIN MEADOWS RESTROOMS & BARN

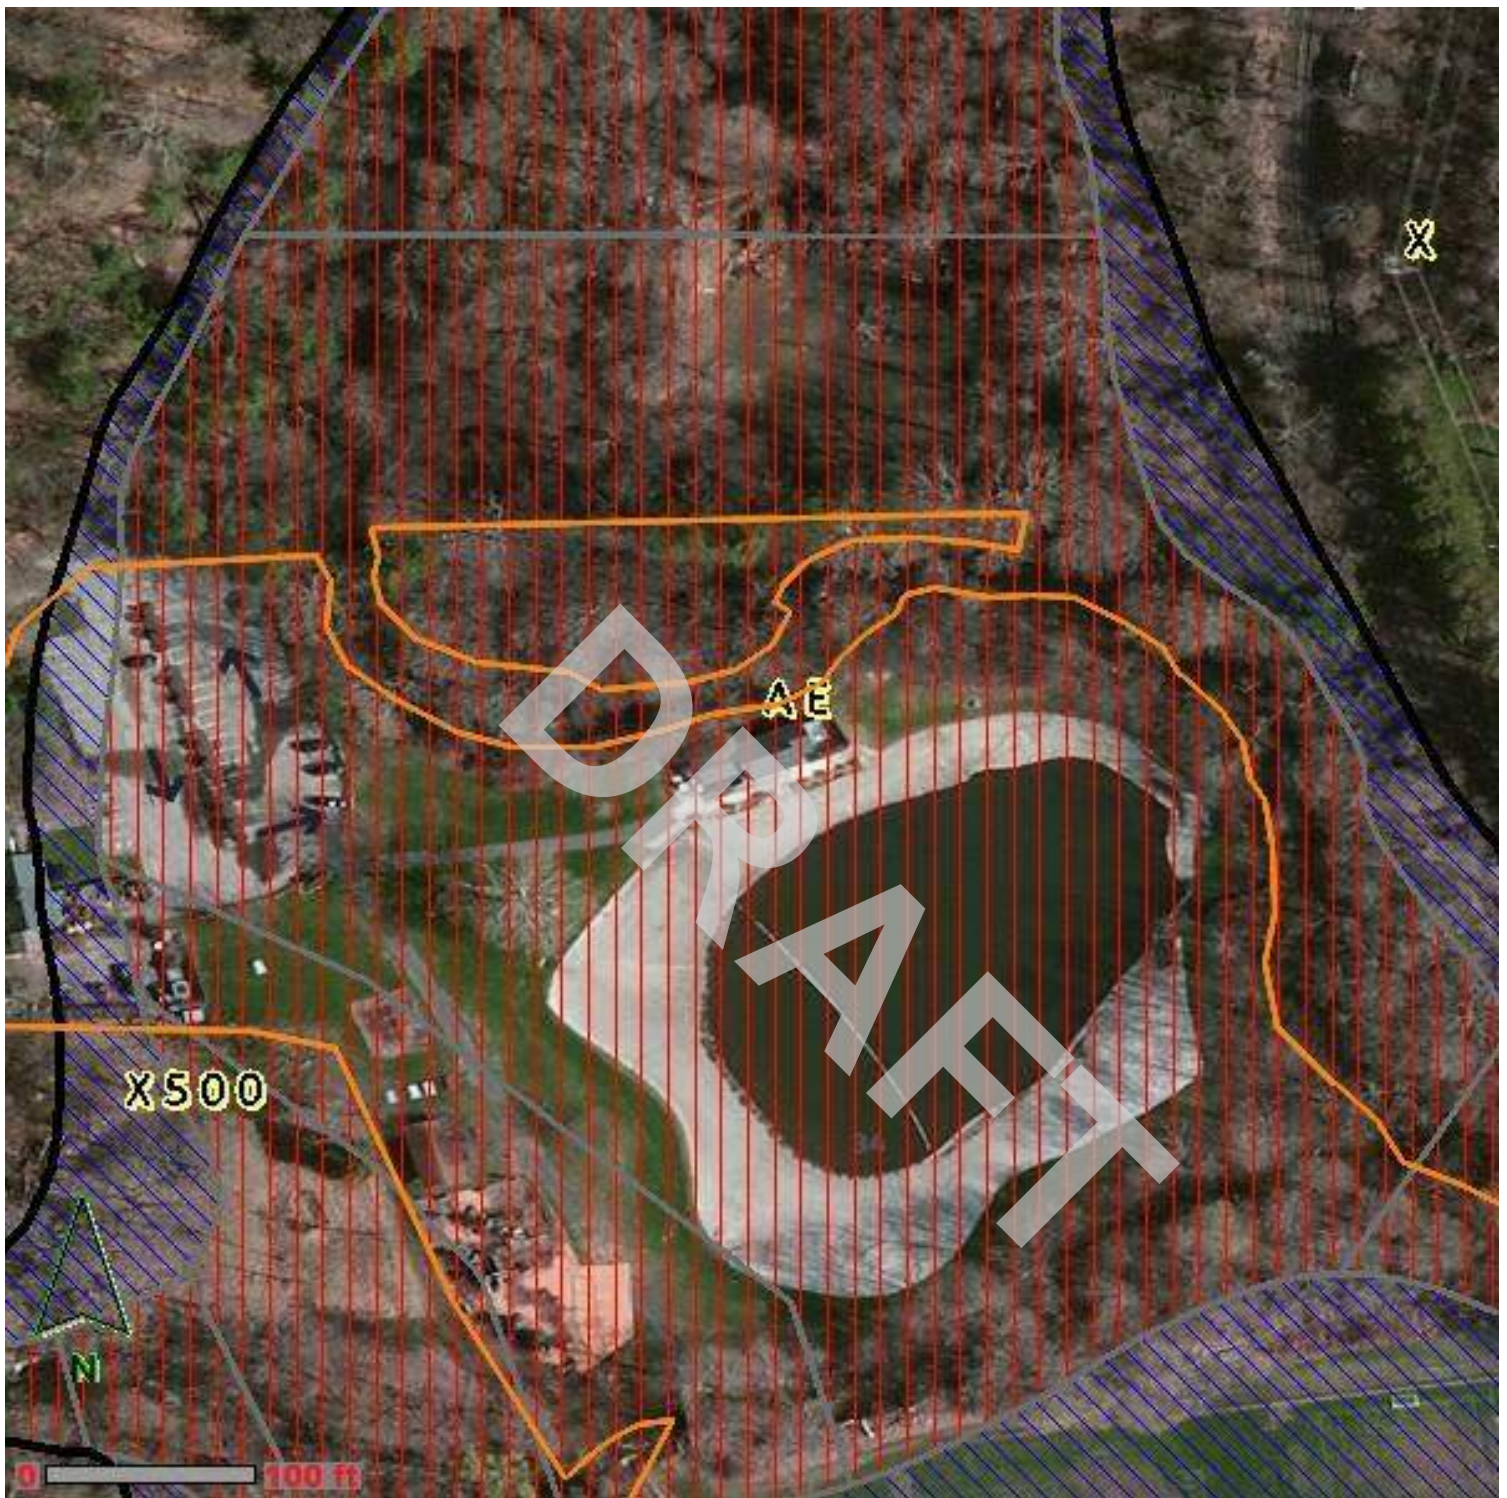
<b>Flood Zones Legend</b>

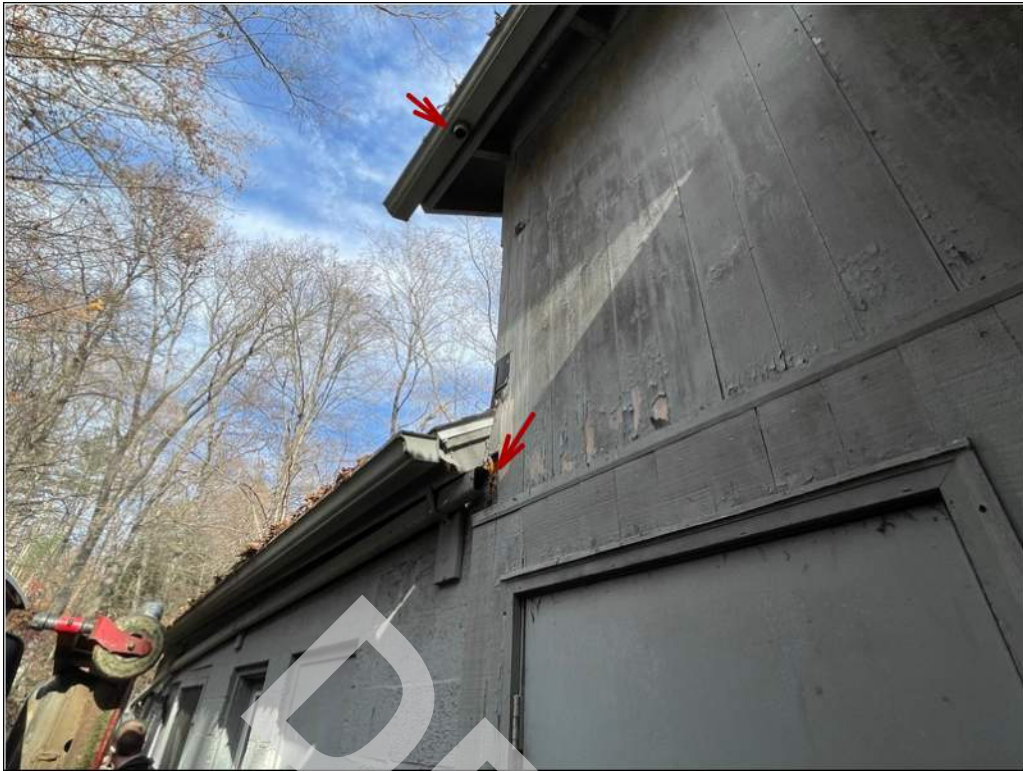
7 - Barn: A roof leader is missing along the west side of the barn.

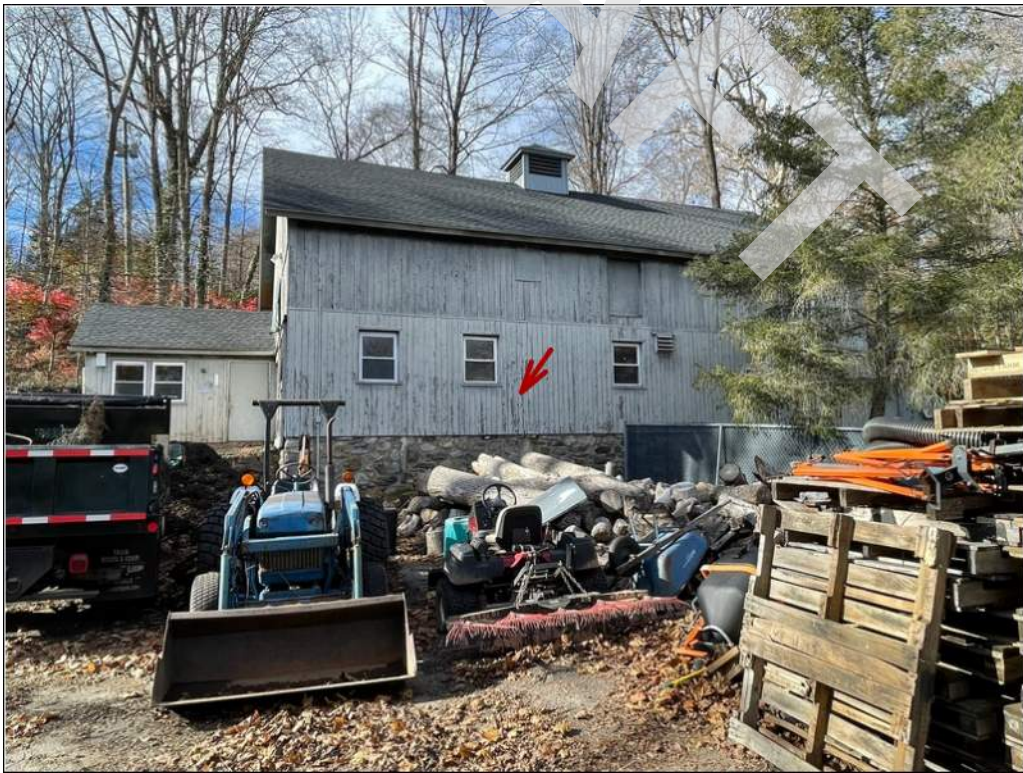
8 - Barn: Paint over, the wood cladding is peeling.

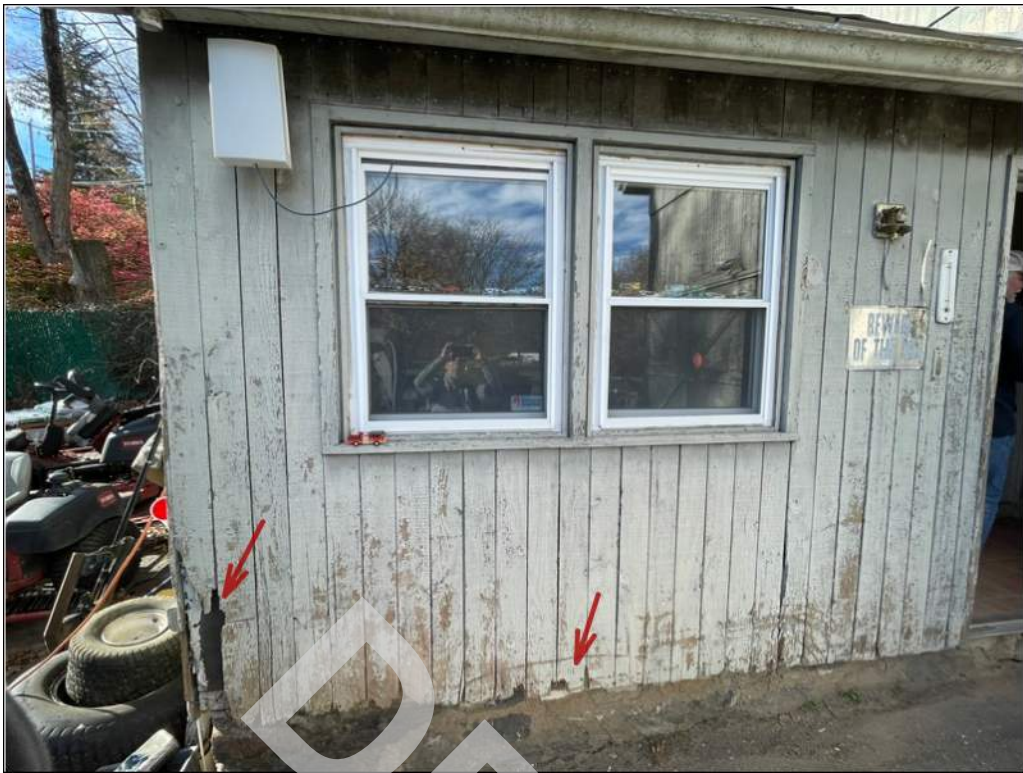
9 - Barn: Wood plank facade is in poor condition, including broken wood planks.

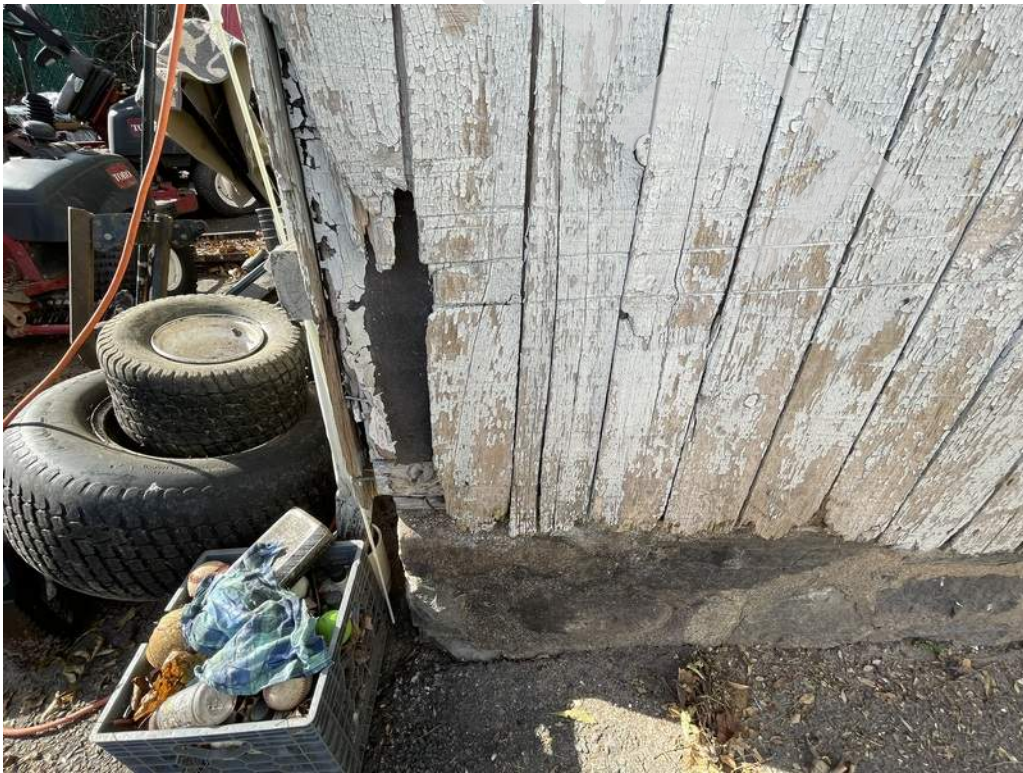
10 - Barn: Close up view of damaged wood and paint finish.

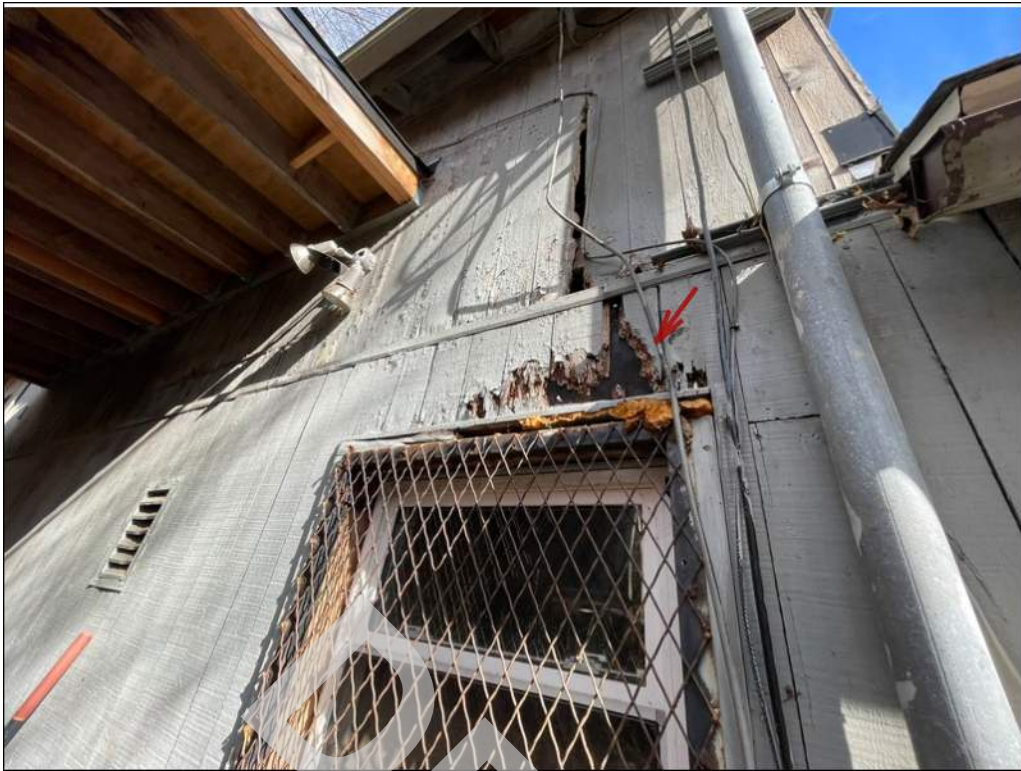
11 - Barn: Localized areas of the wood cladding are rotting.

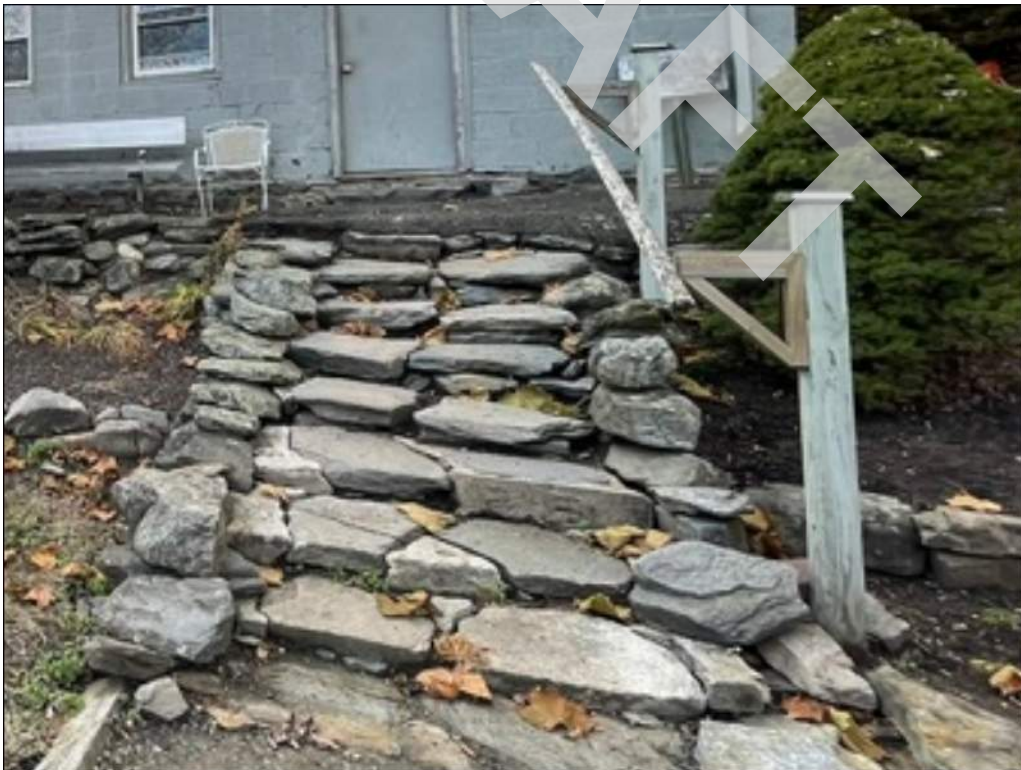
12 - Barn: Rock stair and landing are in poor condition; surfaces are uneven and a second handrail is not provided.

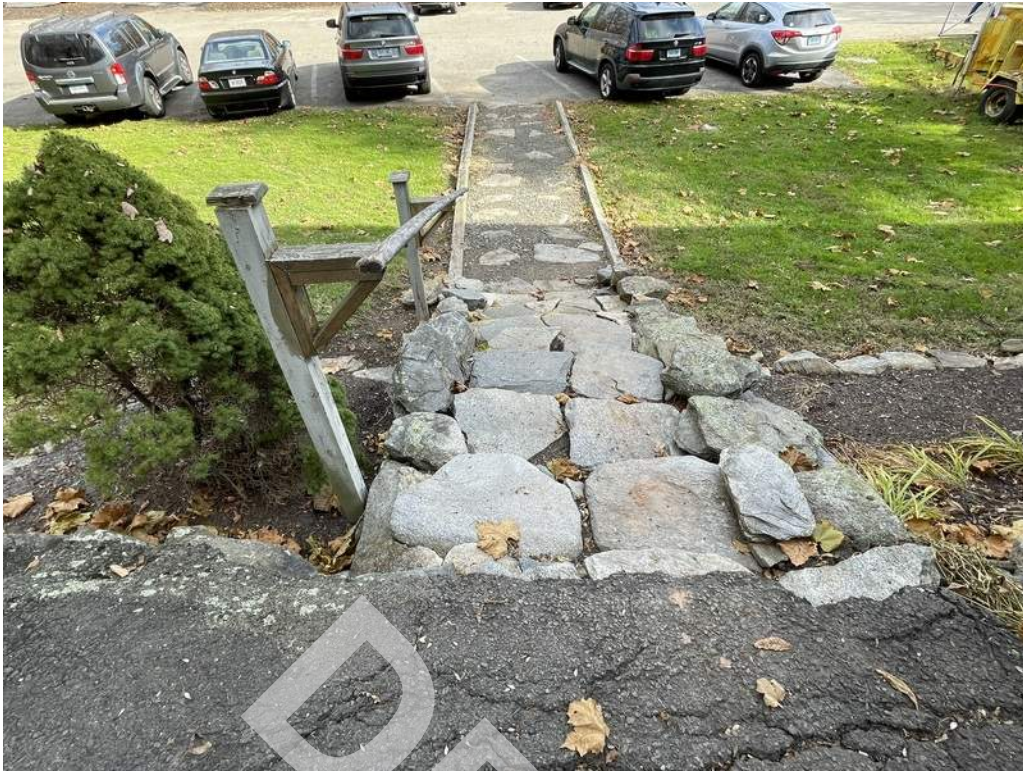
13 - Barn: Rock stair is uneven, and does not have a second handrail.

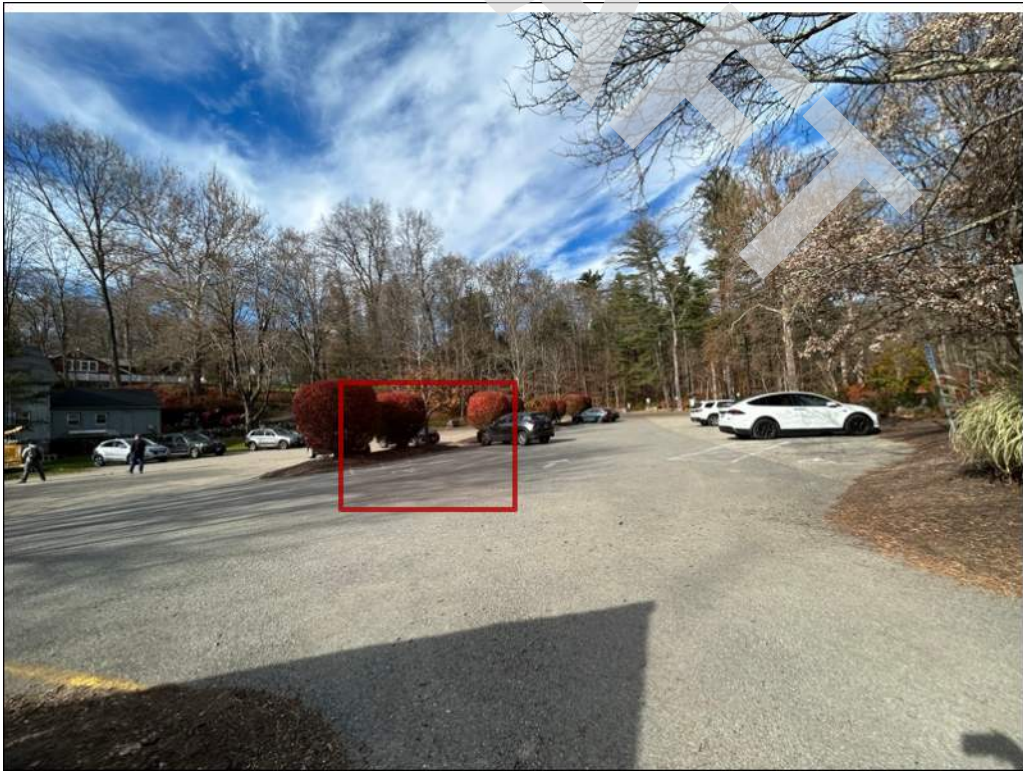
20 - Missing signage was observed at the accessible parking space.

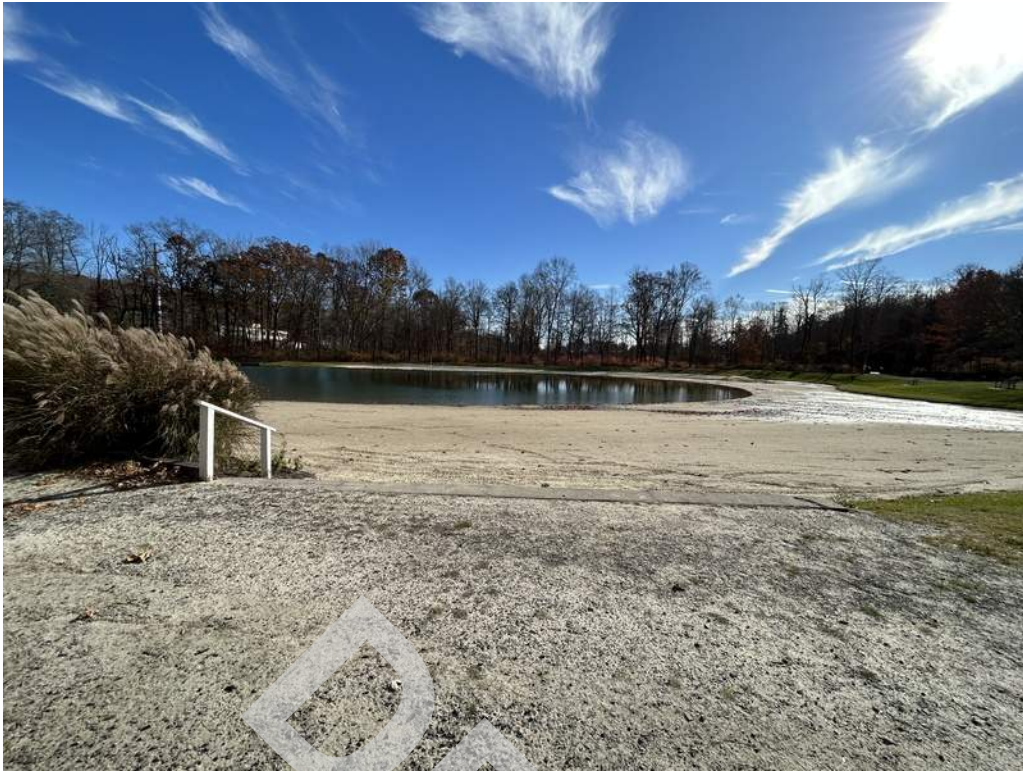
21 - An accessible route is not provided to the lake.
