FACILITY CONDITION ASSESSMENT

238 Danbury Road
Wilton, Connecticut

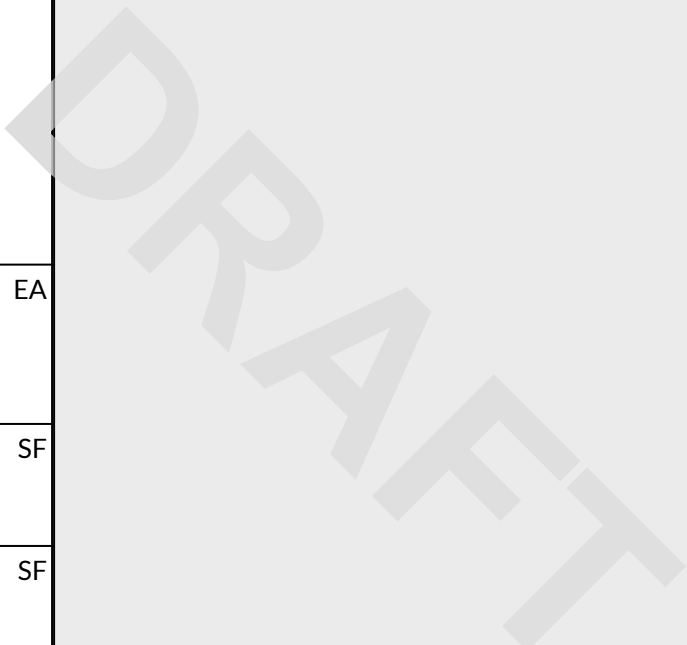
1. Opinions of cost are based on limited observations of readily observable conditions and available documentation. Determination of actual costs require competitive bidding by qualified contractors on a scope of work that may require development of repair documents by a qualified engineer or architect.
 2. Marx|Okubo is not an environmental consultant or evaluator of pest infestation. Opinions of cost exclude abatement of hazardous materials or remediation of pest infestations unless otherwise noted.
 3. This cost table is a supplementary document to the report and should be reviewed in conjunction with the full report and exhibits.
 4. Marx|Okubo's standard inflation rate for the purposes of the Capital Reserve Schedule is 3%. At the request of the Town of Wilton, the rate has been adjusted to 4%.

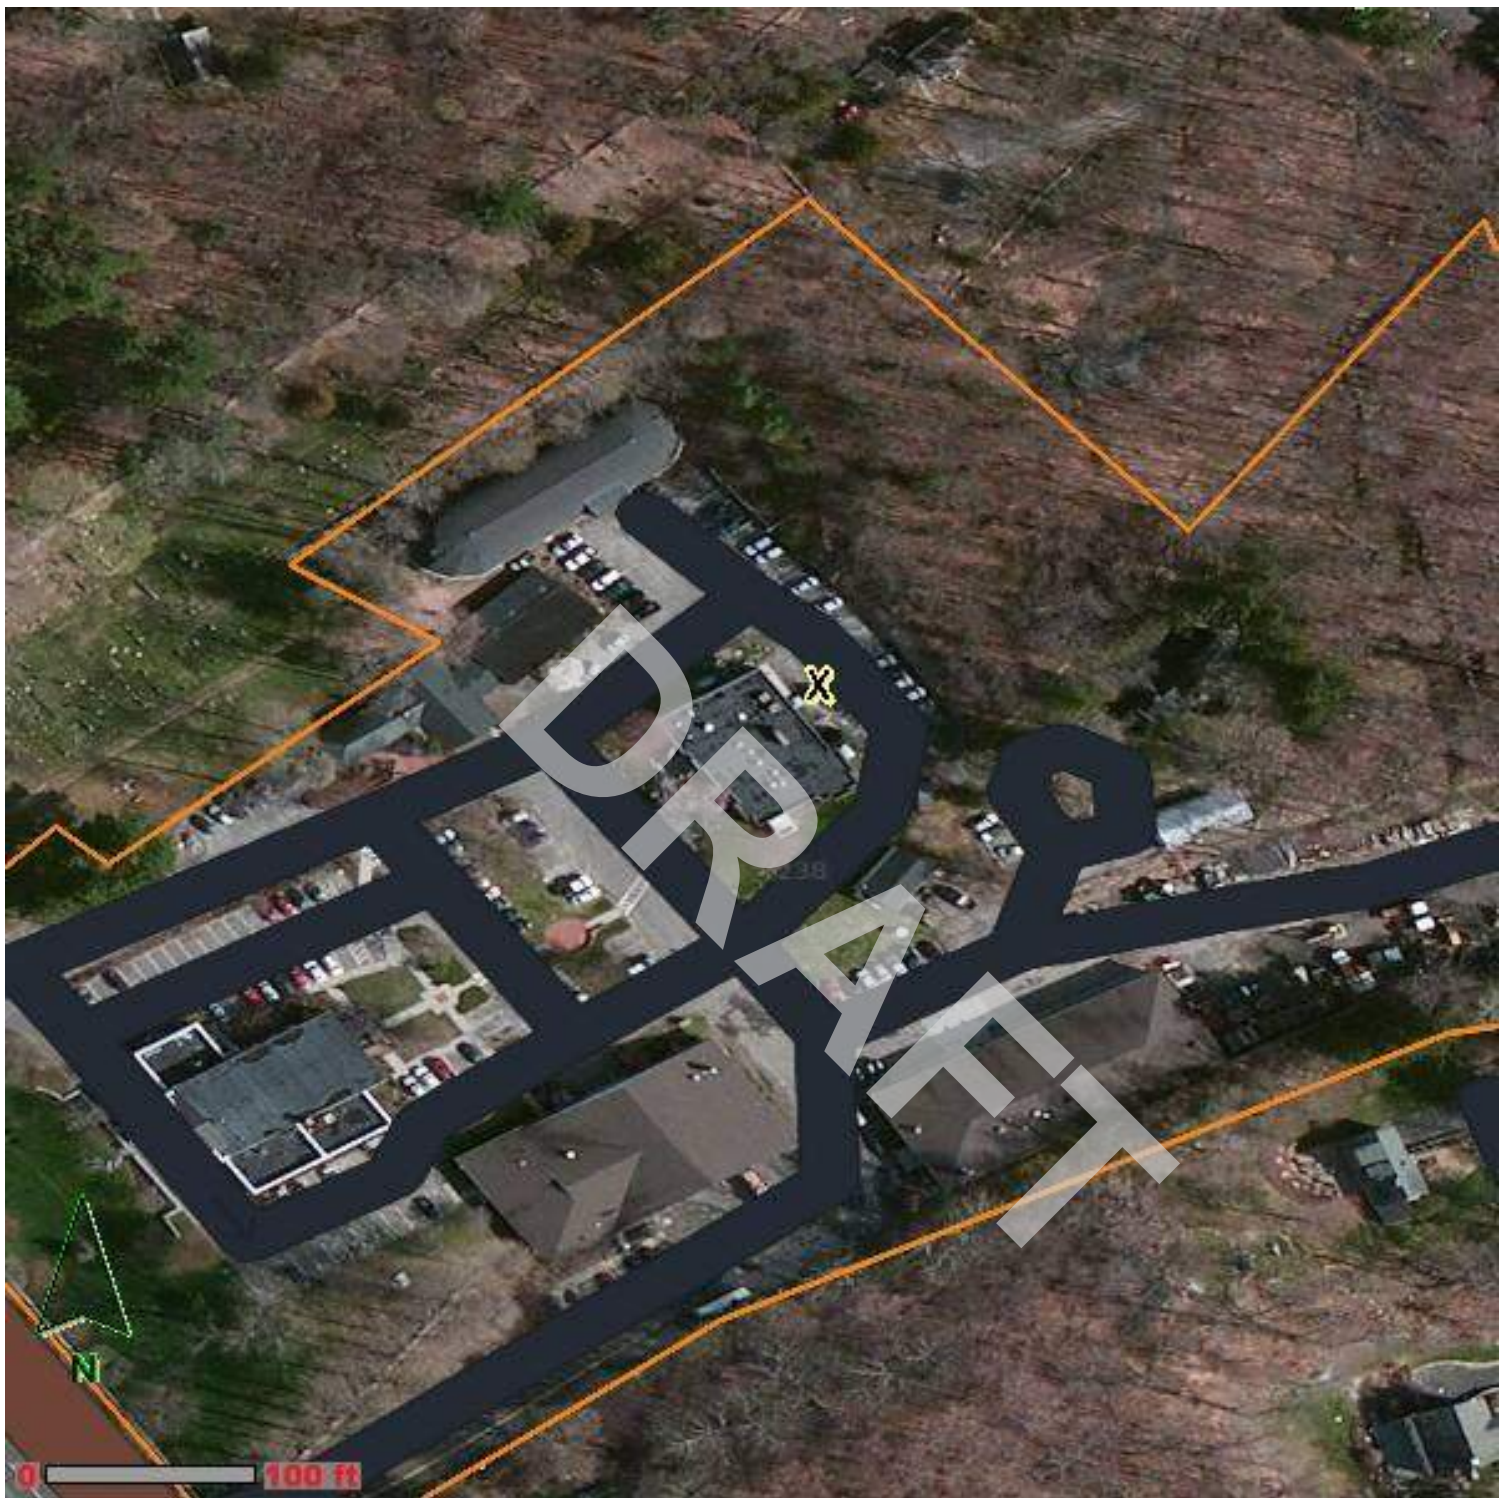
This flood determination is provided to the lender pursuant to the flood disaster protection act and for no other purpose. It does not create any private cause of action on behalf of the Policy Holder against DataVerify Flood Services.

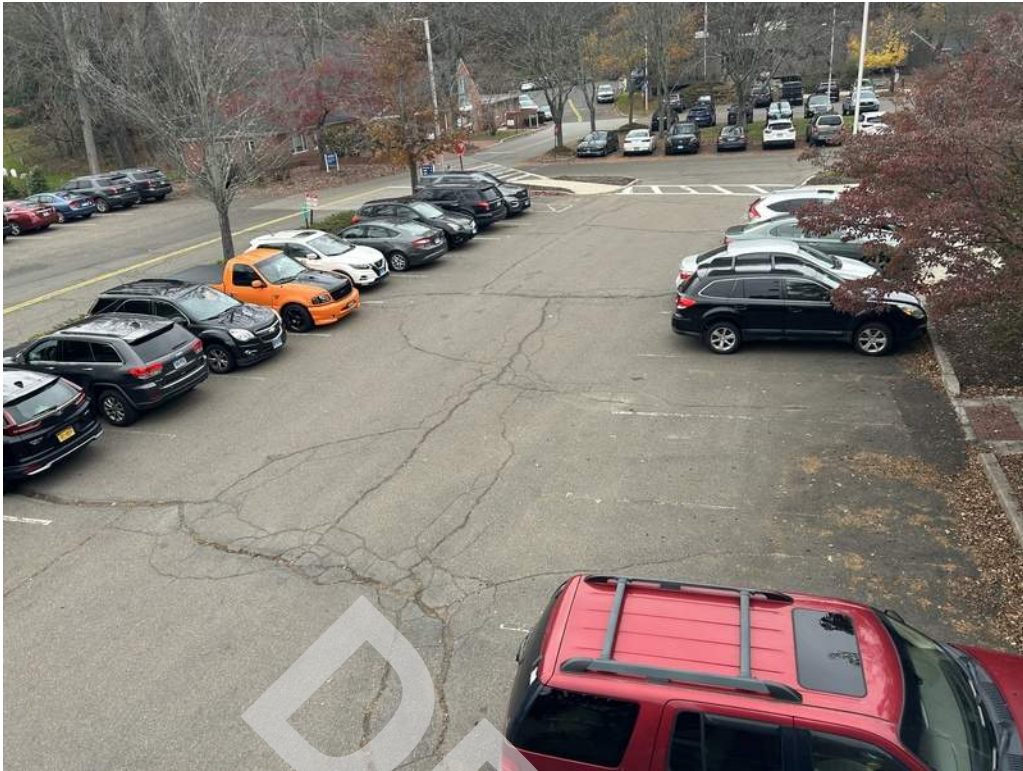
5 - Parking is provided along the north side of the building. Faded striping and alligator and longitudinal cracking was observed throughout the paved parking areas and drive lanes.

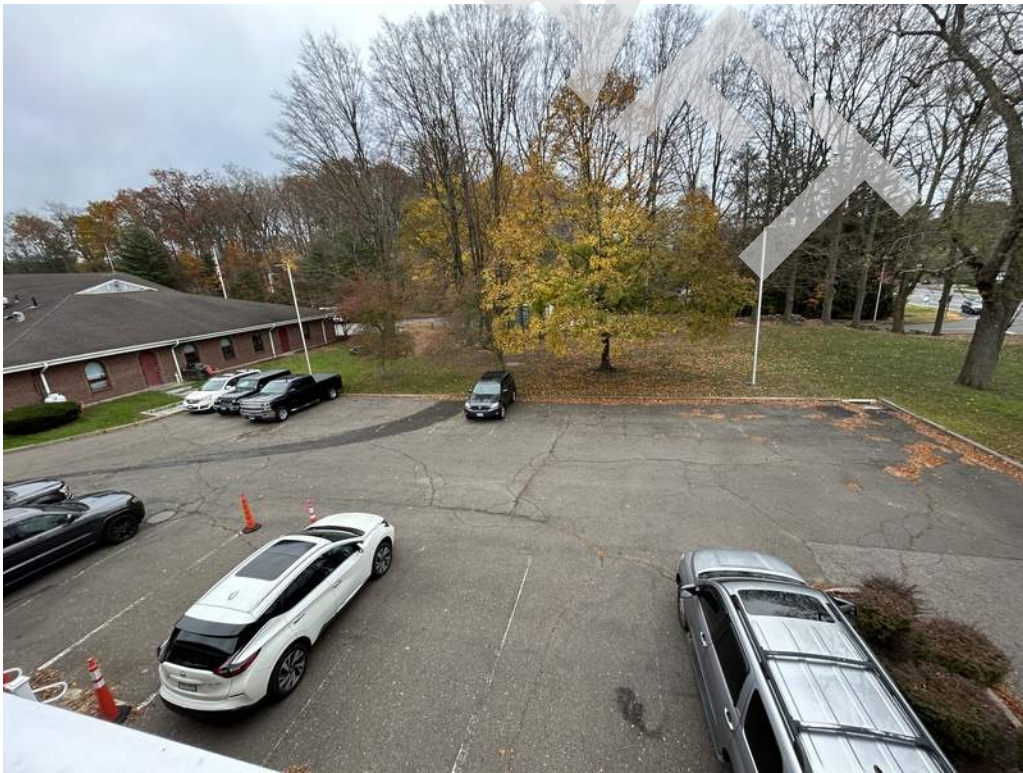
6 - Additional asphalt paved parking is provided on the south side of the building.

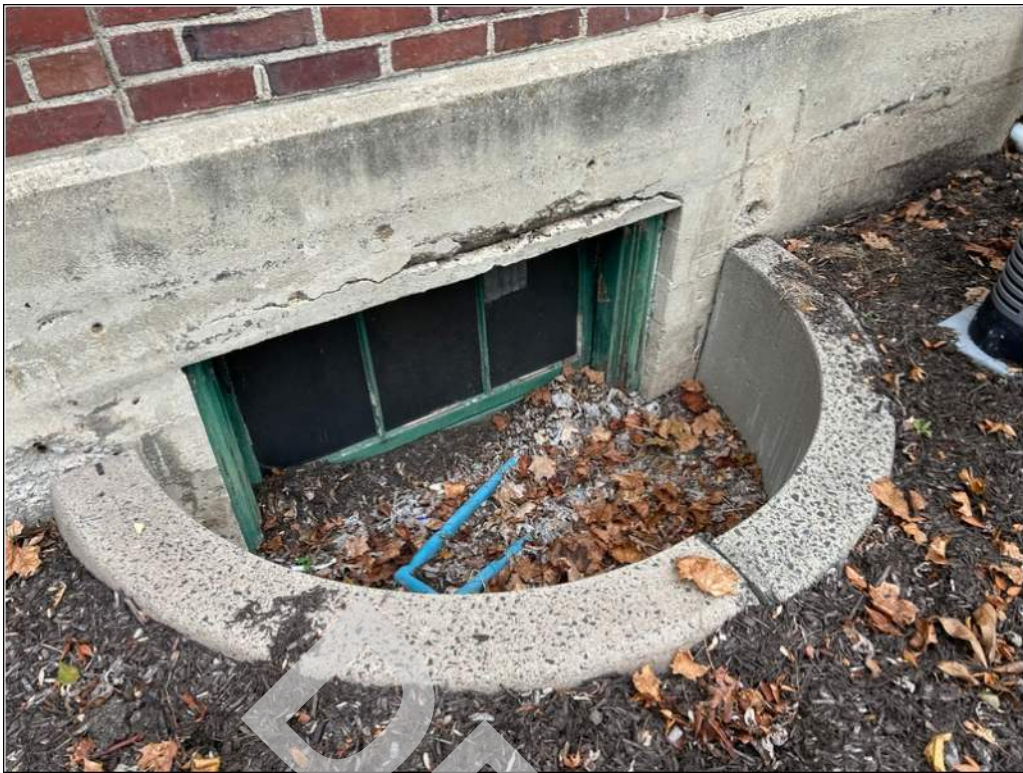
7 - Reinforced concrete foundation wall has spalled and has exposed steel reinforcement.

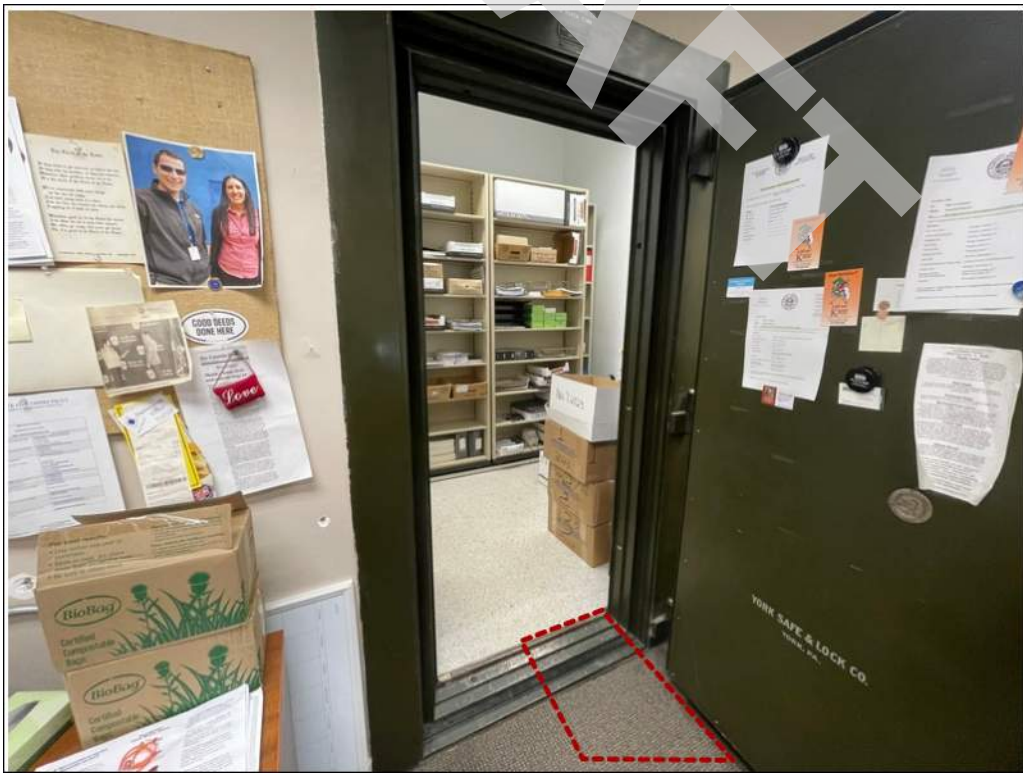
8 - Localized displacement noted near the safe door hinge.

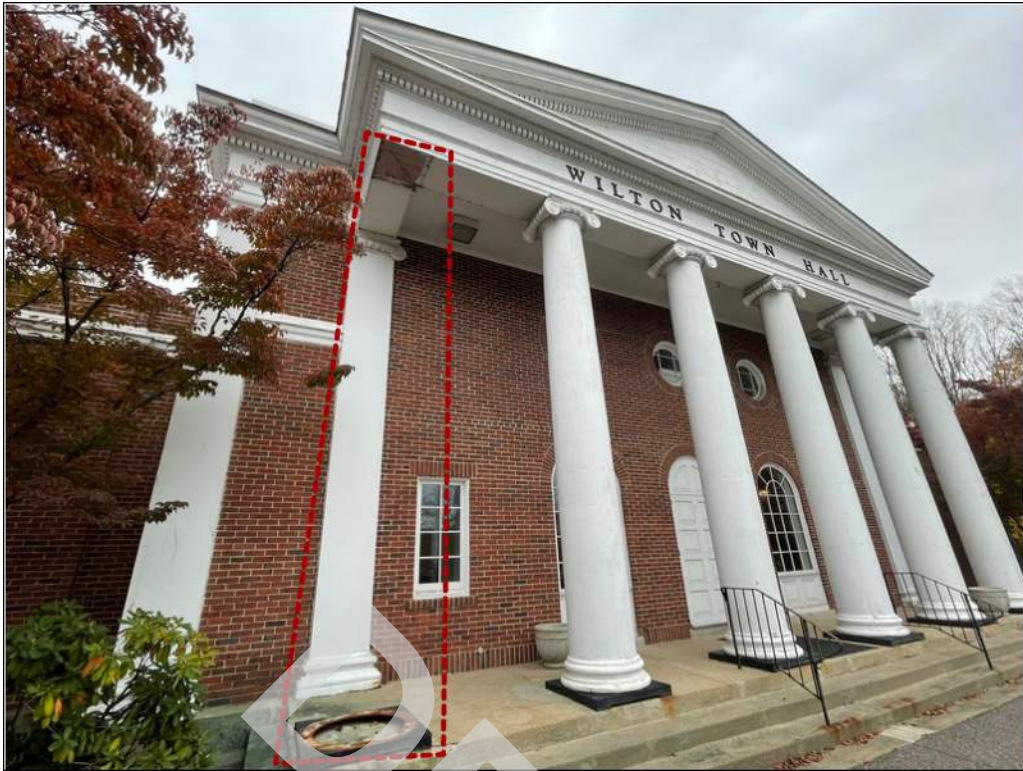
9 - Missing column along the front facade.

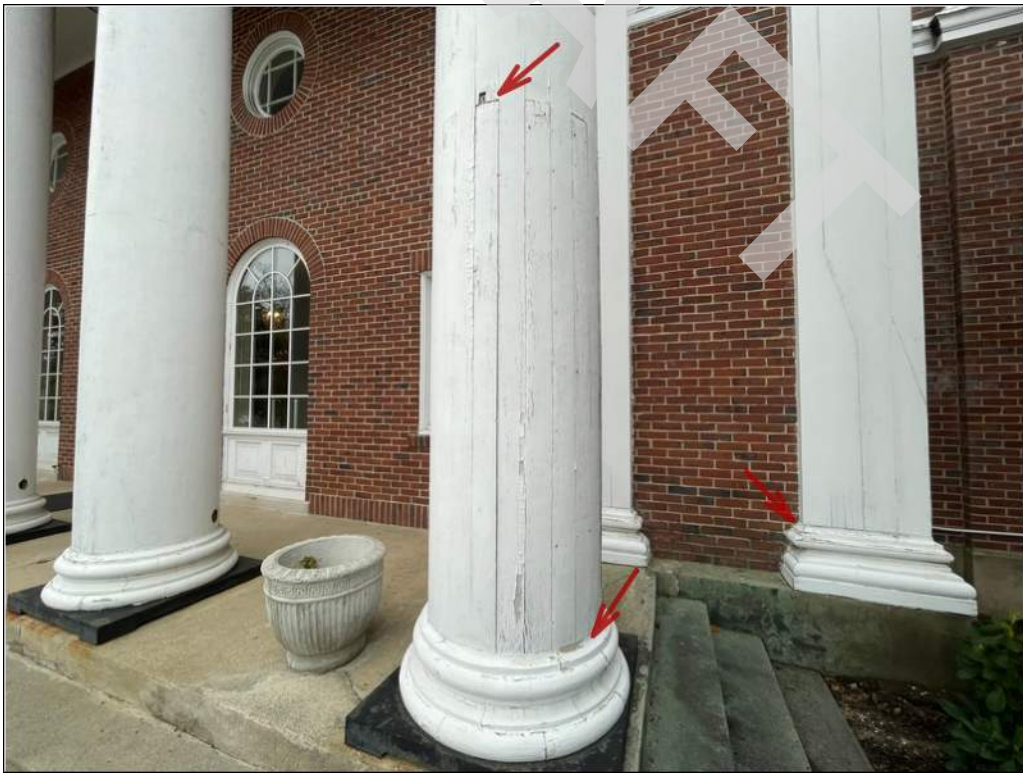
10 - Front facade wood column surface has localized damages and damaged finishes.

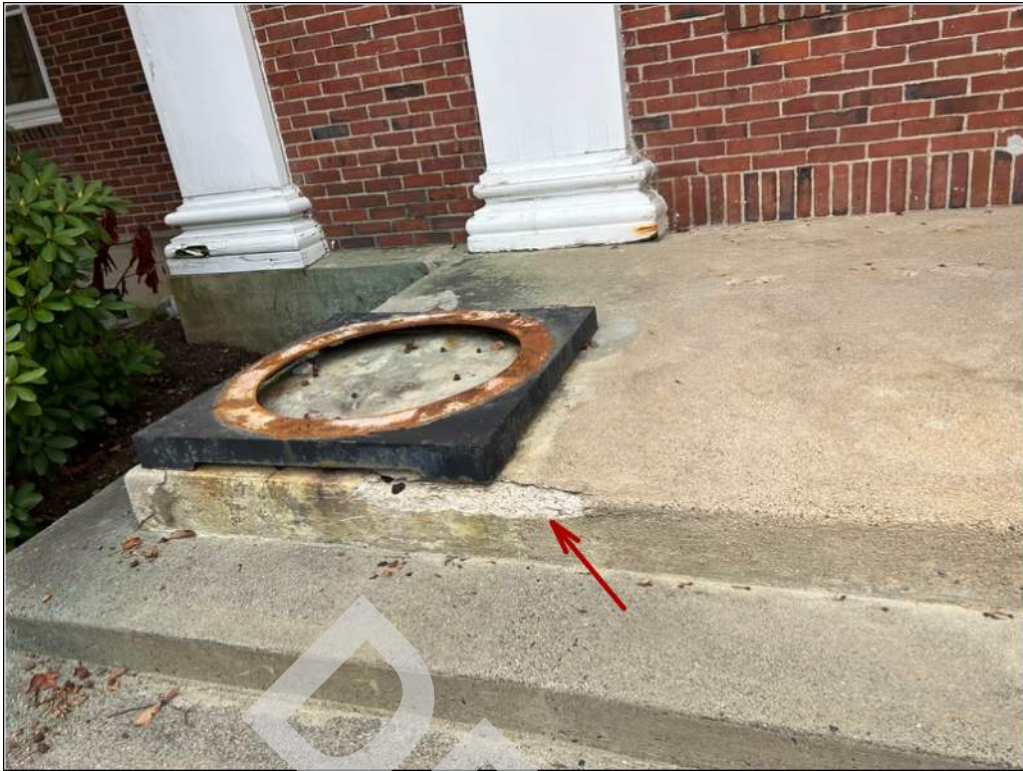
11 - Reinforced concrete at the main entrance plinth has spalled.

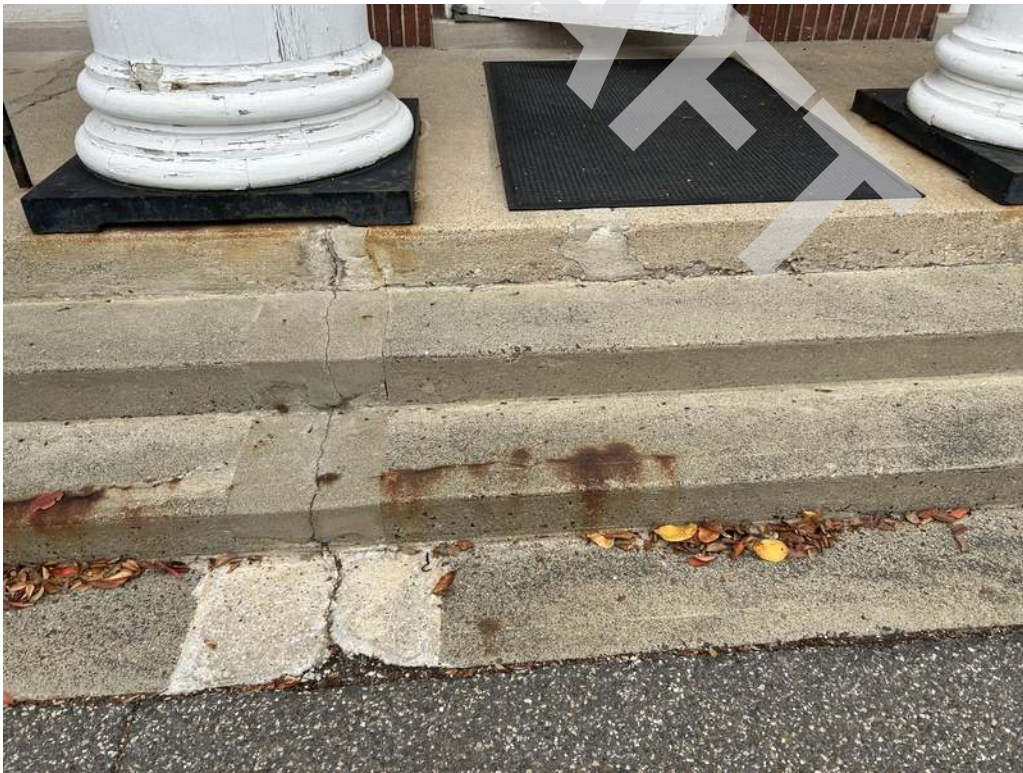
12 - Evidence of prior patching along with additional cracking and corrosion are present at the front concrete porch.

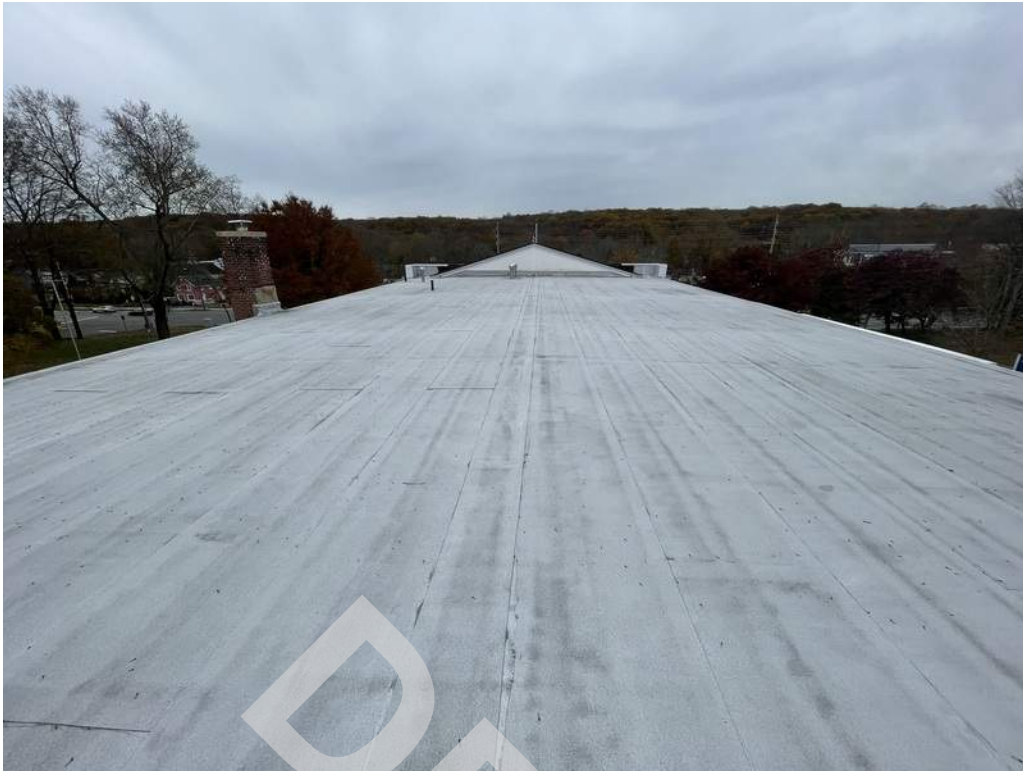
13 - Main roof consist of a modified bitumen roofing system.

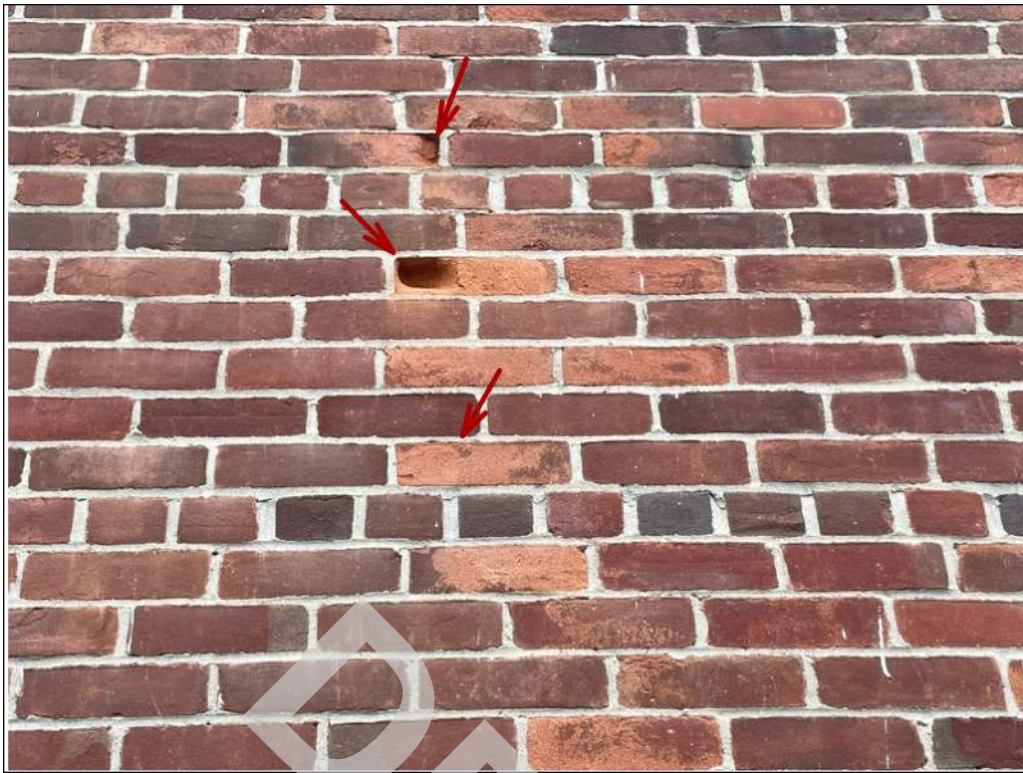
17 - Localized areas of the brick masonry unit facade have spalled units.

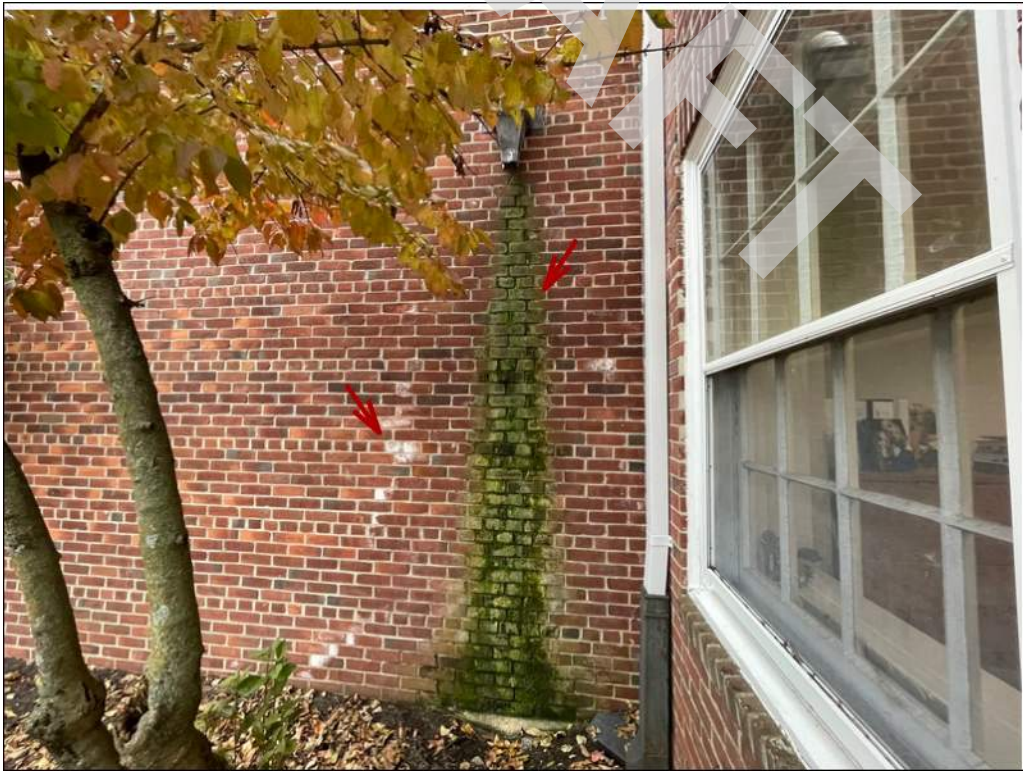
18 - Areas of the brick masonry facade have efflorescence and organic growth. Roof leader is missing.

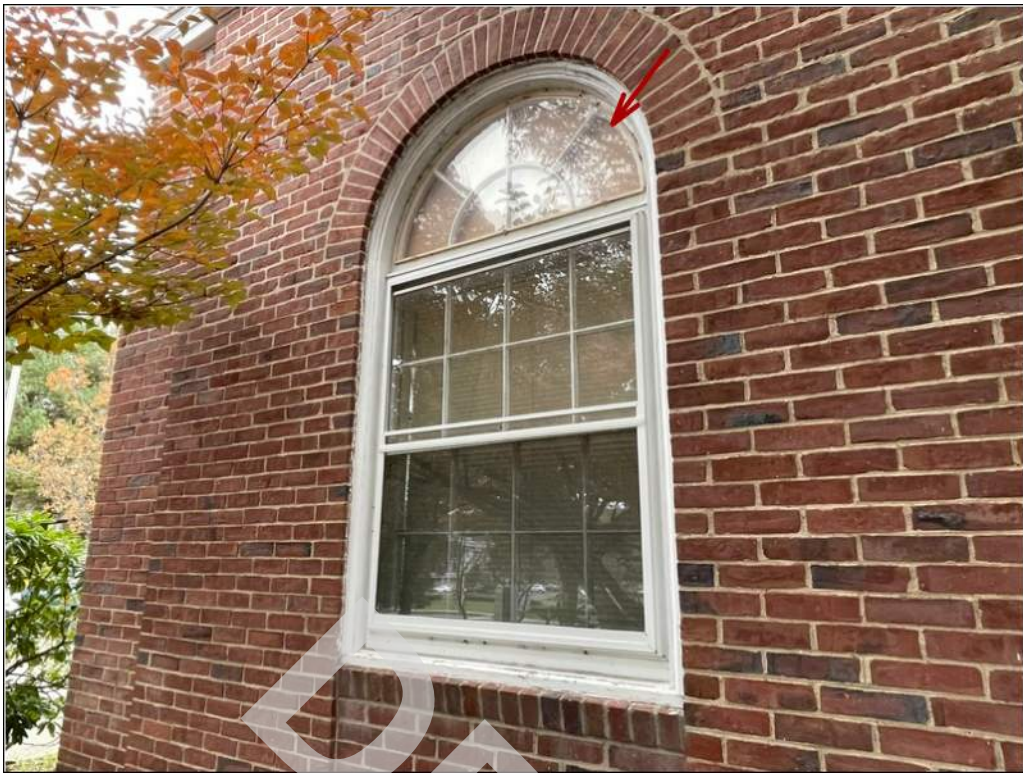
19 - Most of the window units have been covered with a plastic screen on the exterior.

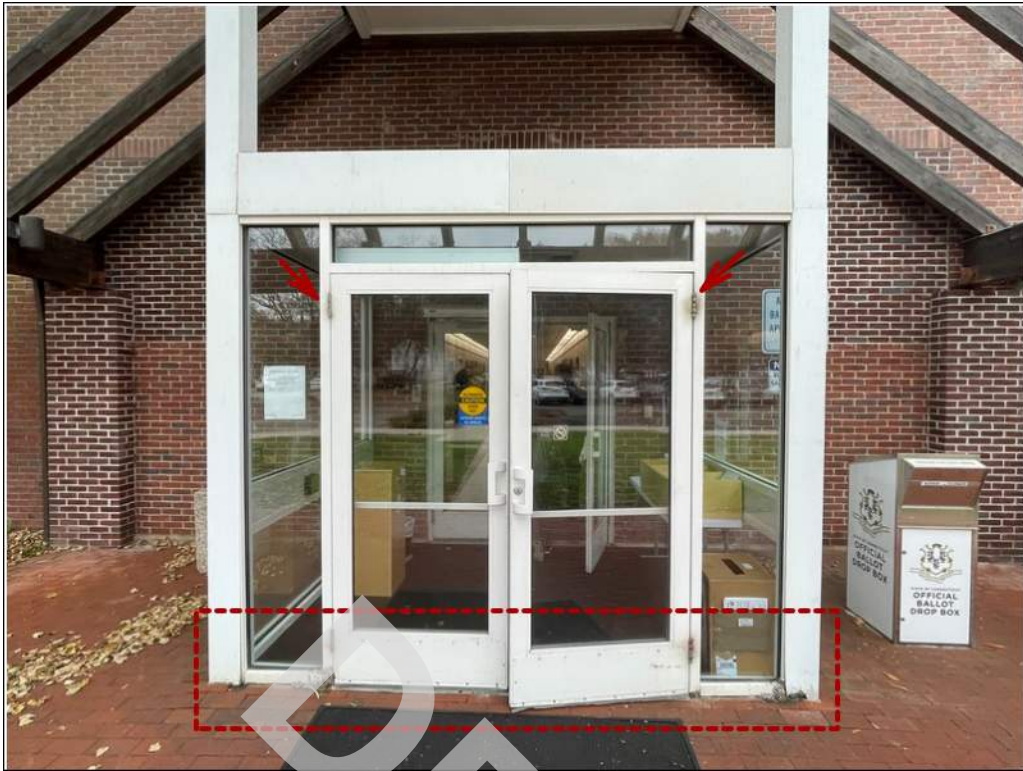
23 - The rear entrance storefront system has deteriorated. Damages include corrosion at the hinges and storefront framing along the base.

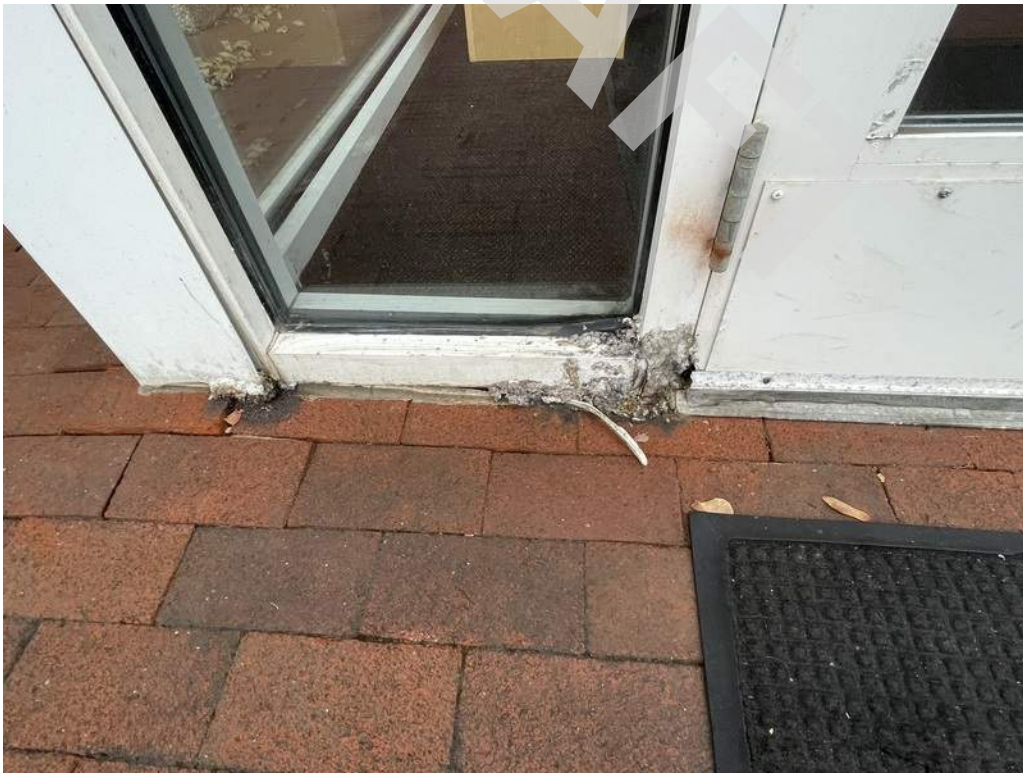
24 - Close up view of the corroded storefront framing components.

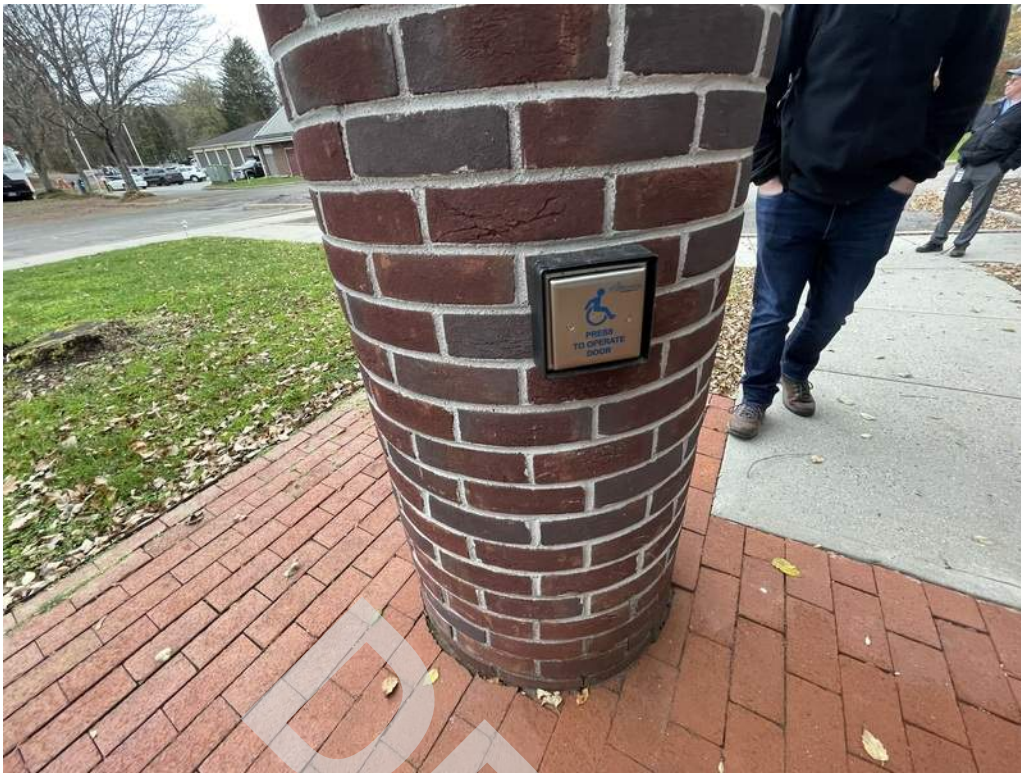
25 - Operated door push plate is located approximately 12' away from the door.

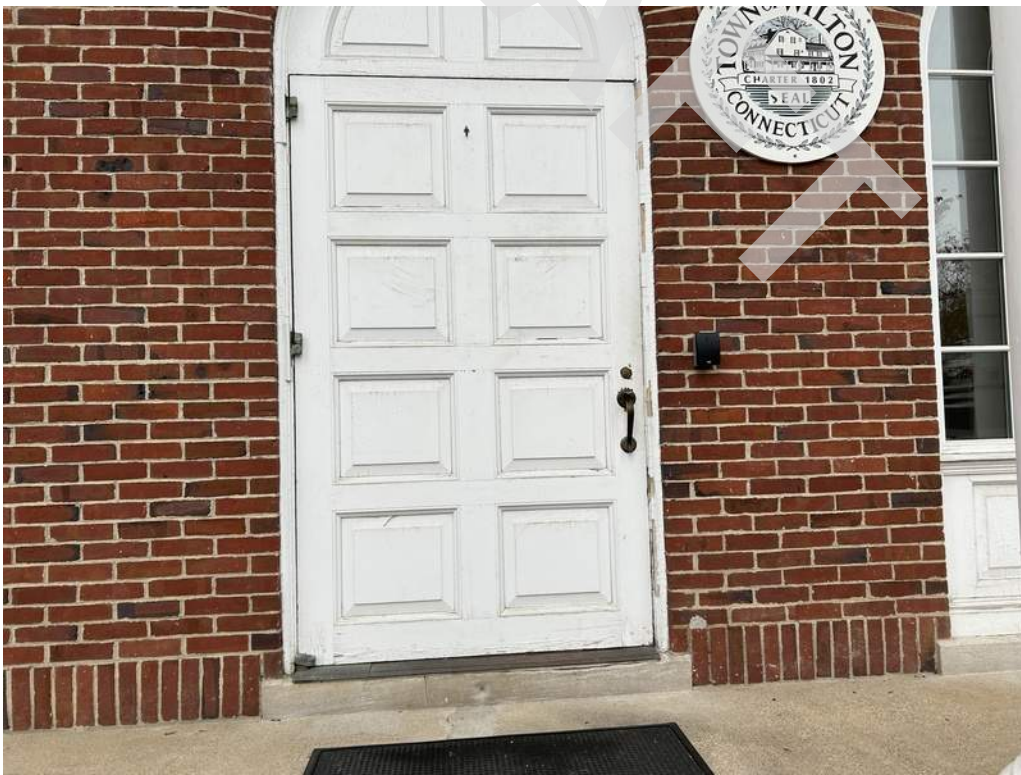
26 - Main entry wood door is in poor condition. Deficiencies include deteriorated door hardware and peeling finish surface.

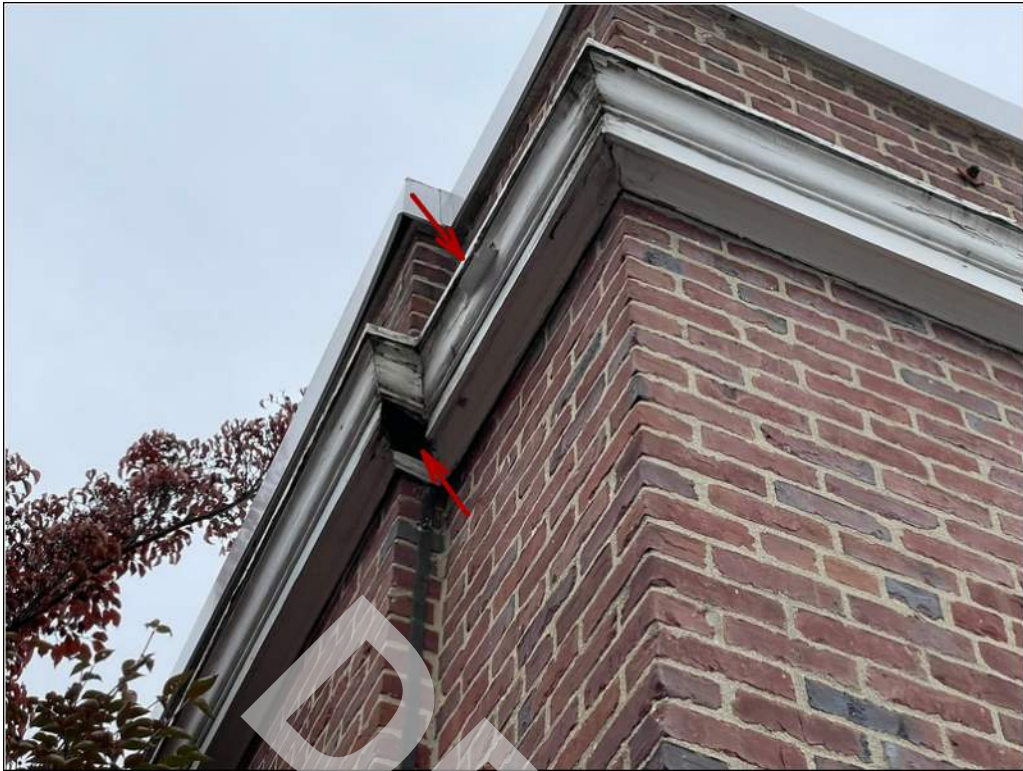
27 - Decorative wood trim cornices have rotted and have peeling finishes.

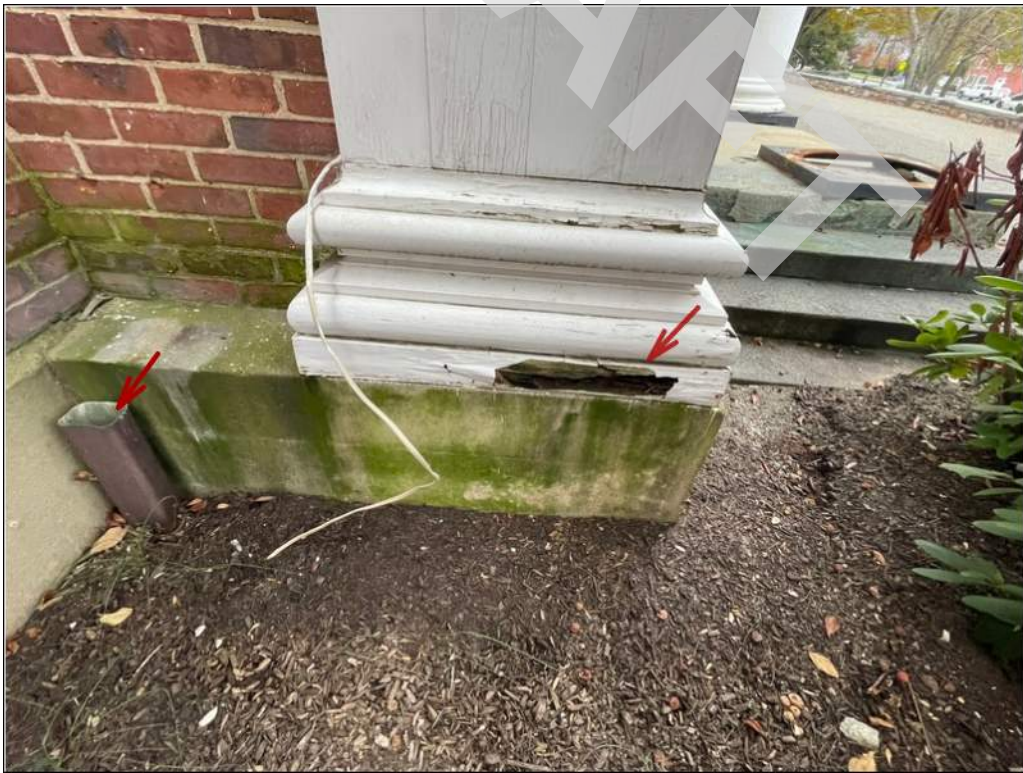
28 - Wood pilaster surfaces have rotted and have peeling finishes. Roof leader is missing.

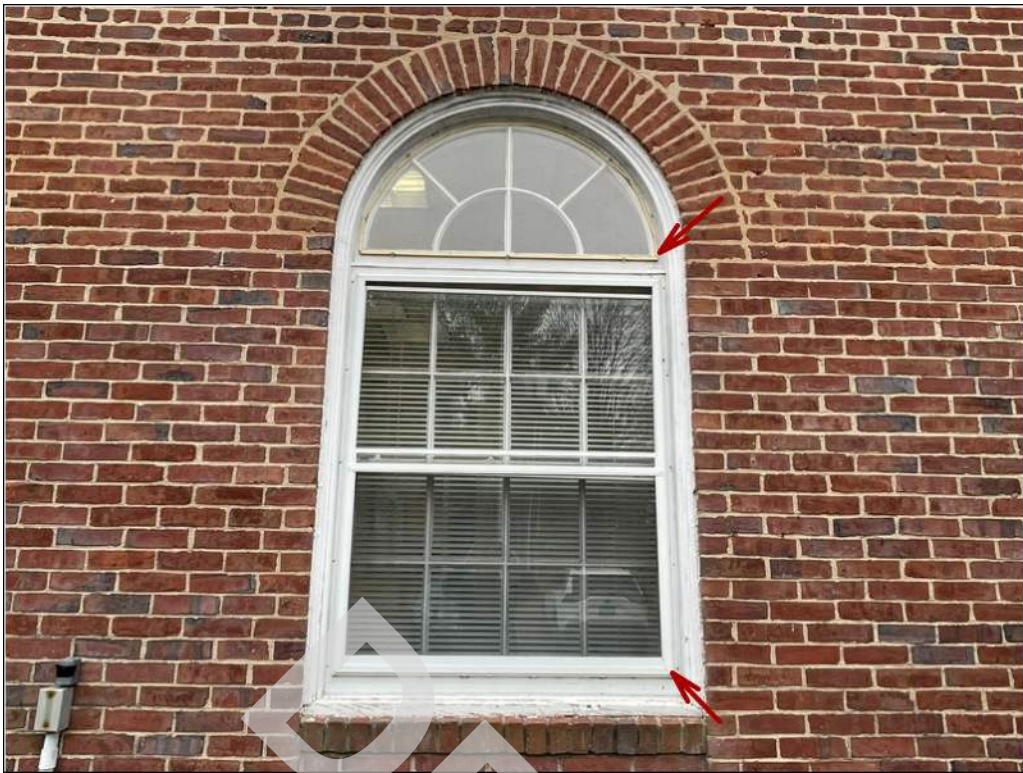
29 - Window assemblies consist of wood framed single pane units. Windows are provided with plastic coverings.

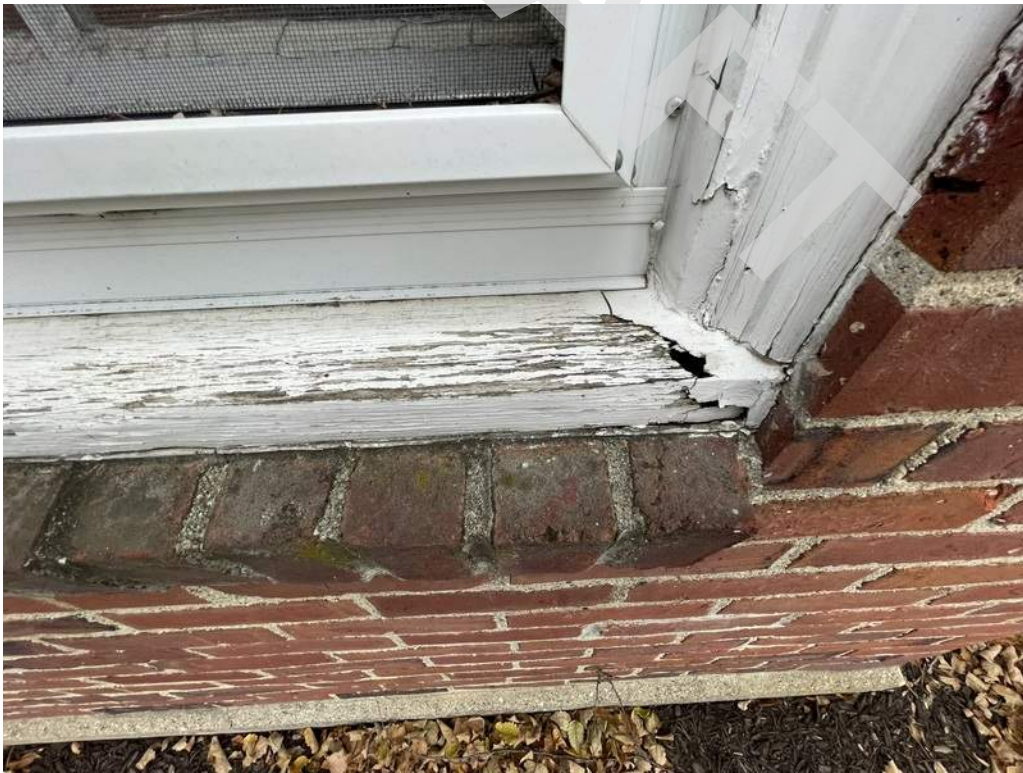
30 - Wood and brick sills are in poor condition. Wood is rotted and brick sill has organic growth, spalled brick units, and deteriorated mortar joints.

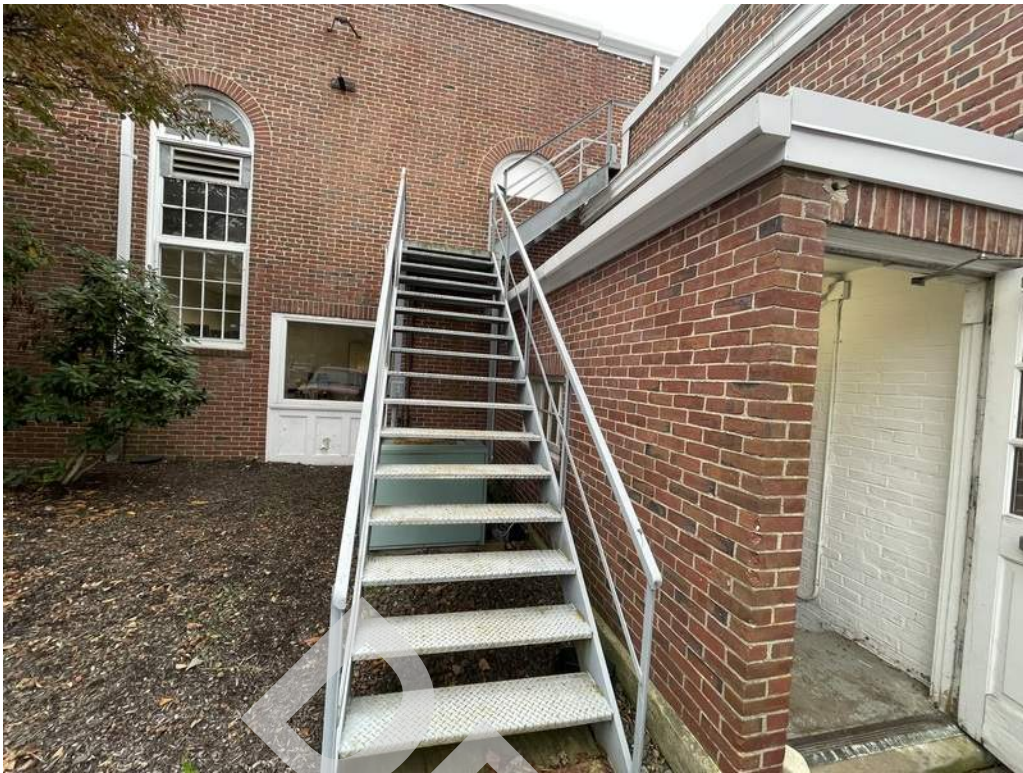
31 - Metal egress stair from the roof.

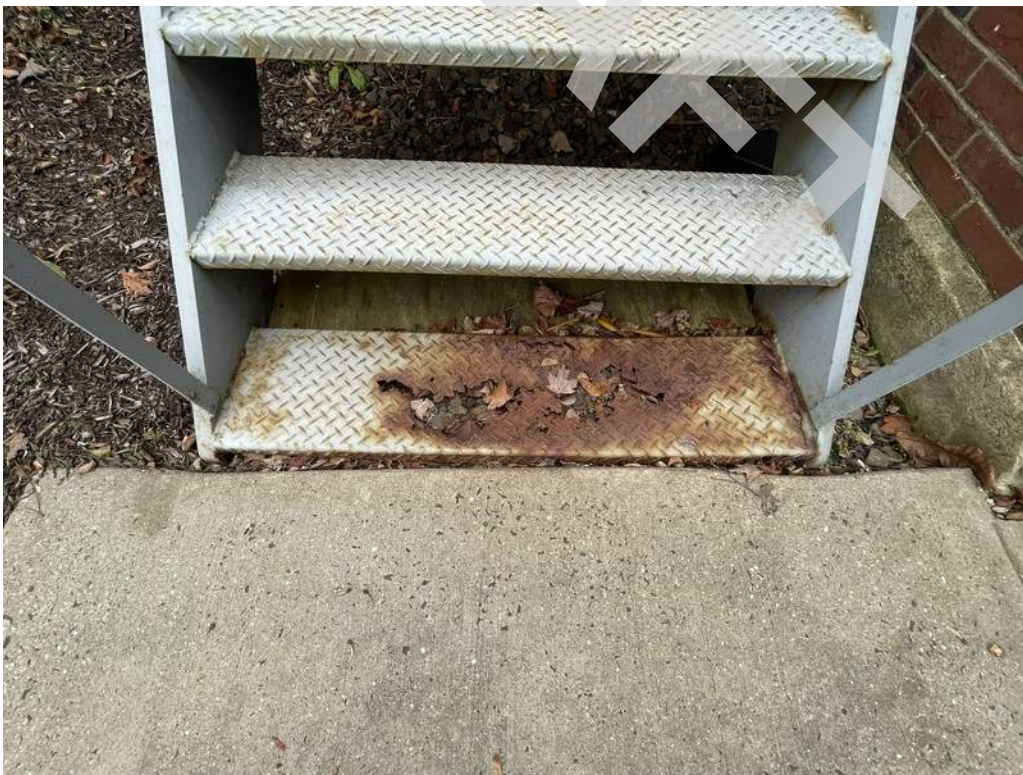
32 - Pitting corrosion at the lowest metal riser.

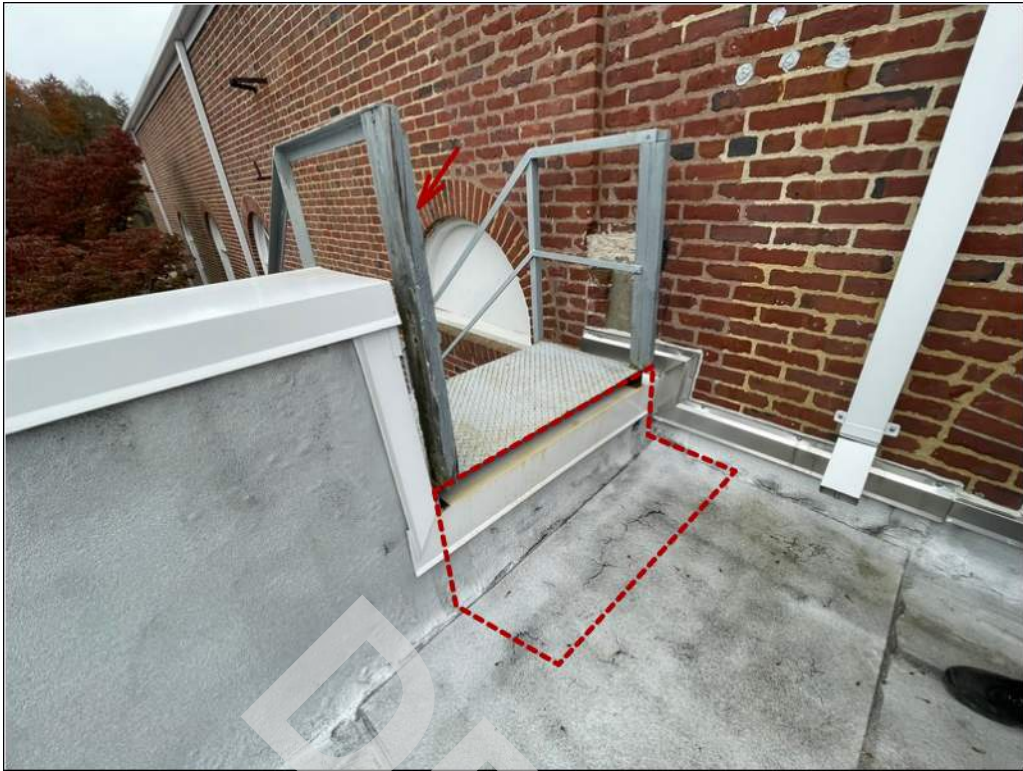
33 - Height of the riser in the path of egress is above the code requirement. Previously repaired handrail support.

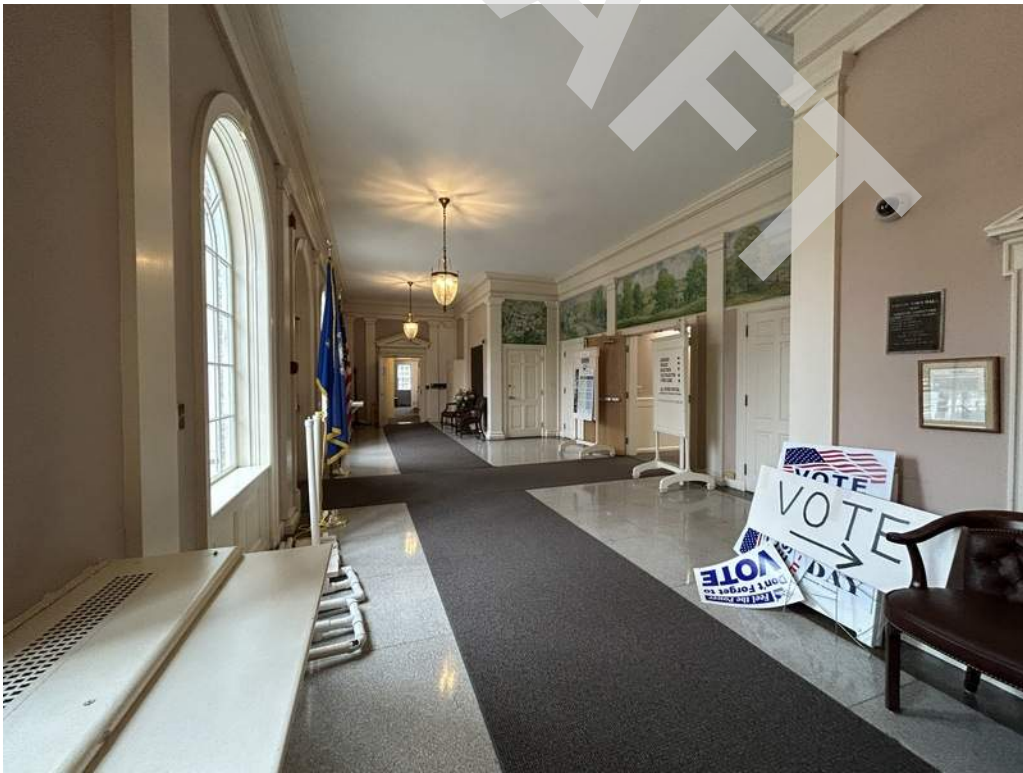
34 - Interior finishes at the lobby consist of painted gypsum ceiling and wall boards and terrazzo floors.

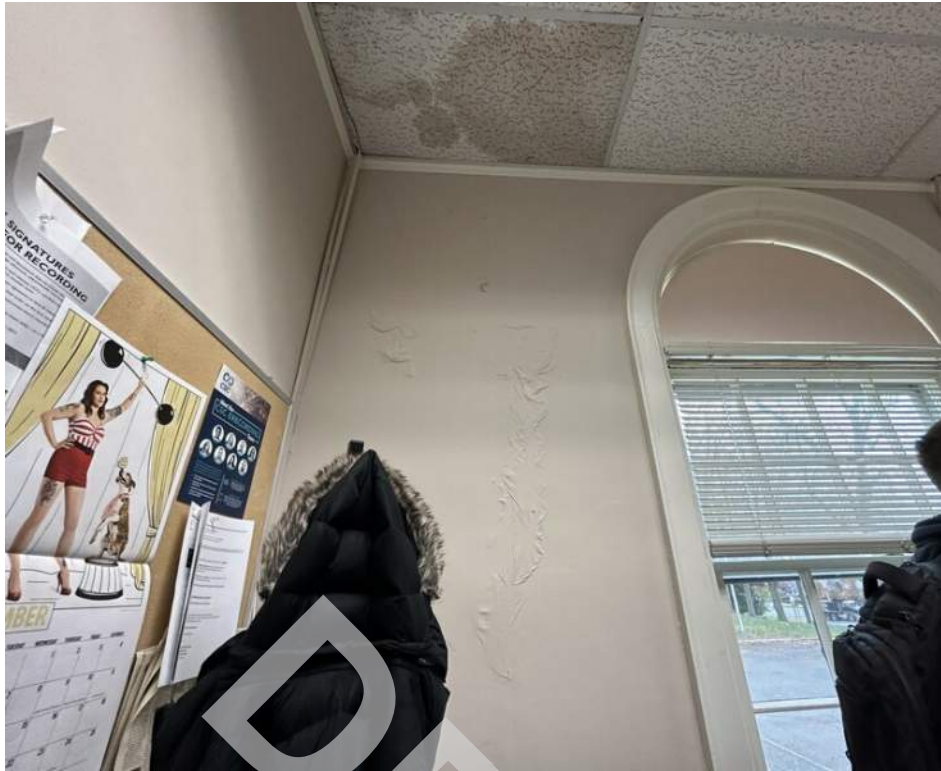
39 - Stained ceiling tiles and paint blisters were observed on the first floor.
