FACILITY CONDITION ASSESSMENT

238 Danbury Road
Wilton, Connecticut

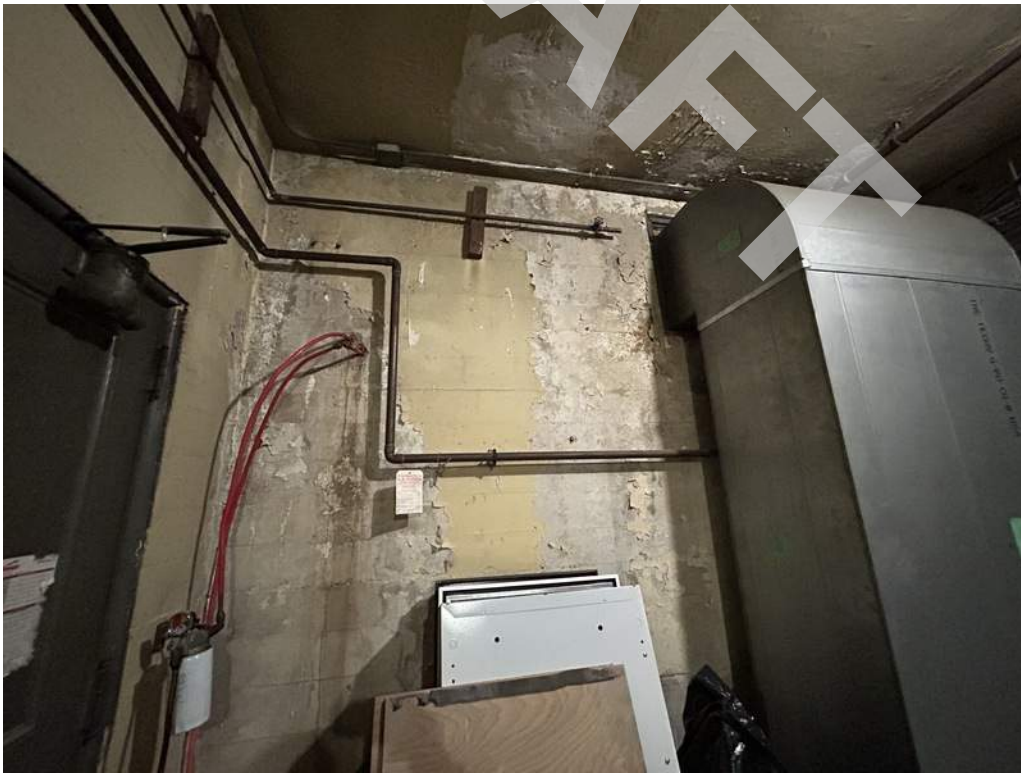
40 - Deteriorated paint and evidence of persistent water intrusion was observed at the boiler room in the basement level.

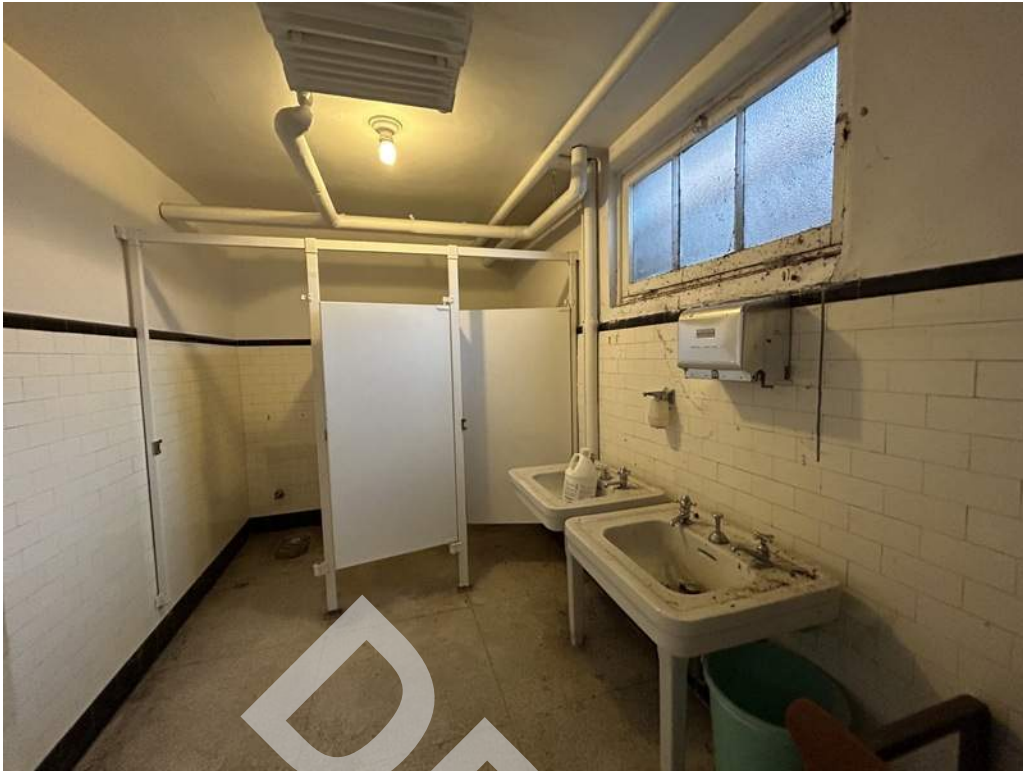
41 - Basement restrooms are out of service.

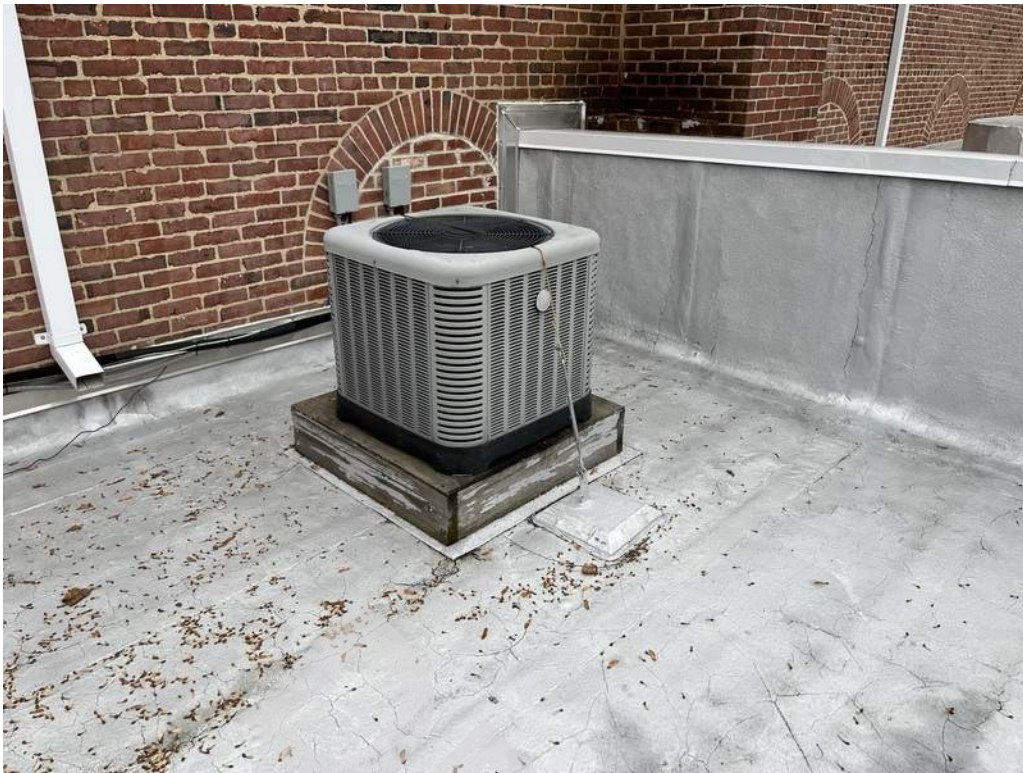
43 - Split system air conditioning units are located on the roof and provide cooling to the office areas of the building.

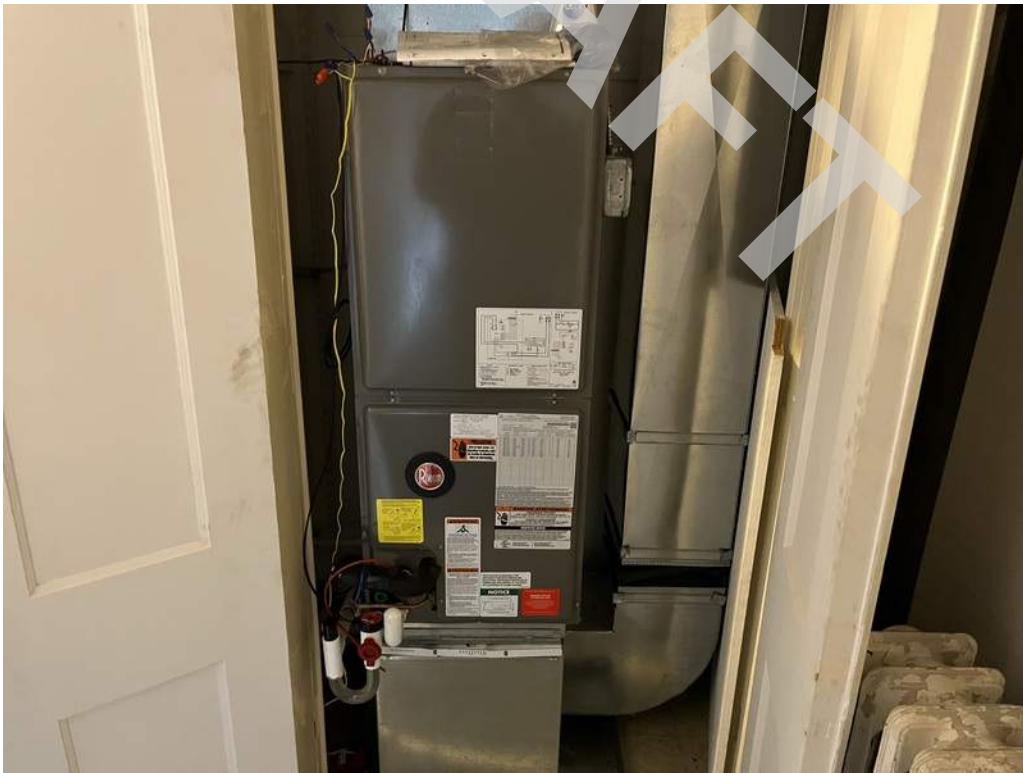
44 - Split system indoor air handling units with auxiliary electric heaters are located within the building and provide air conditioning through ductwork throughout the building.

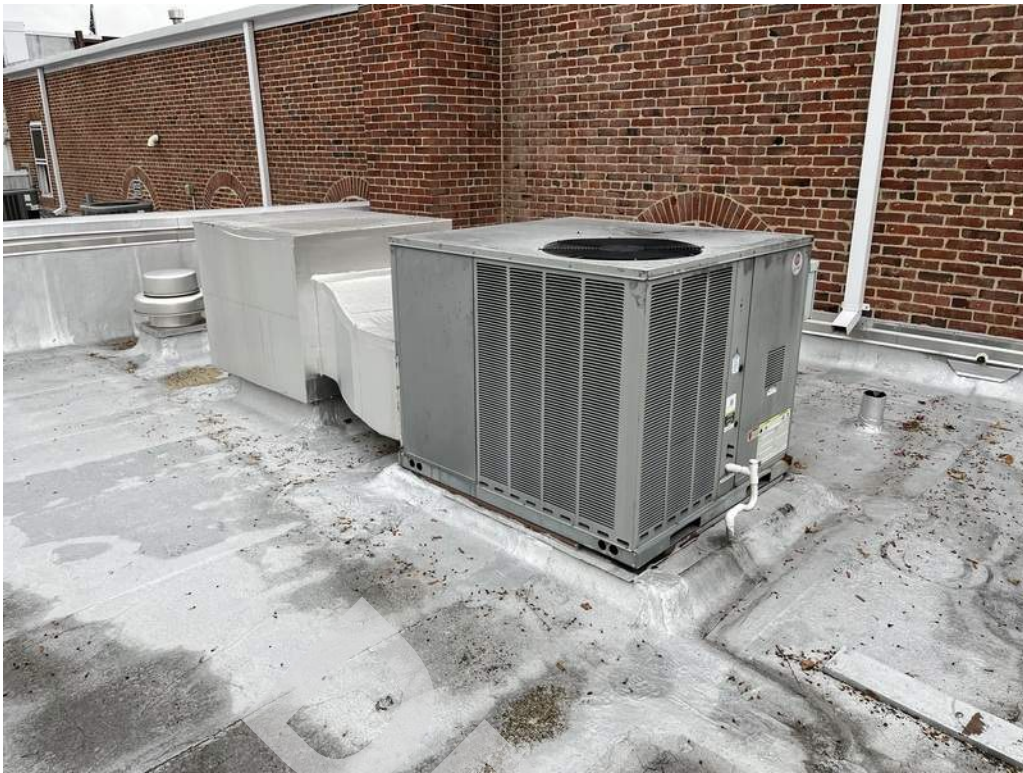
45 - A rooftop packaged unit provides cooling to the vault room on the first floor.

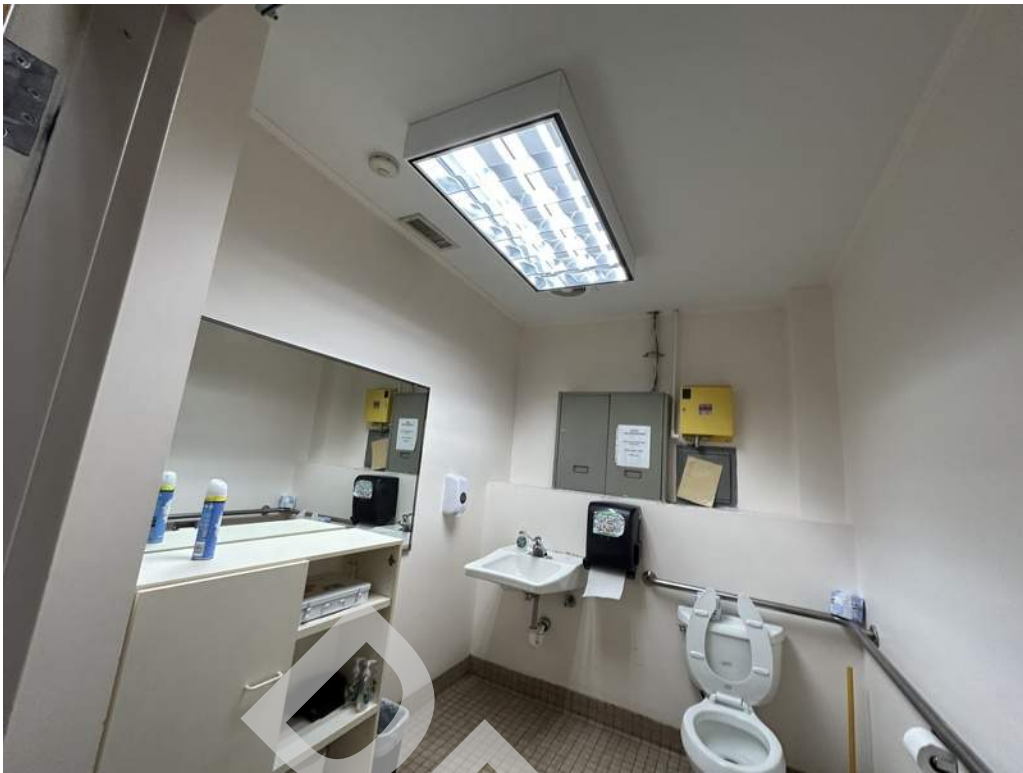
59 - The single user restroom on the ground floor was noted to have various non-compliant items. Items include center of toilet mounted above the the range tolerance from the side wall, inadequate sink depth and clear floor space, and missing scald guard protection beneath the lavatory.

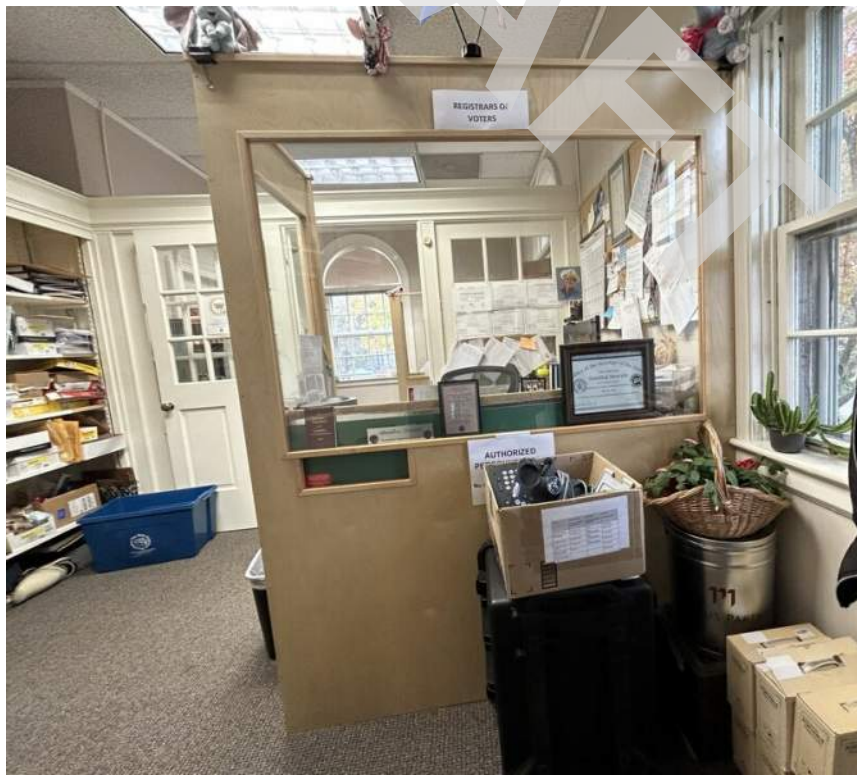
60 - A lowered counter area is not provided at the Registrants of Voters office.
