FACILITY CONDITION ASSESSMENT

VETERANS MEMORIAL STADIUM
CONCESSION & RESTROOM BUILDING

180 School Road
Wilton, Connecticut

January 23, 2024

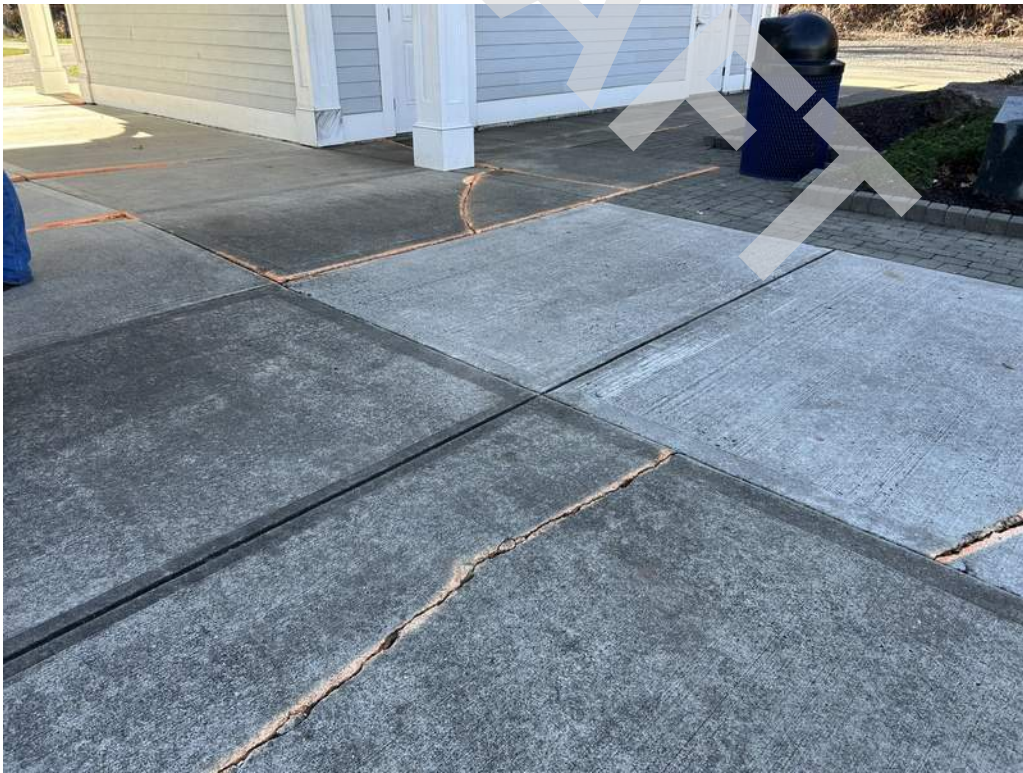
#	Item	QTY	Unit	Unit Cost	EUL	EFF Age	Year 1	Year 2	Year 3	Year 4	Year 5	Year 6	Year 7	Year 8	Year 9	Year 10	Total Cost	Comments
SITE																		
1	Building Integrity: Cracking and vertical displacement were observed throughout the cast-in-place concrete paths around the building. It was reported heaving around the site may be due to drainage related issues and than an engineer has been engaged for site remediation. A scope of work or budget has been not been provided for our review. It is recommended that the scope includes an investigation to review surface drainage from the sloped area directly west of the building, subsurface conditions and drainage capacity of the stormwater system around the site.	1	LS															Priority 2 - Potentially Critical.
2	Building Integrity : Based on the results and recommendations from the engineer investigation, perform the site repairs. Repair scope could include removing all sidewalks surrounding the building, excavating the area to verify subsurface, repairing subsurface conditions, providing new drainage system around the building site, and repouring all the sidewalks.	2,000	SF															Priority 2 - Potentially Critical.

2 - Extensive cracking and vertical displacement was observed throughout the cast-in-place concrete paths.

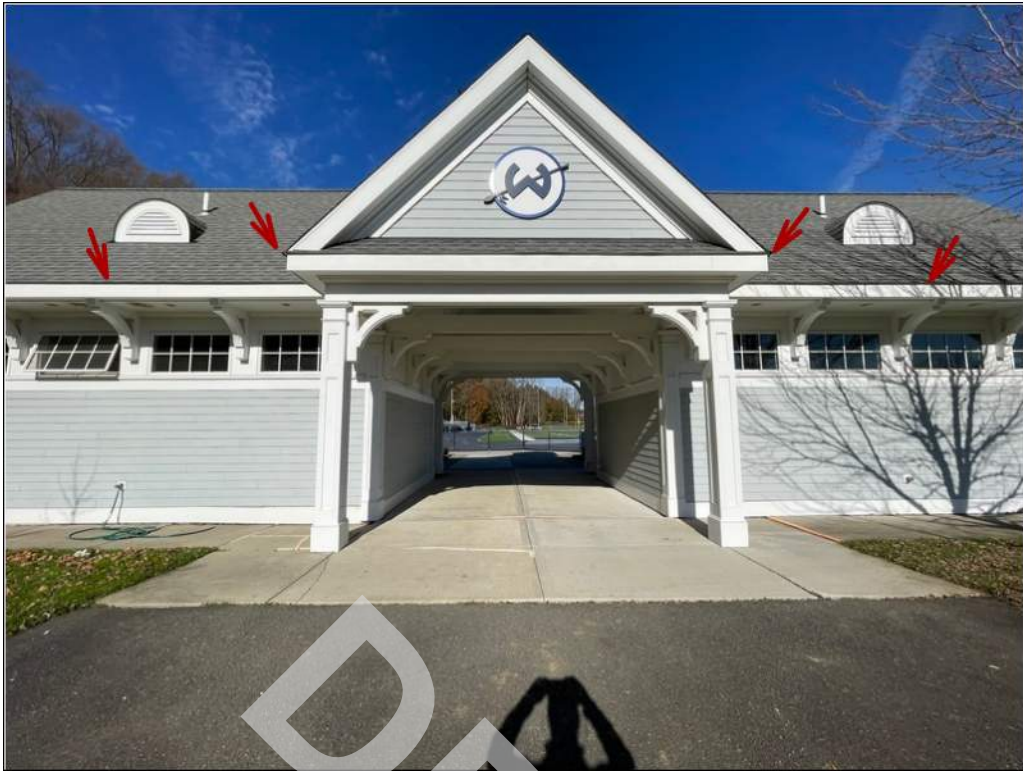
3 - No gutters or leaders are provided throughout the building.

7	Building Integrity: Based on the design by the qualified professional engineer, provide new gutters, leaders, and connect to the site's stormwater management system. Scope of work may include excavating and installing pipes around the perimeter of the building, and should be coordinated with the site repair work.	1	LS															Priority 2 - Potentially Critical.
8	P Building Integrity: localized areas of the trim work and soffits along the perimeter of the building have deteriorated, due to the paving heaving and missing gutters. Perform localized repairs, including replacing corroded soffit vents and replacing or reattaching displaced base and window trim work. Work to the building to be completed immediately after the site work has been finalized.	250	LS															Priority 3 - Necessary - Not Yet Critical.
9	A budget is provided for general contractor overhead, profit, and general conditions for the work associated with the envelope and exterior.	1	LS

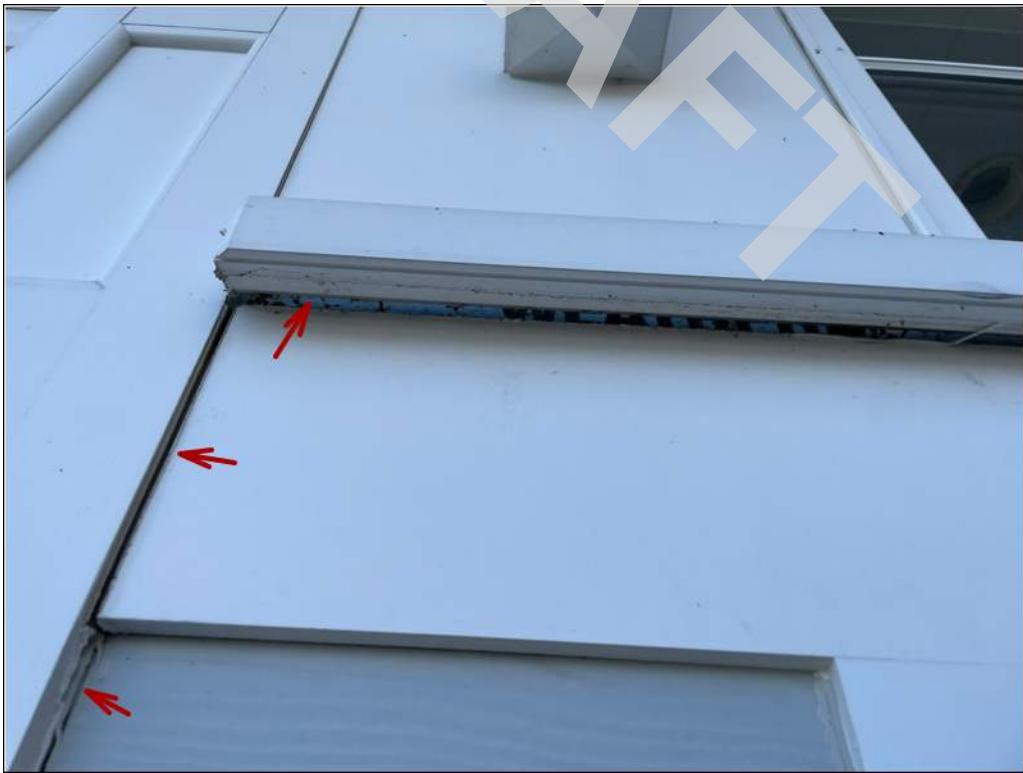
4 - Differential movement noted between fiber cement trim and panels throughout the building enclosure.

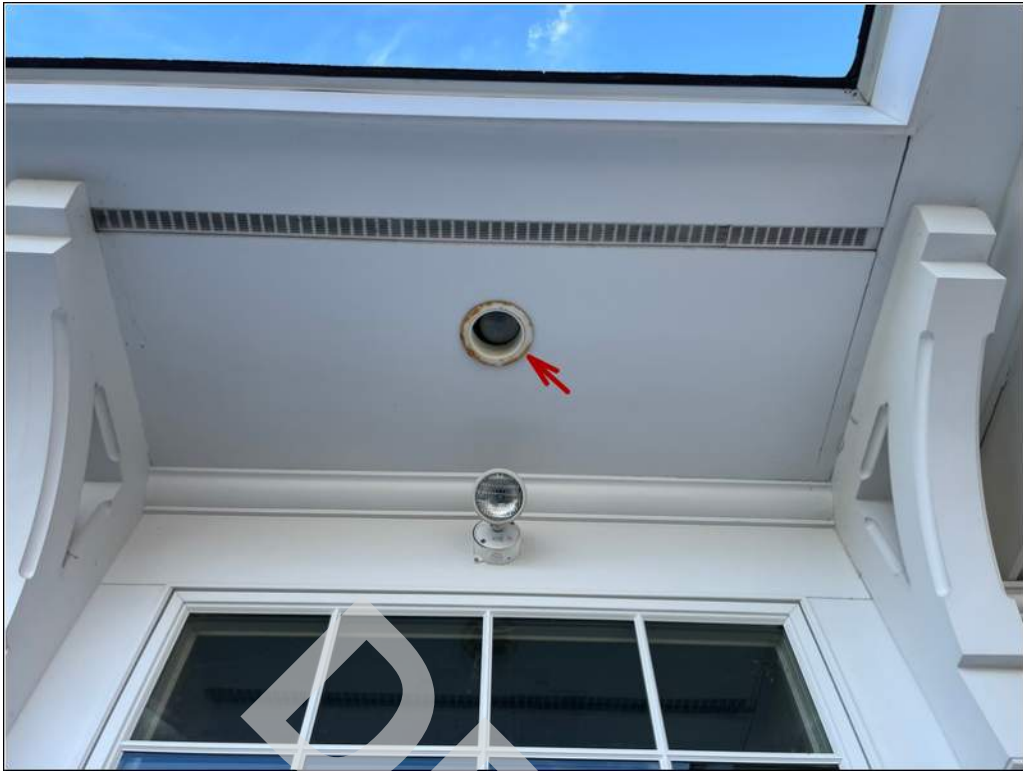
5 - Recessed lighting metal rings have corroded due to water and moisture exposure.

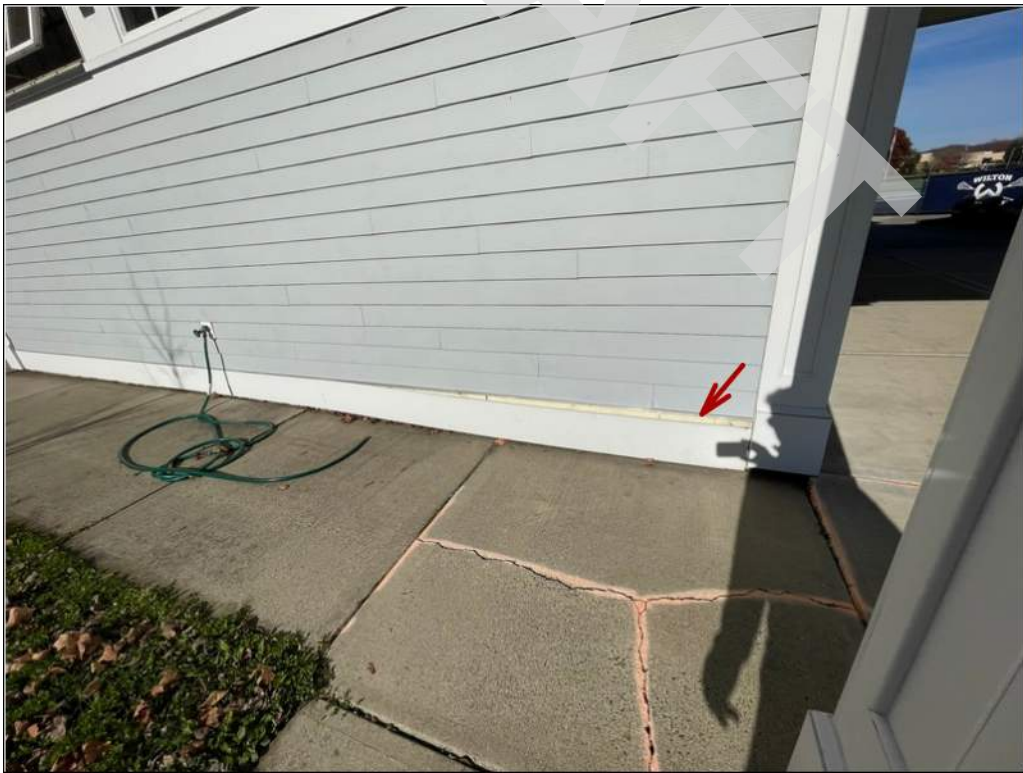
6 - Fiber cement base has displaced and detached from the facade.

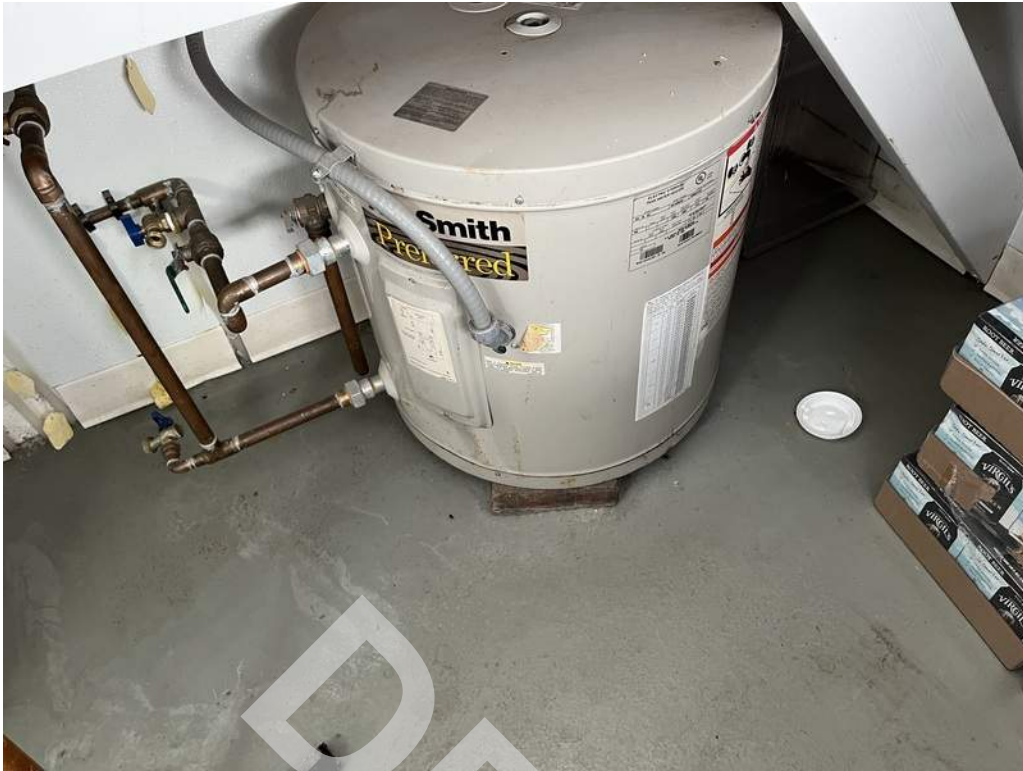
9 - Two electric storage-type water heaters provide hot water to the building.

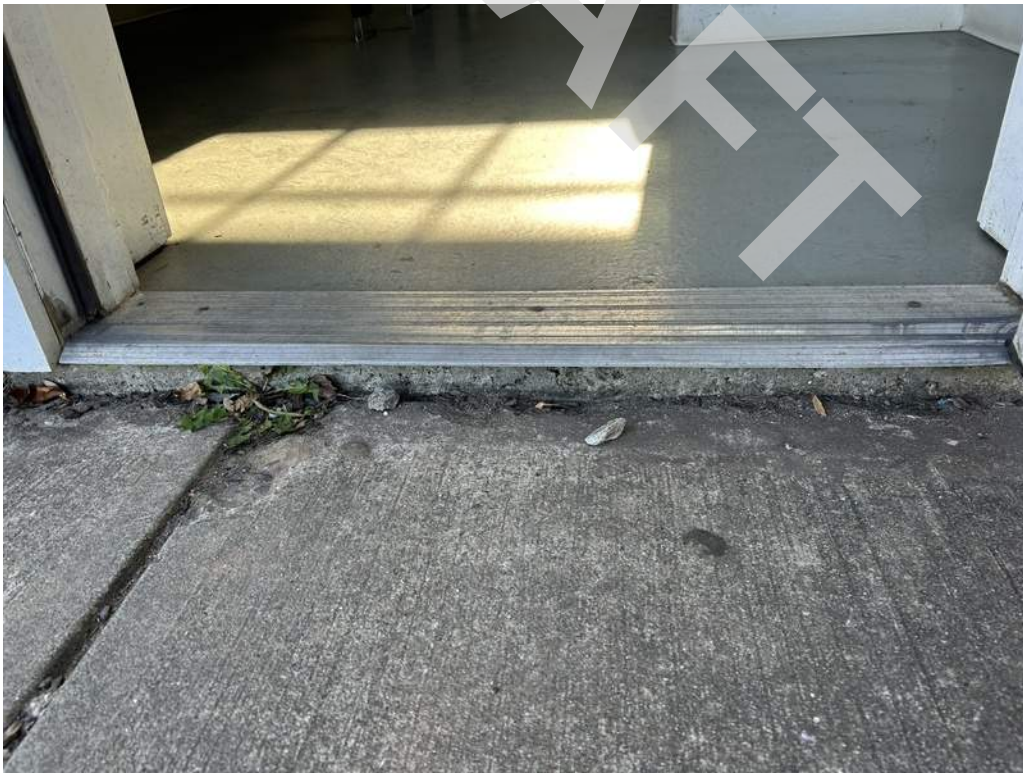
#	Item	QTY	Unit	Unit Cost	Replacement Percent	Immediate Total	Comments
ACCESSIBILITY							
1	ADA: At the men and women's multi-user restrooms, the center of the toilet is mounted below the range tolerance from the side wall and the door threshold exceeds the allowable height. Remount the toilets to the acceptable range and replace thresholds or modify finish surfaces to reduce effective threshold and meet compliance. Door thresholds to be addressed with site repairs and displacement.	2	EA				Priority 1 - Current Critical.
2	ADA: A lowered counter area is not provided at the concession stand. Provide a lowered counter area not exceeding 36" maximum from the finish floor.	1	EA				Priority 1 - Current Critical.
Total Repair Cost

10 - The restroom door threshold exceeds the allowable height.

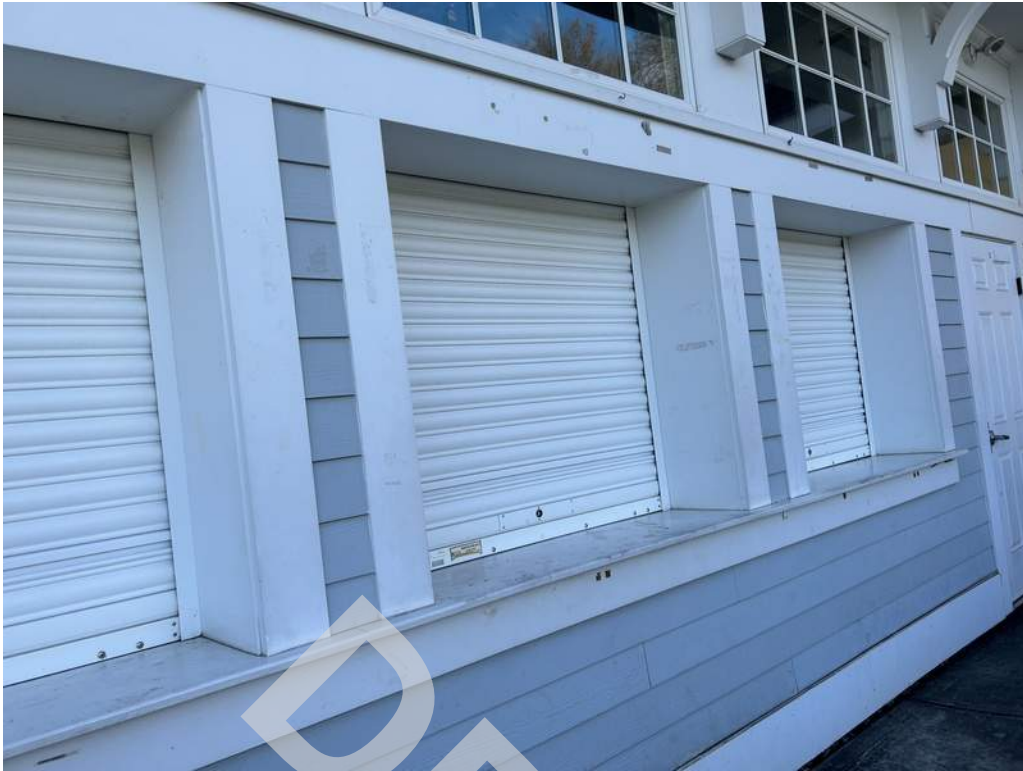
11 - A lowered counter area is not provided at the concession stand.
