APPLICATION FOR AN INTERMEDIATE REGULATED ACTIVITY

Engineering Summary Proposed Culvert Repair 26 Ledgewood Drive, Wilton, CT Map 128, Lot 24

> CULVERT REPAIR PLAN 26 LEDGEWOOD DRIVE WILTON, CONNECTICUT

Wetland Delineation Report

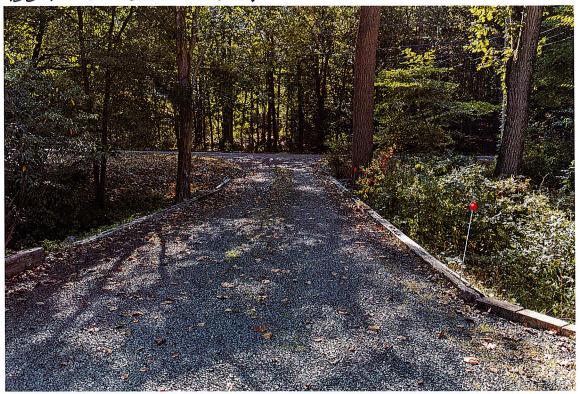
BIC 1: EXISTENS DETVENMY

Our inspection of the driveway culvert revealed that the entire flow line of the culvert has rusted out revealing bare earth below. The stone and boulder banks are very crudely constructed but appear to be stable. No significant erosion was noted. The inlet of the culvert is very narrow and therefore it is susceptible to clogging from leaves and sticks. It requires frequent maintenance from the property owners to ensure it won't clog. The attached pictures highlight the conditions of the existing culvert.

A 24" diameter HDPE pipe is proposed to replace the existing culvert in the same location. The larger diameter pipe will be less prone to clogging and easier to maintain. The stone and boulder slopes will be removed and the stone will be repurposed in the new construction. Two terraced walls will support the banks along the driveway. The lower terrace will consist of 4' high precast concrete or masonry fieldstone headwalls at the pipe inlet and outlet. The upper terrace will consist of a 2' high boulder wall. The boulder wall is also proposed to extend along the edge of the lawn to the north in order to stabilize the existing banks. Additionally the existing gravel parking area will be trimmed back near the southern property line, creating greater separation from the large wetlands area. The "Culvert Repair Plan" prepared for Joseph Kropf and Irene Rosenberg by this office details the proposed work.

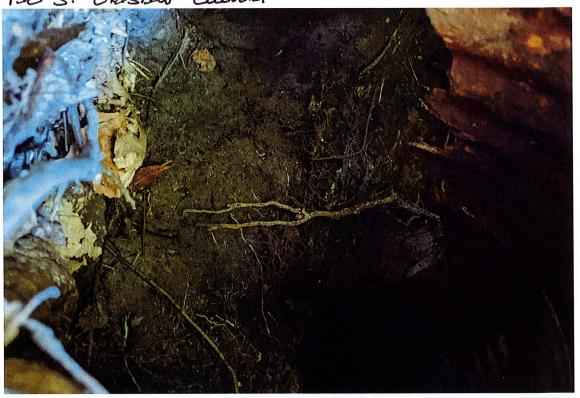
Pic 3: EXASTER CHIVENT

The culvert has surpassed its life expectancy and will degrade rapidly if not repaired. Eventually it will collapse, causing blockage of the stream and damage to the driveway. The culvert is too degraded to attempt to reline and too small to sleeve a new pipe through it. Therefore the best option is to replace the culvert completely.
