Re: Significant Corrective Action Permit - Supplement
220 Nod Hill Road, Wilton, CT

At the request of Herman and Candice Behrens, owners of the above referenced property, Environmental Land Solutions, LLC (ELS) reviewed the "Timber Trespass Report" prepared by Connwood Foresters, Inc., for 220 Nod Hill Road, submitted on behalf of South Norwalk Electric and Water (SNEW). We disagree that trees found on the adjoining property are equal to the density of trees found on the Behrens property before the tree removal work was performed based on the following comments.

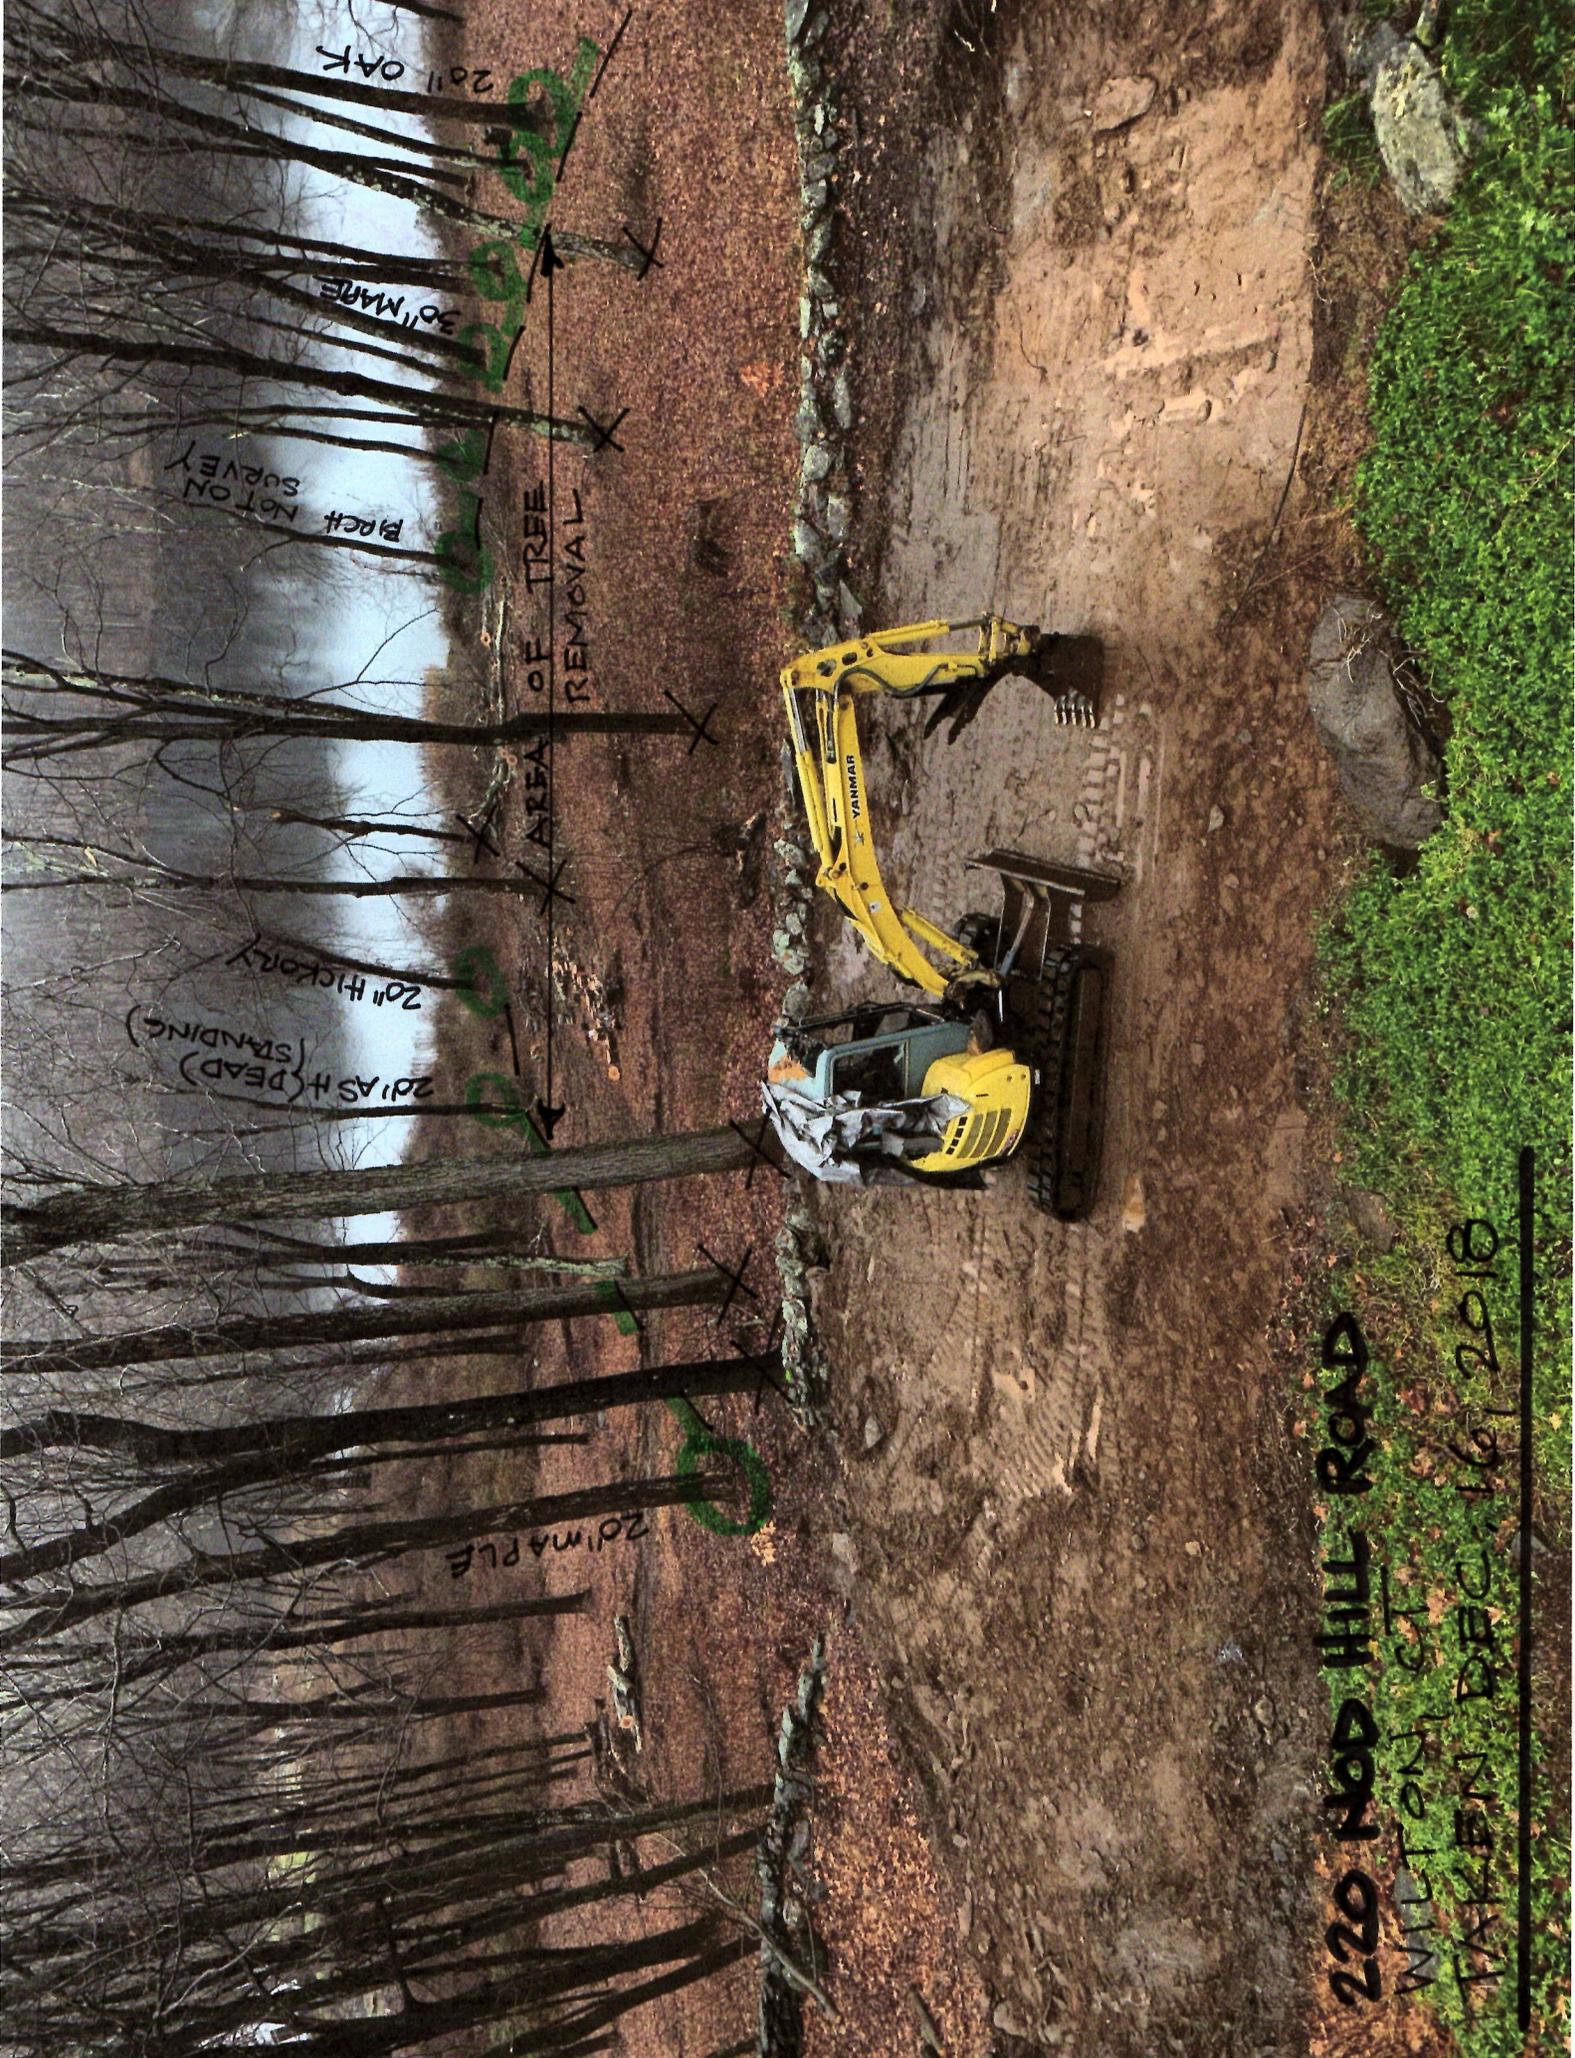
220 NOD HILL ROAD
WILTON, CT
TAKEN DEC. 16, 2018

4. The Behrens' have provided a photograph taken from the house looking down to

the pond on December 16, 2018. This photo shows the existing trees before the contracted tree removal began. In the photo, three trees were cut down and are lying on the ground. Regrading is underway adjacent to the house, near the existing wall. This photo shows the tree canopy before the majority of the work began, and reflects that the view from the house had been thinned over the years by previous owners and there is little to no understory trees or shrubs. The attached marked up photograph based on a site visit this morning verifies what trees remain and are also located on the survey.

2011 OAK

30' MAPLE

BIRCH NOT ON SURVEY

AREA OF TREE REMOVAL

2011 HICKORY

2015+ (DEAD) (STANDING)

20' MAPLE

The attached photograph clearly demonstrates the existing trees along the shoreline, and does not reflect the much higher amounts or densities off the site counted by Connwood. However, in the interest of compromise, the Behrens' are willing to add 3 understory trees to the plan, providing a total of 12 trees on the SNEW property, and a total of 25 new trees for the 100' buffer which is more than all the previous trees in the photograph provided.
