## APPLICATION FOR AN INTERMEDIATE REGULATED ACTIVITY

Re: Application for an Intermediate Activity  
67 Borglum Road, Wilton, CT

Re: Wetland and Watercourse Delineation  
67 Borglum Road, Wilton, Connecticut

**WETLAND & WATERCOURSE MAP**

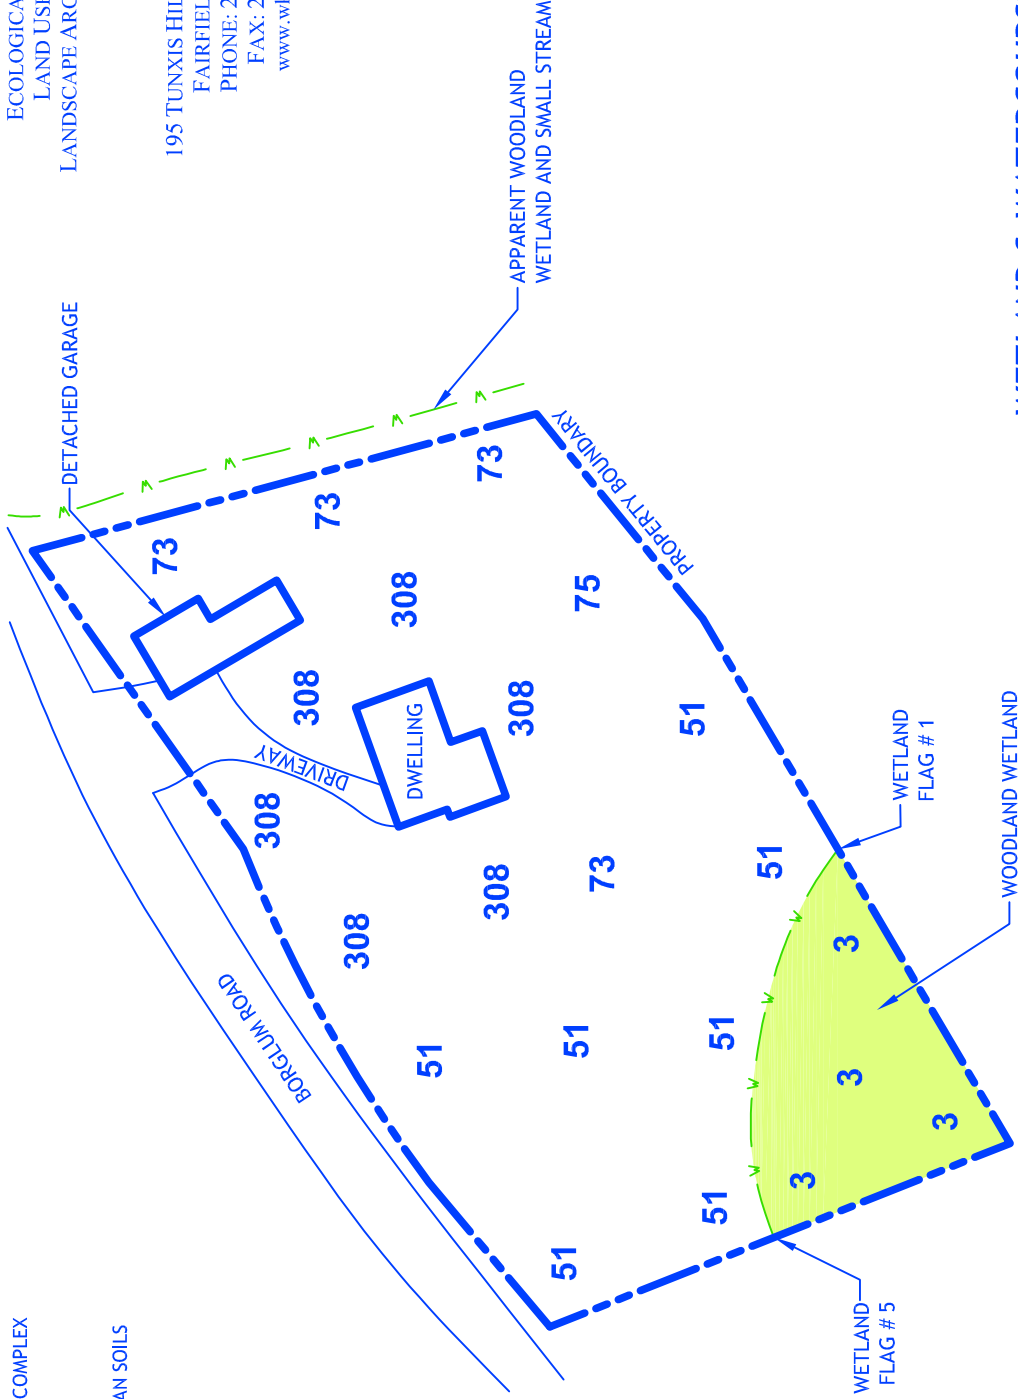
One inland wetland system was identified and delineated. The system, which is located in the southwestern portion of the property, is a gently sloping woodland wetland. In addition to the onsite system, an off-site system was observed. It extends and flows north to south just east of the property and is a small stream and woodland wetland. Wetland soils are primarily poorly drained and formed from glacial till deposits. The approximate location of the system is shown on the attached map. The boundary of the system was marked at the site with flags numbered 1 to 5.

- INFORMATION SHOWN ON THIS DRAWING, INCLUDING THE WETLAND BOUNDARY, IS APPROXIMATE. THE BOUNDARY IS NOT A SURVEYED REPRESENTATION OF WHAT WAS FIELD MARKED (FLAGGED).
- WETLAND AND SOIL INFORMATION PROVIDED BY WILLIAM KENNY ASSOC.
- OTHER INFORMATION TAKEN FROM A TOWN OF WILTON GIS MAP.
- 51, 73, 75, 308 AND 3 ARE SOIL MAPPING UNIT SYMBOLS. SEE WETLAND DELINEATION REPORT FOR THE SOIL MAP UNIT NAMES AND ADDITIONAL RELATED INFORMATION.

Today, we investigated your property at 67 Borglum Road in Wilton, Connecticut and identified and delineated one onsite inland wetland system. In addition to the onsite system, an off-site system was observed. It extends and flows north to south just east of the property and is a small stream and woodland wetland. Thank you for the opportunity to assist you. If you should have any questions or comments, please do not hesitate to contact us.

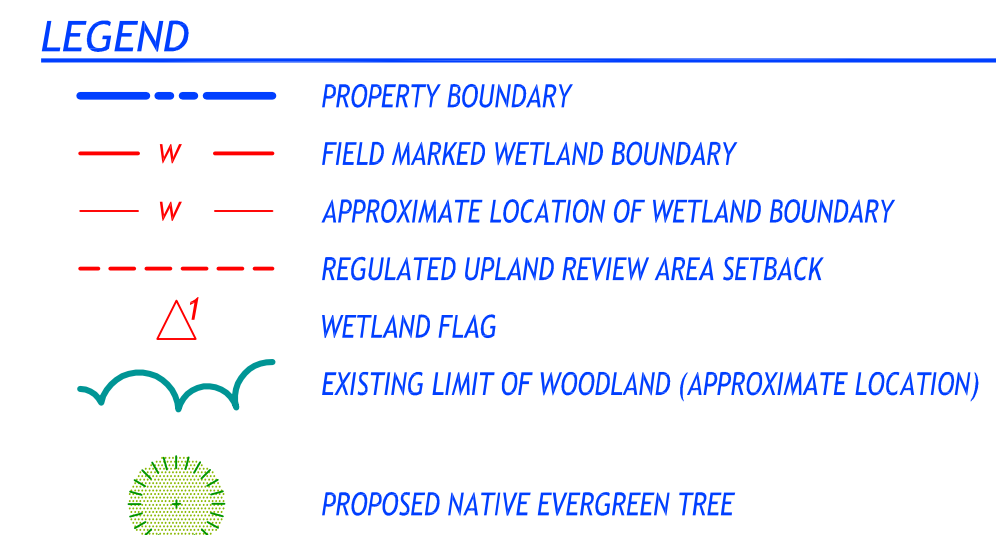
| SYM. | QTY. | SCIENTIFIC NAME | COMMON NAME | SIZE | ROOT |
| PROPOSED EVERGREEN TREES | | | | | |
| JV | 20 | JUNIPERUS VIRGINIANA | EASTERN RED CEDAR | 6'-7' HT. | B&B |
| TP | 20 | THUJA PLICATA 'GREEN GIANT' | GREEN GIANT ARBORVITAE | 6'-7' HT. | B&B |

1. UNLESS NOTED OTHERWISE, EXISTING CONDITIONS INFORMATION TAKEN FROM A SURVEY PREPARED BY ROLAND H. GARDNER.
2. PROPOSED WETLAND & BUFFER HABITAT ENHANCEMENT PLANTING INFORMATION PROVIDED BY WILLIAM KENNY ASSOCIATES LLC.
