MEMORANDUM

IWC Staff Report
Wetland Permit Application - WET#2905 OLD DRIFTWAY LLC
0 Mountain Road, Wilton CT

O Mountain Road – Staff Photos – By Mike Conklin, Director of Environmental Affairs

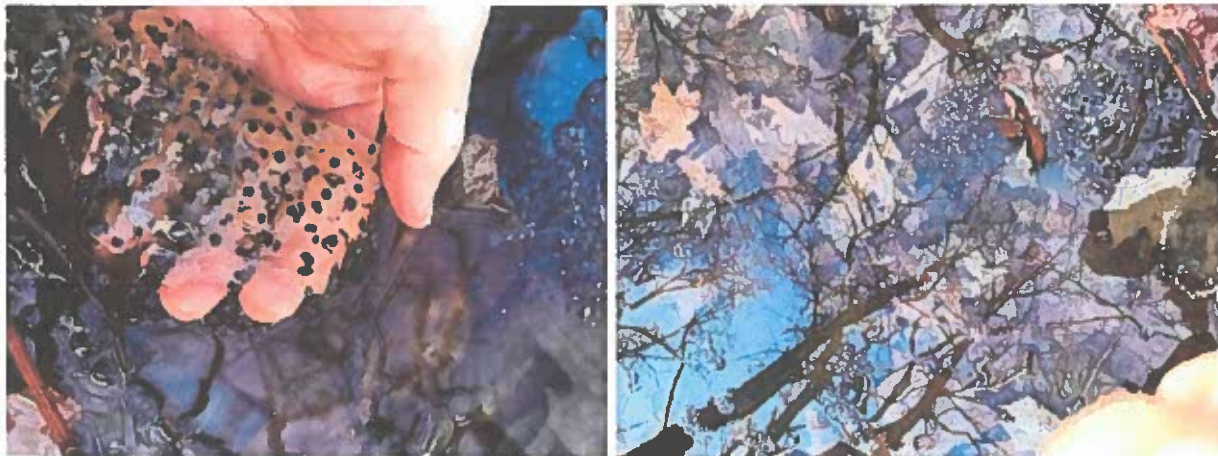
The proposed temporary wetland crossing will be installed along the eastern boundary of the accessway. The flooded areas of the crossing will be covered with timber logs spaced to support play wood plates. Timber supporting the play wood will reduce the contact area with the wetland soil limiting the disturbance and compaction. In addition, the spacing between the timber will allow for a free water movement. Coir logs will be placed along the western side of the crossing to contain egg masses and preventing mixing of the water from the disturbed

crossing area with water in the pool. The total length of wetland crossing is approximately 70 feet. For more details see the sketch below.

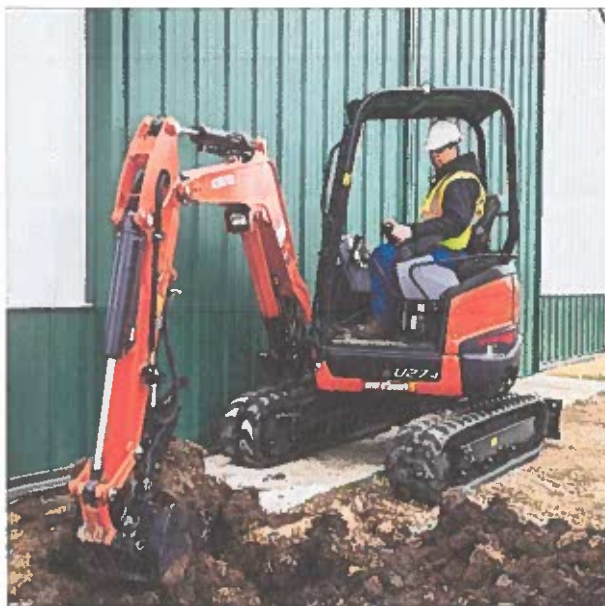
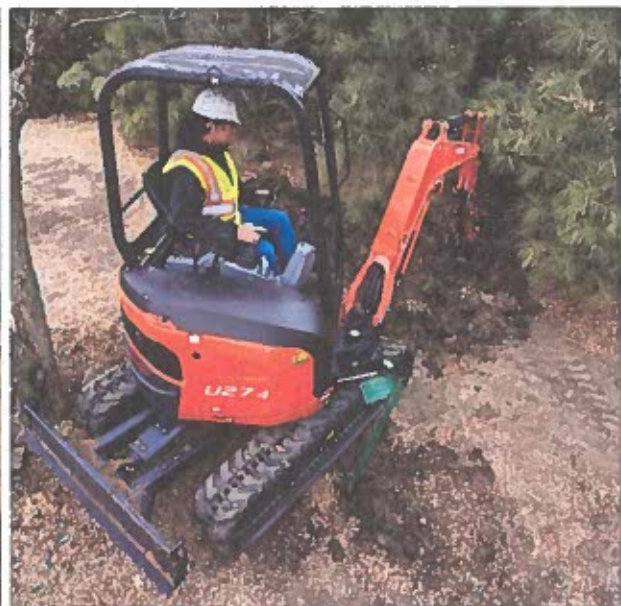
The equipment used at the site will consist of Kubota U27-4 compact excavator which is only 5 feet wide. This light and narrow excavator will have a very minimal and only temporary impact to the wetland crossing area.

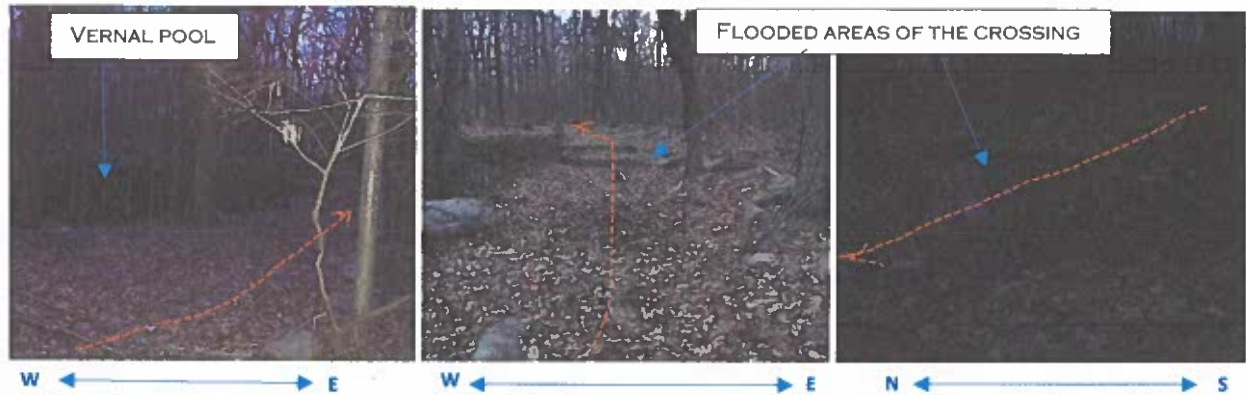
A view of the vernal pool and the proposed crossing.

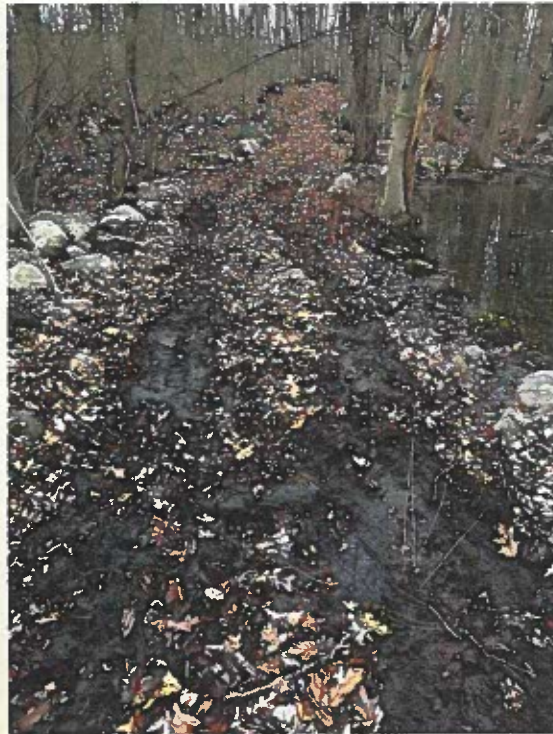
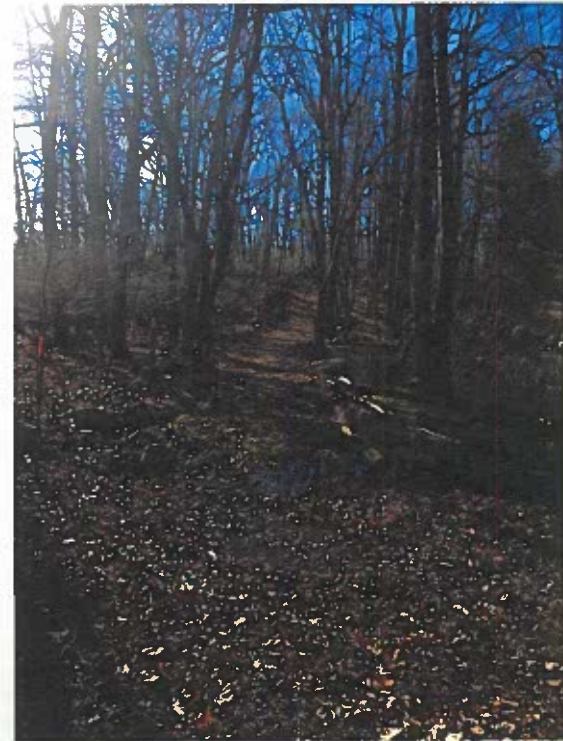
0 Mountain Road – IWC Staff Photos
January 31, 2024 & February 5, 2023

I am attaching my staff photos to this memo from January 31, 2024 and February 5, 2024 that show that support my position that the wetland and vernal pool were impacted by tracked machinery and that clearly someone tried to cover the issue up with leaves after my discussion with Ms. Moch. Ms. Moch's report was drafted in an effort to mislead the Commission and try and prove there was never a problem at the vernal pool location. My site photos show there was a problem at the site and I am requesting the Commission discuss this matter at the next commission meeting.

To follow up with this matter, I spoke with Aleksandra Moch on the phone and expressed my concerns. I explained that no one should do any more work out there until the Inland Wetlands Commission meetings on February 8, 2024 and provides her with guidance. Her contractor Yuri then called me and I told him the same thing. To my surprise, I received a report from Ms. Moch, dated February 3, 2024 in which she includes site photos that show leaves over the areas of concern. She states "Based on my site inspection, there was no disturbance noted within the wetland or wetland buffer area. The site was in compliance."
