APPLICATION FOR AN INTERMEDIATE REGULATED A MINISTRAL PLAND

LOTCIP Project No. L161-0002 Preservation of Bridge No. 04980 Middlebrook Farm Road over Comstock Brook:

RE: WETLANDS REPORT

Bridge Preservation/Rehabilitation Project (State Project No.: L161-0002), Wilton, CT

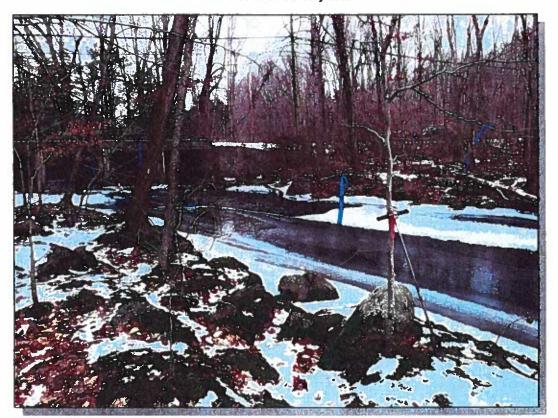
Photo A1: Bridge structure, downriver view; facing northeasterly

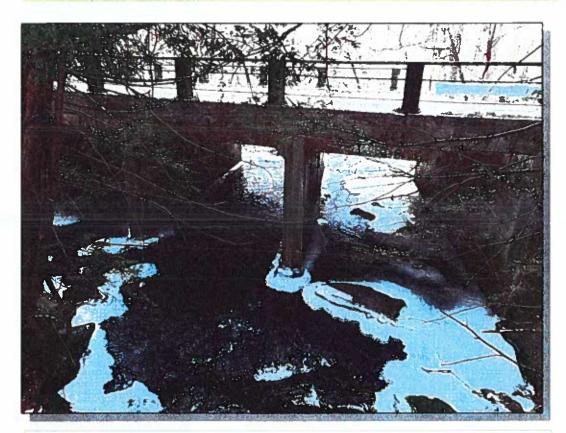
Photo A2: Bridge structure, upriver view from pedestrian bridge; facing southerly

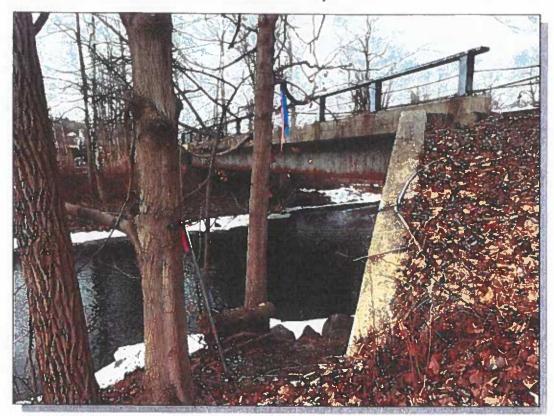
Photo B1: Bridge structure, downriver view; facing northwesterly

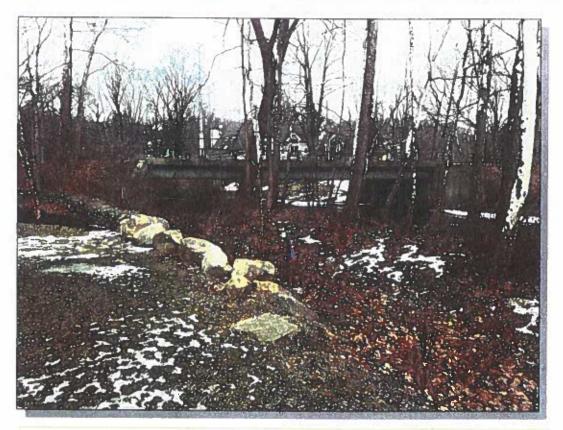
Photo 82: Bridge structure, downriver view, with wooded wetland fringe, facing northeasterly

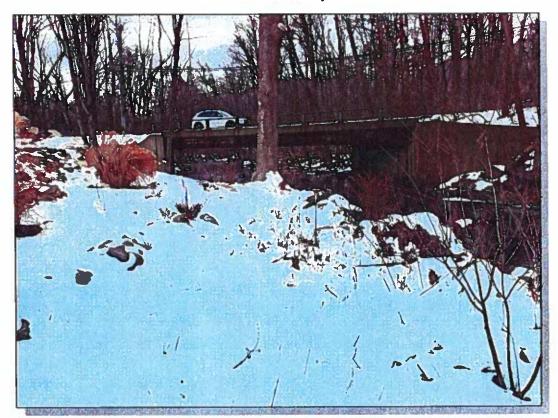
Photo C1: Bridge structure, upriver view; facing southwesterly

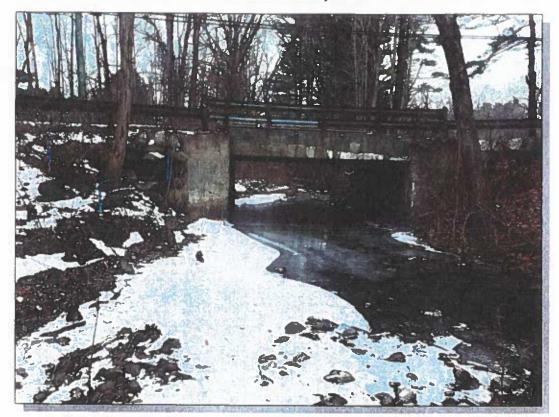
Photo D1: Bridge structure, downstream view, facing northwesterly

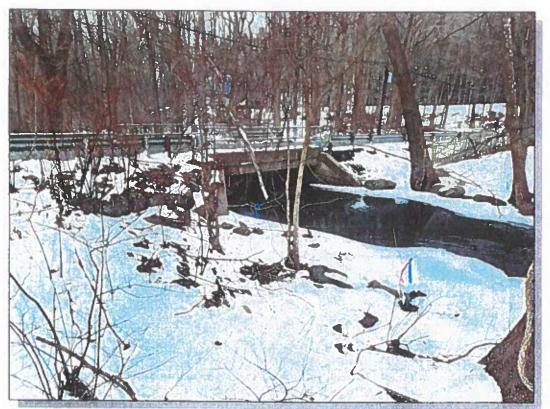
Photo E1: Bridge structure, downriver view, facing northeasterly

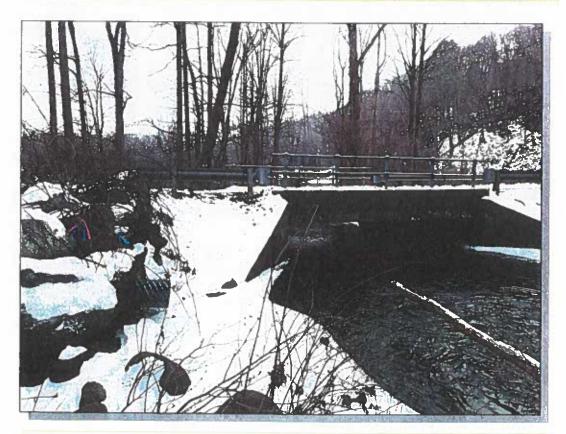
Photo E2: Bridge structure, upriver view; facing southwesterly

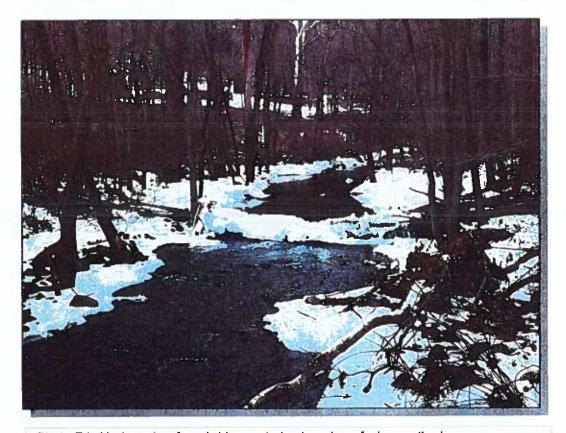
Photo E4: Upriver view from bridge; note ice jam dam; facing northerly
