**WILTON PLANNING AND
ZONING COMMISSION**

**SITE DEVELOPMENT
PLAN**

47 Old Ridgefield Rd Wilton, CT 06897

Section 29 – 8.A.8.

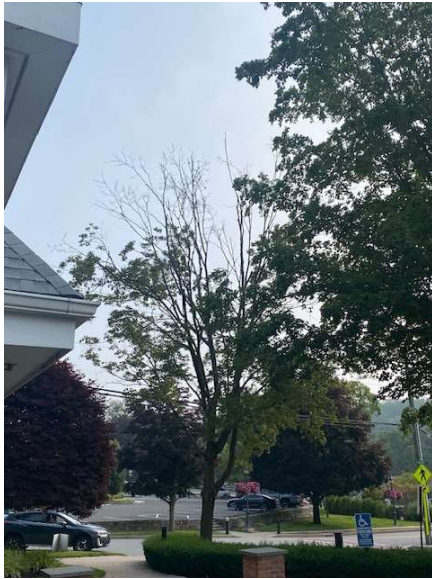
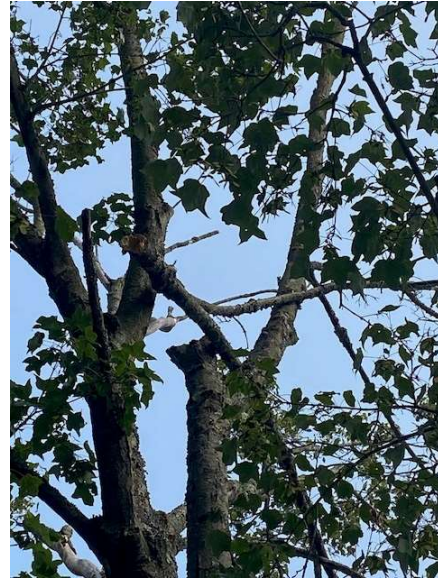
Tree 1: (see 6 pictures below) 13" dbh (trunk diameter at breast height) Sugar Maple *Acer saccharum* located nearest northeast corner of property, approximately 8' off crosswalk at Old Ridgefield Rd x Hubbard Rd. intersection.

Above left: shows current condition of tree canopy of tree 1. Above right focuses on one of several dead/snapped hanging branches in canopy of tree 1.

I observed approximately 40% canopy die back, primarily in the upper crown with multiple limbs, 3" diameter and greater that had broken free and were hanging from the canopy. The remaining foliage is dwarfed in size resulting from long term root growth restriction & root stress typical of trees growing in compacted soil and/or near to impervious surfaces. The existing foliage is chlorotic indicating a deficit of necessary soil moisture/nutrients/biology and/or the trees ability to uptake. The majority of existing foliage displays symptoms of infection, likely maple leaf blister and anthracnose; both considered secondary stressors occurring on trees in decline from environmental stressors.

Taking into consideration the volume of limbs and branches previously removed and the current volume of die-back throughout the canopy it is fair to say this tree has been declining in health and losing structural integrity for several years. Considering its size, proximity to sidewalks, the crosswalk and roads there is an increased risk of damage or injury when portions of the tree continue to fail. My recommendation is to take this tree down.

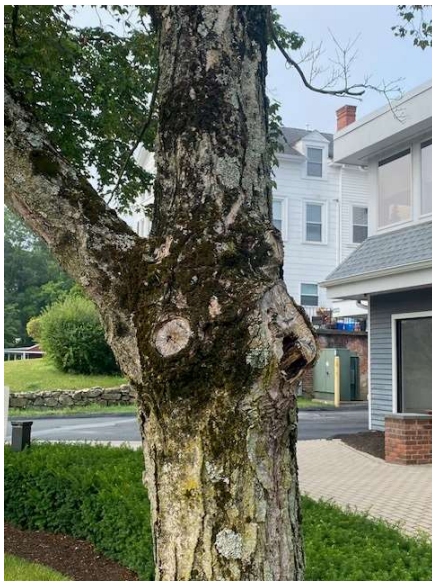
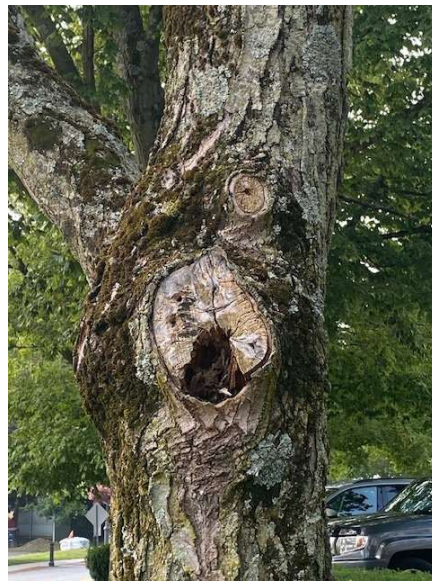
Above left and center focus on multiple wounds on the main stem at or near to the connection point of the largest remaining scaffold limb. The existing wounds are a result of proactive pruning or reactive corrective pruning to failed limbs. The volume of visible decayed interior wood suggests the latter and reduces structural integrity to the remaining scaffold limb connection to the main stem. Above right focuses on a torsion crack (raised spiraling bark ridge) on the largest remaining scaffold limb near to its connection to the main stem, indicating an existing crack and potentially decayed wood inside the limb.

Looking closely at the trunk of the tree there are multiple pruning wounds on the main stem near to the lowest scaffold limb connection. Wound-wood-development (a trees natural response to pruning is to form a bark layer over newly exposed interior wood) around these wounds is minimal and non-existent; there is exposed decaying interior wood visible at all prior pruning locations. Taking into account the condition of the exposed interior wood it is likely that these limbs were removed after an element of decay was present in each limb/the main stem. Focusing on the lowest 9" diameter scaffold limb growing to the east and over Hubbard Road: from its connection to the main trunk extending approximately 2' up the limb, there is a torsion crack visible on the southern side of the limb. Tree limbs, in particular limbs on declining trees or trees with poor branch structure are prone to twisting and cracking in high winds. These cracks often contain decaying interior wood which further reduces structural integrity.

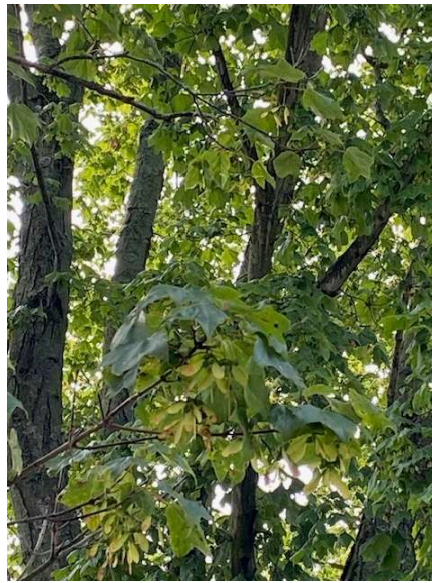
Above center focuses on the existing tree foliage. What remains is dwarfed in size, pale (chlorotic) color and most foliage appears infected with one or more foliar diseases (expected: anthracnose & maple leaf blister)

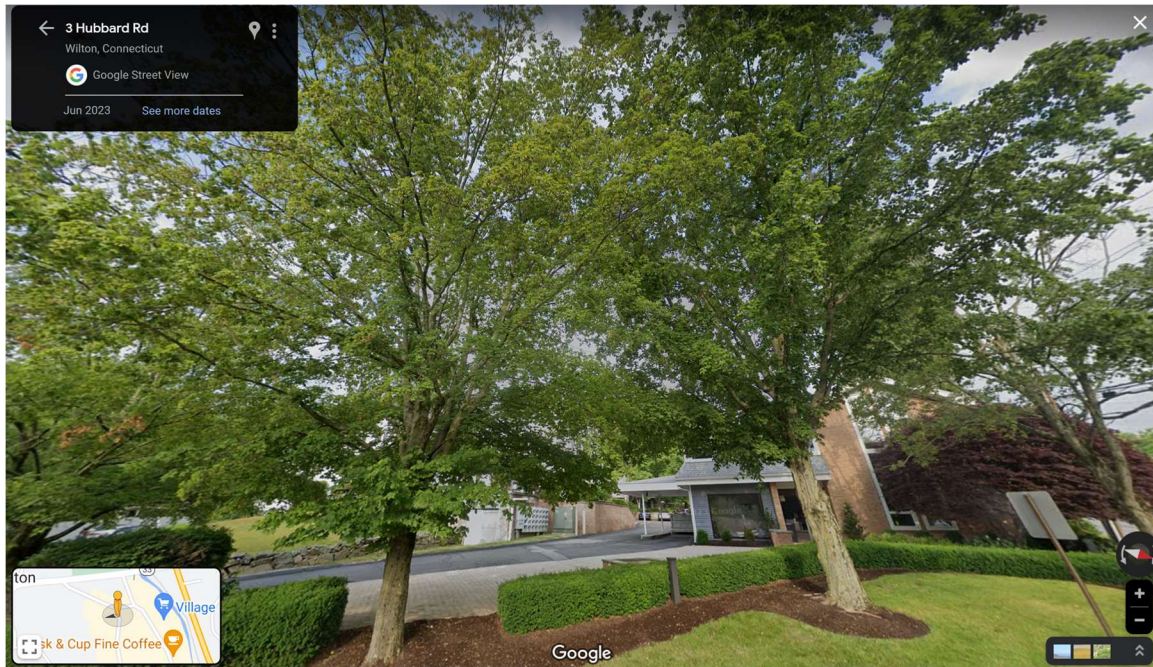
Trees 2 & 3: (see Google street view image below) 17” dbh Sugar Maple *Acer saccharum* (left) and 19” dbh Sugar Maple *Acer saccharum* (right) located within the planting island east of the building, along Hubbard Rd.

The above Google street view image shows the current health and structure of these tree mature sugar maple trees.

I observed approximately 5% canopy die-back distributed evenly throughout both trees canopies. The existing foliage is partially dwarfed in size resulting from long term root growth restriction & root stress typical of trees growing in compacted soil and/or near to impervious surfaces. The existing foliage in the 17” Maple is chlorotic, indicating a deficit of necessary soil moisture/nutrients/biology and/or the trees ability to uptake. Foliage in the lower 50% of both canopies display symptoms of infection, likely maple leaf blister and anthracnose; both considered secondary stressors occurring on trees in decline from environmental stressors.

Focusing on the canopy structure of these trees there are multiple co-dominant stems, crossing/rubbing branches and many limbs that are excessively long; all typical of trees that haven't been pruned to improve structure throughout their development. At this time, I recommend cleaning both canopies of all dead, damaged and poorly spaced branches 2” diameter and greater. Performing select branch-end thinning and reduction cuts on longer lateral limbs to help reduce the risk of future branch failures and lightly elevate both canopies to improve clearance from vehicular traffic.

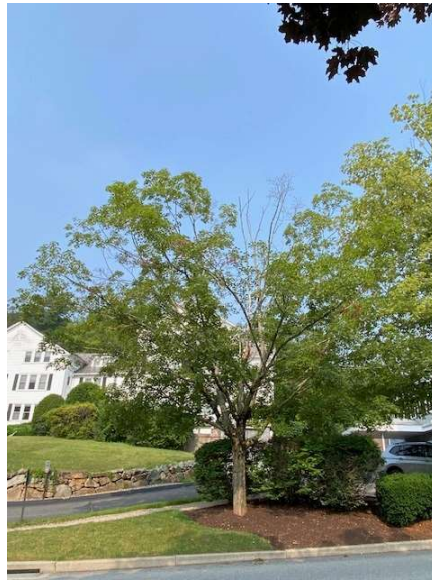
Tree 4: 15" dbh Sugar Maple *Acer saccharum* (see 3 pictures below) the southern-most tree within the planting island east of the building, along Hubbard Rd.

The above picture shows the current condition of tree 4. The central canopy lead trunk has died back to a lower three-way co-dominant stem union. The surrounding viable co-dominant stems show symptoms of decline.

I observed die-back of the central canopy leader to its connection at the base of the canopy. The remaining viable three co-dominant stems showed multiple symptoms of decline including: dwarfed foliage resulting from long term root growth restriction & root stress typical of trees growing in compacted soil and/or near to impervious surfaces. The thin volume of foliage in middle and upper half of canopy and general leaf chlorosis indicating a deficit of necessary soil moisture/nutrients/biology and/or the trees ability to uptake & effectively translocate. Most of the existing foliage displays symptoms of infection, likely maple leaf blister and anthracnose; both considered secondary stressors occurring on trees in decline from environmental stressors.

Taking into consideration the die-back in the central leader, known element of dead/decaying internal wood at the canopy's primary connection point and extent of symptoms of decline in remaining major canopy parts it is fair to say this tree has been declining in health and losing structural integrity for several years. Considering the canopy size, proximity to sidewalks, driveway and roads there is an increased risk of damage or injury when portions of the tree fail. My recommendation is to take this tree down.

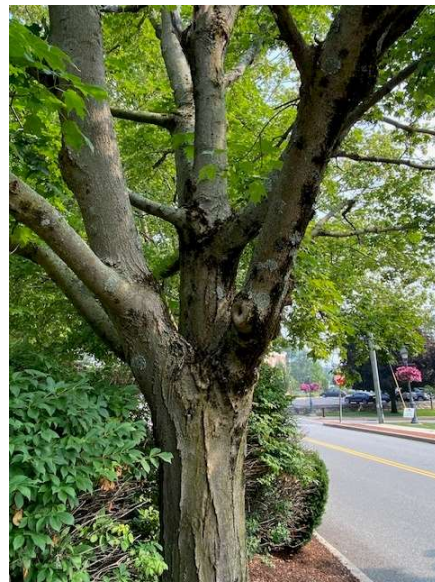
Above left focuses on the dead central lead trunk. Above right focuses on primary connection of three co-dominant stems.

At the base of the canopy three co-dominant stems connect. The previous central leading trunk has been girdled by the co-dominant stems. This dead central trunk is an indicator of dead/decaying wood inside the tree where the three remaining stems merge. Dead/decaying interior wood increases the risk of future stem failure. Symptoms of decline in each of the three co-dominant stems whose primary connection to the tree is compromised is concerning.

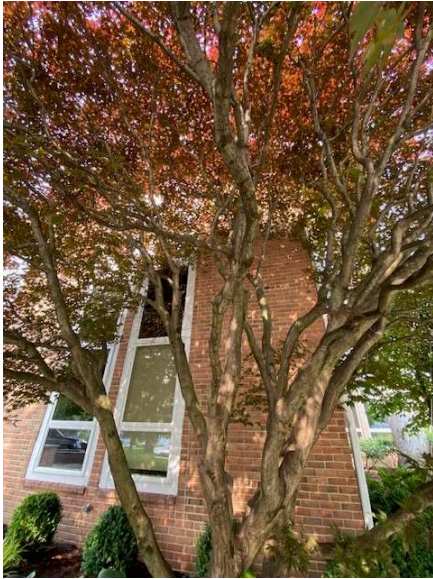
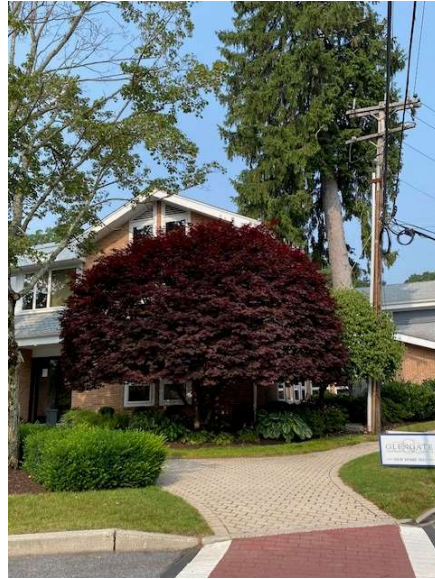
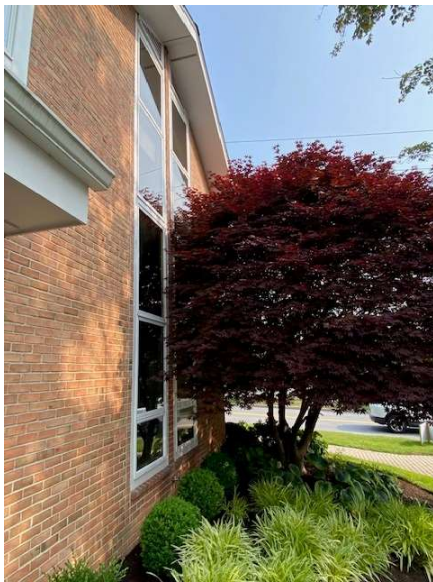
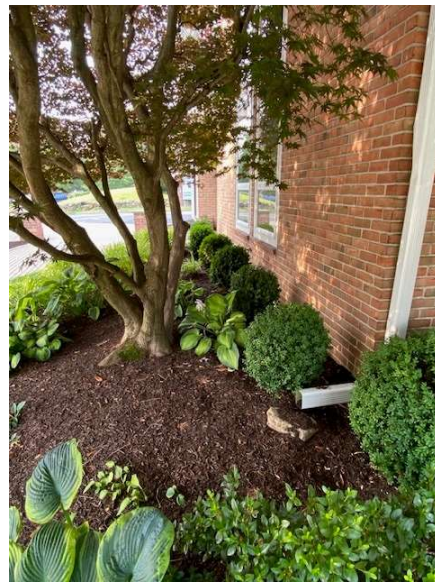
Tree 5: Multi-stem Japanese Maple *Acer palmatum* (see 4 pictures below) located in the eastern building foundation planting bed.

The four pictures above show the trees location, canopy size and proximity of both canopy and root system to neighboring structure.

This is a semi-mature Japanese maple, in good health planted approximately 4' from the foundation of the building. Over the course of several decades this tree outgrew its planting site and is brushing against/interfering with the building windows, trim, brick and mortar. The trees root system adapted well to the site and continual pruning has and will encourage aggressive annual canopy growth. The healthy canopy is a reflection of a healthy root system, abutting the building foundation potentially causing harm to the structure. I recommend removing and replacing this with a smaller, native ornamental tree or large, native ornamental shrub.

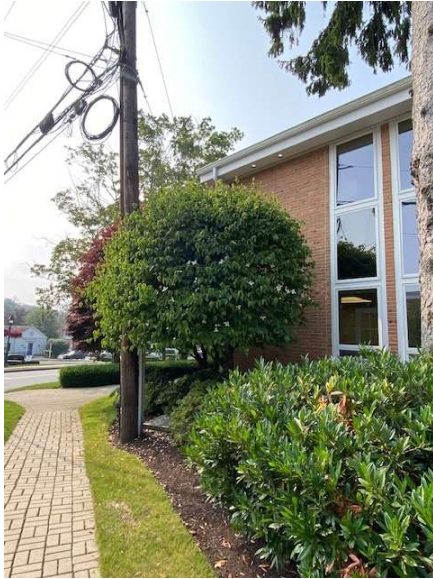
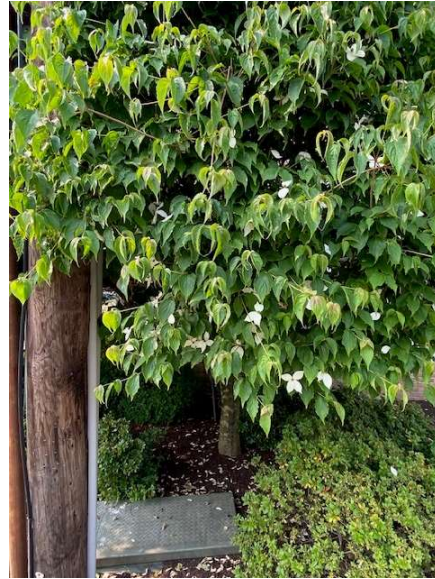
Tree 6: 8" dbh Kousa Dogwood *Cornus kousa* (see 2 pictures below) located in the northern building foundation planting bed, nearest the northeast corner of the building.

The two pictures above show the tree location, canopy size and proximity of both canopy and root system to neighboring structure.

This is a semi-mature Kousa Dogwood, in good health planted approximately 4' from the foundation of the building. Over the course of several decades this tree outgrew its planting site and is brushing against/interfering with the building façade. This species is valued in the landscape by its volume of large showy flowers, which on this tree are hidden beneath aggressive annual sprout growth; a result of annual façade and sidewalk clearance pruning. The aggressive canopy growth is a reflection of a healthy root system, abutting the building foundation potentially causing harm to the structure. I recommend removing and replacing this with a smaller, native ornamental tree or large, native ornamental shrub.
