APPLICATION FOR AN INTERMEDIATE REGULATED ACTIVITY

Engineering Summary Proposed Culvert Repair 26 Ledgewood Drive, Wilton, CT Map 128, Lot 24

> CULVERT REPAIR PLAN 26 LEDGEWOOD DRIVE WILTON, CONNECTICUT

Wetland Delineation Report

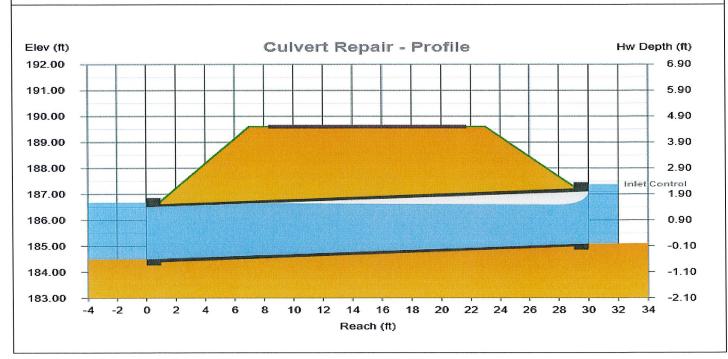
Discharge			Velocity		Depth		HGL @ Hw/D = 1.13		
Total	Culvert	Over Top	Down	Up	Down	Up	Down	Up	Hw
(cfs)	(cfs)	(cfs)	(ft/s)	(ft/s)	(in)	(in)	(ft)	(ft)	(ft)
15.26	15.26	0.00	4.86	6.05	24.0	18.0	186.67	186.60	187.37

Notes:IDF Curves = Atlas14-IDF.idf; Tailwater = Channel 1, Id = Lachat Stream, Velocity = 0.51 ft/s, Tailwater Elev. = 186.67 ft

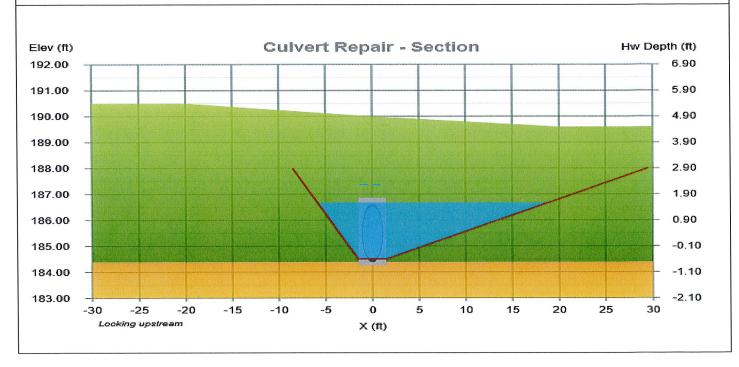
Discharge			Velocity		Depth		HGL @ Hw/D = 1.13		
Total	Culvert	Over Top	Down	Up	Down	Up	Down	Up	Hw
(cfs)	(cfs)	(cfs)	(ft/s)	(ft/s)	(in)	(in)	(ft)	(ft)	(ft)
15.26	15.26	0.00	4.86	6.05	24.0	18.0	186.67	186.60	187.37

Notes:IDF Curves = Atlas14-IDF.idf; Tailwater = Channel 1, Id = Lachat Stream, Velocity = 0.51 ft/s, Tailwater Elev. = 186.67 ft

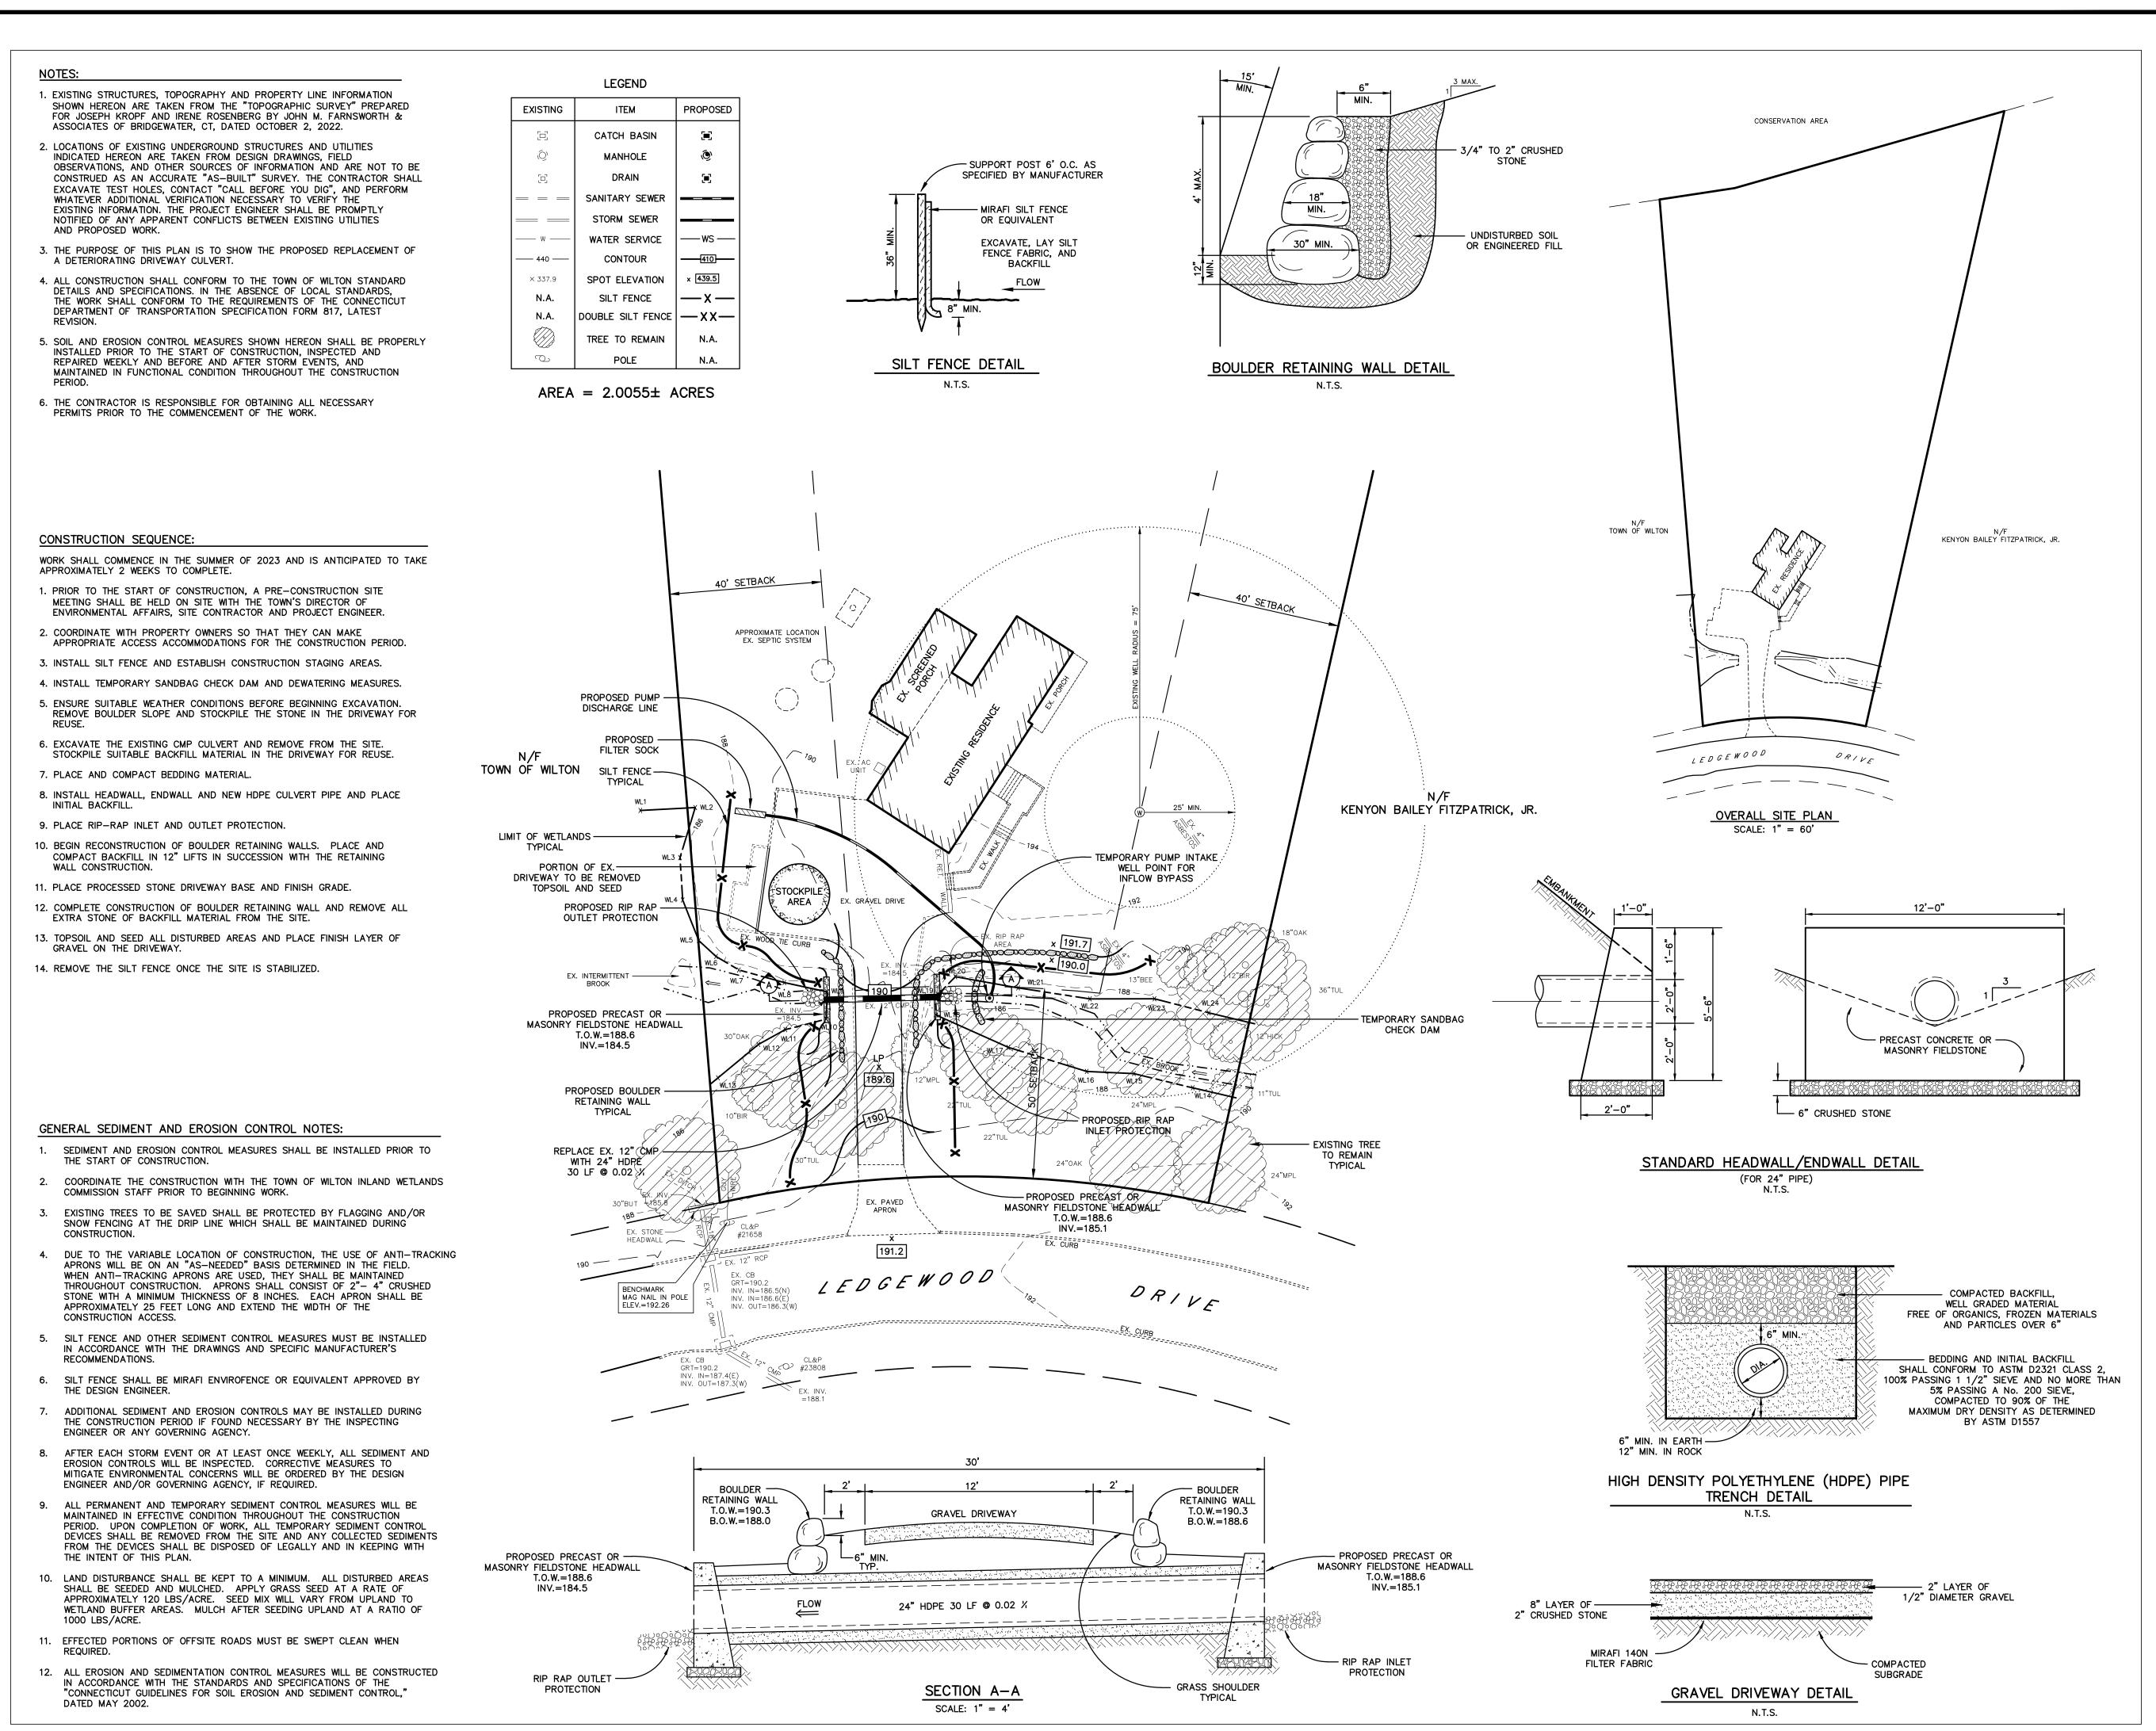
The "Culvert Repair Plan" shows silt fence to protect the stream and banks during construction. It also includes a construction sequence outlining the critical steps of the repair. Work will be staged from the existing driveway which will protect the existing vegetation. One 12" Maple will need to be removed to facilitate construction. Stones and boulders from the existing slopes will be reused in the new construction. It is also anticipated that the soil excavated can be reused for general backfill. Approximately 35 cubic yards of clean aggregate will need to be imported for bedding the new pipe and replacing the disturbed portion of the gravel driveway. Excess material from the project will be removed from the site.

A 24" diameter HDPE pipe is proposed to replace the existing culvert in the same location. The larger diameter pipe will be less prone to clogging and easier to maintain. The stone and boulder slopes will be removed and the stone will be repurposed in the new construction. Two terraced walls will support the banks along the driveway. The lower terrace will consist of 4' high precast concrete or masonry fieldstone headwalls at the pipe inlet and outlet. The upper terrace will consist of a 2' high boulder wall. The boulder wall is also proposed to extend along the edge of the lawn to the north in order to stabilize the existing banks. Additionally the existing gravel parking area will be trimmed back near the southern property line, creating greater separation from the large wetlands area. The "Culvert Repair Plan" prepared for Joseph Kropf and Irene Rosenberg by this office details the proposed work.
