McChord Engineering Associates, Inc.
Civil Engineers and Land Planners

June 16, 2020

Re: Engineering Summary
Proposed Culvert Repair
68 McFadden Drive, Wilton, CT
Map 85, Lot 13

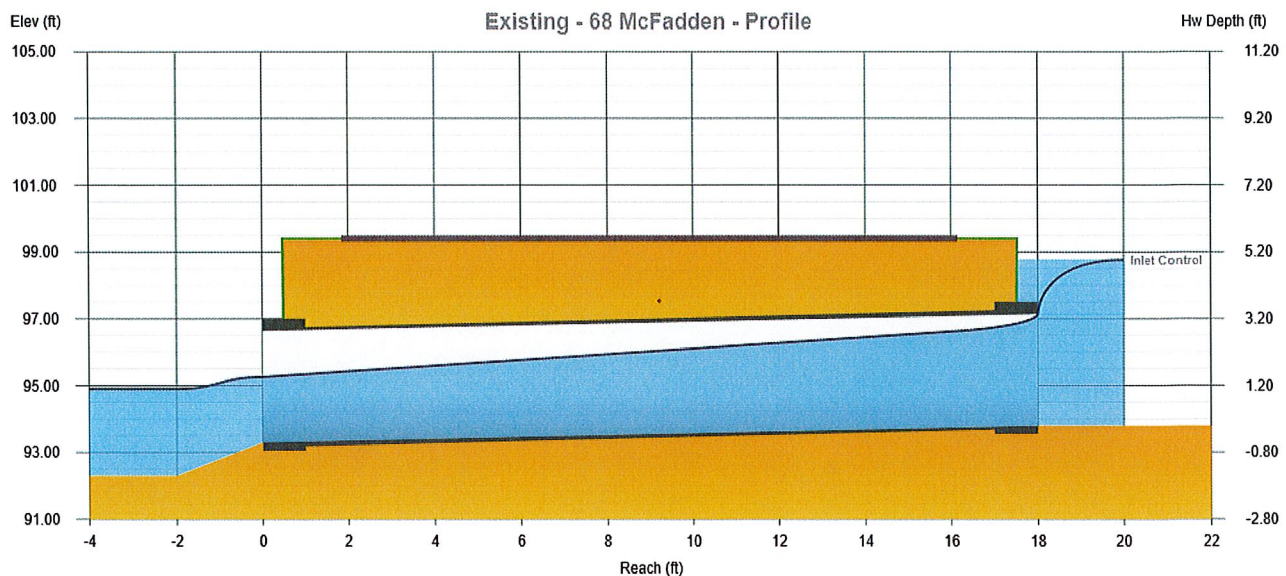
Existing - 68 McFadden

Discharge			Velocity		Depth		HGL @ Hw/D = 1.49		
Total	Culvert	Over Top	Down	Up	Down	Up	Down	Up	Hw
(cfs)	(cfs)	(cfs)	(ft/s)	(ft/s)	(in)	(in)	(ft)	(ft)	(ft)
217.70	217.70	0.00	12.05	8.81	23.5	35.8	95.26	96.79	98.76

Notes: IDF Curves = Atlas14-IDF.idf; Tailwater = Channel 1, Id = Sample Channel, Velocity = 7.61 ft/s, Tailwater Elev. = 94.90 ft

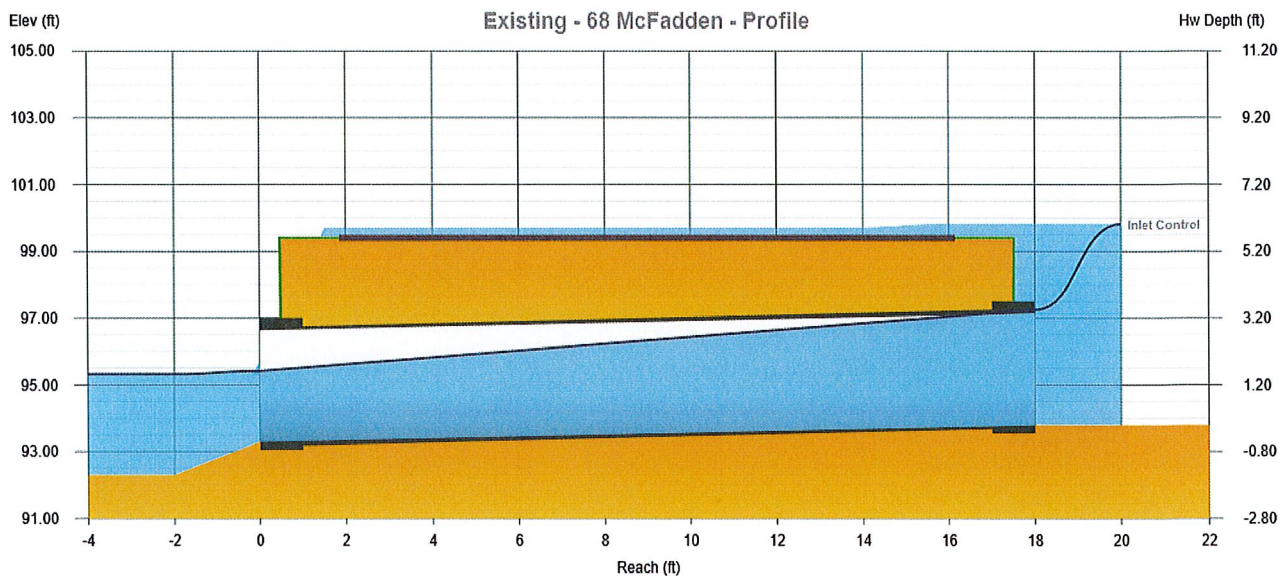
Existing - 68 McFadden

Discharge			Velocity		Depth		HGL @ Hw/D = 1.81		
Total	Culvert	Over Top	Down	Up	Down	Up	Down	Up	Hw
(cfs)	(cfs)	(cfs)	(ft/s)	(ft/s)	(in)	(in)	(ft)	(ft)	(ft)
269.56	256.59	12.97	13.30	9.97	25.4	40.0	95.41	97.25	99.82

Notes: IDF Curves = Atlas14-IDF.idf; Tailwater = Channel 1, Id = Sample Channel, Velocity = 8.11 ft/s, Tailwater Elev. = 95.32 ft

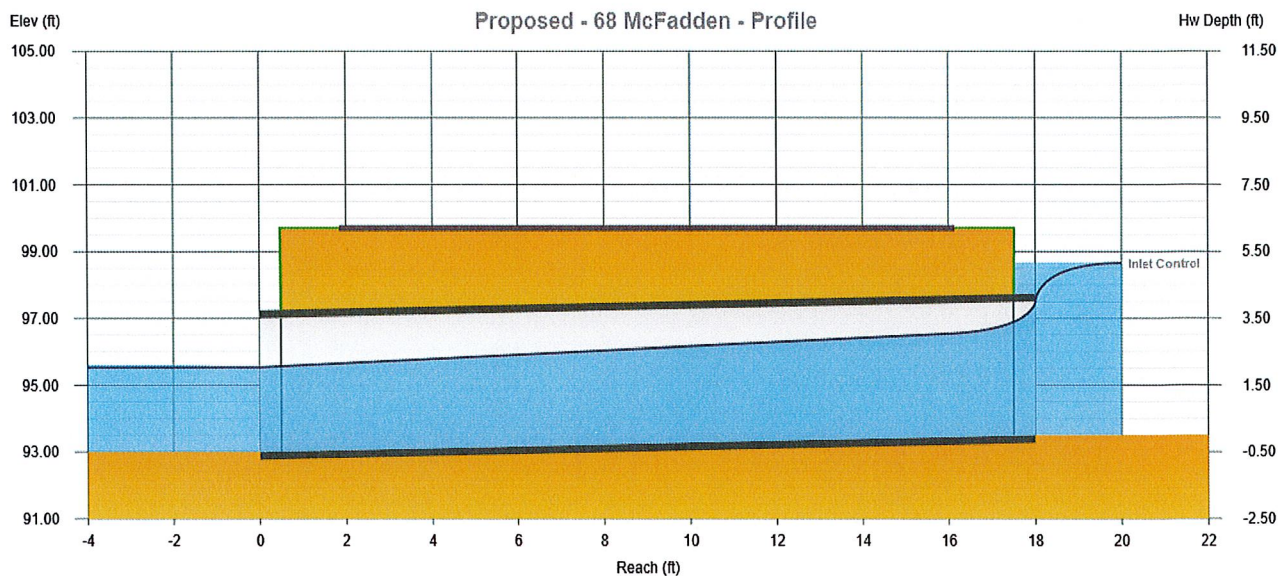
Discharge			Velocity		Depth		HGL @ Hw/D = 1.29		
Total	Culvert	Over Top	Down	Up	Down	Up	Down	Up	Hw
(cfs)	(cfs)	(cfs)	(ft/s)	(ft/s)	(in)	(in)	(ft)	(ft)	(ft)
217.70	217.70	0.00	12.98	10.22	30.4	37.9	95.53	96.66	98.66

Notes: IDF Curves = Atlas14-IDF.idf; Tailwater = Channel 2, Id = Sample Channel, Velocity = 7.61 ft/s, Tailwater Elev. = 95.60 ft

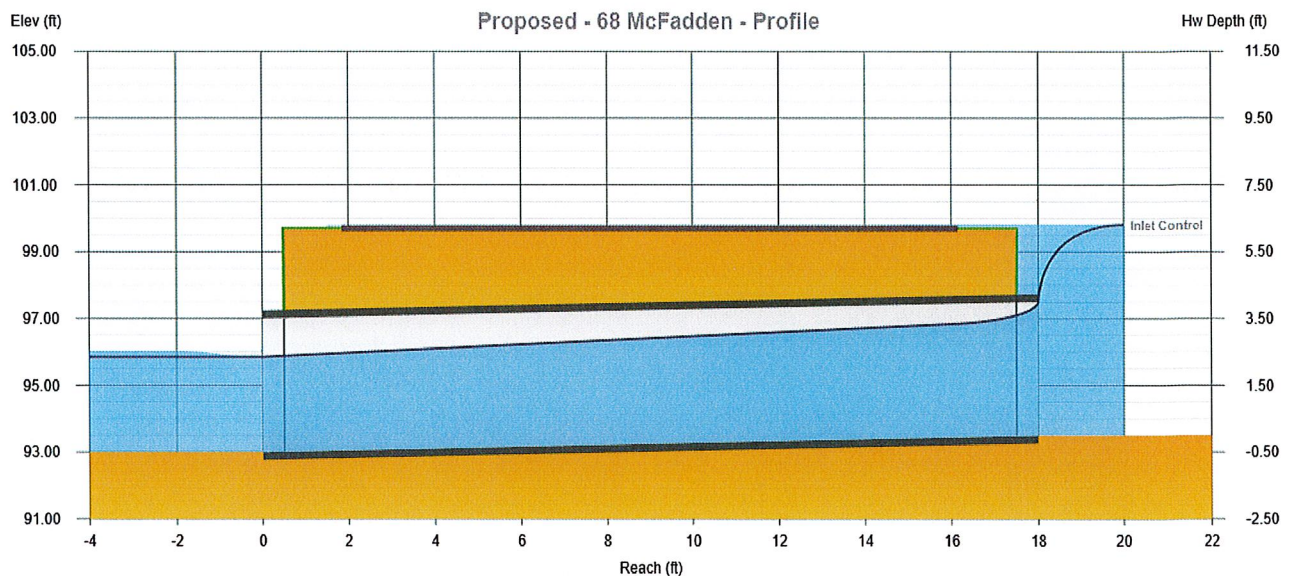
Discharge			Velocity		Depth		HGL @ Hw/D = 1.58		
Total	Culvert	Over Top	Down	Up	Down	Up	Down	Up	Hw
(cfs)	(cfs)	(cfs)	(ft/s)	(ft/s)	(in)	(in)	(ft)	(ft)	(ft)
269.56	267.90	1.66	13.98	11.59	34.2	41.5	95.85	96.96	99.81

Notes: IDF Curves = Atlas14-IDF.idf; Tailwater = Channel 2, Id = Sample Channel, Velocity = 8.11 ft/s, Tailwater Elev. = 96.02 ft
