Home Inspection Report

197 Catalpa Road
Wilton, CT 06897

Date of Inspection: 10/13/2020

Inspection No. 27233-4300

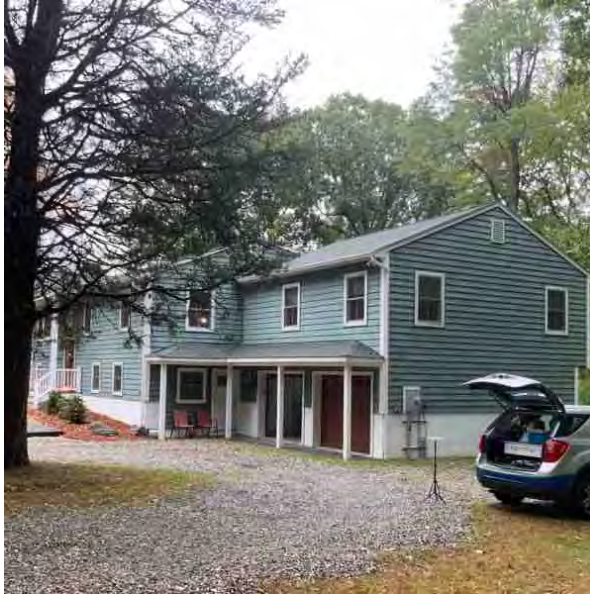
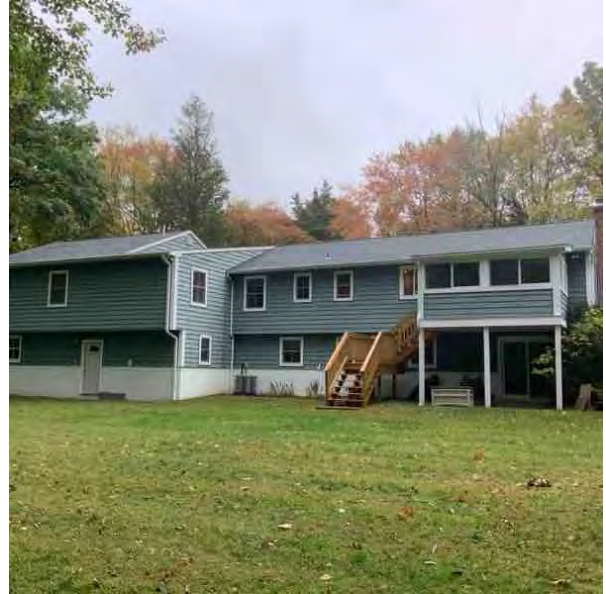
1.1.1 The subject is an attractive 1966 raised ranch style home with a built-in two car garage.

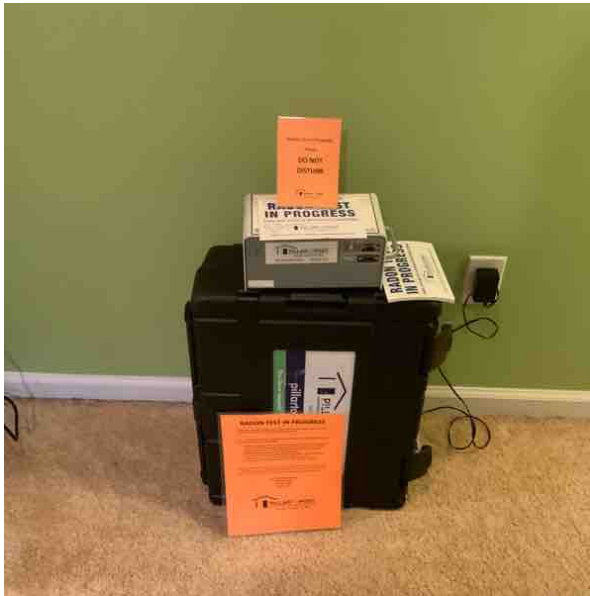
7.10.1 A Sun Nuclear computerized continuous radon monitor was placed for a minimum 48 hour exposure and measurement period. The device will be retrieved and read on-site at the conclusion of the test period. The radon-in-air test results read onsite were 2.4 pCi/L. A written report will be e-mailed to you and your Realtor the same day.

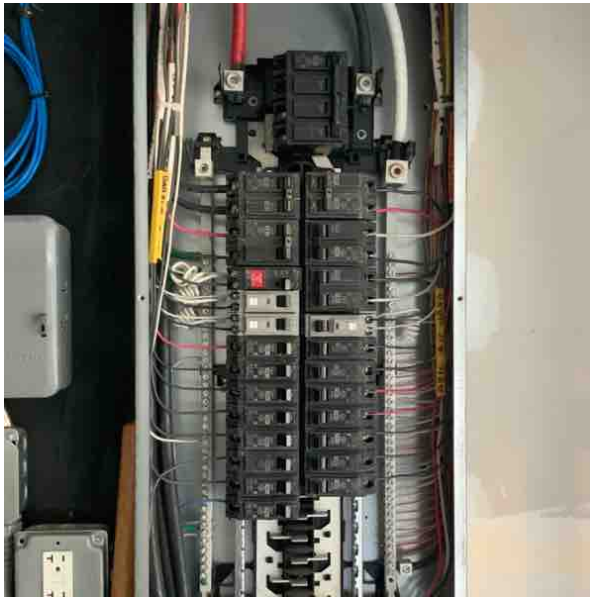
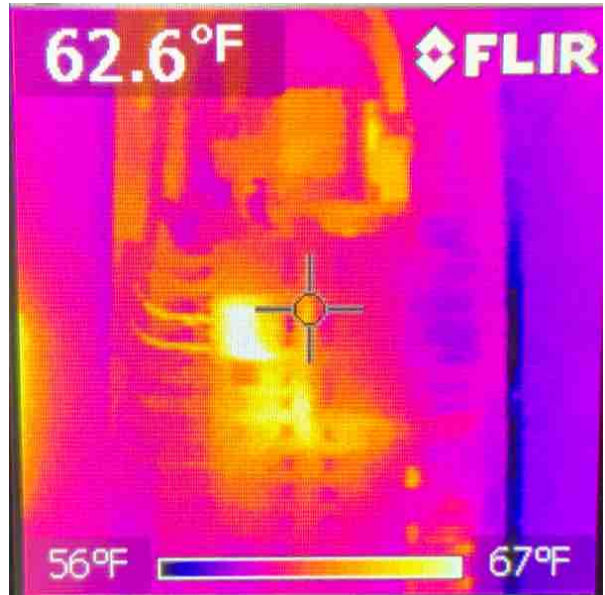
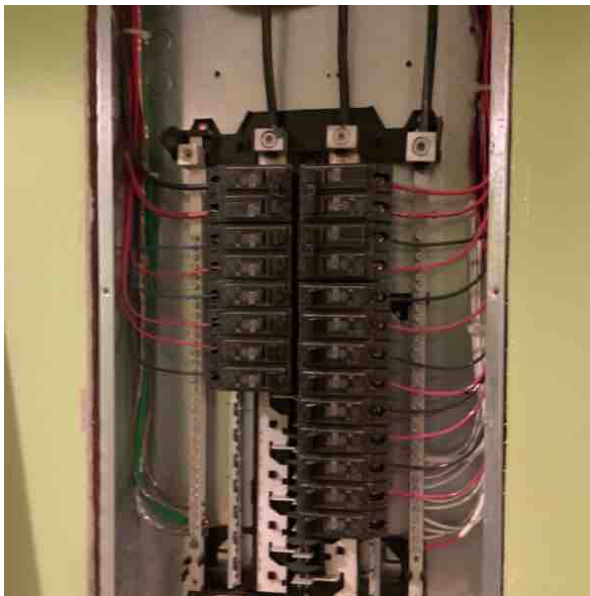
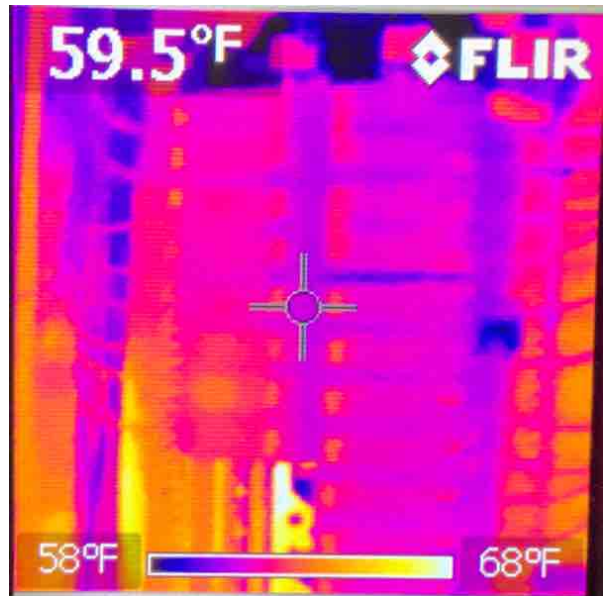
8.2.1 An infrared scan of the electrical distribution panel, wall switches and receptacles was performed under load. Unless otherwise noted, the thermography scan did not reveal any instances of overheating of conductors, circuit breakers, switches or outlets at the time of the inspection.
