## FACILITY CONDITION ASSESSMENT

# FIRE HEADQUARTERS

238 Danbury Road  
Wilton, Connecticut

January 23, 2024

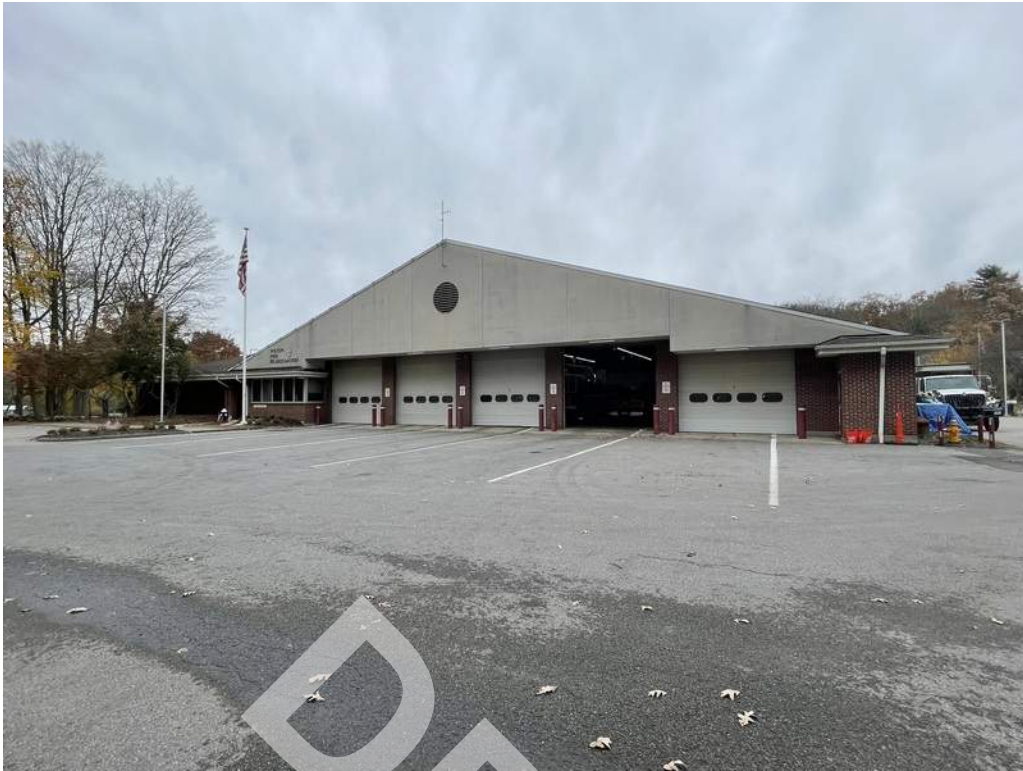
1 - Overview of the building.

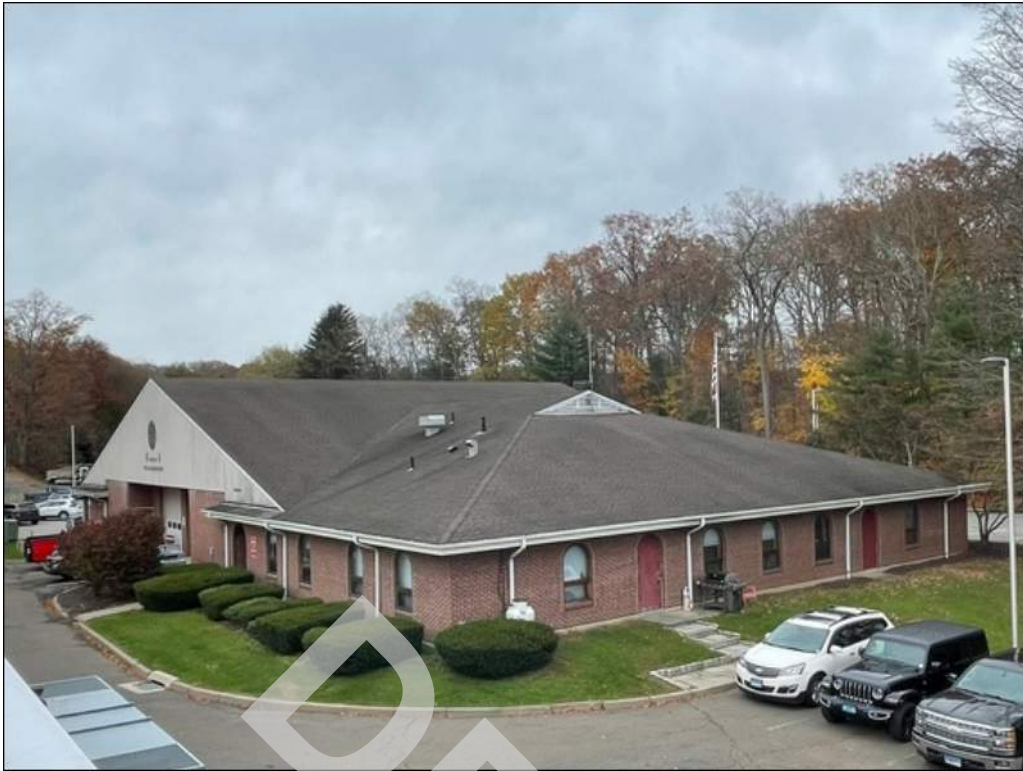
7 - Roof consists of asphalt shingles.

#	Item	QTY	Unit	Unit Cost	EUL	EFF Age	Year 1	Year 2	Year 3	Year 4	Year 5	Year 6	Year 7	Year 8	Year 9	Year 10	Total Cost	Comments	
9	Building Integrity: Based on the design and recommendations from the roof consultant, repair, replace, or provide new gutter and leaders throughout the roof.	1	LS																Priority 3 - Necessary - Not Yet Critical.
10	Energy: Portions of the sloped roof could be considered for the addition of photovoltaic (PV) solar panels. Engage the services of a registered Structural Engineer to perform an analysis to determine if the structure can support the added loads of a PV system as well as a qualified party to perform a feasibility study, including a solar analysis. Based on the results of a preliminary structural and solar analysis, consideration could be given to the addition of PV panels on the roof. The results of the analysis will determine the system's limitations and requirements. PV solar panels can provide the building with a renewable, clean source of energy.	1	LS																Priority 4 - Recommended

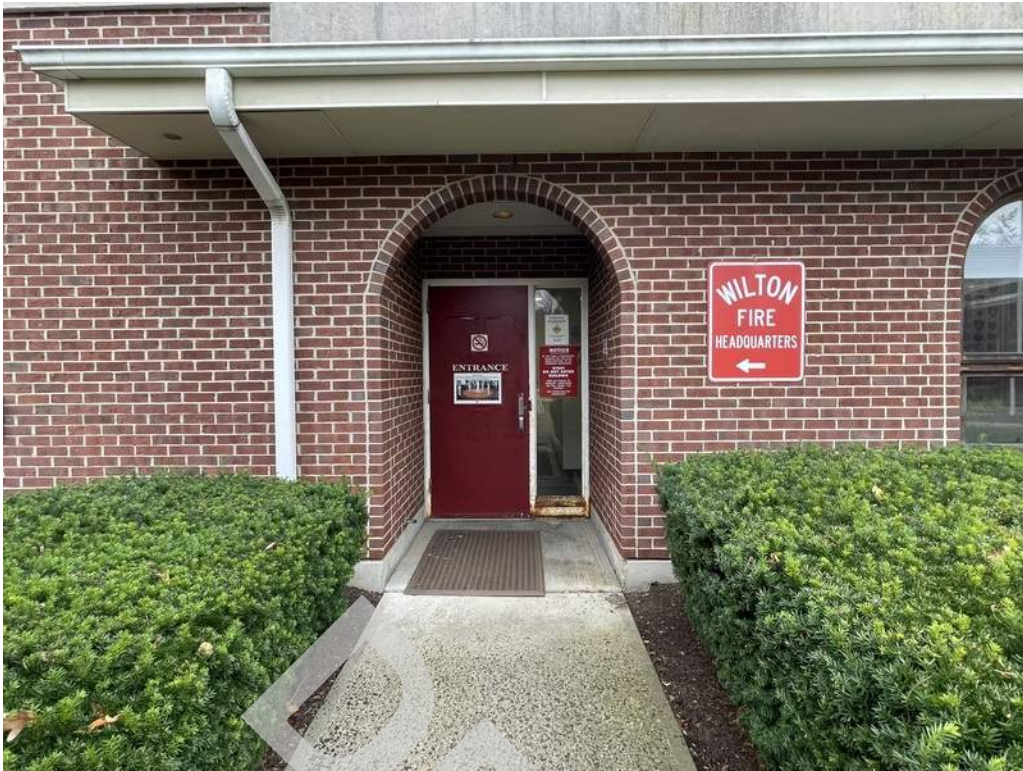
9 - Roof gutter and leaders are provided throughout the roof perimeter.

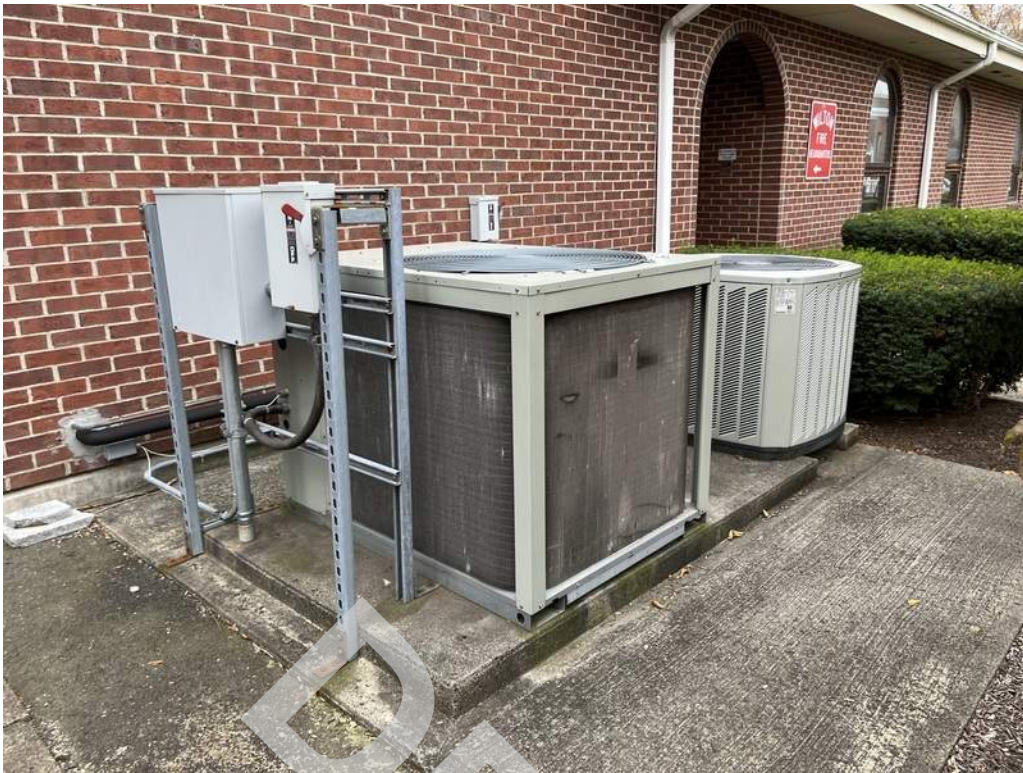
19 - Split system air conditioning units are located on the exterior of the building and provide cooling throughout the building.

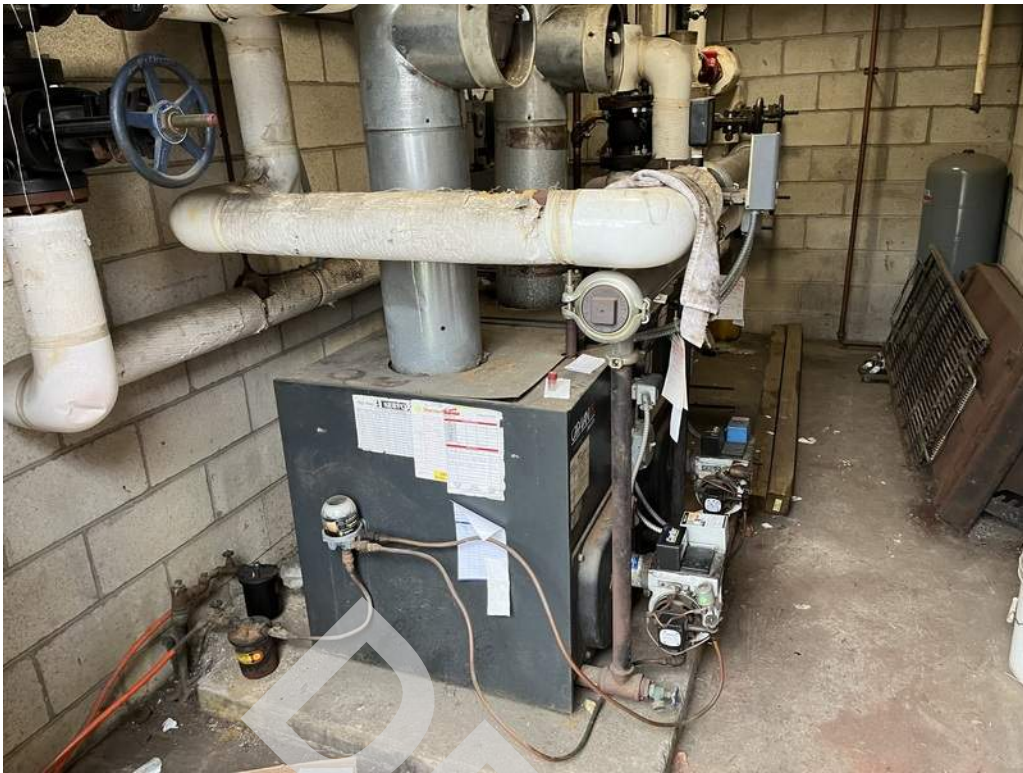
21 - Two oil fired boilers provide heating hot water throughout the building.

#	Item	QTY	Unit	Unit Cost	EUL	EFF Age	Year 1	Year 2	Year 3	Year 4	Year 5	Year 6	Year 7	Year 8	Year 9	Year 10	Total Cost	Comments
<b>MECHANICAL/ELECTRICAL/PLUMBING</b>																		
20	Building Integrity: Four heating hot water boilers provide heating to the building. The boilers are located in a mechanical room, and each are rated for 300,000 British Thermal Units (BTU) per hour. The boilers were installed in approximately 2000 and reportedly function properly and appear to be in fair condition. Replacement of the boilers is recommended as they reach the end of their service life or as maintenance costs dictate. The budget includes a replacement in kind of the boilers with the reuse of all associated piping. The boilers were manufactured by Slant/Fin.	2	EA															Priority 3 - Necessary - Not Yet Critical
21	Building Integrity: Air-cooled, ducted split systems provide cooling to the building. There are two units located on the exterior of the building and one in the garage. Each system consists of a condensing unit and a fan coil unit. The systems have capacities ranging between two and ten tons and distributes air through overhead ductwork. Replace each system when it reaches the end of its service life or as maintenance costs dictate. The budget includes a replacement in kind of the units with the reuse of ductwork, refrigerant piping, and controls. The units were installed between 2009 and 2010 and were manufactured by Trane and Mitsubishi.	16	EA															Priority 3 - Necessary - Not Yet Critical

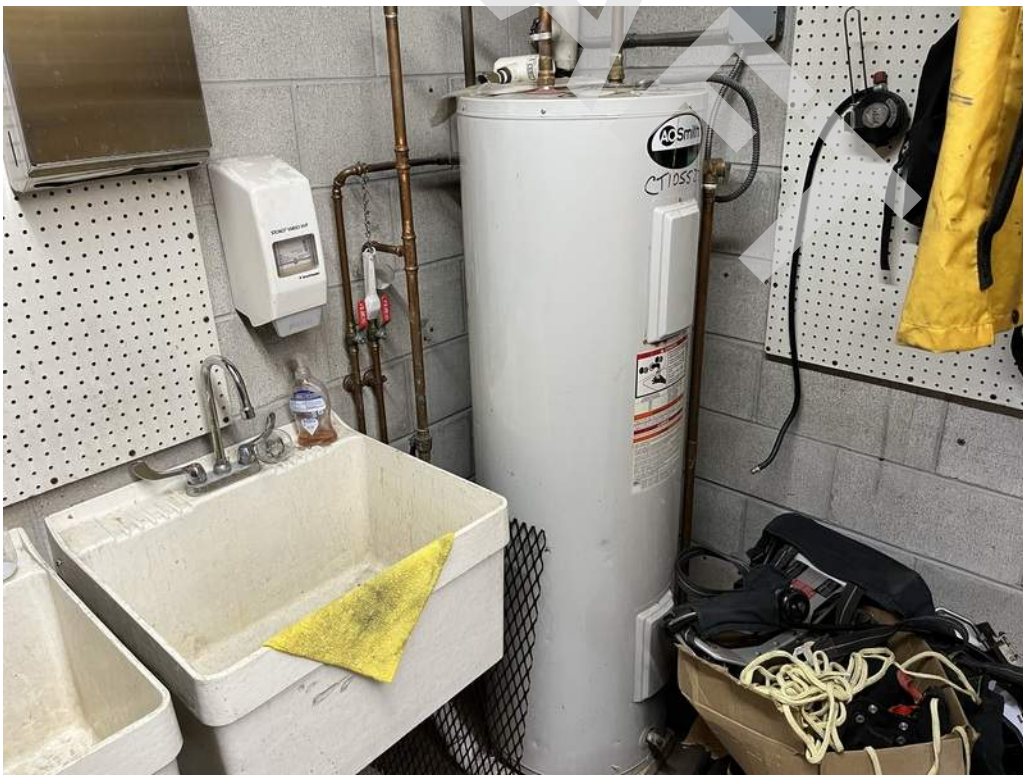
22 - An electric storage-type water heater located on the first floor provides hot water throughout the building.

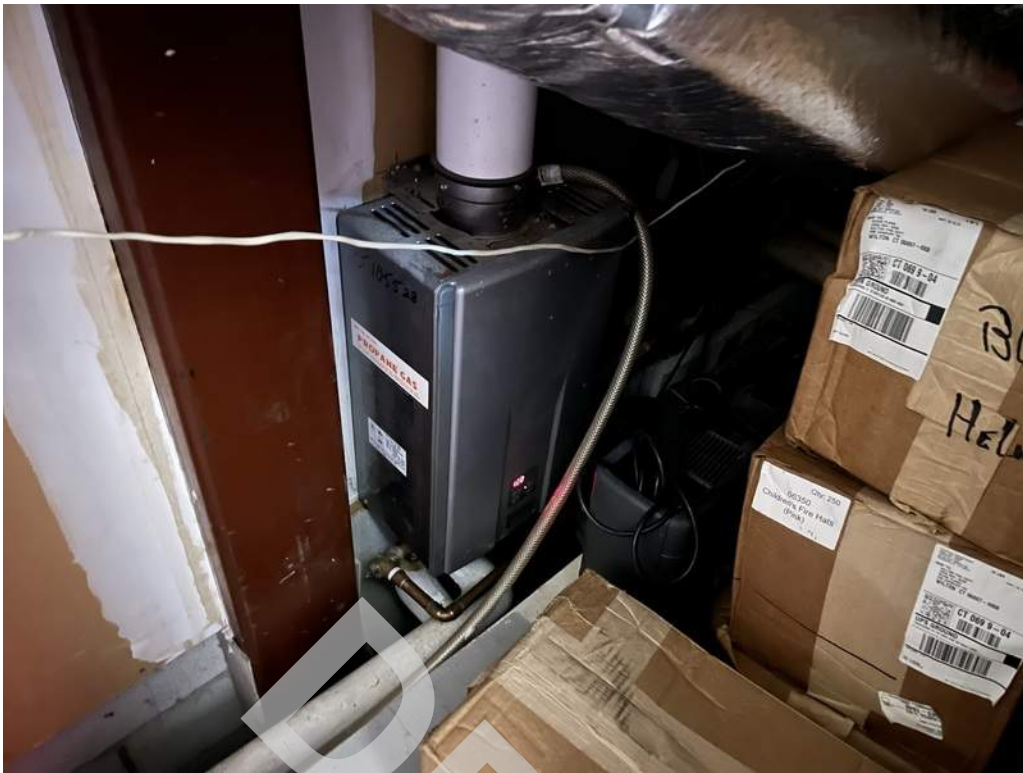
23 - A propane fired tankless water heater is located on the second floor and provides hot water throughout the building.

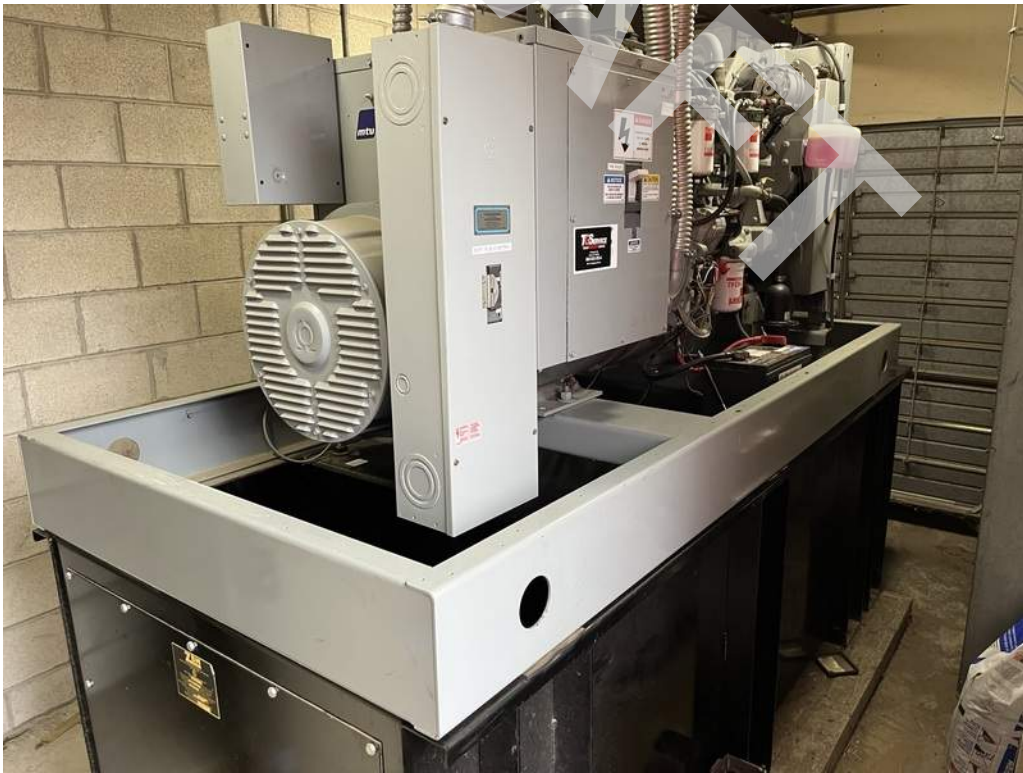
24 - A diesel-fired emergency generator located in a generator room in the Fire Headquarters provides emergency power to the Fire Headquarters and Garage buildings.

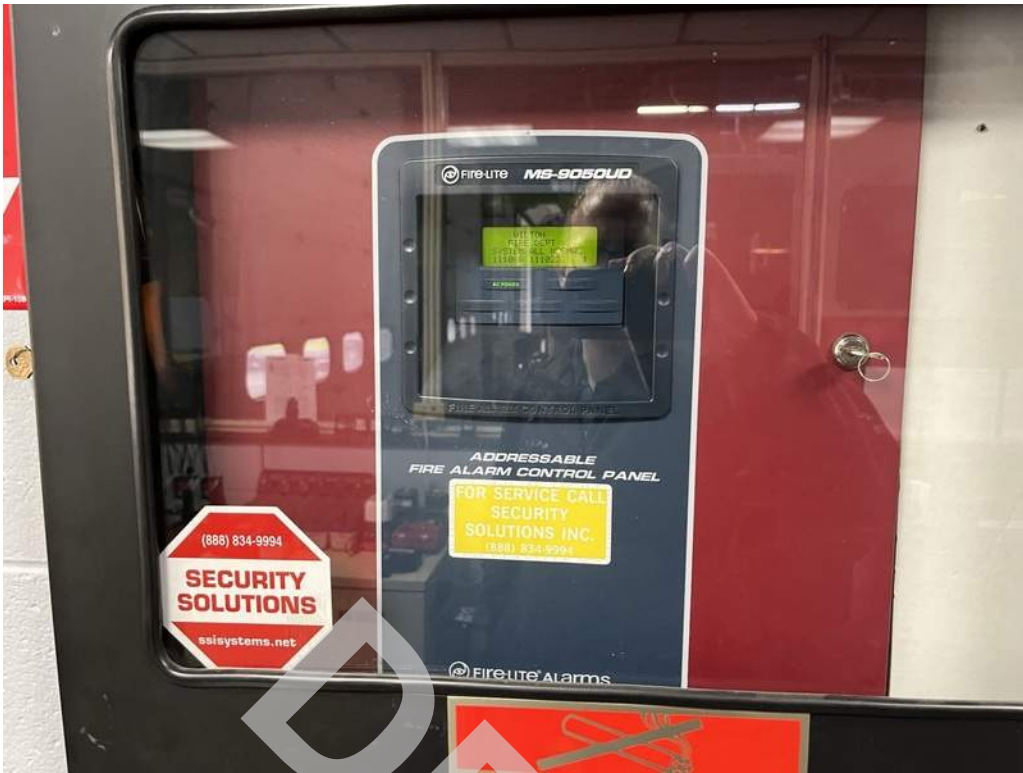
25 - The building is provided with a MS-9050UD Fire Alarm Panel.

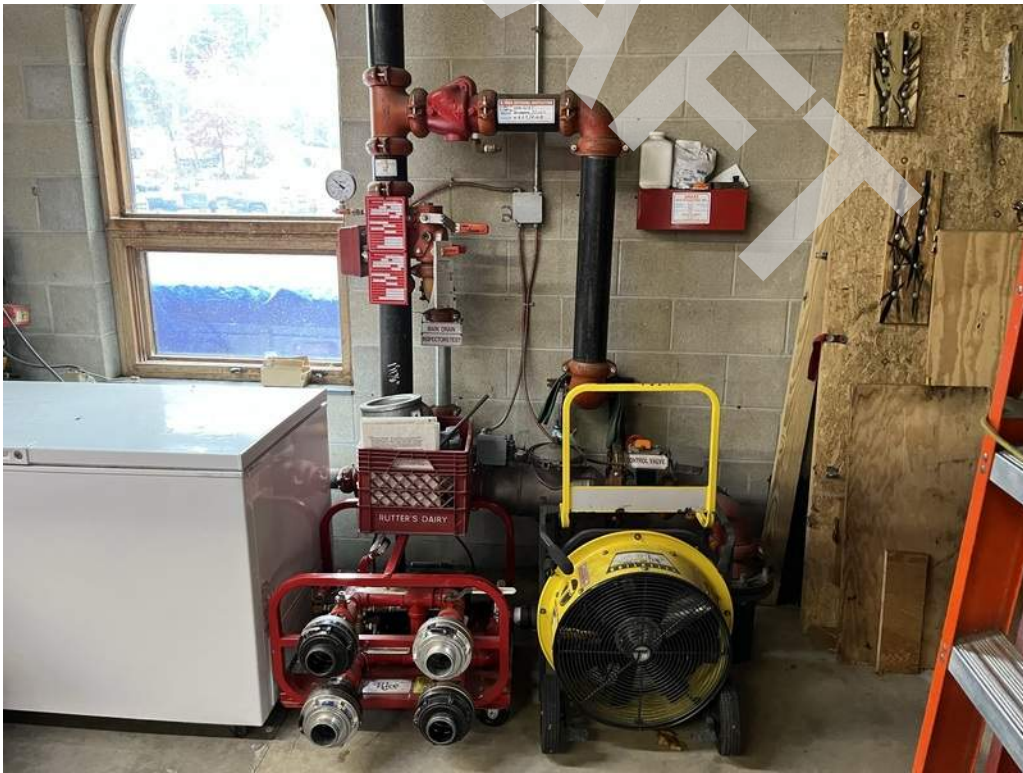
26 - The building is equipped with a wet sprinkler system.
