## 141 DANBURY ROAD SOILS TESTING

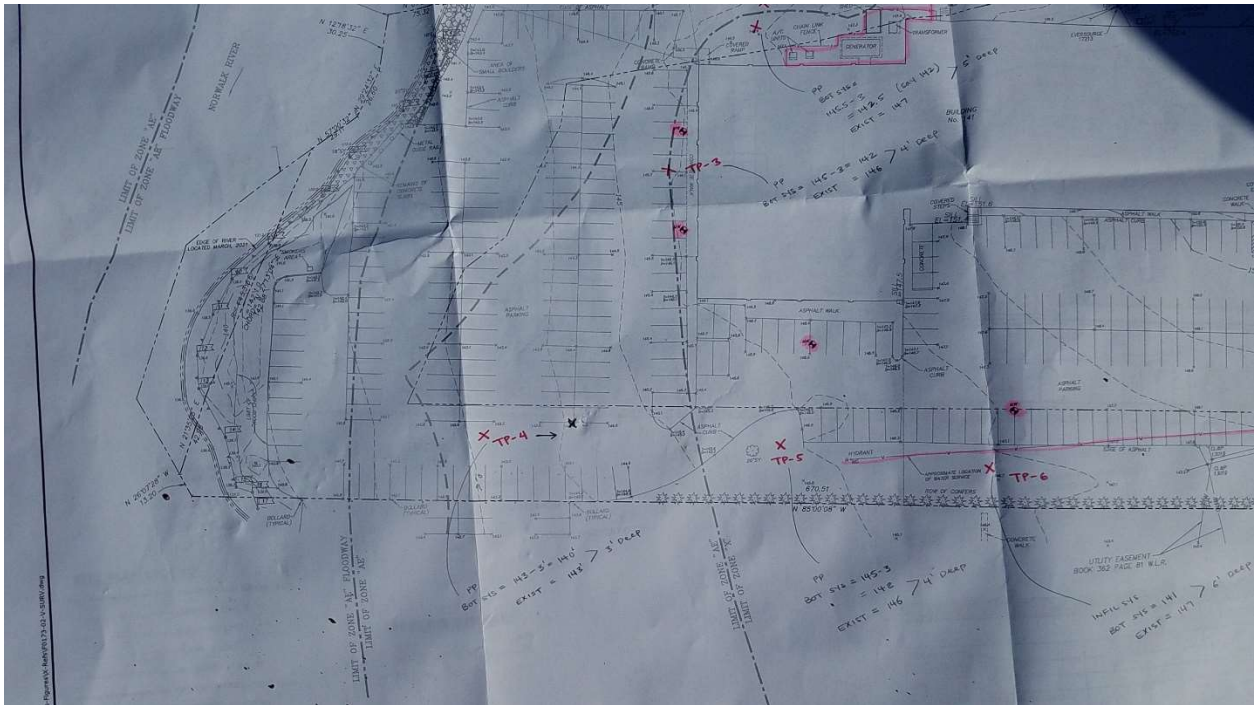
Map showing location of testing on 9/20/2021. TP-4 was located at the black X to the right of the handwritten TP-4. TP-3 was also dug yesterday. TP-5 was being dug around 12:15 pm on 9/20.

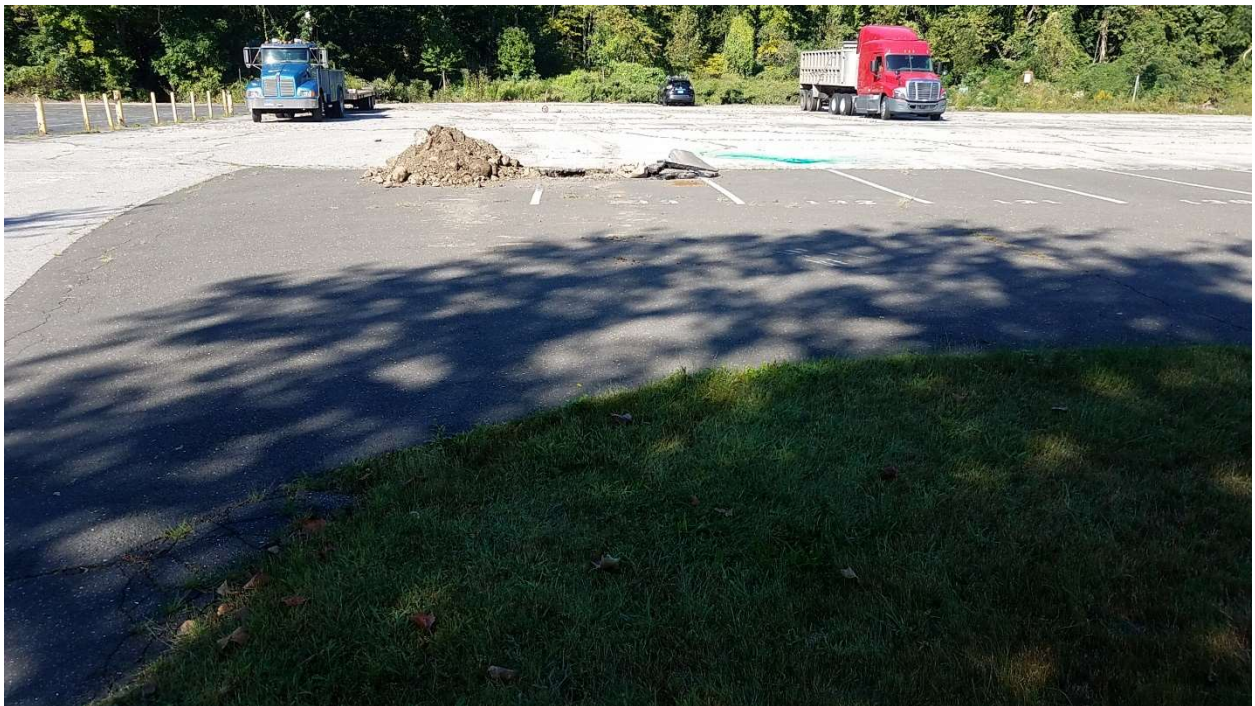
Location of TP-4 in parking area.

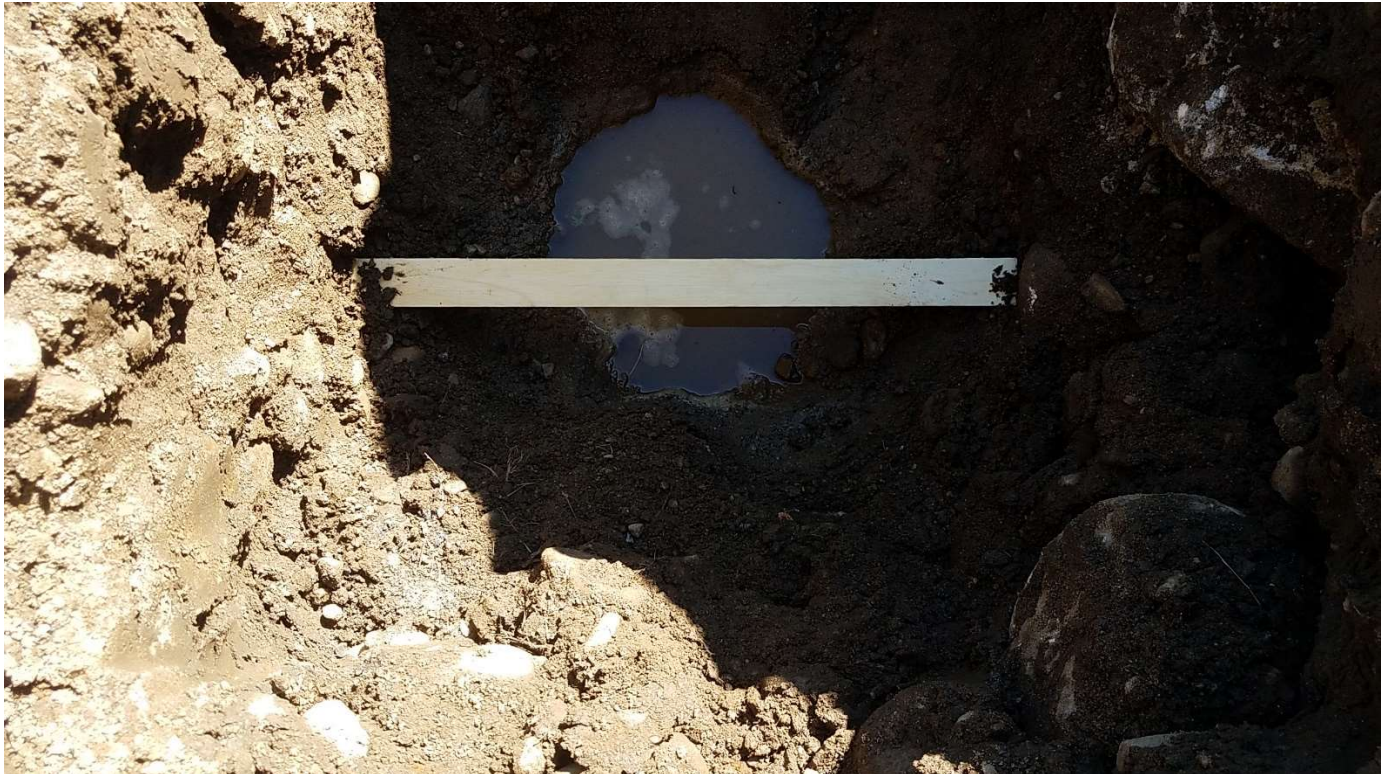
*TP-4 percolation test. Top of perc hole is 3' below pavement grade. Water level in hole did not percolate into the soil during the 30 minute +/- duration it was observed.*

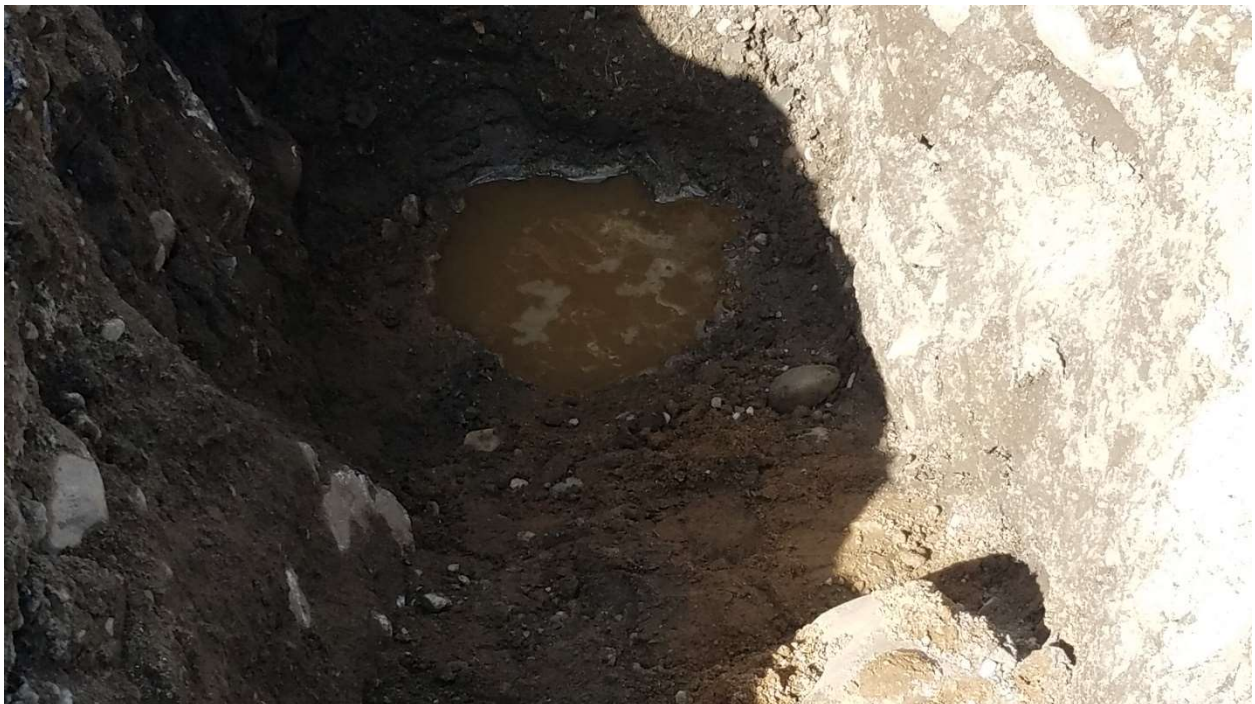
*TP-4 percolation test. Top of perc hole is 4' below pavement grade. Water level in hole again did not percolate into the soil during the 30 minute +/- duration it was observed.*

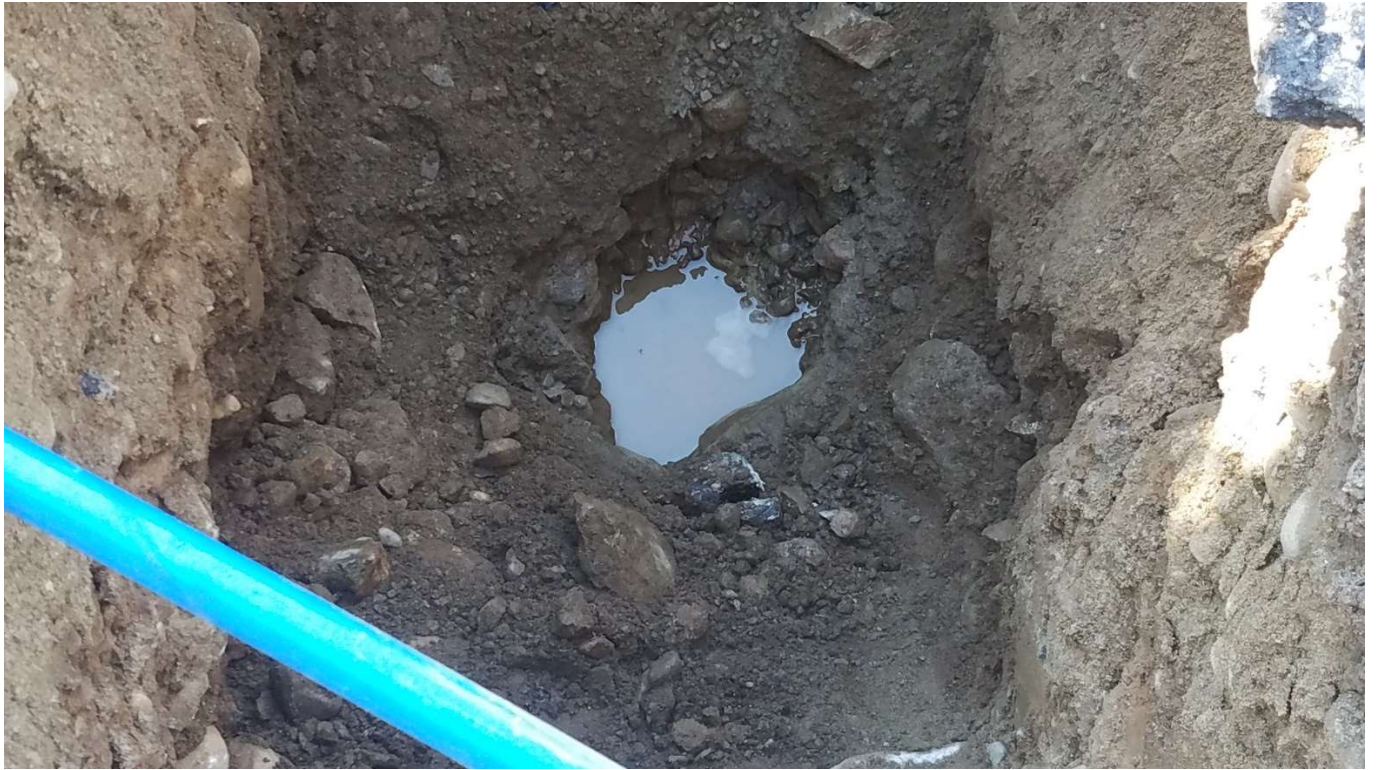
*TP-5 percolation test. Top of perc hole is 4' below pavement grade. Water level in hole readily percolated into the ground during the test.*

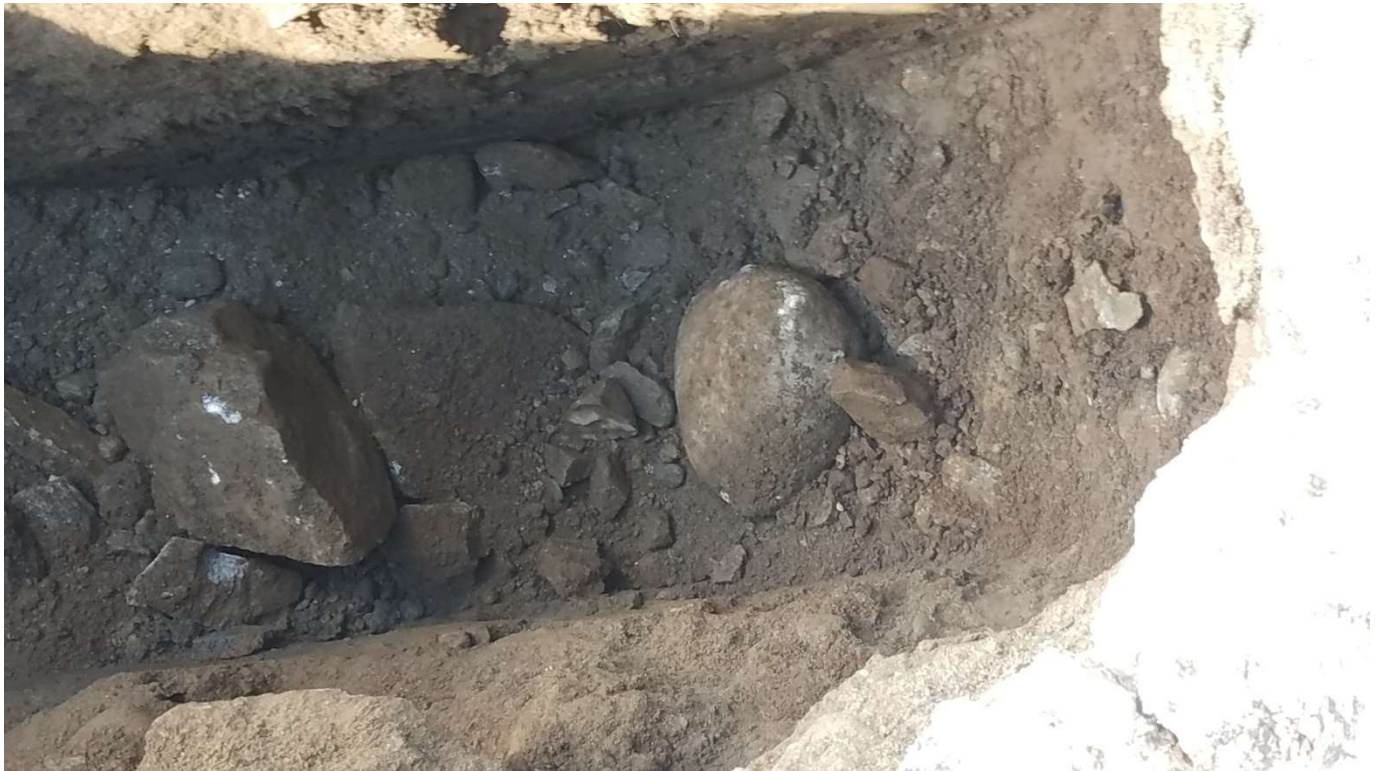
*TP-5 percolation test. Top of perc hole is 4' below pavement grade. Water level in hole readily percolated into the ground during the test.*
